DEMORY, TENN.  
13615-W8400 7.5  
1952  
PHOTOREPRODUCED (1971)

LANDSLIDES AND RELATED FEATURES

OF THE DEMORY, TENN. QUADRANGLE  
by  
Röger E. Thomas and Alfred R. Taylor

U.S. Geological Survey  
OPEN FILE MAP 82-653(C-16)

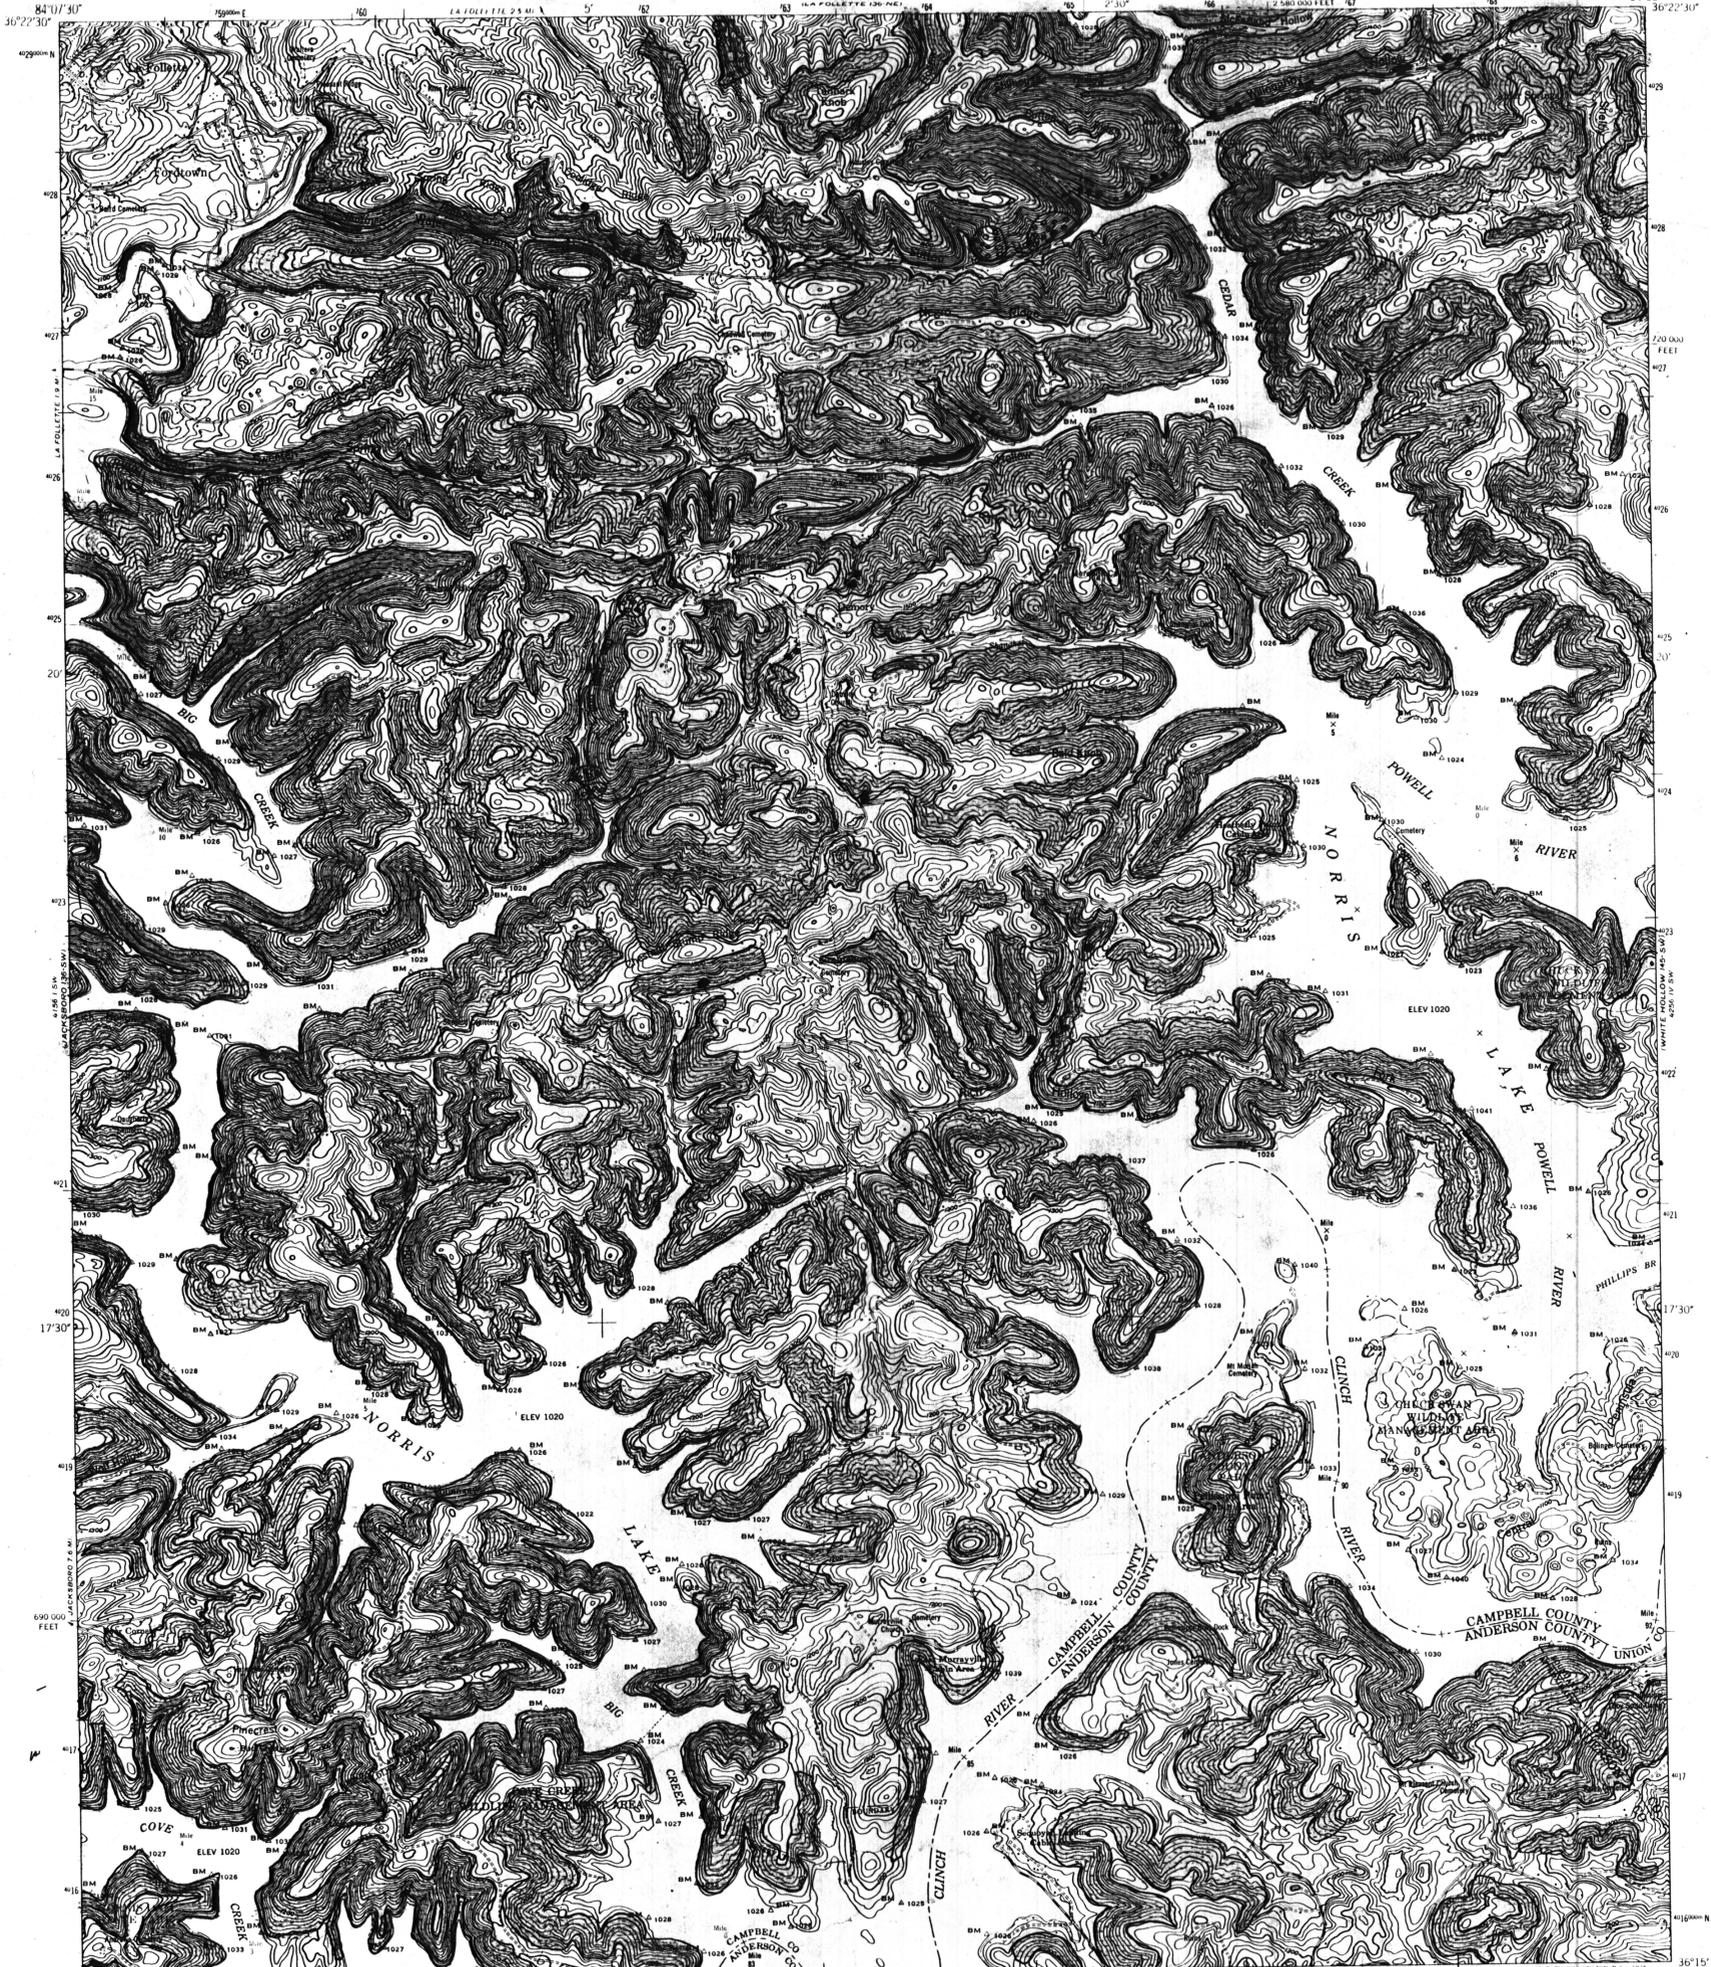
Landslides and related features interpreted  
from field check 1982.

**ACTIVE OR RECENTLY ACTIVE LANDSLIDE**  
Complex landslide composed of earthflow, debris slide, earth and rock slump. Identified from historical records, and from scars, debris and other field evidence. Ground extremely unstable; sliding accelerated by excavation, loading and changes in drainage conditions. May include areas with several active slides too small to be shown separately. Questioned where doubtful.

**OLD LANDSLIDE**  
Area of extensive hummocky ground caused by earthflow and earth and rock slump. Lacks clear evidence of active sliding. Relatively stable in natural, undisturbed state, generally not affected by small structures properly sited in areas away from the edge of the toe; can be reactivated by extensive, rapid excavation, loading, and changes in ground water and surface water conditions. Area of old landslide probably includes recent ones not identified from field evidence or otherwise documented. Upslope boundary of landslide generally defined by modified scarp, but downslope (toe) may be gradational and not well defined. Questioned where doubtful.

**COMBINATION LANDSLIDE**  
Area of recent and old slides in which individual slides are not identified.
-

**COLLUVIAL SLOPE**  
Valley wall along major streams with slope as steep as 40° (85%); stony, clayey silt soil up to 50 ft. (15 m) thick; commonly buttressed by a terrace or bench at the toe of the slope; very susceptible to sliding by cutting of toe area, removal of terrace or bench, and overloading; slide commonly activated without apparent cause.

**COLLUVIAL SLOPES WITH LANDSLIDES**  
Landslides too small or obscure to map individually.
-

**AREAS SUSCEPTIBLE TO DEBRIS FLOWS AND DEBRIS AVALANCHES**  
Primarily shallow, narrow ravines and chutes with accumulation of stony colluvium generally 10 ft. (3 m) or less in thickness; susceptible to rapid movement during intense rainfall. Most ravines and chutes designated show evidence of former debris flows and avalanches.

**AREAS SUSCEPTIBLE TO ROCKFALL**  
Steep, locally vertical, natural and man-made slopes and cliffs, 15 ft. (4.5 m) or more high; formed dominantly of sandstone, limestone, sandy shale, mudstone and claystone. Interbedded mudstone, claystone and shale weather rapidly leaving sandstone and limestone rock faces unsupported.

**SOIL AND ROCK SUSCEPTIBLE TO LANDSLIDING**  
Soil and rock similar to that involved in landslides elsewhere in map area; primarily areas underlain by claystone, mudstone and shale associated with other rock types. Rock weathers rapidly on exposure forming clayey soil highly susceptible to sliding. Includes coves (U-shaped, shallow valleys) containing thick layers of clayey soil that are very susceptible to sliding where excavation breaks continuity of slope and where overloaded by artificial fill.

**AREAS LEAST PRONE TO LANDSLIDES**  
Map areas in which no patterns or symbols are shown; primarily valley floors, ridge tops and broad benches; modification by excavation and fill may lead to local landslides.

**NOTE**  
Information shown is intended as a general guide to ground conditions as of the date of field check. Additional landslides and rockfalls should be anticipated in all map units. The map unit depicts the dominant condition in the area delineated and variations in slope stability may occur at any point in the unit. This map is suitable for general planning purposes and as a supplement to more detailed studies for site selection. The map cannot be used as a substitute for detailed geologic and engineering investigations to establish design and construction criteria of specific sites. Some symbols may not appear on this map because the description is applicable to a series of maps.
