BECKWITH, W. VA.  
 SW/4 FAYETTEVILLE 15 QUADRANGLE  
 N3800-WB107.5/7.5

### LANDSLIDES AND RELATED FEATURES

OF THE BECKWITH, W.VA. QUADRANGLE  
 by GREGORY C. OHLMACHER  
 U.S. Geological Survey  
 OPEN FILE MAP 85-80 (A-7)

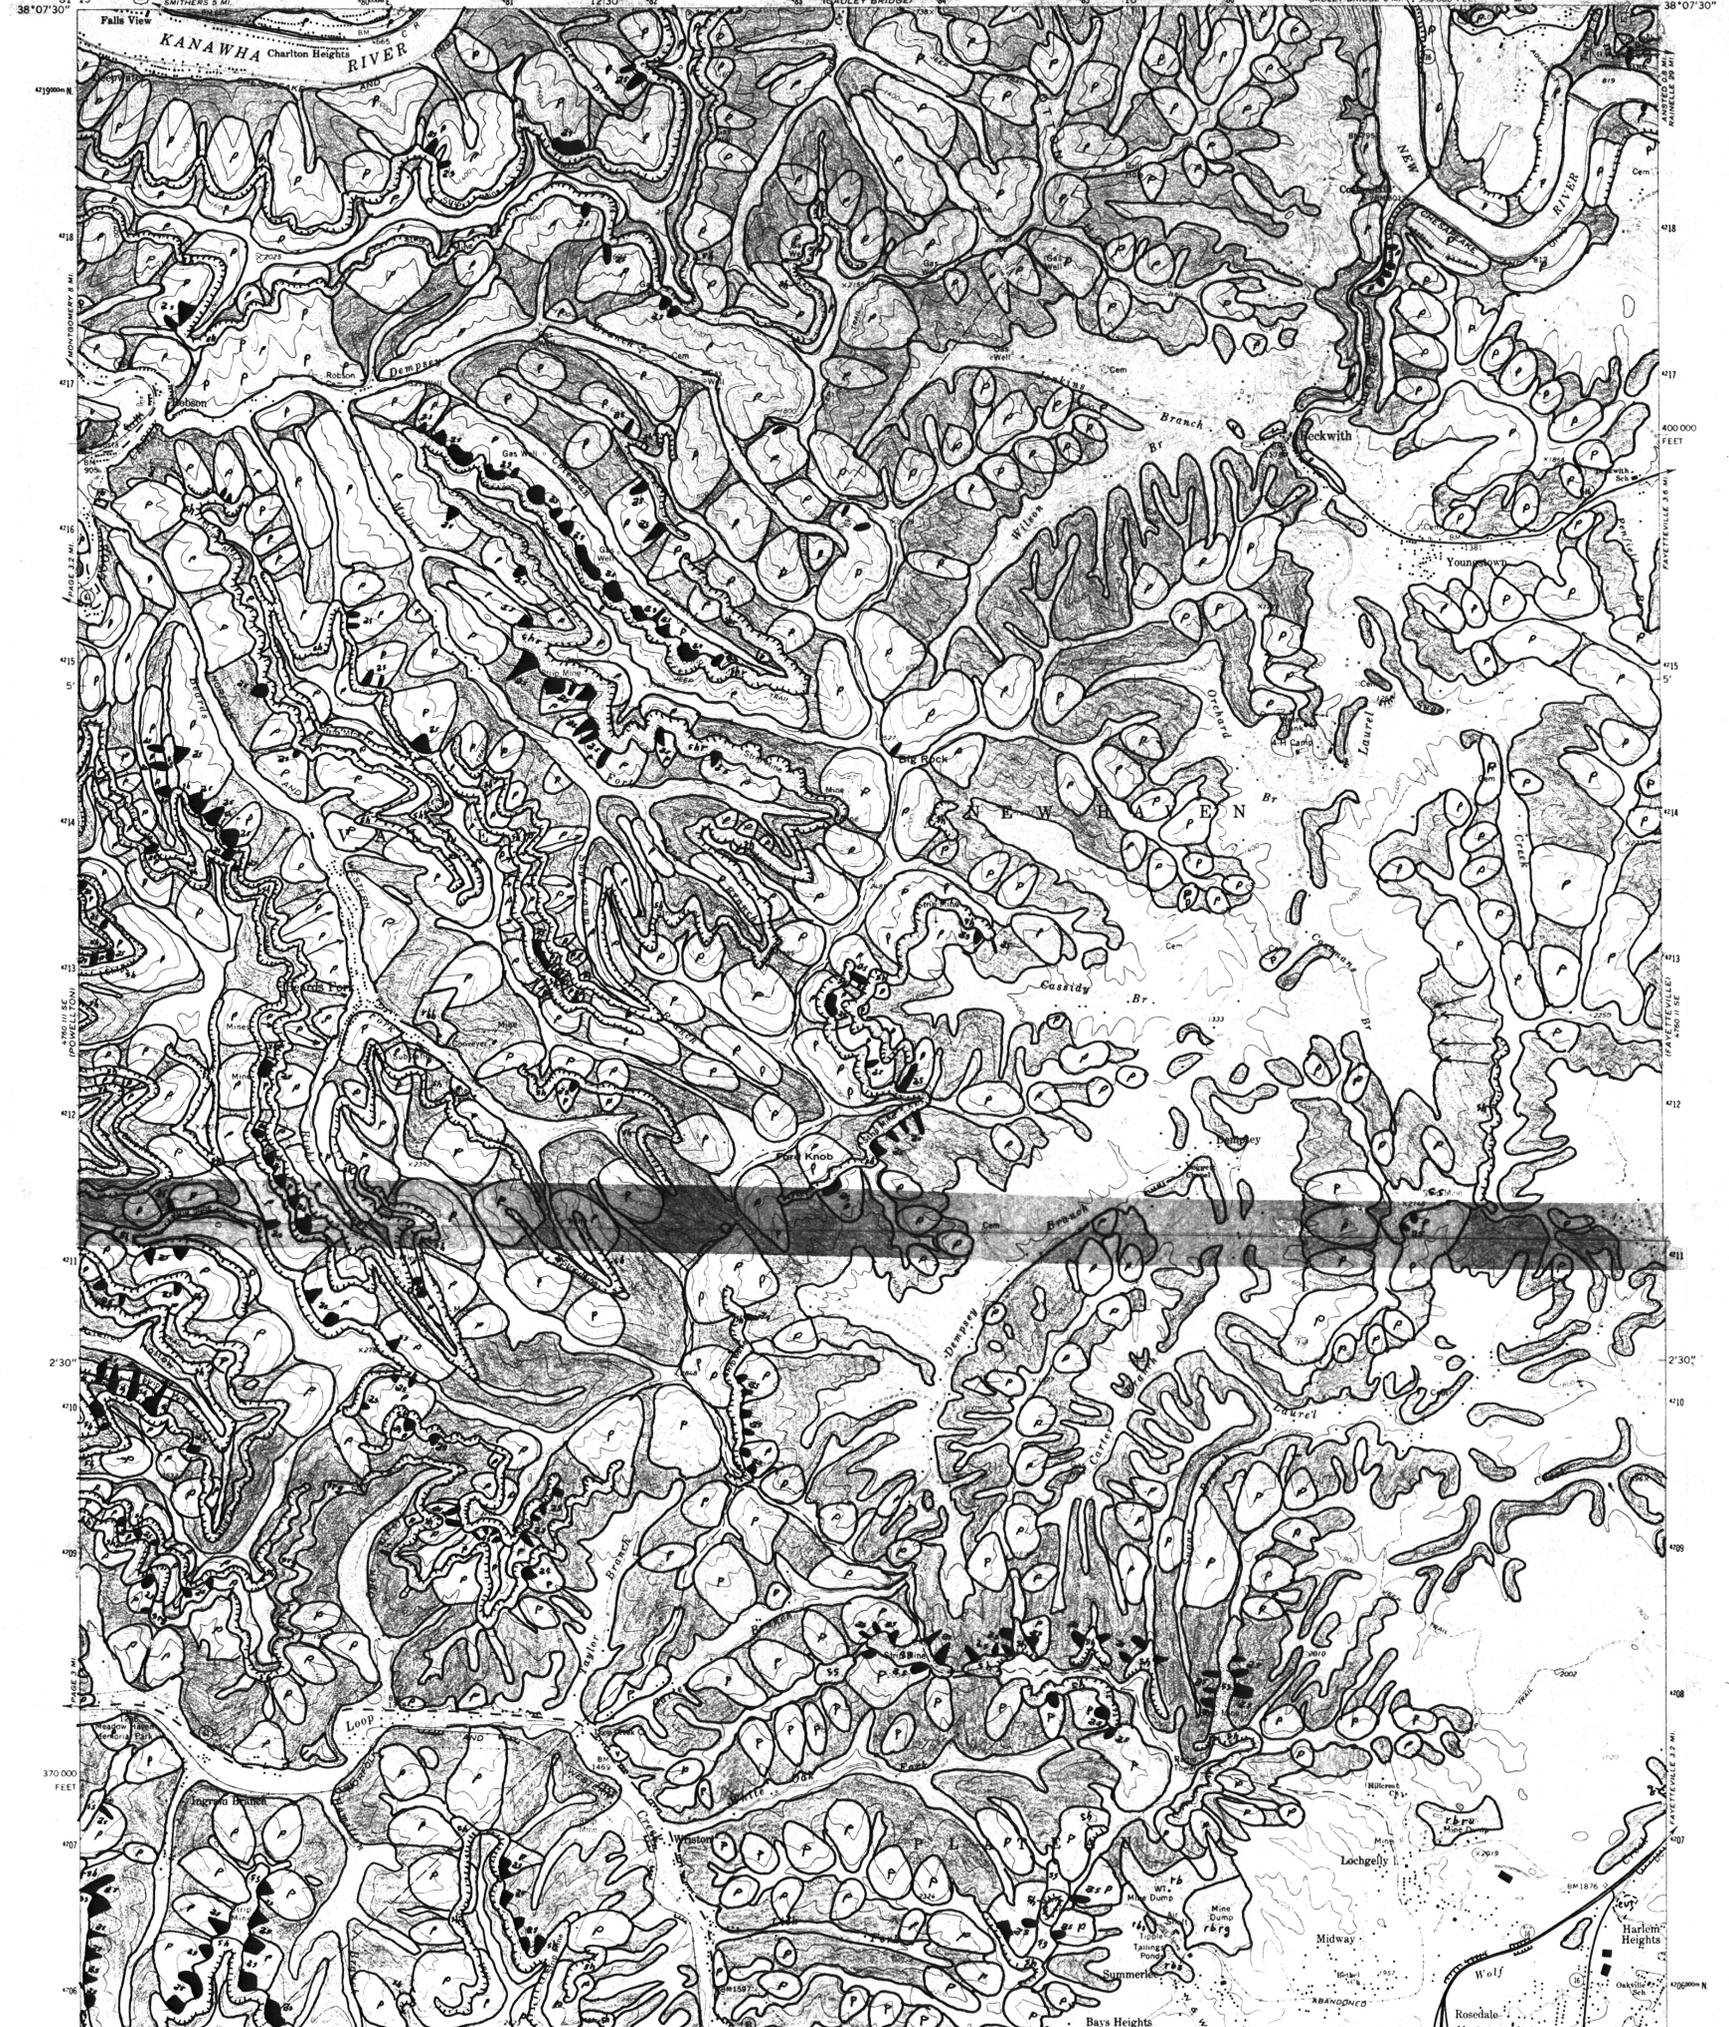
Landslides and related features interpreted from aerial photographs:  
 1:60,000 SCALE BLACK AND WHITE 1960  
 1:125,000 SCALE COLOR INFRARED 1973  
 1:60,000 SCALE BLACK AND WHITE 1977  
 Photointerpretation and field check 1979.  
 This map has not been edited or reviewed for conformity with Geological Survey standards and nomenclature.

- ACTIVE OR RECENTLY ACTIVE LANDSLIDE**  
 Complex landslide composed of earthflow, debris slide, earth and rock slump. Identified from historical records, and from scars, debris and other field evidence. Ground extremely unstable, sliding accelerated by excavation, loading and changes in drainage conditions. May include areas with several active slides too small to be shown separately.

- OLD LANDSLIDE**  
 Area of extensive hummocky ground caused by earthflow and earth and rock slump. Lacks clear evidence of active sliding. Relatively stable in natural, undisturbed state, generally not affected by small structures properly sited in areas away from the edge of the toe, can be reactivated by extensive, rapid excavation, loading, and changes in ground water and surface water conditions. Area of old landslide probably includes recent ones not identified from field evidence or otherwise documented. Upslope boundary of landslide generally defined by modified scarp, but downslope (toe) may be gradational and not well defined.

- COLLUVIAL SLOPE**  
 Valley wall along major streams with slope as steep as 40° (85%), stony, clayey silt soil up to 50 ft. (15 m) thick; commonly buttressed by a terrace or bench at the toe of the slope, very susceptible to sliding by cutting of toe area, removal of terrace or bench, and overloading, slide commonly activated without apparent cause.

- AREAS SUSCEPTIBLE TO DEBRIS FLOWS AND DEBRIS AVALANCHES**  
 Primarily shallow, narrow ravines and chutes with accumulation of stony colluvium generally 10 ft. (3 m) or less in thickness; susceptible to rapid movement during intense rainfall. Most ravines and chutes designated show evidence of former debris flows and avalanches. Symbol designates historical debris flow or debris avalanche.

- AREAS SUSCEPTIBLE TO ROCKFALL**  
 Steep, locally vertical, natural and man-made slopes and cliffs, 15 ft. (4.5 m) or more high, formed dominantly of sandstone, limestone, sandy shale, mudstone and claystone. Interbedded mudstone, claystone and shale weather rapidly leaving sandstone and limestone rock faces unsupported.

- SOIL AND ROCK SUSCEPTIBLE TO LANDSLIDING**  
 Soil and rock similar to that involved in landslides elsewhere in map area; primarily areas underlain by claystone, mudstone and shale associated with other rock types. Rock weathers rapidly on exposure forming clayey soil highly susceptible to sliding. Includes coves (U-shaped, shallow valleys) containing thick layers of clayey soil that are very susceptible to sliding where excavation breaks continuity of slope and where overlaid by artificial fill.

- AREAS LEAST PRONE TO LANDSLIDES**  
 Map areas in which no patterns or symbols are shown; primarily valley floors, ridge tops and broad benches; modification by excavation and fill may lead to local landslides.

- MAN-MADE FEATURES**
- Strip mines (combination of letter symbols indicates complex formed or more than one type of strip mine)**
    - sh bench with high wall
    - sf furrowed with high wall
    - sd multiple furrows and multiple benches
    - ss hilltop removed
    - sry reclaimed by grading
    - sru reclaimed by secondary use
    - shr regraded in part, high wall remains
  - Coal refuse banks**
    - r identified on aerial photographs; not classified in field check
    - rb not burnt nor on fire
    - rbb burnt
    - rbd burning
    - rbs sludge
  - Quarries**
    - q quarry site
  - Gravel pits**
    - g site of gravel pit
  - Slides in man-made features**
    - af earth flow in fill
    - as earth flow in strip castings
    - ar earth flow in coal refuse
