LANDSLIDES AND RELATED FEATURES

OF THE FORK MOUNTAIN, W.VA. QUADRANGLE

GREGORY C. OHLMACHER

OPEN FILE MAP 85-80 (B-13)

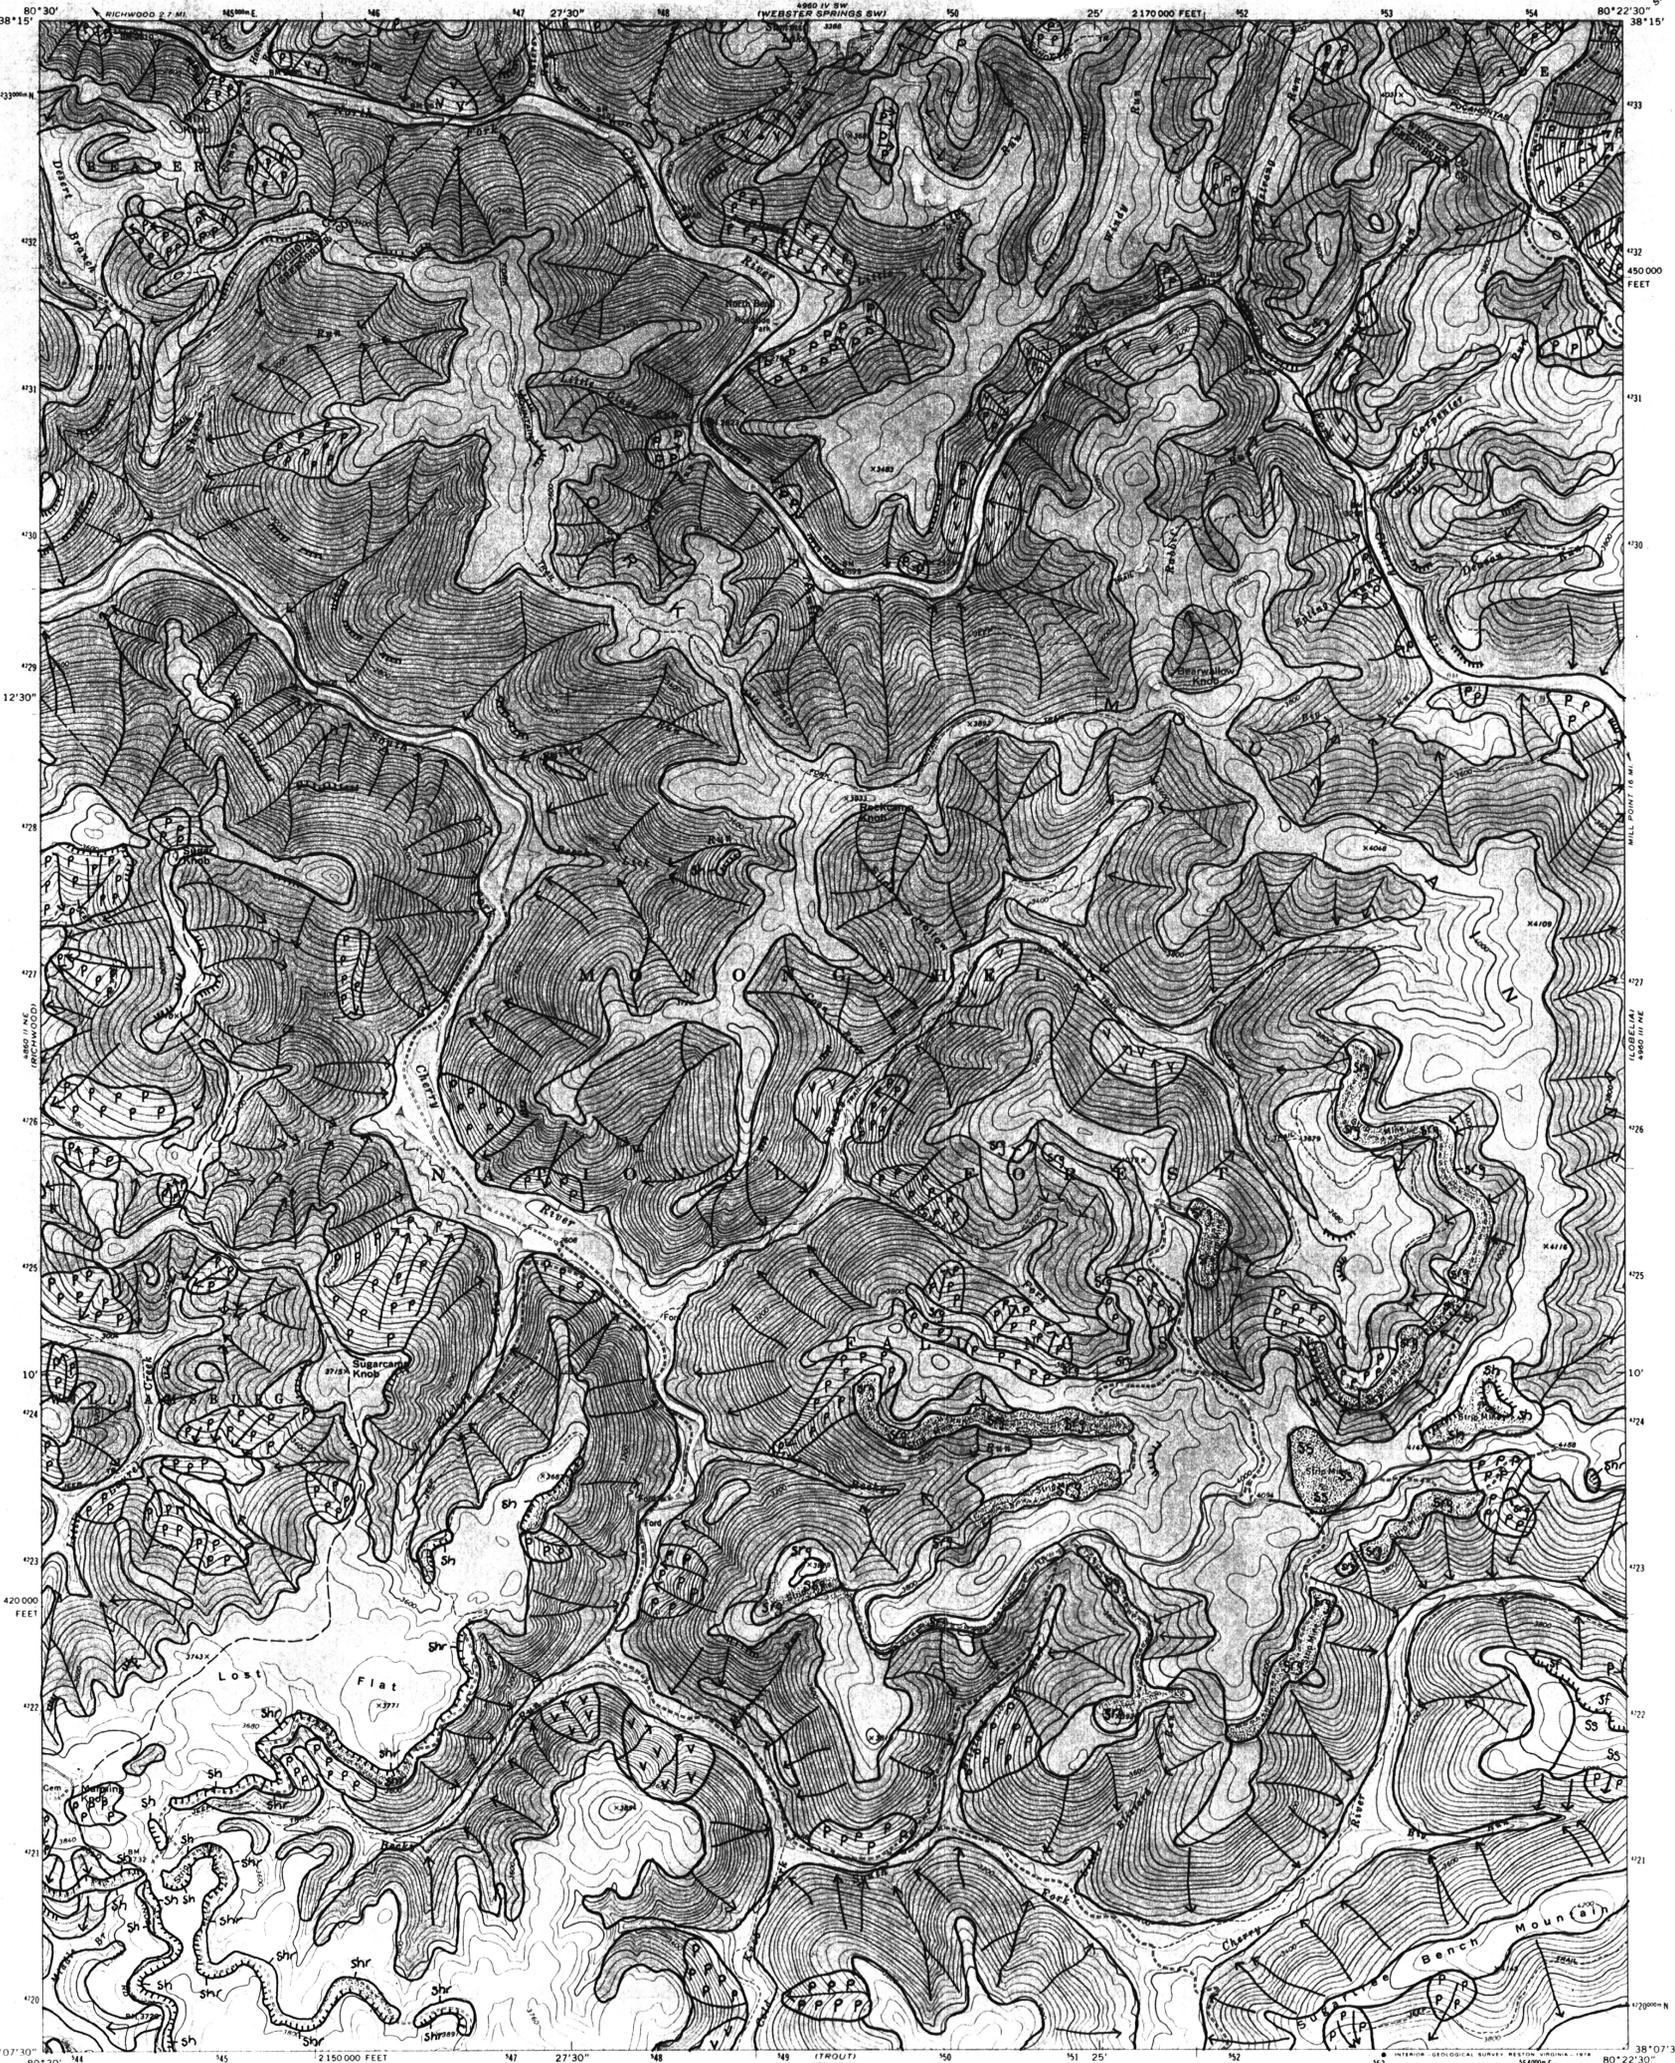
FORK MOUNTAIN, W. VA.
NW/4 LOBELIA 19 QUADRANGLE
N3807.5-W8022.5/7.5

Landslides and related features interpreted from aerial photographs:
1:60,000 SCALE BLACK AND WHITE 1960
1:125,000 SCALE COLOR INFRARED 1973

Photointerpretation and field check 1980.
This map has not been edited or reviewed for conformity with Geological Survey standards and nomenclature.

ACTIVE OR RECENTLY ACTIVE LANDSLIDE
Complex landslide composed of earthflow, debris slide, earth and rock slump. Identified from historical records, and from scars, debris and other field evidence. Ground extremely unstable, sliding accelerated by excavation, loading and changes in drainage conditions. May include areas with several active slides too small to be shown separately.

OLD LANDSLIDE
Area of extensive hummocky ground caused by earthflow and earth and rock slump. Lacks clear evidence of active sliding. Relatively stable in natural, undisturbed state, generally not affected by small structures properly sited in areas away from the edge of the toe, can be reactivated by extensive, rapid excavation, loading, and changes in ground water and surface water conditions. Area of old landslide probably includes recent ones not identified from field evidence or otherwise documented. Upslope boundary of landslide generally defined by modified scarp, but downslope (toe) may be gradational and not well defined.

COLLUVIAL SLOPE
Valley wall along major streams with slope as steep as 40° (85%), stony, clayey silt soil up to 50 ft. (15 m) thick, commonly buttressed by a terrace or bench at the toe of the slope, very susceptible to sliding by cutting of toe area, removal of terrace or bench, and overloading, slide commonly activated without apparent cause.

AREAS SUSCEPTIBLE TO DEBRIS FLOWS AND DEBRIS AVALANCHES
Primarily shallow, narrow ravines and chutes with accumulation of stony colluvium generally 10 ft. (3 m) or less in thickness, susceptible to rapid movement during intense rainfall. Most ravines and chutes designated show evidence of former debris flows and avalanches. Symbol 'a'-designates historical debris flow or debris avalanche.

AREAS SUSCEPTIBLE TO ROCKFALL
Steep, locally vertical, natural and man-made slopes and cliffs, 15 ft. (4.5 m) or more high, formed dominantly of sandstone, limestone, sandy shale, mudstone and claystone. Interbedded mudstone, claystone and shale weather rapidly leaving sandstone and limestone rock faces unsupported.

SOIL AND ROCK SUSCEPTIBLE TO LANDSLIDING
Soil and rock similar to that involved in landslides elsewhere in map area; primarily areas underlain by claystone, mudstone and shale associated with other rock types. Rock weathers rapidly on exposure forming clayey soil highly susceptible to sliding. Includes coves (U-shaped, shallow valleys) containing thick layers of clayey soil that are very susceptible to sliding where excavation breaks continuity of slope and where overloaded by artificial fill.

AREAS LEAST PRONE TO LANDSLIDES
Map areas in which no patterns or symbols are shown; primarily valley floors, ridge tops and broad benches; modification by excavation and fill may lead to local landslides.
