POCATALICO, W. VA.  
NW¼ CHARLESTON 1° QUADRANGLE  
N3822.5-W8137.5/5

### LANDSLIDES AND RELATED FEATURES

OF THE POCATALICO, W. VA. QUADRANGLE  
by  
GREGORY C. OHLMACHER  
U.S. Geological Survey  
OPEN FILE MAP 83-80 (B-3)

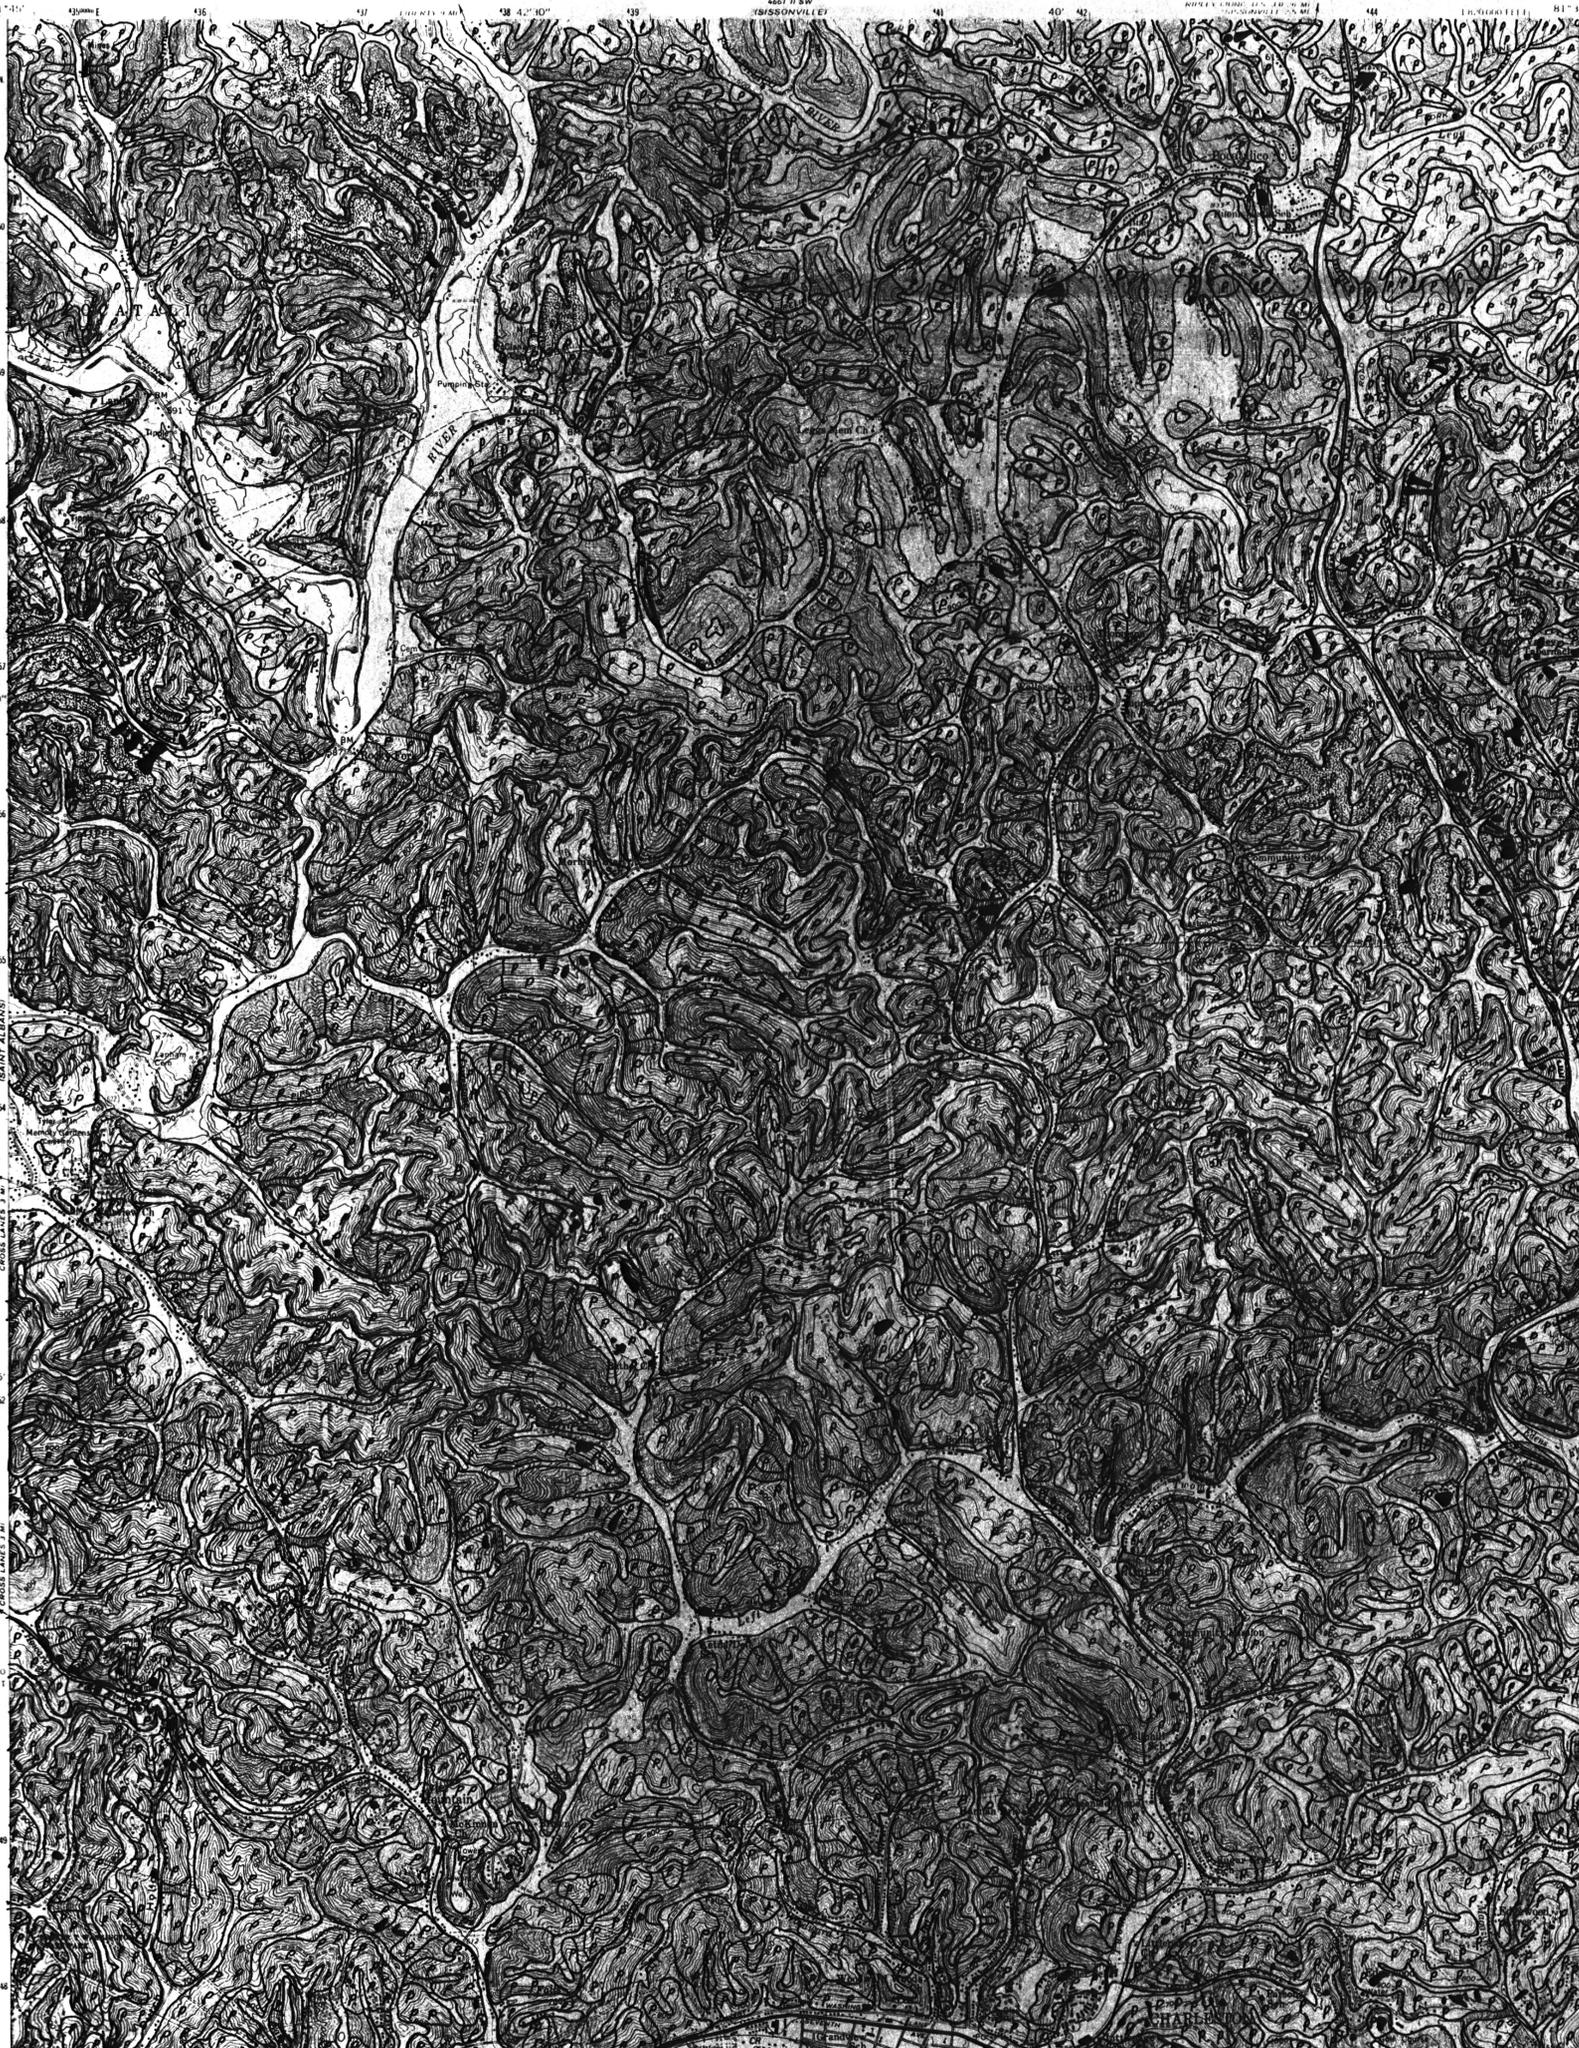
Landslides, rockfall and slide-prone areas modified from Lessing, P., Kulander, B. R., Wilson, B. D., Dean, S. L., and Woodring, S. M., 1976, West Virginia landslides and slide-prone areas: West Virginia Geological and Economic Survey, Environmental Geology Bulletin 15. Other features interpreted from aerial photographs:  
1:60,000 SCALE BLACK AND WHITE 1960  
1:125,000 SCALE COLOR INFRARED 1973  
1:80,000 SCALE BLACK AND WHITE 1977

Photointerpretation and field check 1976.  
This map has not been edited or reviewed for conformity with Geological Survey standards and nomenclature.

<p><b>ACTIVE OR RECENTLY ACTIVE LANDSLIDE</b> Complex landslide composed of earthflow, debris slide, earth and rock slump. Identified from historical records, and from scars, debris and other field evidence. Ground extremely unstable; sliding accelerated by excavation, loading and changes in drainage conditions. May include areas with several active slides too small to be shown separately.</p> <p><b>OLD LANDSLIDE</b> Area of extensive hummocky ground caused by earthflow and earth and rock slump. Lacks clear evidence of active sliding. Relatively stable in natural, undisturbed state, generally not affected by small structures properly sited in areas away from the edge of the toe; can be reactivated by extensive, rapid excavation, loading, and changes in ground water and surface water conditions. Area of old landslide probably includes recent ones not identified from field evidence or otherwise documented. Upslope boundary of landslide generally defined by modified scarp, but downslope (toe) may be gradational and not well defined.</p> <p><b>COLLUVIAL SLOPE</b> Valley wall along major streams with slope as steep as 40° (85%); stony, clayey silt soil up to 50 ft. (15 m) thick; commonly buttressed by a terrace or bench at the toe of the slope; very susceptible to sliding by cutting of toe area, removal of terrace or bench, and overloading; slide commonly activated without apparent cause.</p>	<p><b>AREAS SUSCEPTIBLE TO DEBRIS FLOWS AND DEBRIS AVALANCHES</b> Primarily shallow, narrow ravines and chutes with accumulation of stony colluvium generally 10 ft. (3 m) or less in thickness, susceptible to rapid movement during intense rainfall. Most ravines and chutes designated show evidence of former debris flows and avalanches. Symbol 'a' designates historical debris flow or debris avalanche.</p> <p><b>AREAS SUSCEPTIBLE TO ROCKFALL</b> Steep, locally vertical, natural and man-made slopes and cliffs, 15 ft. (4.5 m) or more high, formed dominantly of sandstone, limestone, sandy shale, mudstone and claystone. Interbedded mudstone, claystone and shale weather rapidly leaving sandstone and limestone rock faces unsupported.</p> <p><b>SOIL AND ROCK SUSCEPTIBLE TO LANDSLIDING</b> Soil and rock similar to that involved in landslides elsewhere in map area; primarily areas underlain by claystone, mudstone and shale associated with other rock types. Rock weathers rapidly on exposure forming clayey soil highly susceptible to sliding. Includes coves (U-shaped, shallow valleys) containing thick layers of clayey soil that are very susceptible to sliding where excavation breaks continuity of slope and where overloaded by artificial fill.</p> <p><b>AREAS LEAST PRONE TO LANDSLIDES</b> Map areas in which no patterns or symbols are shown; primarily valley floors, ridge tops and broad benches; modification by excavation and fill may lead to local landslides.</p>	<p><b>MAN-MADE FEATURES</b> Strip mines (combination of letter symbols indicates complex formed or more than one type of strip mine) sh bench with high wall sf furrowed with high wall sd multiple furrows and multiple benches ss hilltop removed sry reclaimed by grading sru reclaimed by secondary use shr regraded in part, high wall remains Coal refuse banks r identified on aerial photographs, not classified in field check rb not burnt nor on fire rbb burnt rbd burning rbs sludge quarries q quarry site Gravel pits y site of gravel pit Slides in man-made features af earth flow in fill as earth flow in strip castings ar earth flow in coal refuse</p>

NOTE  
Information shown is intended as a general guide to ground conditions as of the date of field check. Additional landslides and rockfalls should be anticipated in all map units. The map unit depicts the dominant condition in the area delineated and variations in slope stability may occur at any point in the unit. This map is suitable for general planning purposes and as a supplement to more detailed studies for site selection. The map cannot be used as a substitute for detailed geologic and engineering investigations to establish design and construction criteria of specific sites. Some symbols may not appear on this map because the description is applicable to a series of maps.
