LANDSLIDES AND RELATED FEATURES

OF THE WINFIELD, W. VA. QUADRANGLE
by
GREGORY C. OHLMACHER
U.S. Geological Survey
OPEN FILE MAP 83-80 (2-E)

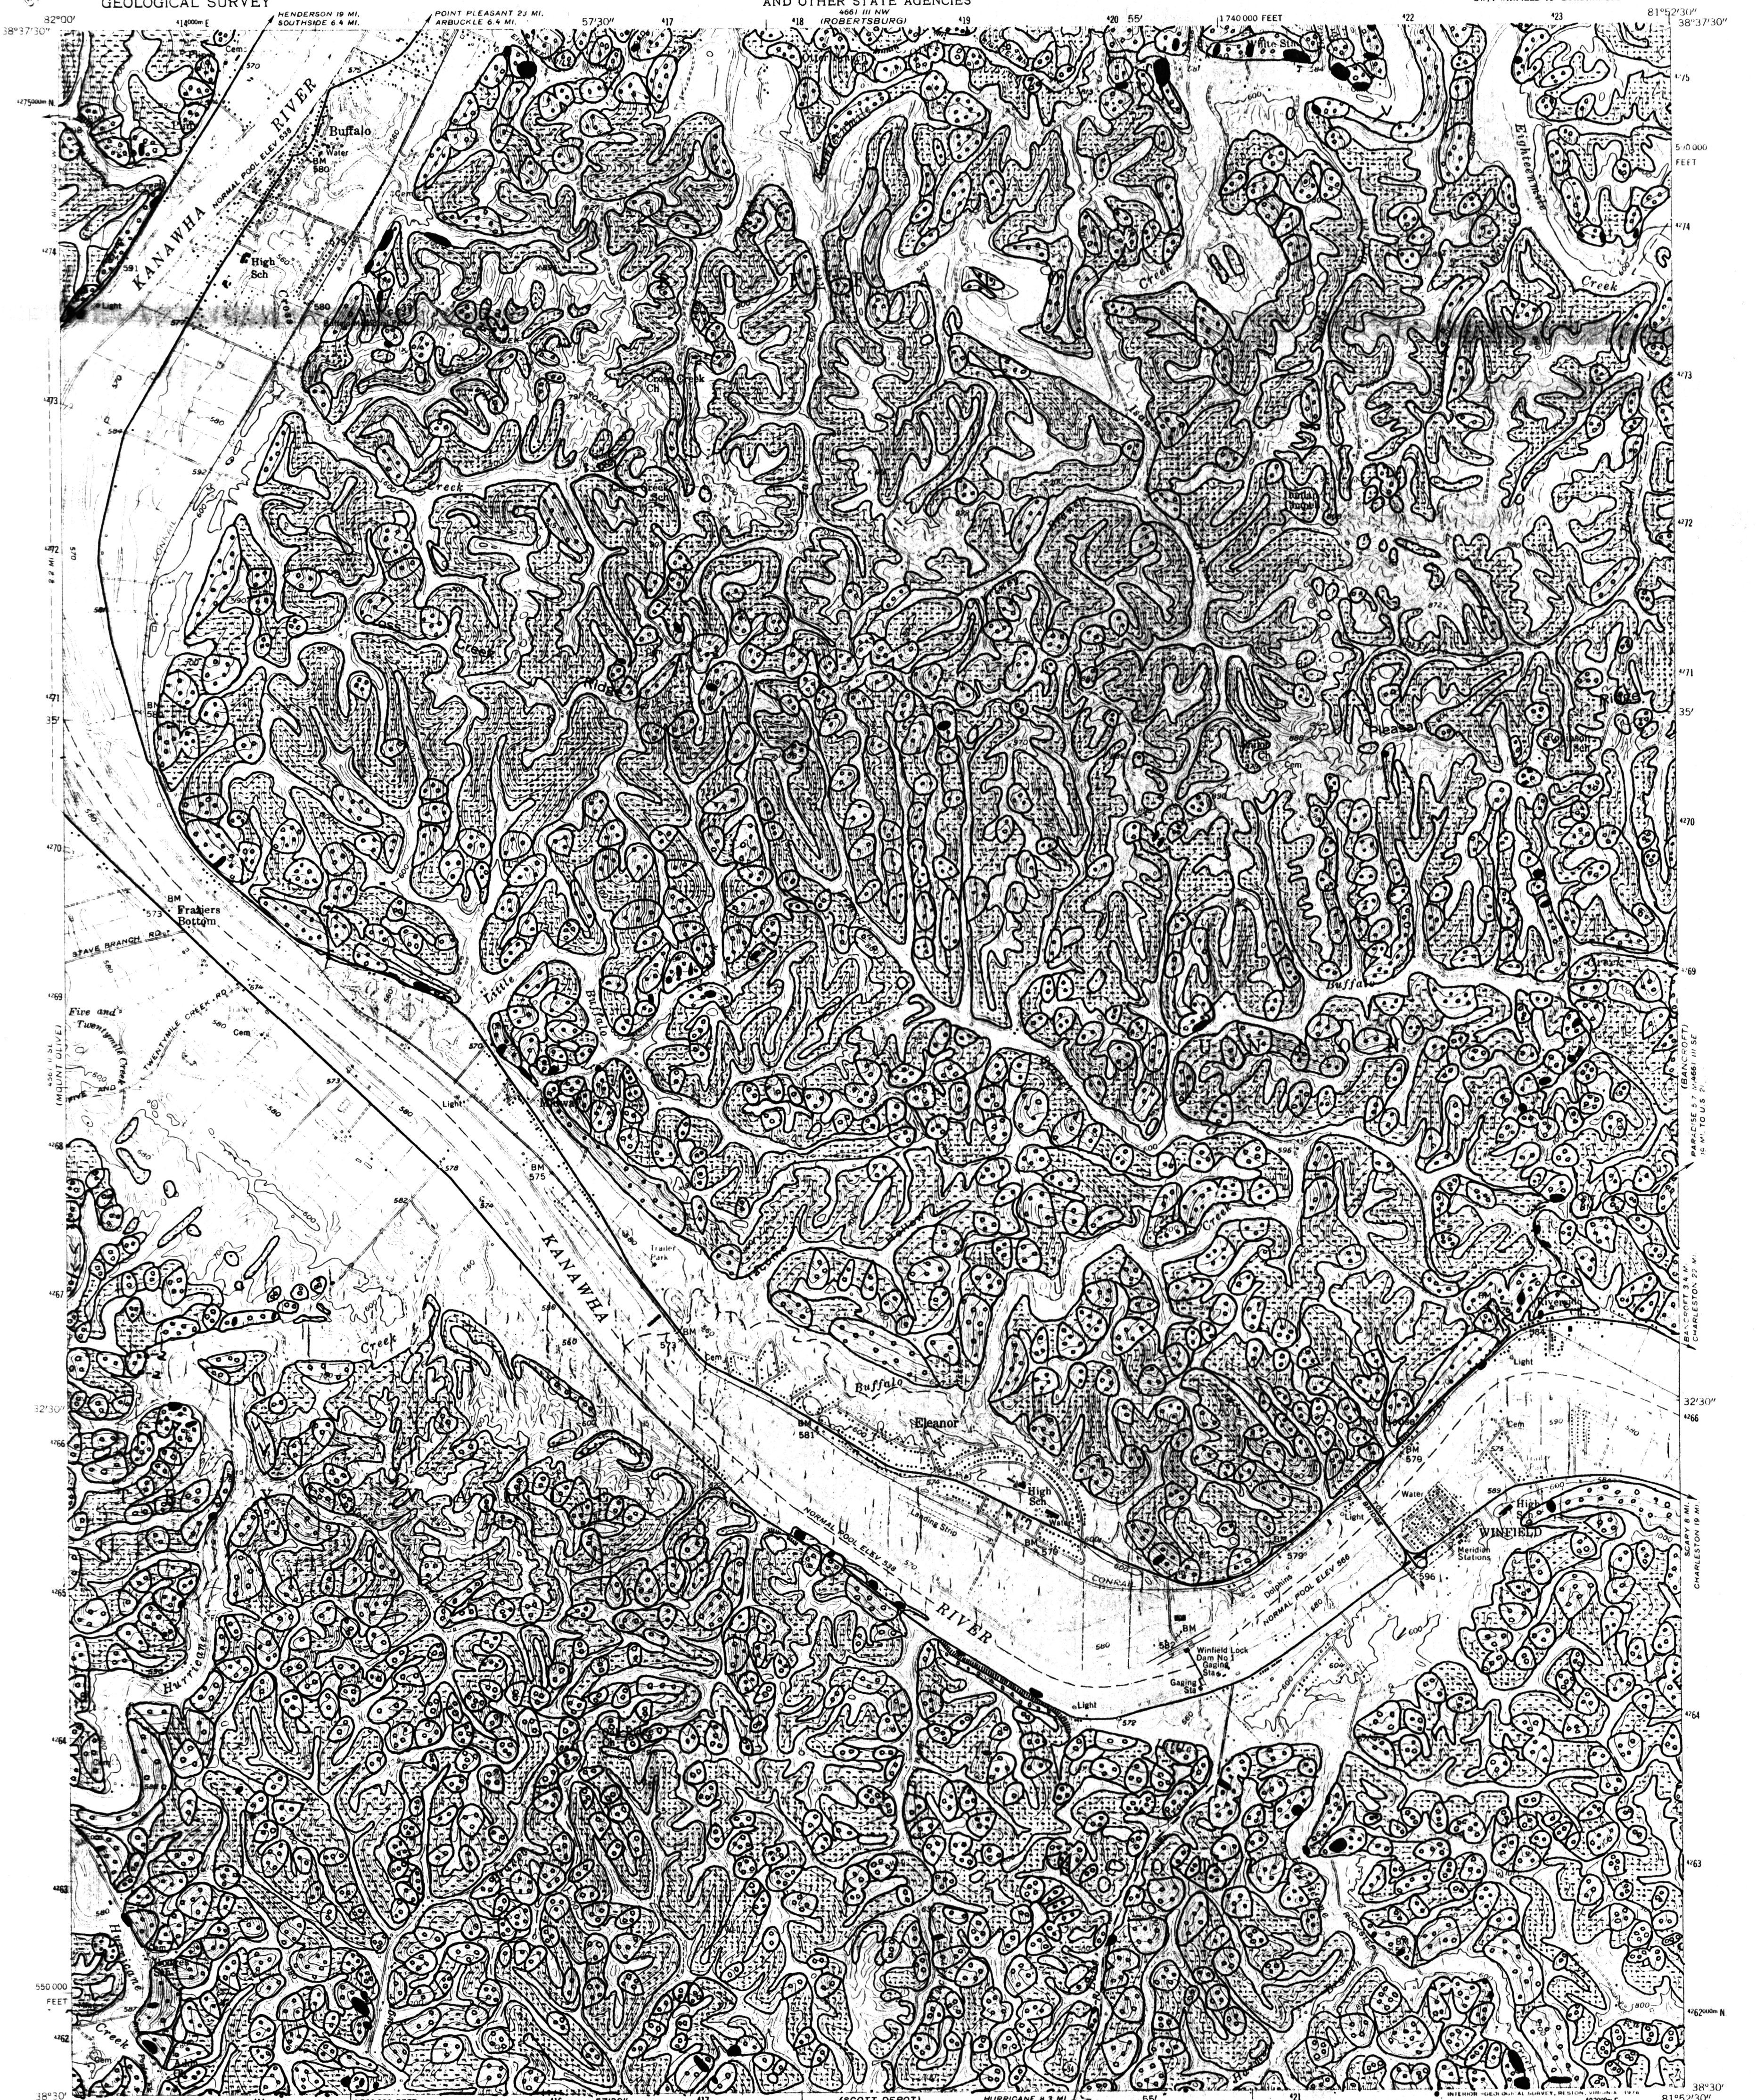
Landslides and related features interpreted
from aerial photographs:
1:60,000 SCALE BLACK AND WHITE 1960
1:125,000 SCALE COLOR INFRARED 1973
1:80,000 SCALE BLACK AND WHITE 1975
Photointerpretation and field check 1978.
This map has not been edited or reviewed
for conformity with Geological Survey
standards and nomenclature.

NOTE
Information shown is intended as a
general guide to ground conditions as of
the date of field check. Additional
landslides and rockfalls should be anticipated
in all map units. The map unit depicts
the dominant condition in the area delineated
and variations in slope stability may occur
at any point in the unit. This map is suitable
for general planning purposes and as a
supplement to more detailed studies for site
selection. The map cannot be used as a
substitute for detailed geologic and engineering
investigations to establish design and
construction criteria of specific sites.
Some symbols may not appear on this map
because the description is applicable to a
series of maps.
