STRANGE CREEK, W. VA.
SW 4 GASSAWAY 15 QUADRANGLE
N3830—W8052.5/7.5

LANDSLIDES AND RELATED FEATURES
OF THE STRANGE CREEK, W. VA. QUADRANGLE

by
GREGORY C. OHLMACHER
U.S. Geological Survey
OPEN FILE MAP 83-80 (E-9)

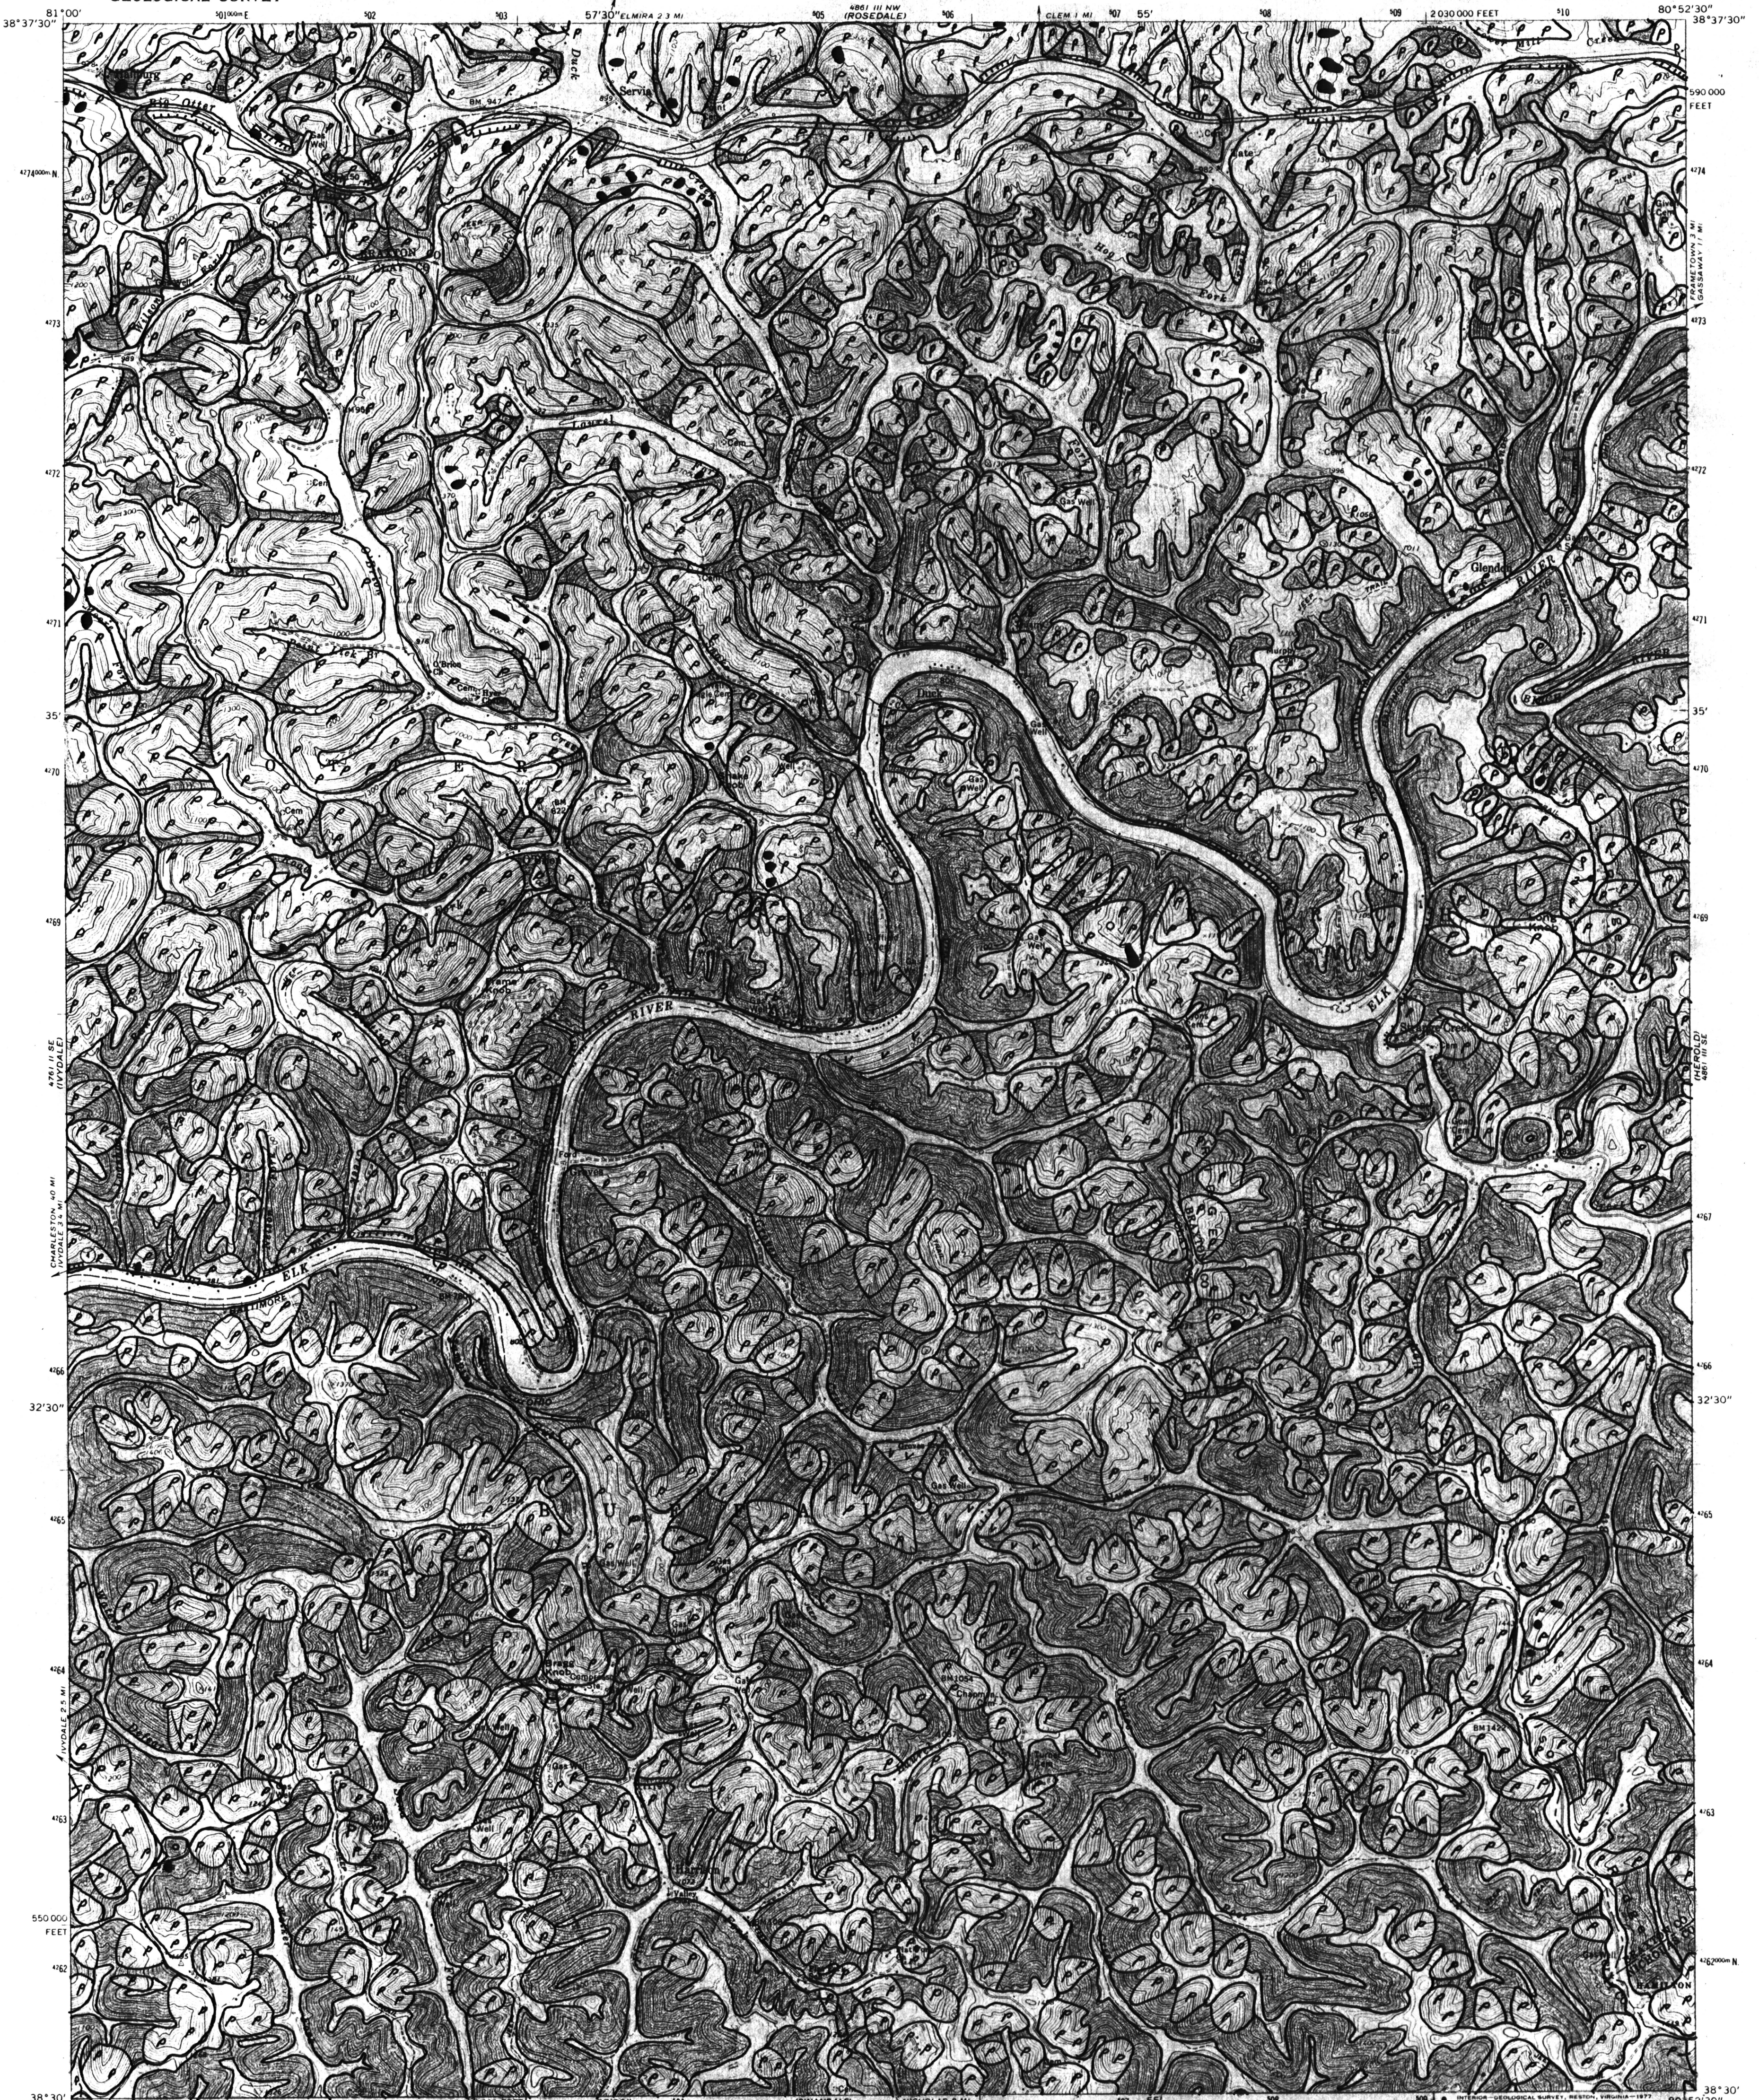
Landslides and related features interpreted from aerial photographs:
1:60,000 SCALE BLACK AND WHITE 1960
1:125,000 SCALE COLOR INFRARED 1973
1:80,000 SCALE BLACK AND WHITE 1976

Photointerpretation and field check 1980.
This map has not been edited or reviewed for conformity with Geological Survey standards and nomenclature.

- ACTIVE OR RECENTLY ACTIVE LANDSLIDE**
Complex landslide composed of earthflow, debris slide, earth and rock slump. Identified from historical records, and from scars, debris and other field evidence. Ground extremely unstable, sliding accelerated by excavation, loading and changes in drainage conditions. May include areas with several active slides too small to be shown separately.

- OLD LANDSLIDE**
Area of extensive hummocky ground caused by earthflow and earth and rock slump. Lacks clear evidence of active sliding. Relatively stable in natural, undisturbed state, generally not affected by small structures properly sited in areas away from the edge of the toe, can be reactivated by extensive, rapid excavation, loading, and changes in ground water and surface water conditions. Area of old landslide probably includes recent ones not identified from field evidence or otherwise documented. Upslope boundary of landslide generally defined by modified scarp, but downslope (toe) may be gradational and not well defined.

- COLLUVIAL SLOPE**
Valley wall along major streams with slope as steep as 40° (85%), stony, clayey silt soil up to 50 ft. (15 m) thick; commonly buttressed by a terrace or bench at the toe of the slope; very susceptible to sliding by cutting of toe area, removal of terraced or bench, and overloading, slide commonly activated without apparent cause.

- AREAS SUSCEPTIBLE TO DEBRIS FLOWS AND DEBRIS AVALANCHES**
Primarily shallow, narrow ravines and chutes with accumulation of stony colluvium generally 10 ft. (3 m) or less in thickness; susceptible to rapid movement during intense rainfall. Most ravines and chutes designated show evidence of former debris flows and avalanches. Symbol 'a' designates historical debris flow or debris avalanche.

- AREAS SUSCEPTIBLE TO ROCKFALL**
Steep, locally vertical, natural and man-made slopes and cliffs, 15 ft. (4.5 m) or more high, formed dominantly of sandstone, limestone, sandy shale, mudstone and claystone. Interbedded mudstone, claystone and shale weather rapidly leaving sandstone and limestone rock faces unsupported.

- SOIL AND ROCK SUSCEPTIBLE TO LANDSLIDING**
Soil and rock similar to that involved in landslides elsewhere in map area; primarily areas underlain by claystone, mudstone and shale associated with other rock types. Rock weathers rapidly on exposure forming clayey soil highly susceptible to sliding. Includes coves (U-shaped, shallow valleys) containing thick layers of clayey soil that are very susceptible to sliding where excavation breaks continuity of slope and where overloaded by artificial fill.

- AREAS LEAST PRONE TO LANDSLIDES**
Map areas in which no patterns or symbols are shown; primarily valley floors, ridge tops and broad benches; modification by excavation and fill may lead to local landslides.

- MAN-MADE FEATURES**
Strip mines (combination of letter symbols indicates complex formed or more than one type of strip mine)
- sh bench with high wall
 - sf furrowed with high wall
 - sd multiple furrows and multiple benches
 - ss hilltop removed
 - srg reclaimed by grading
 - sru reclaimed by secondary use
 - shr regraded in part, high wall remains
- Coal refuse banks identified on aerial photographs; not classified in field check
- rb not burnt nor on fire
 - rbb burnt
 - rbd burning
 - rbs sludge
- Quarries
- q quarry site
- Gravel pits
- g site of gravel pit
- Slides in man-made features
- af earth flow in fill
 - as earth flow in strip castings
 - ar earth flow in coal refuse
