BURNSVILLE, W. VA.  
SW/4 BURNSVILLE 15' QUADRANGLE  
N3845-W8037.5/7.5

### LANDSLIDES AND RELATED FEATURES

OF THE BURNSVILLE, W. VA. QUADRANGLE  
by  
GREGORY C. OHLMACHER  
U.S. Geological Survey  
OPEN FILE MAP 83-80 (6-11)

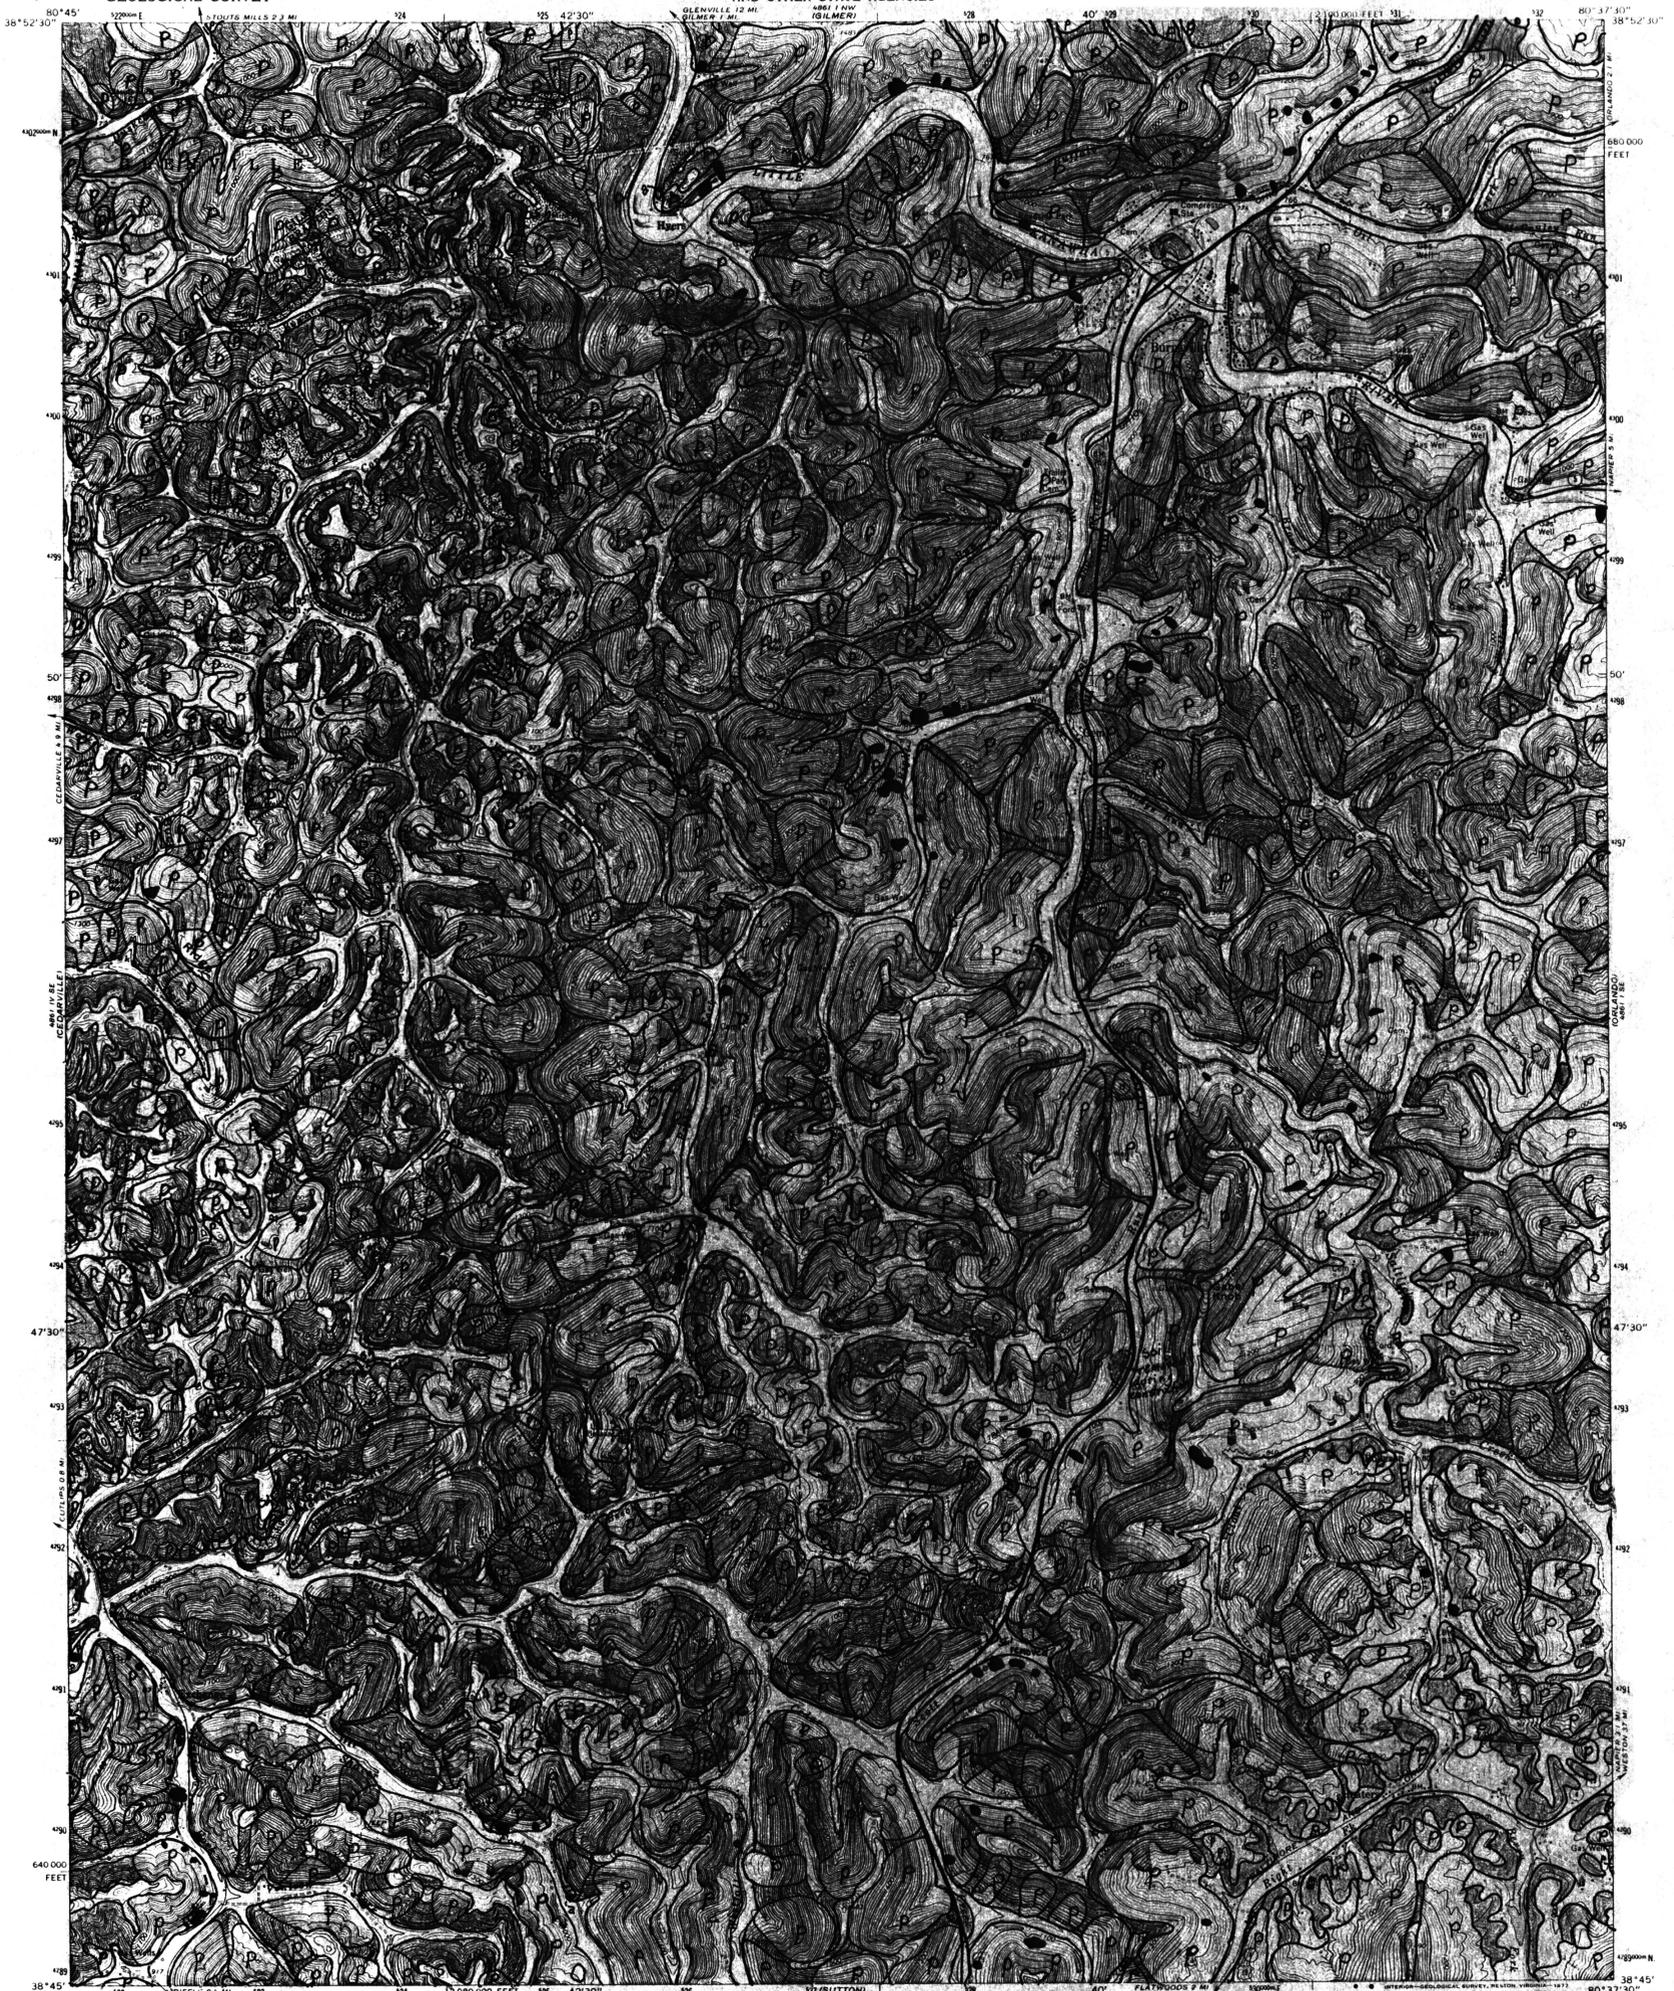
Landslides and related features interpreted  
from aerial photographs:  
1:60,000 SCALE BLACK AND WHITE 1960  
1:125,000 SCALE COLOR INFRARED 1973  
1:80,000 SCALE BLACK AND WHITE 1976  
Photointerpretation and field check 1980.  
This map has not been edited or reviewed  
for conformity with Geological Survey  
standards and nomenclature.

**ACTIVE OR RECENTLY ACTIVE LANDSLIDE**  
Complex landslide composed of earthflow, debris  
slide, earth and rock slump. Identified from  
historical records, and from scars, debris and  
other field evidence. Ground extremely unstable,  
sliding accelerated by excavation, loading and  
changes in drainage conditions. May include  
areas with several active slides too small to  
be shown separately.

**OLD LANDSLIDE**  
Area of extensive hummocky ground caused by  
earthflow and earth and rock slump. Lacks  
clear evidence of active sliding. Relatively  
stable in natural, undisturbed state,  
generally not affected by small structures properly  
sited in areas away from the edge of the toe,  
can be reactivated by extensive, rapid excavation,  
loading, and changes in ground water and  
surface water conditions. Area of old landslide  
probably includes recent ones not identified  
from field evidence or otherwise documented.  
Upslope boundary of landslide generally defined  
by modified scarp, but downslope (toe) may be  
gradational and not well defined.

**COLLUVIAL SLOPE**  
Valley wall along major streams with slope as  
steep as 40° (85%), stony, clayey silt soil up  
to 50 ft. (15 m) thick, commonly buttressed by  
a terrace or bench at the toe of the slope, very  
susceptible to sliding by cutting of toe area,  
removal of terrace or bench, and overloading,  
slide commonly activated without apparent cause.

**AREAS SUSCEPTIBLE TO DEBRIS FLOWS AND DEBRIS  
AVALANCHES**  
Primarily shallow, narrow ravines and chutes with  
accumulation of stony colluvium generally 10 ft.  
(3 m) or less in thickness; susceptible to rapid  
movement during intense rainfall. Most ravines  
and chutes designated show evidence of former  
debris flows and avalanches. Symbol-a designates  
historical debris flow or debris avalanche.

**AREAS SUSCEPTIBLE TO ROCKFALL**  
Steep, locally vertical, natural and man-made  
slopes and cliffs, 15 ft. (4.5 m) or more high,  
formed dominantly of sandstone, limestone, sandy  
shale, mudstone and claystone. Interbedded mudstone,  
claystone and shale weather rapidly leaving  
sandstone and limestone rock faces unsupported.

**SOIL AND ROCK SUSCEPTIBLE TO LANDSLIDING**  
Soil and rock similar to that involved in landslides  
elsewhere in map area; primarily areas  
underlain by claystone, mudstone and shale  
associated with other rock types. Rock weathers  
rapidly on exposure forming clayey soil highly  
susceptible to sliding. Includes coves (U-shaped,  
shallow valleys) containing thick layers of clayey  
soil that are very susceptible to sliding where  
excavation breaks continuity of slope and where  
overloaded by artificial fill.

**AREAS LEAST PRONE TO LANDSLIDES**  
Map areas in which no patterns or symbols are shown;  
primarily valley floors, ridge tops and broad  
benches; modification by excavation and fill may  
lead to local landslides.

**MAN-MADE FEATURES**  
Strip mines (combination of letter symbols  
indicates complex formed or more than one  
type of strip mine)
