**DEBRIS FLOWS FROM TRIBUTARIES OF THE COLORADO RIVER,
GRAND CANYON NATIONAL PARK, ARIZONA**

Open-File Report 87-118

By Robert H. Webb, Patrick T. Pringle, and Glen R. Rink

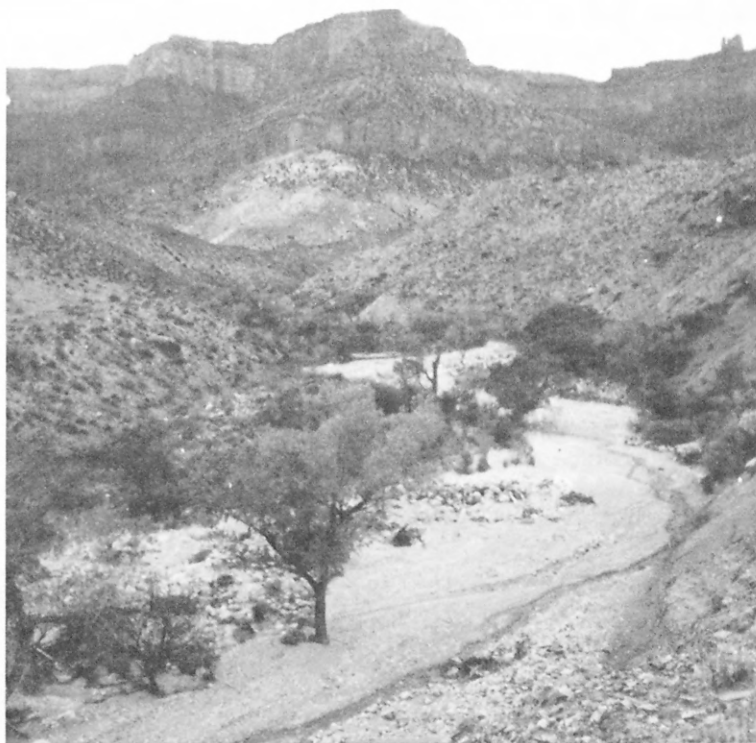
A. May 1966

Figure 3.--Lava Creek at the confluence with Chuar Creek, 3.8 miles upstream from the Colorado River. View B is slightly different from A and shows significant channel alteration following the 1966 debris flow. View C matches B and shows revegetation and entrenchment of the channel after the 1966 and subsequent debris flows.

B. May 1967

C. March 1986

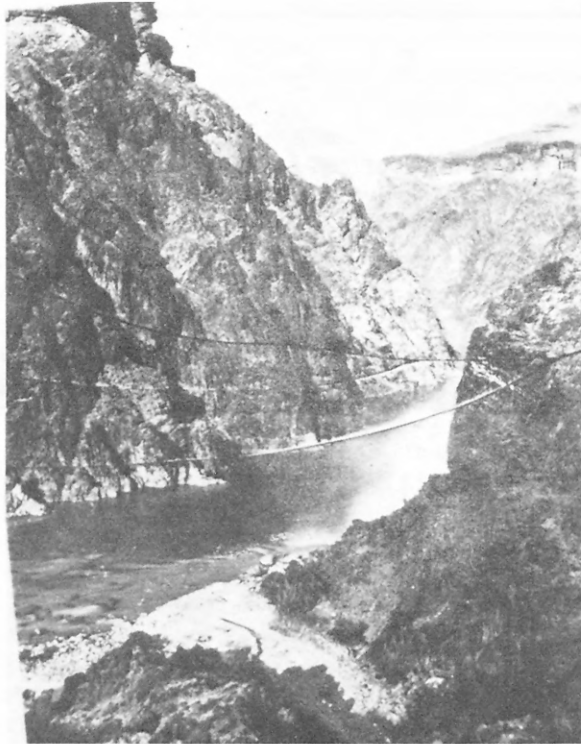
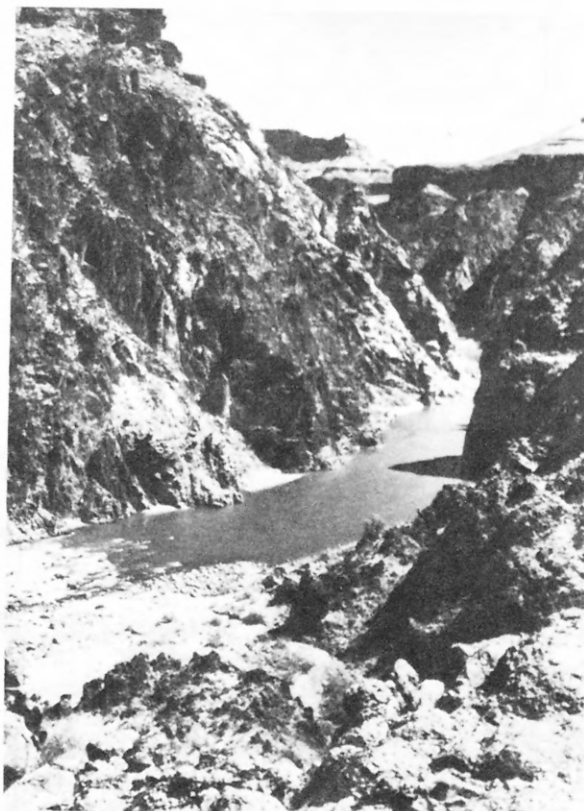
Figure 8.--The mouth of Monument Creek. In view A, the discharge in the Colorado River apparently is between 20,000 and 25,000 cubic feet per second. Curved lines in the center of the photograph are cracks in the original glass-plate negatives. In view B, the discharge in the Colorado River is about 8,000 cubic feet per second. The river appears to be more constricted than in 1872 despite differences in discharge, and a debris flow that occurred 2 to 7 years prior to the photograph date may have contributed to the constriction. In view C, the discharge in the Colorado River is 28,500 cubic feet per second. The 1984 debris flow has constricted the river significantly, especially in comparison with 1872 conditions.

Photographs B and C are reversed. Photograph on left was taken April 1986; photograph on right was taken September 1968.

Near the Colorado River, the deposits in the center of the channel abruptly change to well-sorted and imbricated boulder bars (fig. 8C) superficially resembling sieve deposits (Hooke, 1967). The debris flow at this point was confined and deposition occurred to an average depth of 5 ft. At locally unconfined sites, the critical thickness of the debris flow was 3 ft. The particle-size distribution (fig. 10D) shows a well-sorted cobble deposit with a median diameter of 32 mm, although poorly sorted matrix was found on the channel margin. We speculate that either recessional or post-event streamflow, dewatering of the deposit after deposition, or positive pore pressures from springs in the channel bed caused the nearly complete removal of the debris-flow matrix from the boulders and its subsequent transport into the Colorado River.

The new debris fan at the Colorado River (fig. 8) was surveyed to estimate the volume of material deposited during the debris flow of 1984. The debris flow entered and partially dammed the Colorado River (Mike Yard, boatman, Humphry's Summit Adventures, Flagstaff, Arizona, oral commun., 1986), which had a mean discharge of about 24,000 ft³/s on July 25. Observers noted that the newly formed fan contained significant amounts of matrix immediately after the debris flow, but that the mud was quickly eroded from the fan. Higher discharges on the Colorado River in

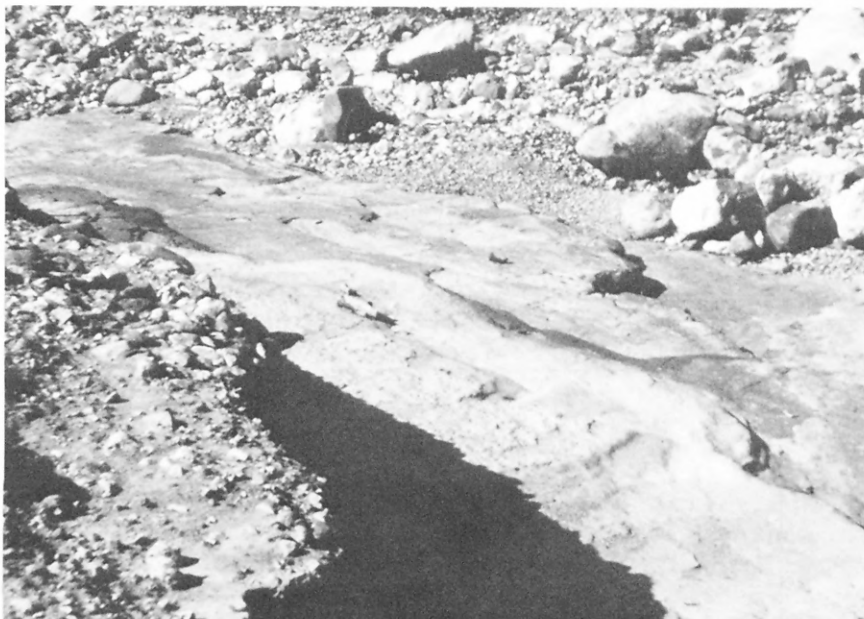
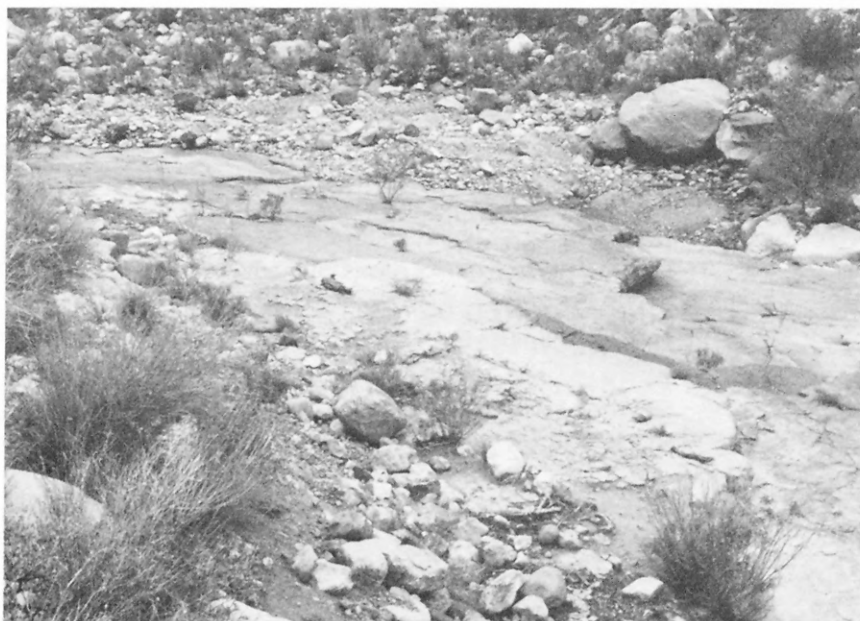
Figure 15.--Dragon Creek, 6.2 miles upstream from the Colorado River. The piece of driftwood at the left center of view B is not the same piece as in view A. Note in view B that the large rocks at the upper left and right have been moved downstream and the bank has collapsed in the foreground. Flow in the channel moves right to left.

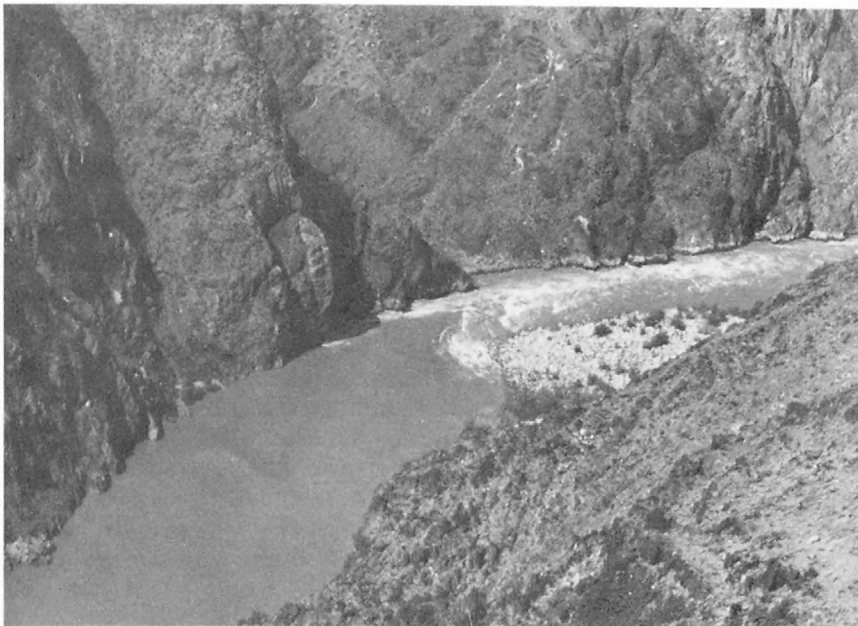
Figure 17.--Crystal Rapid at the mouth of Crystal Creek. The poor visual quality of view A results from deterioration of the original color slide. Note the small debris fan and smooth tongue of water entering the rapid at the right center of the river. The discharge of the Colorado River is 16,000 cubic feet per second. In view B, the tongue of the rapid has been forced to the left as a result of the debris fan deposited during the debris flow of 1966. The discharge of the Colorado River is 28,500 cubic feet per second.
