**AGGRADATION AND DEGRADATION OF ALLUVIAL SAND DEPOSITS,  
1965 TO 1986, COLORADO RIVER, GRAND CANYON NATIONAL  
PARK, ARIZONA**

By John C. Schmidt and Julia B. Graf

Open-File Report 87-555

Prepared in cooperation with the  
U.S. BUREAU OF RECLAMATION

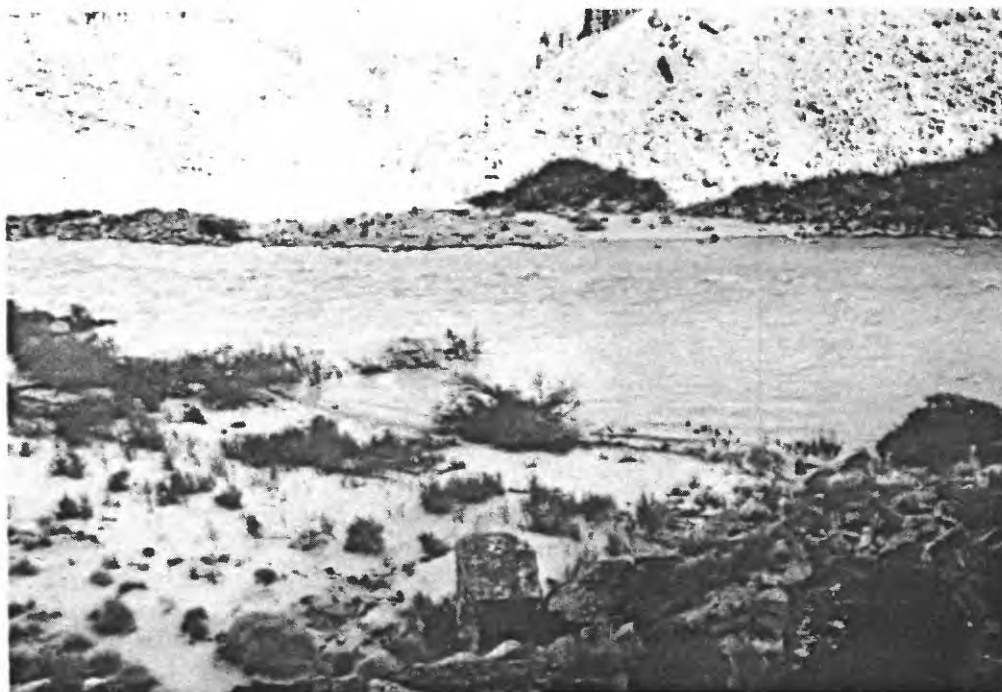
Figure 10.--Separation deposits downstream from Badger Creek Rapid, July 30, 1985. Separation deposits mantle Badger Creek debris fan in foreground and Jackass Creek debris fan on opposite bank. Photograph site located in figure 5.

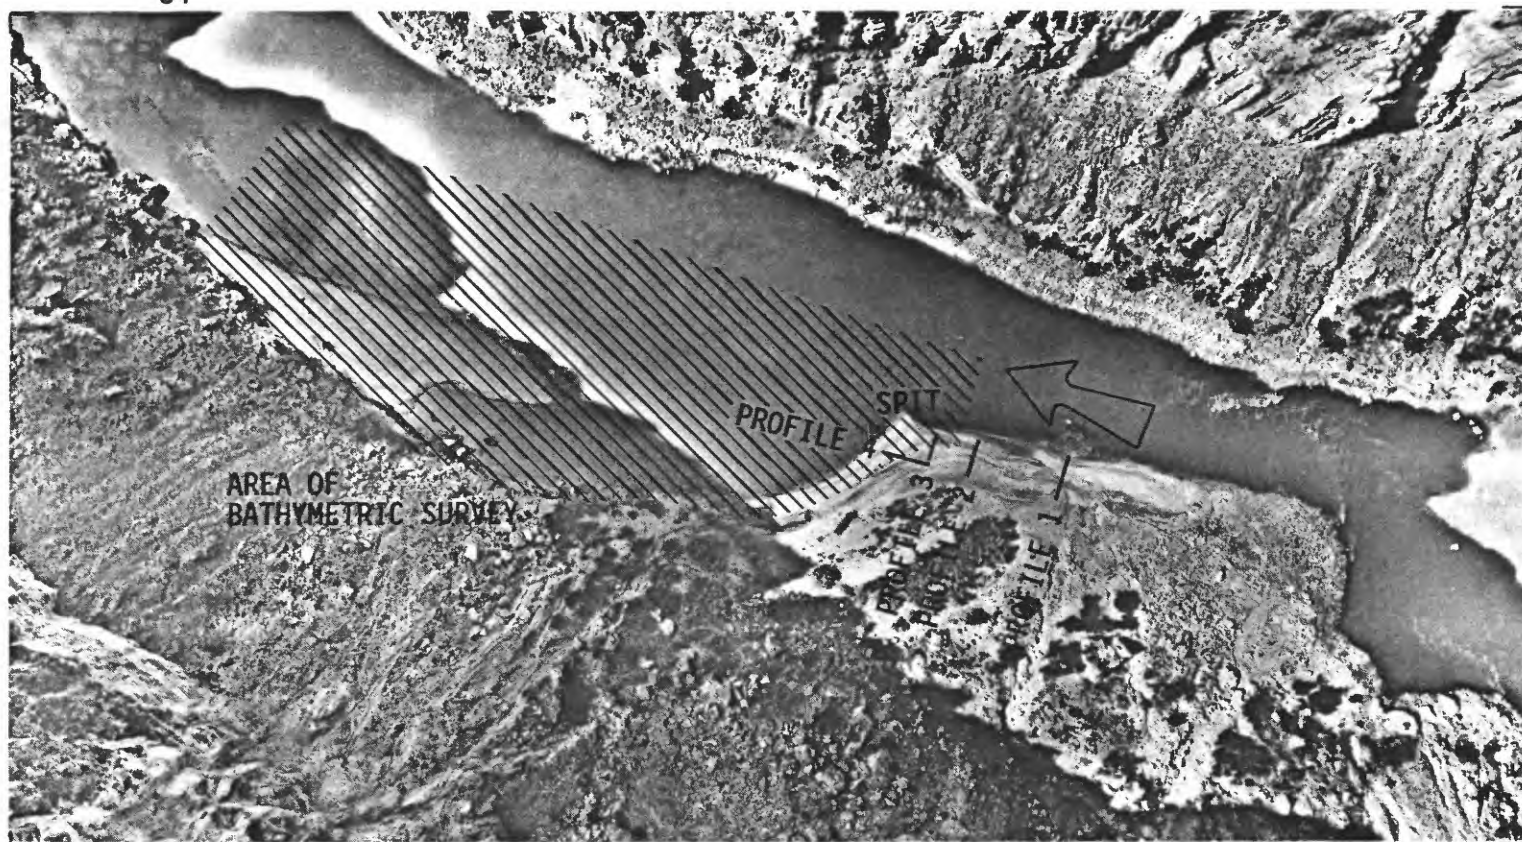
Figure 14.

Figure 14.--Surficial geology and hydraulic features at Eminence Break Camp.

Separation deposits are not found downstream from all debris fans. For separation deposits to form, a stage-discharge relation and local topography must result in the existence of a low-velocity area and (or) secondary eddies upstream from the primary-eddy return current at some discharges. Debris fans with steep, high slopes do not typically have separation deposits because no discharges occur at which a low-velocity area or secondary eddy exists. At the study site Above Cathedral Wash, only discharges much greater than  $100,000 \text{ ft}^3/\text{s}$  would overtop the constricting fan. Some fine sediments exist on the talus at elevations associated with floods in excess of  $100,000 \text{ ft}^3/\text{s}$ . No low-elevation part of the separation deposit projects downstream, however, because the primary-eddy return current is adjacent to the talus at discharges less than  $100,000 \text{ ft}^3/\text{s}$ . In contrast, at Eminence Break Camp, a large low-velocity area exists between the debris fan and the primary-eddy return current at discharges between  $21,000$  and at least  $44,000 \text{ ft}^3/\text{s}$  (fig. 14, bottom). Mean velocities in this area at Eminence

Reattachment deposits occur at the downstream end of many recirculation zones and project upstream as spits (fig. 3). A slipface typically exists along the shoreward side of the spit (fig. 18). The form of these deposits is well displayed in aerial photographs (fig. 14) taken

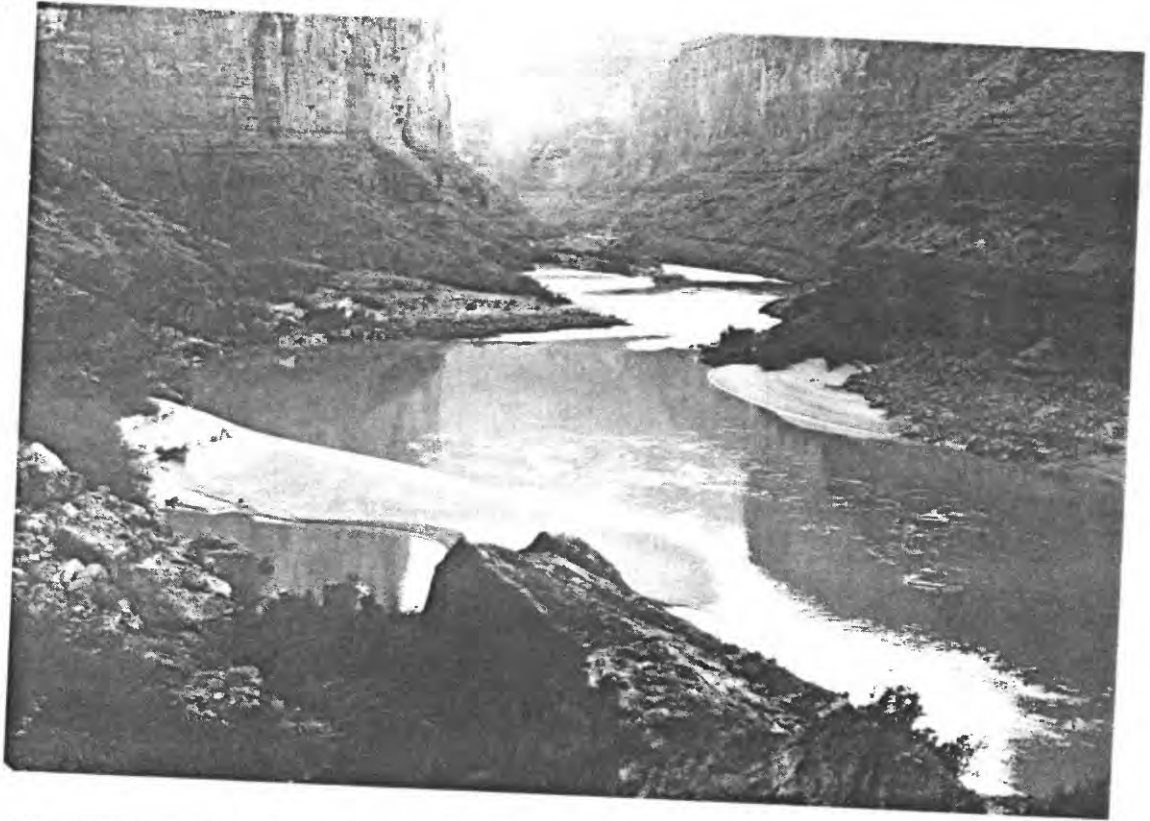
Figure 18.--Reattachment deposit at Eminence Break Camp, October 12, 1985, discharge 3,000 cubic feet per second.
