CONTOUR INTERVAL 25 FEET
Sheet 3. SAN MATEO QUADRANGLE

MAPS SHOWING RECENTLY ACTIVE FAULT BREAKS ALONG THE SAN ANDREAS FAULT FROM MUSSEL ROCK TO THE CENTRAL SANTA CRUZ MOUNTAINS, CALIFORNIA

By
E.H. Pampeyan
1995

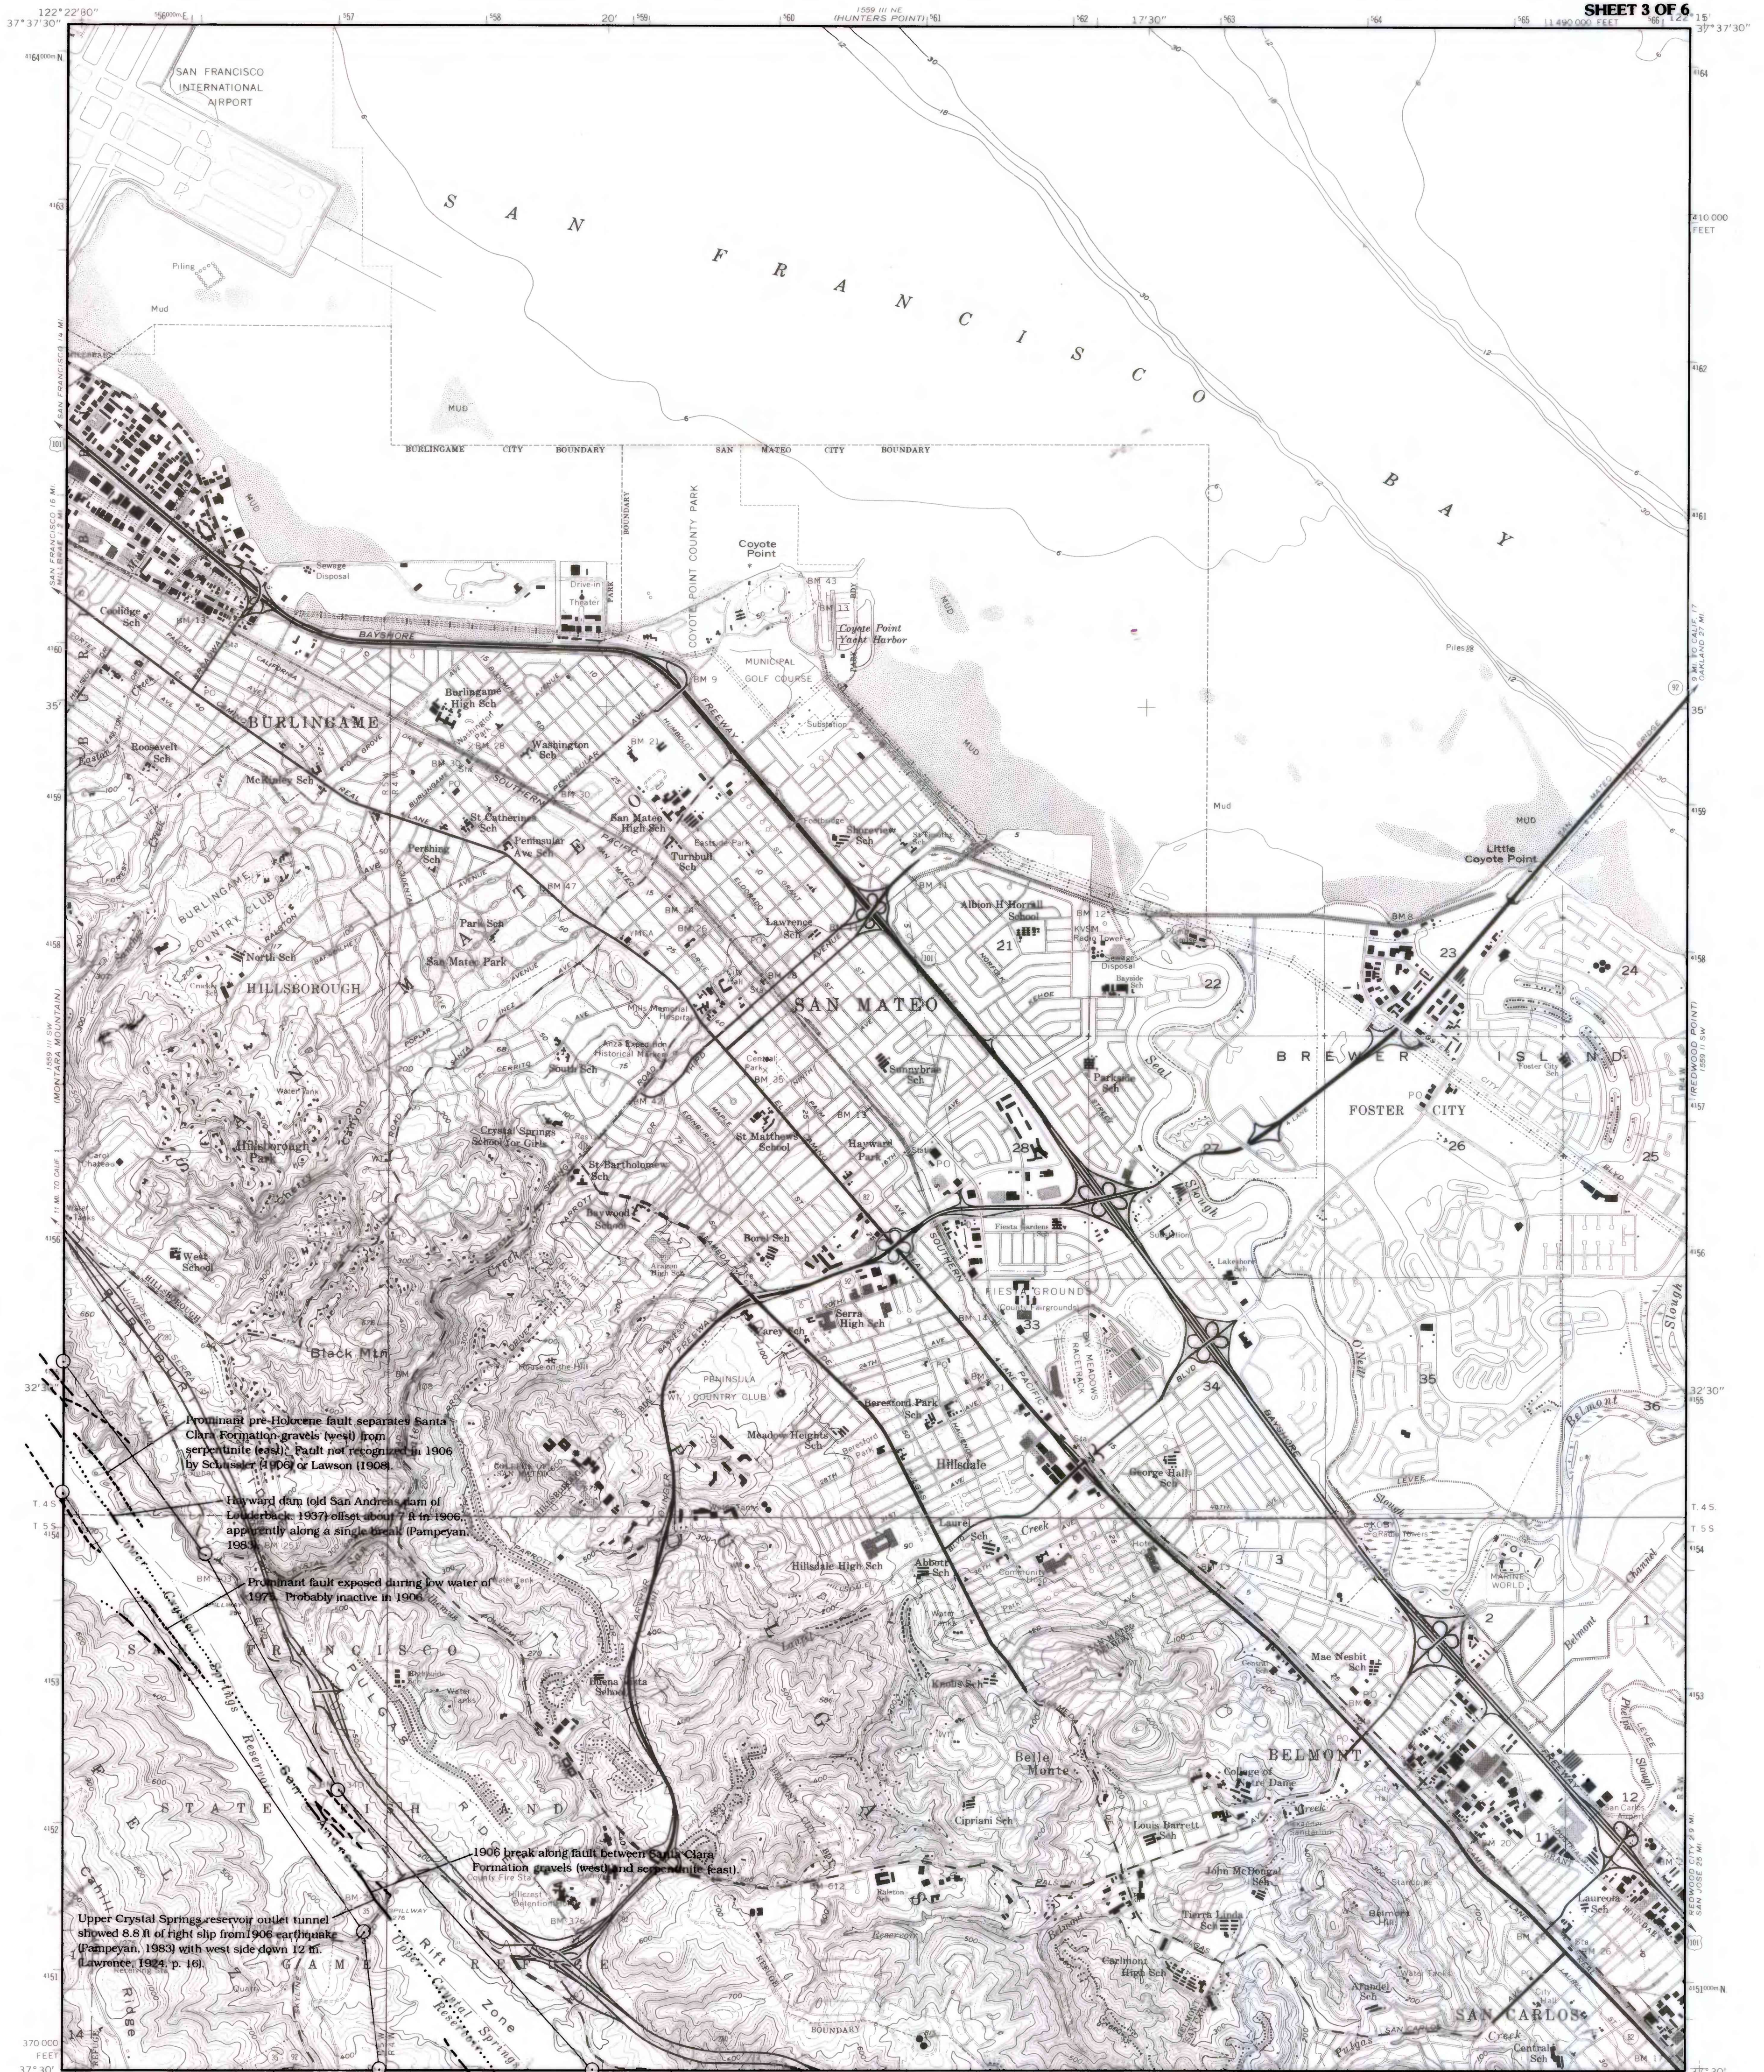
Prominent pre-Holocene fault separates Santa Clara Formation gravels (west) from serpentine (east). Fault not recognized in 1906 by Schuster, Hoge or Lawson (1908).

Hayward dam (old San Andreas) dam of Lower block 1937 offset about 7 ft in 1906, apparently along a single fault (Pampeyan, 1983).

Prominent fault exposed during low water of 1977. Probably inactive in 1906.

1906 break along fault between Santa Clara Formation gravels (west) and serpentine (east).

Upper Crystal Springs reservoir outlet tunnel showed 8.8 ft of right slip from 1906 earthquake (Pampeyan, 1983) with west side down 12 ft. (Lawrence, 1984, p. 16).
