FAULTS AND FOLDS MAPPED DURING PREVIOUS INVESTIGATIONS AND ZONES OF LINEAMENTS BETWEEN LOS ALTOS HILLS AND LOS GATOS, CALIFORNIA

PLATE 1 USGS National Earthquake Hazards Reduction Program
Northeastern Margin of the Southern Santa Cruz Mountains

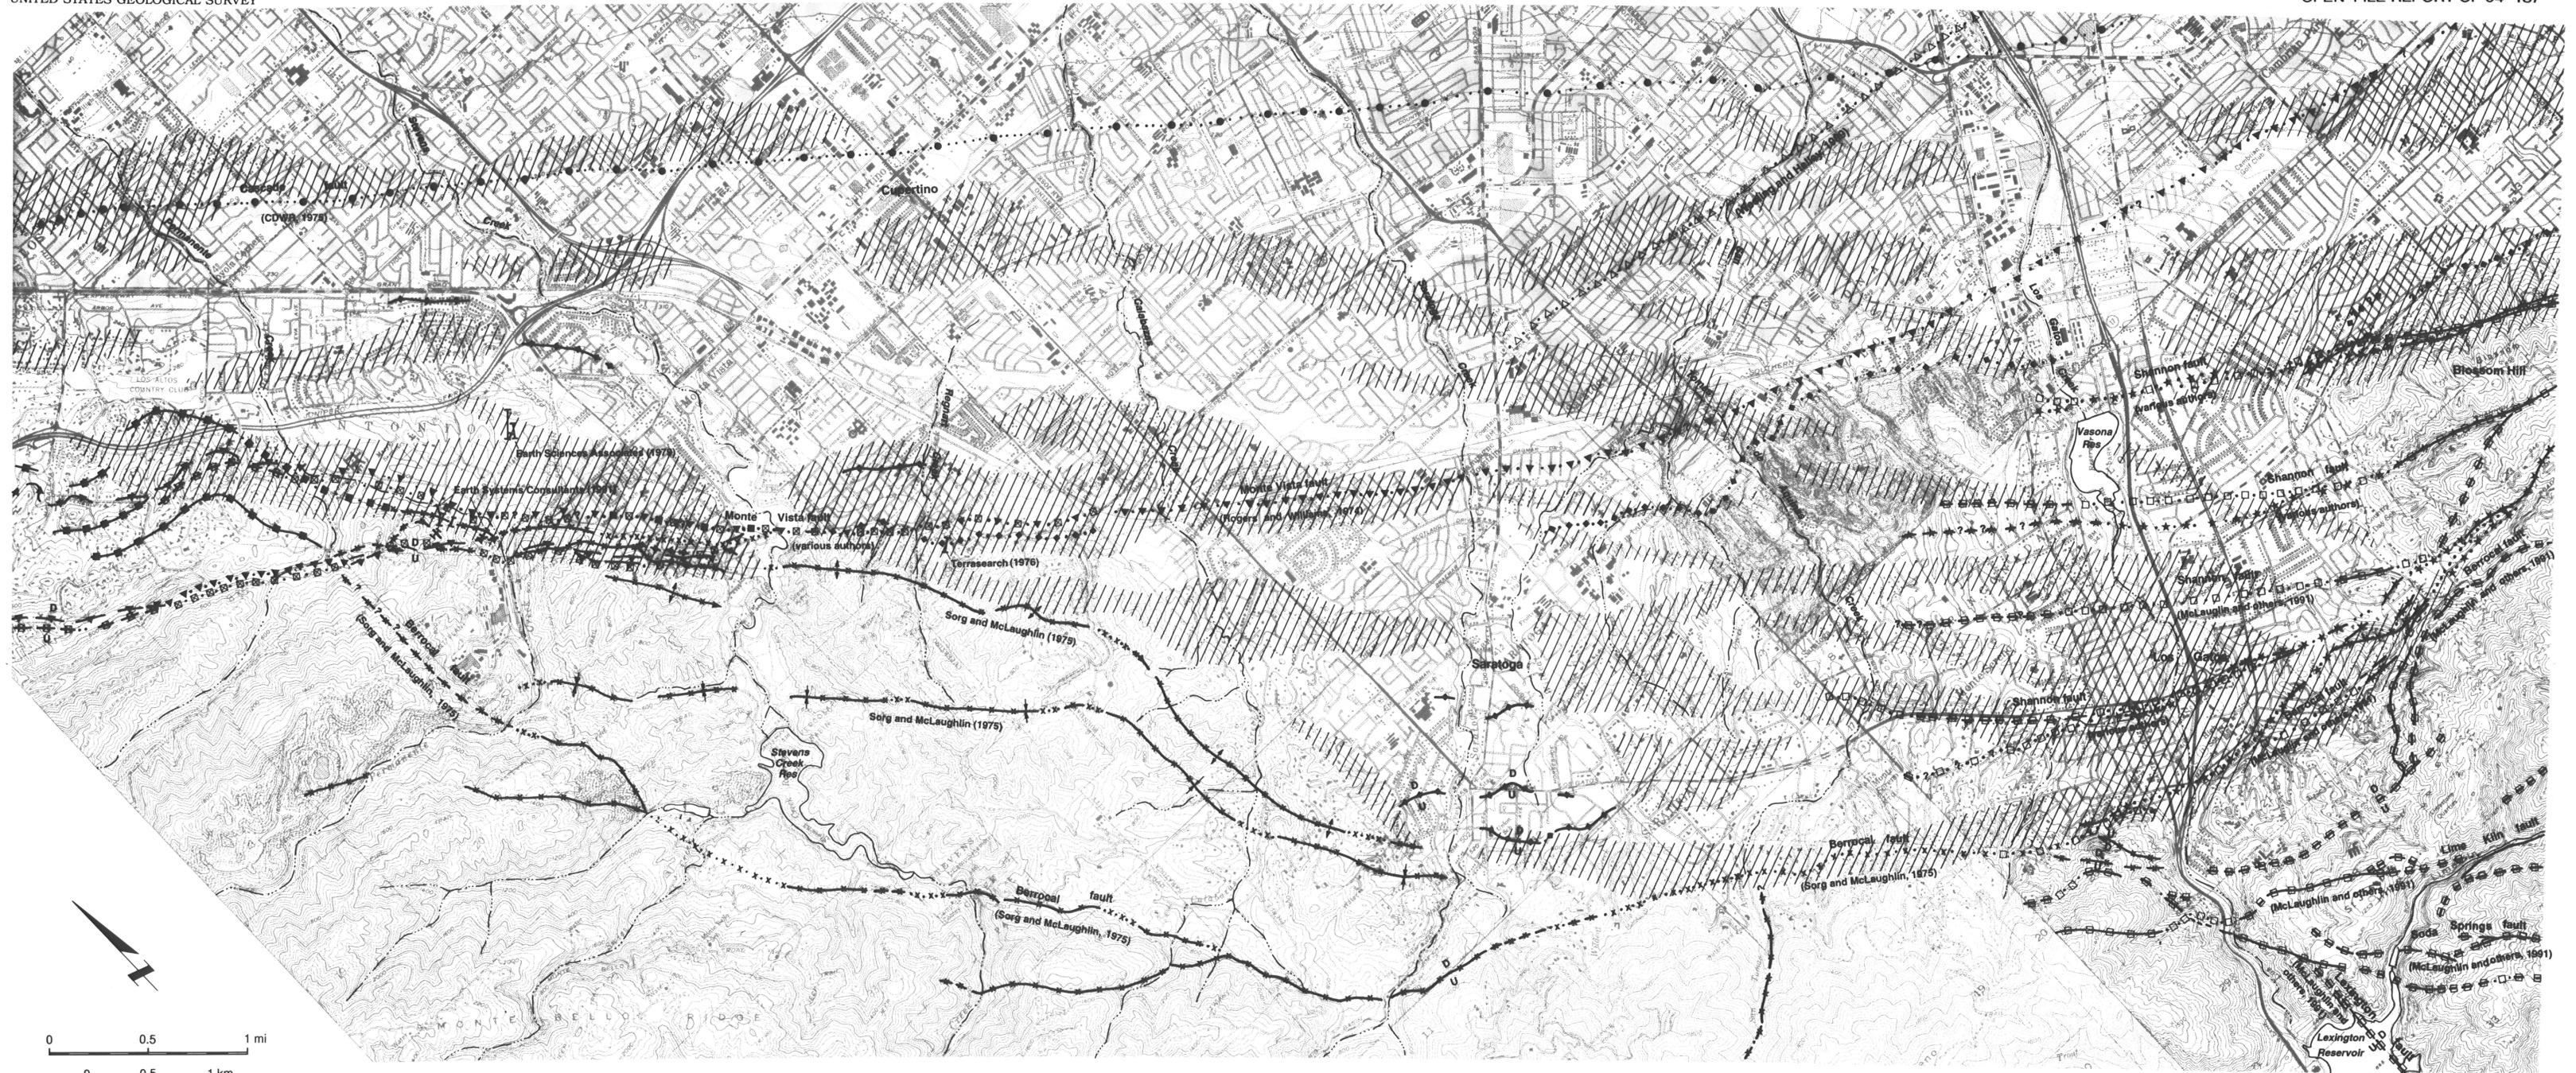
Lineaments shown on this map are not necessarily fault-traces, nor are they necessarily fault-related. This map provides geologic data based on field reconnaissance, interpretation of aerial photographs, and review of published and unpublished geologic reports and maps. It is not intended as a substitute for detailed, site-specific geotechnical or geologic investigations. This map is not intended for planning purposes.

- Fault, dashed where approximately located, dotted where concealed, queried where uncertain. U = up / D = down indicates relative sense of movement where known
- ... Anticlinal axis, dotted where concealed
- ... Synclinal axis, dotted where concealed
- ▨ Zone of lineaments (this study)
- ⊥ Trench referred to in text. Investigator and year indicated
