**DISTRIBUTION OF SURFICIAL SEDIMENTS IN OHIO'S  
NEARSHORE (LAKE ERIE) AS INTERPRETED FROM  
SIDESCAN SONAR AND 3.5 KHZ SUBBOTTOM DATA**

**Open File Report 96-520**

**August 1996**

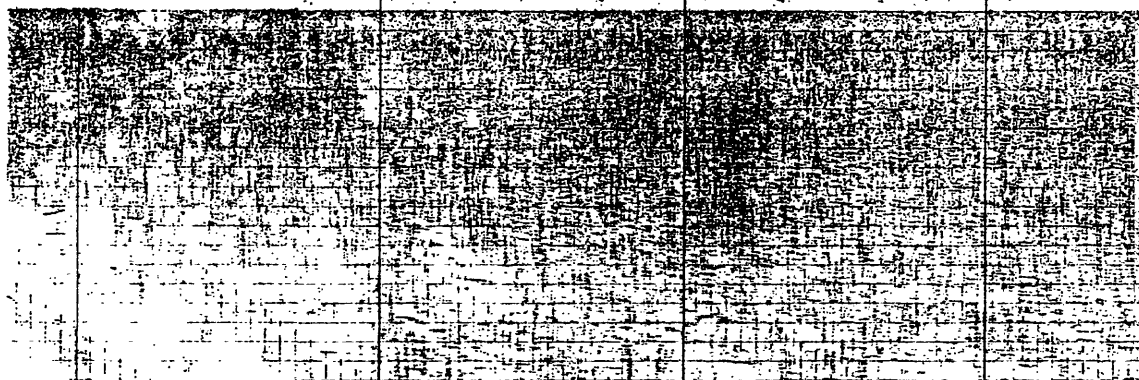
Fig. 3. Till outcrop as seen on the side scan sonar (top) and 3.5 kHz seismic-reflection (bottom) records. For interpretation see table 3.

Cruise LEGS 1 9/94, line 9.

<u>SEDIMENT</u>	<u>SIDESCAN SONAR RECORD</u>	<u>3.5 kHz REFLECTION RECORD</u>
Mud	Low backscatter, little reflection	Internal reflectors, no water bottom multiple
(with gas)	High backscatter	Strong reflectors - poor penetration, strong water bottom multiples
Muddy sand	Intermediate to strong backscatter, few surface features	Intermediate reflectors, may have internal reflectors
Sand/silt	Intermediate backscatter, complex surface, fairly consistent backscatter	Smooth surface, few to no internal reflectors, some multiples
Till, laminated till, glacial lake clay	Intermediate to high backscatter, strong reflections, complex surface	Many internal reflectors and rough surface, to no internal reflectors and smooth surface, multiples common
Rock	High backscatter, dark complex pattern, bedding planes in shale surface	Sharp hard reflector, rough surface, multiples very common

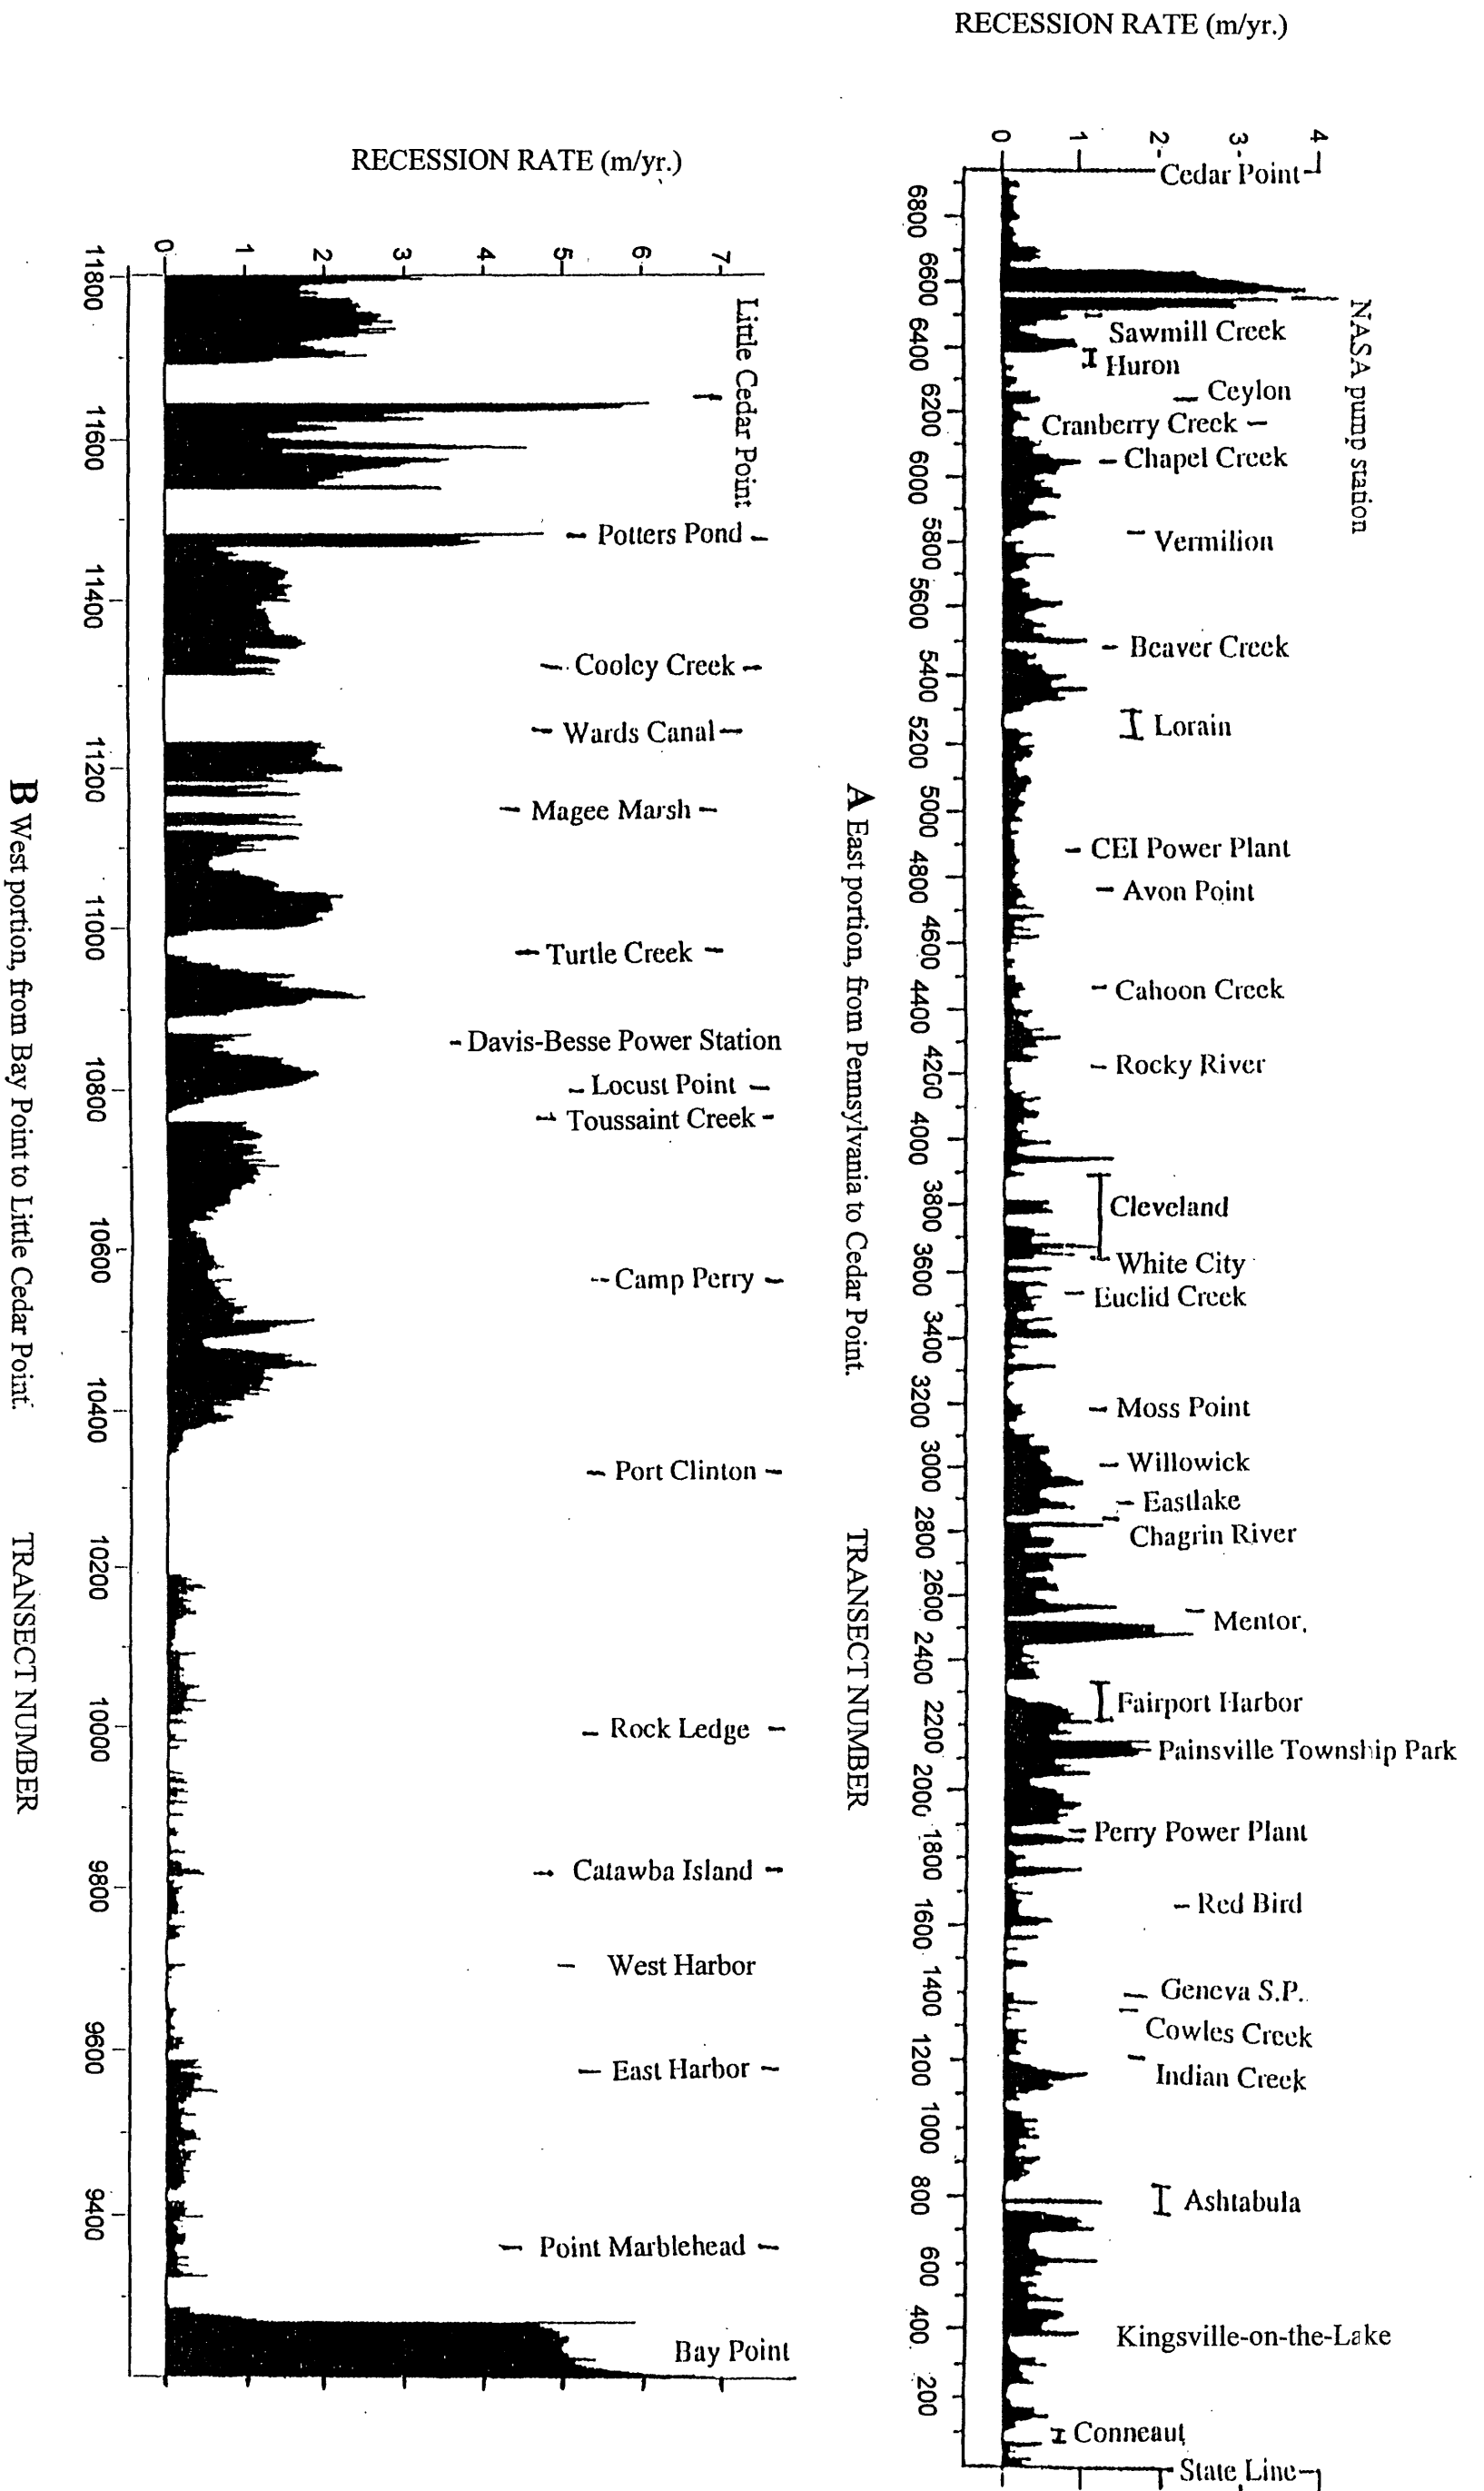
Fig. 7. Long-term recession rates (nominally 1876-1973) of the top of the bluff. The profile numbers and bluff recession rates are from preliminary designations of Coastal Hazard Zone Mapping being carried out by the Ohio Geological Survey. A. Modified from Mackey and Guy, 1994. B. Mackey and Guy file data. Missing transect numbers between A and B are within Sandusky Bay.

From the west side of Cleveland to Cranberry Creek (maps 7-11) the sand beach/bar system varies from 0 to a couple of hundred meters wide. Rock dominates the inner 1.5 km of nearshore deposits with mud extending out to the edge of the mapped areas. The exception to this is between just east of Lorain to Beaver Creek (map 10) where till and related sediments dominate the area beyond the beach/bar system. The average bluff recession rates appear to correlate with bluff composition and the exposure of rock on the lake bottom. Where rock dominates the bluff and the inner nearshore, rates are relatively slower in comparison to those areas where till and unconsolidated sediments are dominant (fig. 7; Mackey and Guy, 1994).

area. This reach has a long fetch from the northeast and has the greatest long-term bluff recession rate, about 5 m/yr., in Ohio's central basin area (fig. 7). However, this rate is not directly comparable to those elsewhere along the shore because it represents retreat of the vegetated upland and movement of a sand spit rather than permanent loss of cohesive bluff material. Along this reach the recession rates and the environments are very similar to those just west of the NASA pump station where the sand barrier was pushed back into a marsh.
