Rock-fall Hazards in the Yosemite Valley

Open File Report

1998

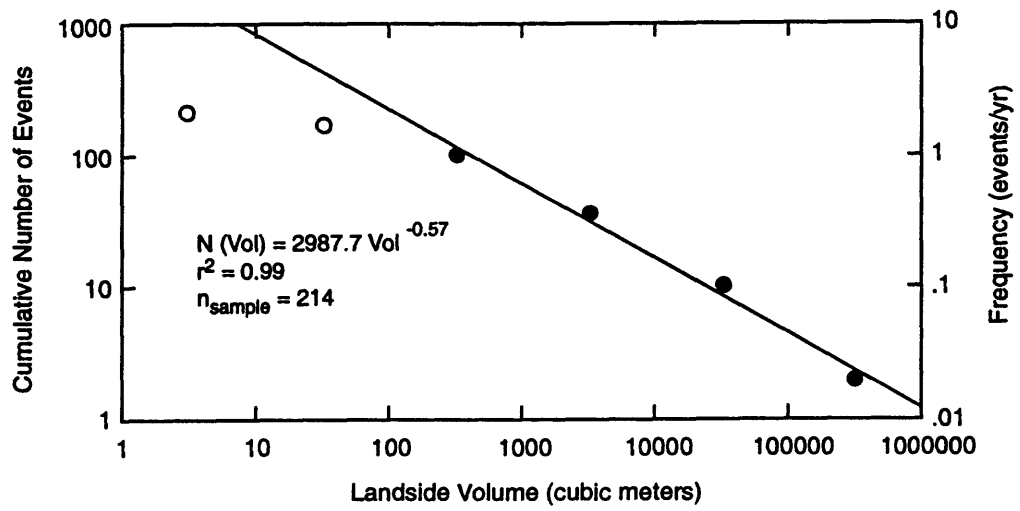
Yosemite Valley Rock Falls 1900 - 1992

1. Graph of volume-frequency distribution of rock falls in the Yosemite Valley from 1900-1992 (from Wiczorek et al., 1995).
2. Sketch of rock-fall talus at base of slope and outlying boulders illustrating rock-fall shadow and shadow angle (after Evans and Hungr, 1993).
3. Graph of volume versus ratio of H (height) to L (length) of worldwide rock falls (modified from Li, 1983). Letters (a to e) represent large rock avalanches in Yosemite Valley shown on Plate 1 and listed in Table 2. Bar indicates range of uncertainty for measurement of ratio of H/L.

Rock falls range in size from small individual blocks of less than 1 m³ to rock avalanches of several million cubic meters. Even a rapidly moving small boulder can cause serious injury to a person and considerable damage to vehicles or buildings. The frequency of different size rock falls has been determined from an analysis of historical rock falls (Figure 1) (Wieczorek et al., 1995). Many small rock falls are observed every year in the Yosemite Valley, many more small rock falls probably go unreported each year. Larger size rock falls occur less frequently. For example, the return period for rock-fall events with volumes equal or greater than the 1996 Happy Isles rock fall (approximately 30,000 m³) is about 11 years.
