Physical, Chemical, and Biological Data for Two Sites on the Upper Kenai River, Alaska, 1998

Open-File Report 99-258

by Joseph M. Dorava and Lee Ness

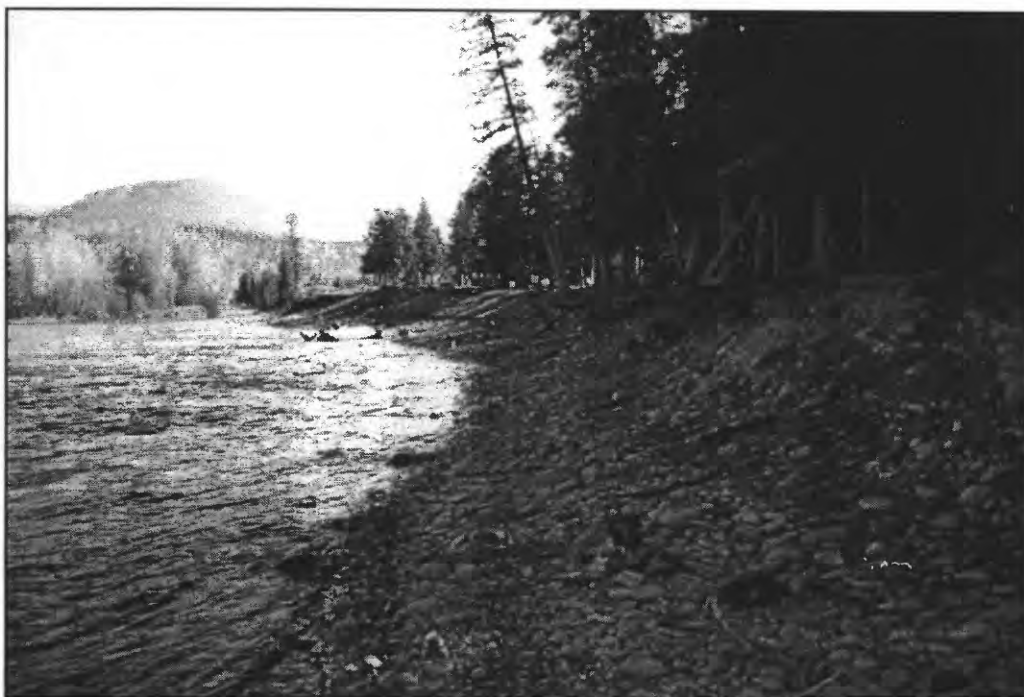
Figure 7. Eroding streambank at Sportsman's Landing. Southern bank of the Kenai River near the Russian River ferry crossing. View is upstream looking to the east.

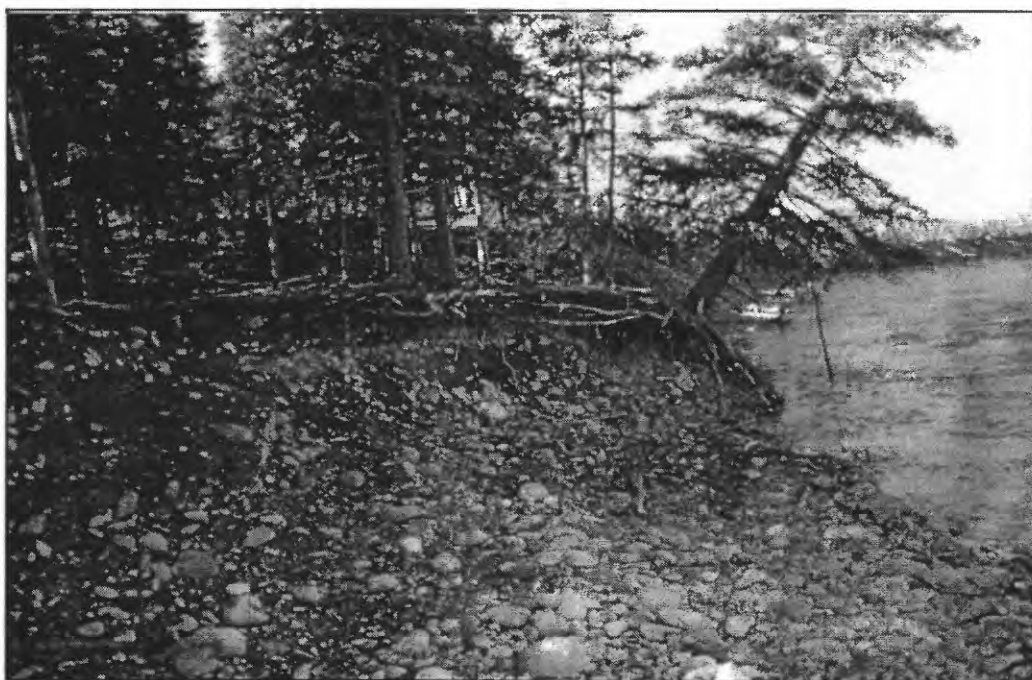
Figure 8. Eroding streambank at Sportsman's Landing. Southern bank of the Kenai River near the Russian River ferry crossing. View is downstream looking to the west.
