Coastal Vulnerability Assessment of Virgin Islands National Park (VIIS) to Sea-Level Rise

By Elizabeth A. Pendleton, E. Robert Thieler, and S. Jeffress Williams

Open-File Report 2004-1398

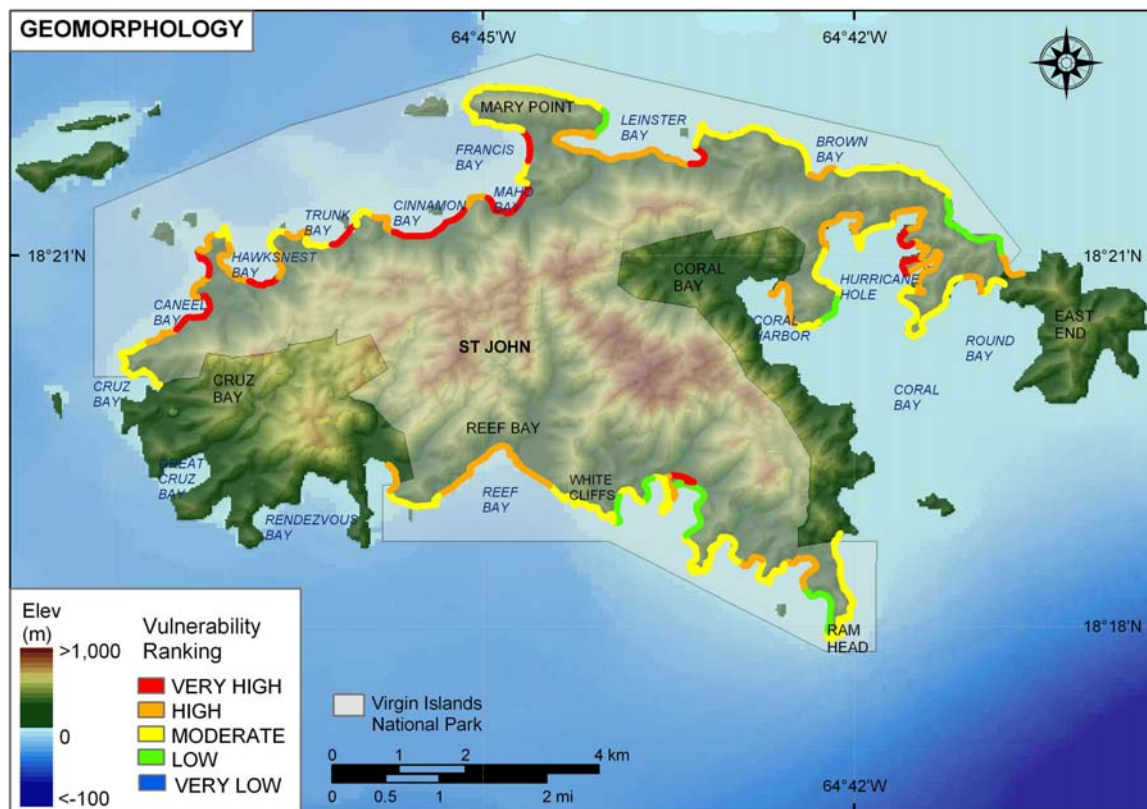
Figure 4. Coastal Geomorphology of Virgin Islands National Park. The colored shoreline represents the variations in coastal geomorphology within the park. The very high vulnerability geomorphology is mostly sand beaches or mangrove wetlands. High vulnerability geomorphology includes gravel or cobble-sized beaches or cliff-backed beaches. Moderate vulnerability geomorphology consists of alluvium or fringing reefs fronting low cliffs. Low vulnerability geomorphology includes medium cliffs and rock headlands.

The **geomorphology** variable expresses the relative erodibility of different landform types (Table 1). These data were derived from 1999 vertical aerial photography provided by NOAA's biogeography program. In addition, field visits were made within accessible locations of the park to verify the geomorphologic classification (Figure 5 A-H). Virgin Islands National Park contains several geomorphology types, including low vulnerability rock cliffs, moderate vulnerability alluvium and cliffs with fringing reefs, high vulnerability gravel beaches or cliff backed beaches, and very high vulnerability mangrove wetlands and sand beaches (Figure 4 and Figure 5 A-H).

Figure 4. Coastal Geomorphology of Virgin Islands National Park. The colored shoreline represents the variations in coastal geomorphology within the park. The very high vulnerability geomorphology is mostly sand beaches or mangrove wetlands. High vulnerability geomorphology includes gravel or cobble-sized beaches or cliff-backed beaches. Moderate vulnerability geomorphology consists of alluvium or fringing reefs fronting low cliffs. Low vulnerability geomorphology includes medium cliffs and rock headlands.

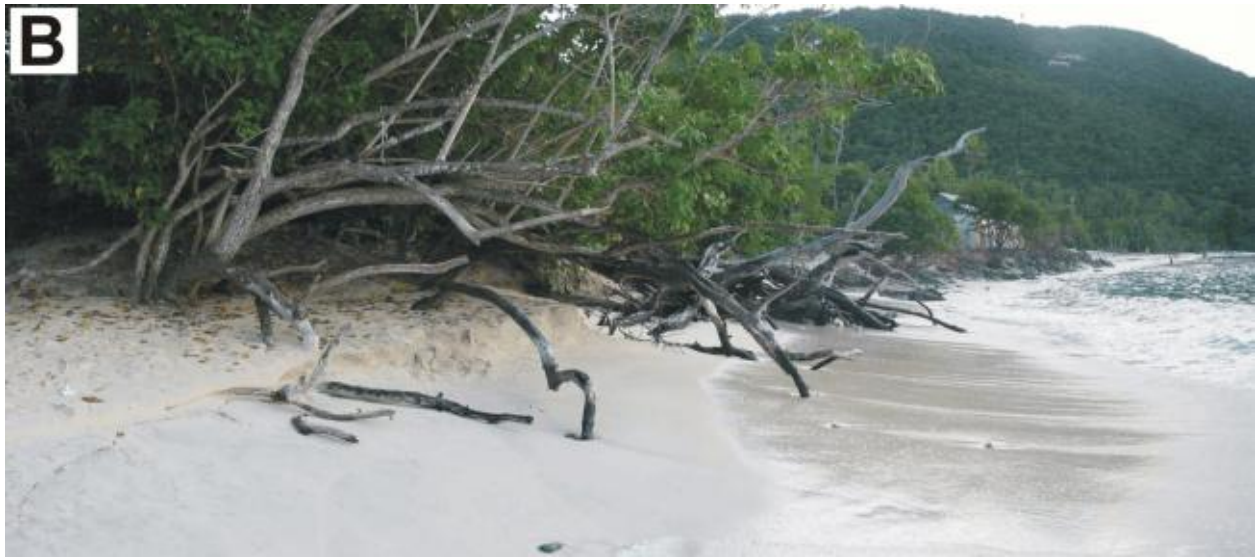
Figure 5. B) The shoreline at Cinnamon Bay is experiencing erosion, very high vulnerability.

B) The shoreline at Cinnamon Bay is experiencing erosion, very high vulnerability.

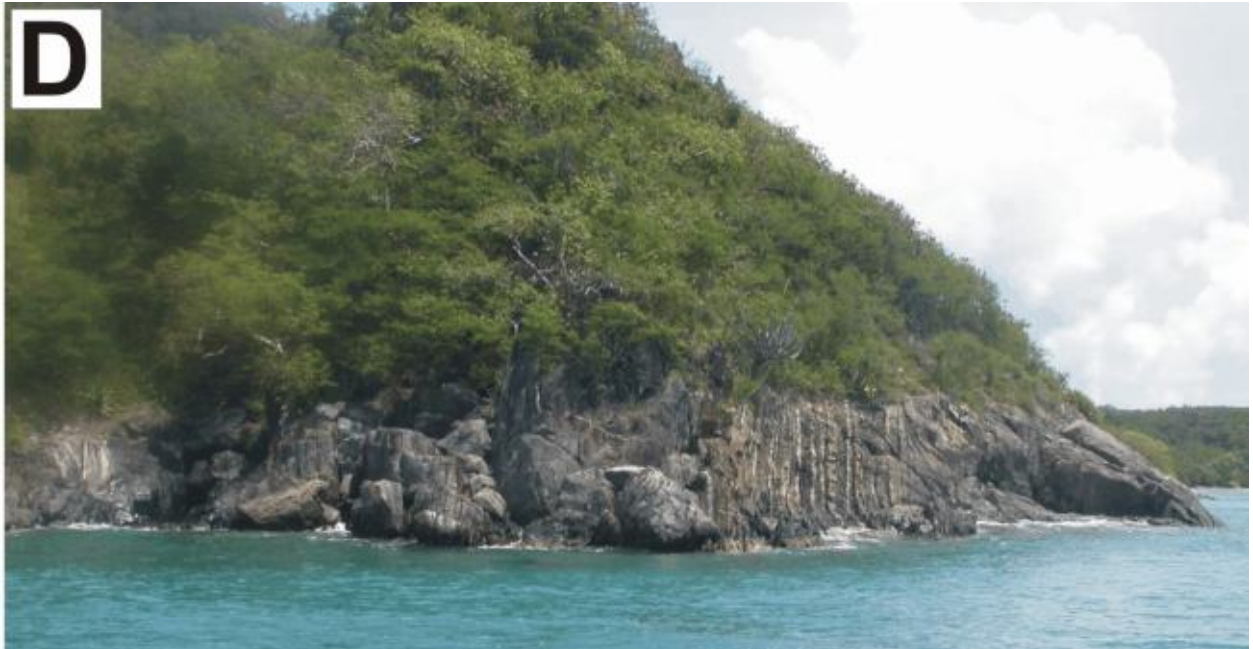
Figure 5. D) Mary Point was ranked as low vulnerability (photo by Rebecca Beavers).

D) Mary Point was ranked as low vulnerability (photo by Rebecca Beavers).

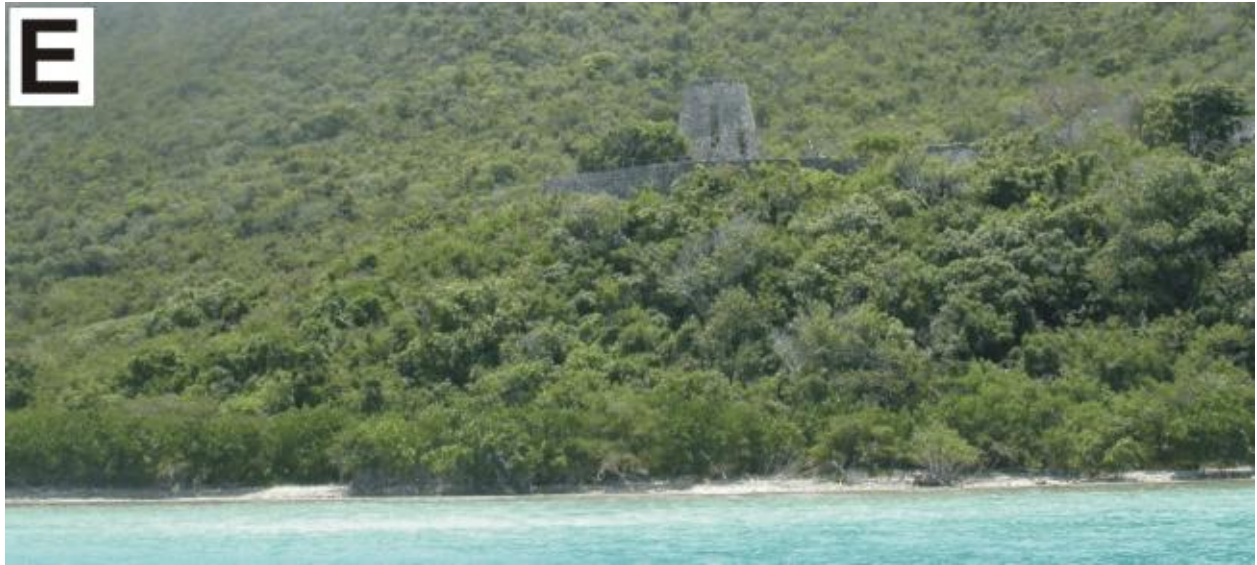
Figure 5. E) The Annaberg Mill ruins are in an area ranked as high vulnerability with respect to geomorphology (photo by Rebecca Beavers).

E) The Annaberg Mill ruins are in an area ranked as high vulnerability with respect to geomorphology (photo by Rebecca Beavers).

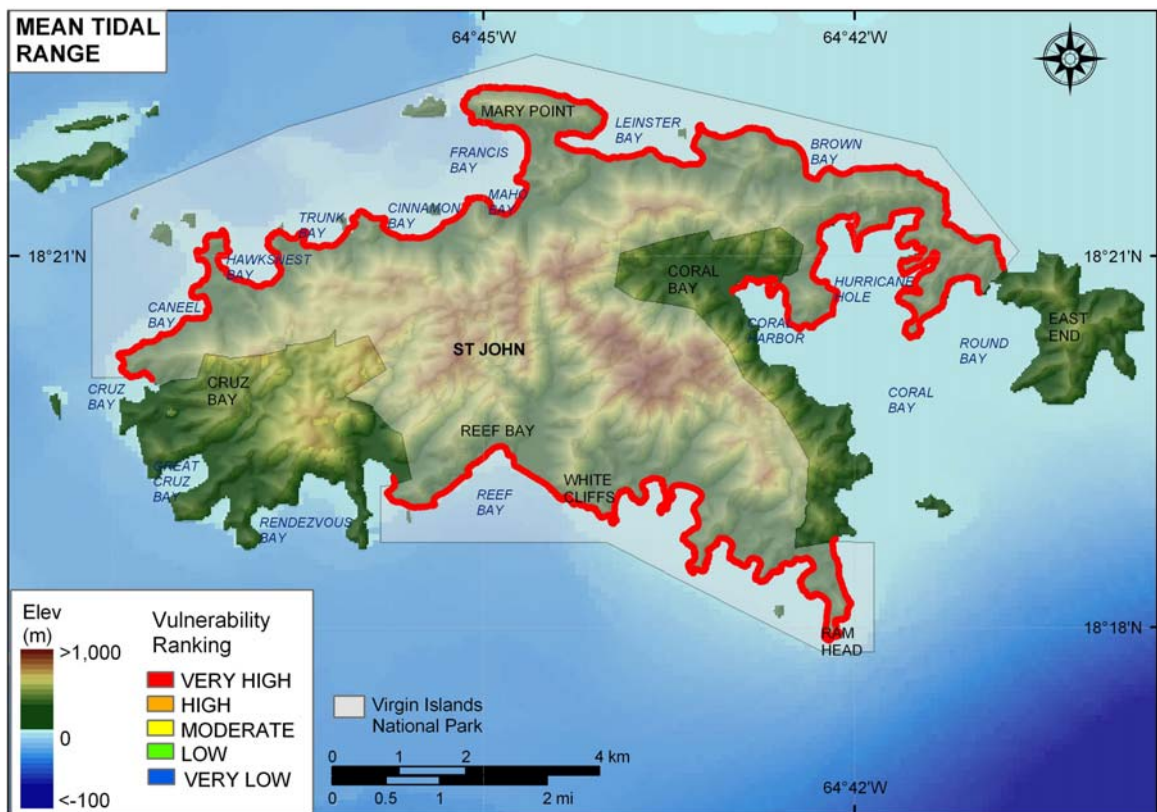
Figure 10. Mean Tidal Range for Virgin Islands National Park. The colored shoreline represents the ranked mean tidal range for Virgin Islands. All of Virgin Islands National Park is ranked as very high vulnerability with respect to tidal range.

Tidal range is linked to both permanent and episodic inundation hazards. Tide range data were obtained from a NOAA/NOS published benchmark on St. John Island in Coral Harbor. Mean tidal range here is 0.262 m; therefore Virgin Islands National Park is classified as very high vulnerability (> 1meter) with respect to tidal range (Figure 10).

Figure 10. Mean Tidal Range for Virgin Islands National Park. The colored shoreline represents the ranked mean tidal range for Virgin Islands. All of Virgin Islands National Park is ranked as very high vulnerability with respect to tidal range.

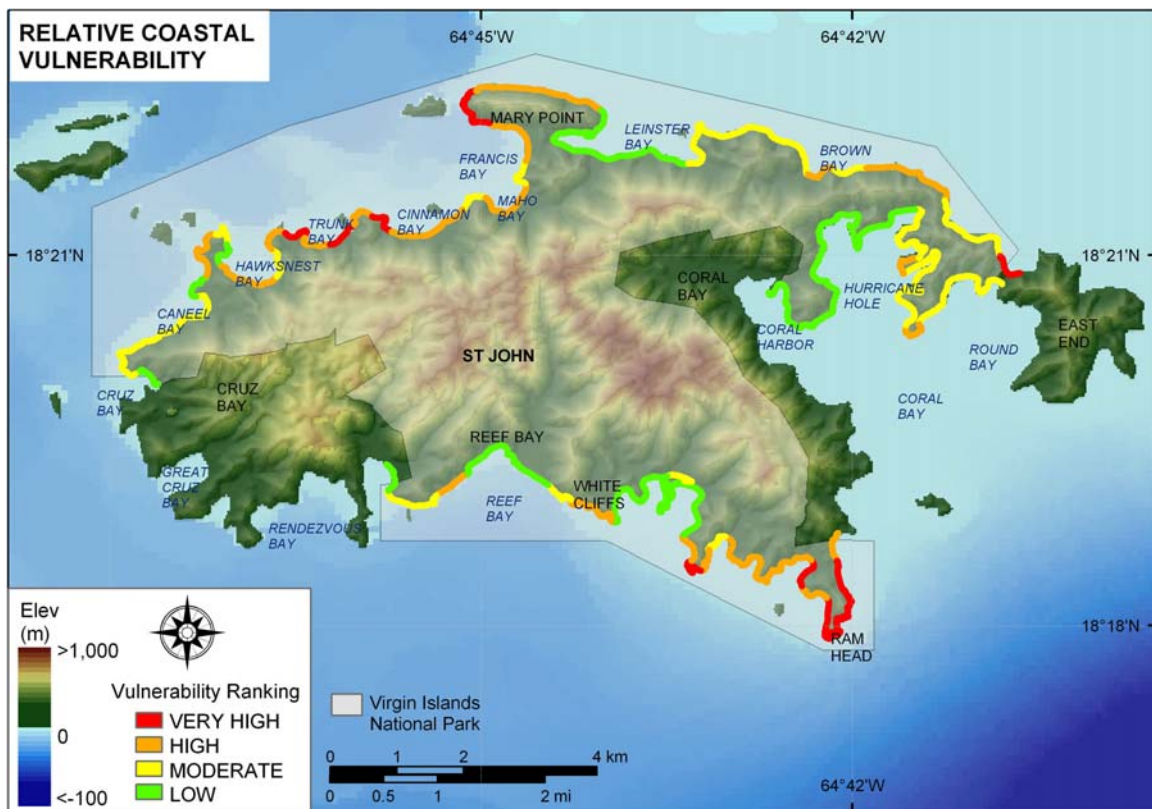
Figure 11. Relative Coastal Vulnerability for Virgin Islands National Park. The colored shoreline represents the relative coastal vulnerability index (CVI) determined from the six variables. The very high vulnerability shoreline is located along sandy pocket beaches where coastal slope is low and significant wave heights are high. The low vulnerability shoreline is generally located along rock cliffs or in sheltered areas such as in Hurricane Hole.

Figure 11 shows a map of the coastal vulnerability index for Virgin Islands National Park. The CVI scores are divided into low, moderate, high, and very high-vulnerability categories based on the quartile ranges and visual inspection of the data. CVI values below 1.83 are assigned to the low vulnerability category. Values from 1.83 to 2.24 are considered moderate vulnerability. High-vulnerability values lie between 2.25 and 2.74. CVI values above 2.74 are classified as very high vulnerability. Figure 12 shows the percentage of Virgin Islands shoreline in each vulnerability category. Nearly all of the shoreline of St. John is evaluated for the Virgin Islands National Park. Thirteen percent of the mapped shoreline is classified as being at very high vulnerability due to future sea-level rise. Twenty-nine percent is classified as high vulnerability, twenty-eight percent as moderate vulnerability, and twenty-nine percent as low vulnerability.

The geologic variables show the most spatial variability and thus have the most influence on CVI variability (Figure 11). Geomorphology in the park includes very high vulnerability sandy beach shoreline, high vulnerability gravel beaches, moderate vulnerability alluvium or cliffs with fringing reefs, and low vulnerability rock and cliff features (Figure 4 and Figure 5 A-H). Vulnerability assessment based on shoreline change remains constant at moderate vulnerability for all of Virgin Islands NP (Figure 6). Regional coastal slope is in the very low to very high vulnerability range for Virgin Islands.

Figure 11. Relative Coastal Vulnerability for Virgin Islands National Park. The colored shoreline represents the relative coastal vulnerability index (CVI) determined from the six variables. The very high vulnerability shoreline is located along sandy

pocket beaches where coastal slope is low and significant wave heights are high. The low vulnerability shoreline is generally located along rock cliffs or in sheltered areas such as in Hurricane Hole.
