Coastal Vulnerability Assessment of Virgin Islands National Park (VIIS) to Sea-Level Rise

By Elizabeth A. Pendleton, E. Robert Thieler, and S. Jeffress Williams

Open-File Report 2004-1398

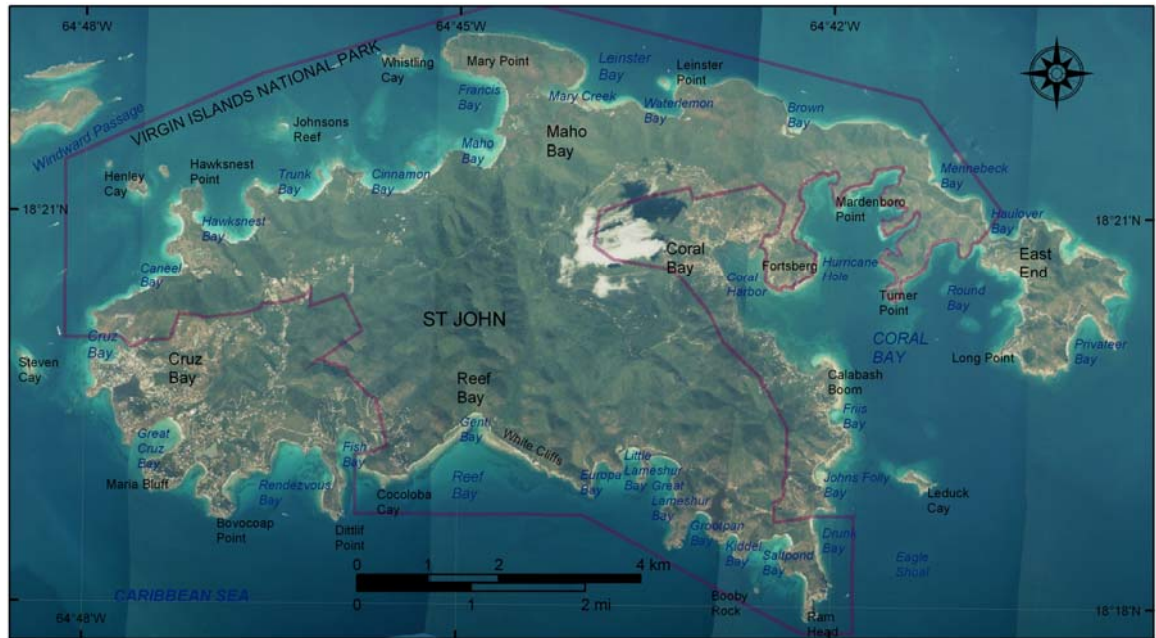
Figure 2. Virgin Islands National Park on St. John Island. Aerial photo mosaic produced from NOAA/NOS photos (<http://biogeo.nos.noaa.gov/projects/mapping/caribbean/>) showing physiography and location labels. The red line is the boundary of Virgin Islands National Park.

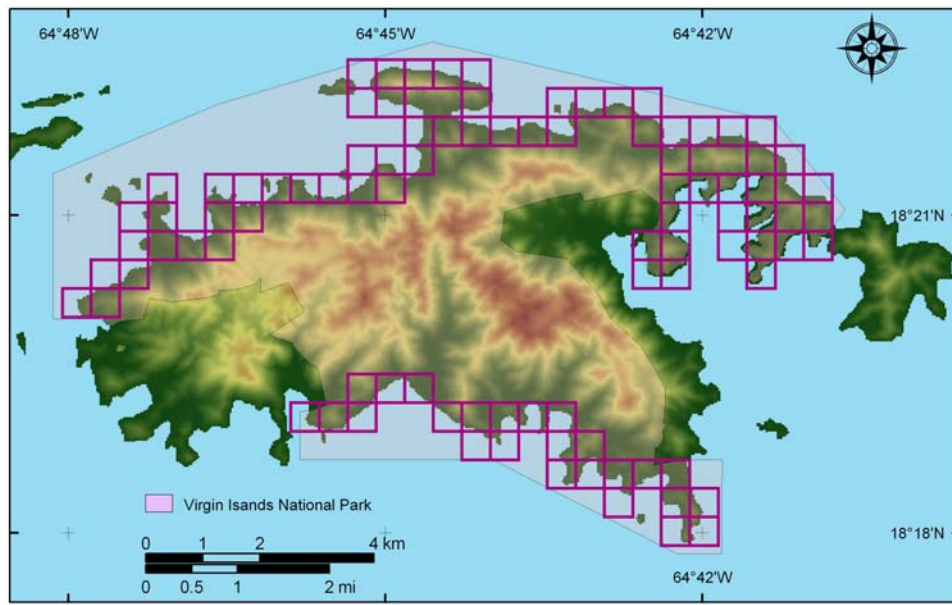
Figures 3. Shoreline grid for Virgin Islands National Park. Each cell is approximately 500 meters of shoreline and represents a shoreline segment for which each variable is defined.

The database was constructed using a 1:48,000-scale shoreline for Virgin Islands that was obtained from the National Oceanic and Atmospheric Administration's Biogeography Program (<http://biogeo.nos.noaa.gov/products/benthic/>). Data for each of the six variables (geomorphology, shoreline change, coastal slope, relative sea-level rise, significant wave height, and tidal range) were added to the shoreline attribute table using a 500-meter grid (Figure 3). For segments of shoreline that experienced geomorphologic changes within one grid cell, smaller shoreline segments were created. Next each variable in each grid cell or shoreline segment was assigned a vulnerability value from 1-5 (1 is very low vulnerability, 5 is very high vulnerability) based on the potential magnitude of its contribution to physical changes on the coast as sea level rises (Table 1).

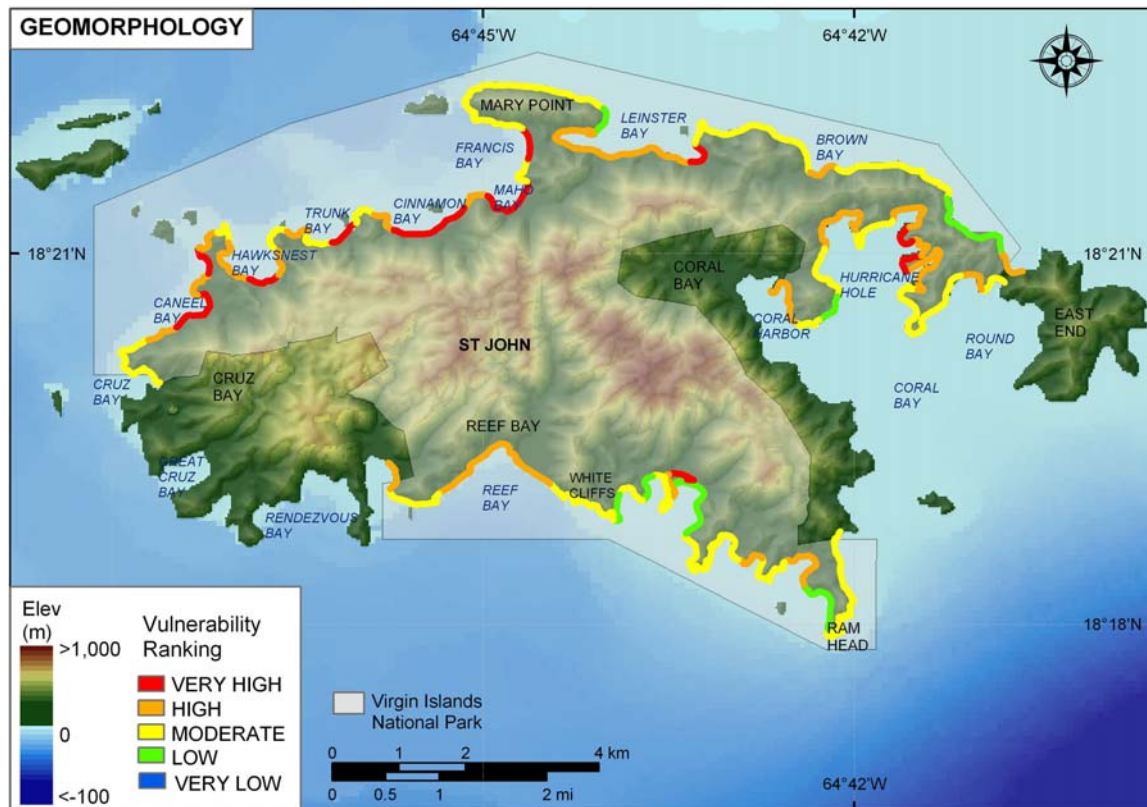
Figure 4. Coastal Geomorphology of Virgin Islands National Park. The colored shoreline represents the variations in coastal geomorphology within the park. The very high vulnerability geomorphology is mostly sand beaches or mangrove wetlands. High vulnerability geomorphology includes gravel or cobble-sized beaches or cliff-backed beaches. Moderate vulnerability geomorphology consists of alluvium or fringing reefs fronting low cliffs. Low vulnerability geomorphology includes medium cliffs and rock headlands.

The **geomorphology** variable expresses the relative erodibility of different landform types (Table 1). These data were derived from 1999 vertical aerial photography provided by NOAA's biogeography program. In addition, field visits were made within accessible locations of the park to verify the geomorphologic classification (Figure 5 A-H). Virgin Islands National Park contains several geomorphology types, including low vulnerability rock cliffs, moderate vulnerability alluvium and cliffs with fringing reefs, high vulnerability gravel beaches or cliff backed beaches, and very high vulnerability mangrove wetlands and sand beaches (Figure 4 and Figure 5 A-H).

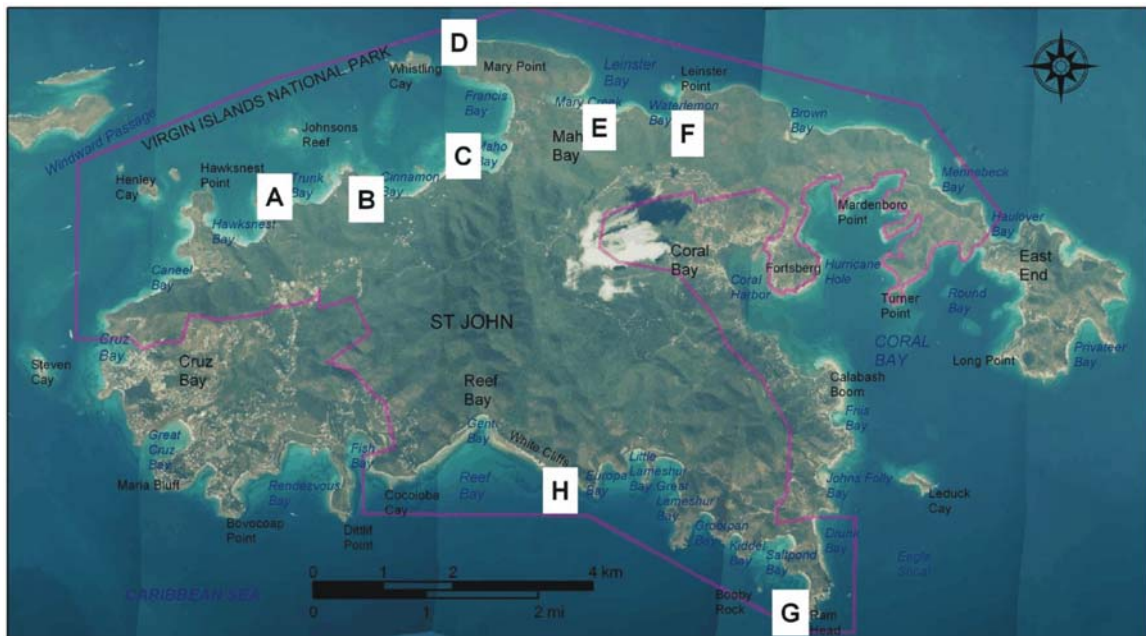
Figure 5. Photos of different geomorphologic types within Virgin Islands National Park. *Click on a letter to see a photo near that location.*

- A) A view of Trunk Bay from the east, very high vulnerability.
- B) The shoreline at Cinnamon Bay is experiencing erosion, very high vulnerability.
- C) A view of Maho Bay from the east, very high vulnerability.
- D) Mary Point was ranked as low vulnerability (photo by Rebecca Beavers).
- E) The Annaberg Mill ruins are in an area ranked as high vulnerability with respect to geomorphology (photo by Rebecca Beavers).
- F) The shoreline surrounding Waterlemon Bay is a cobble beach, high vulnerability
- G) Ram Head is a rocky headland, low vulnerability (photo by Rebecca Beavers). H) The white cliffs near Reef Bay were ranked as low vulnerability (photo by Rebecca Beavers).

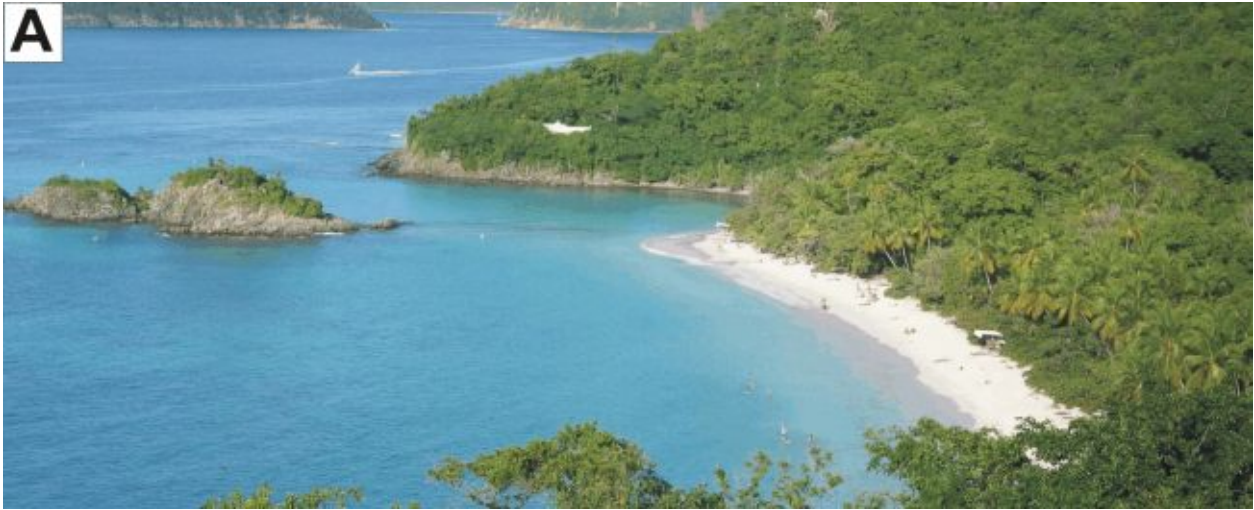
Figure 5. A) A view of Trunk Bay from the east, very high vulnerability.

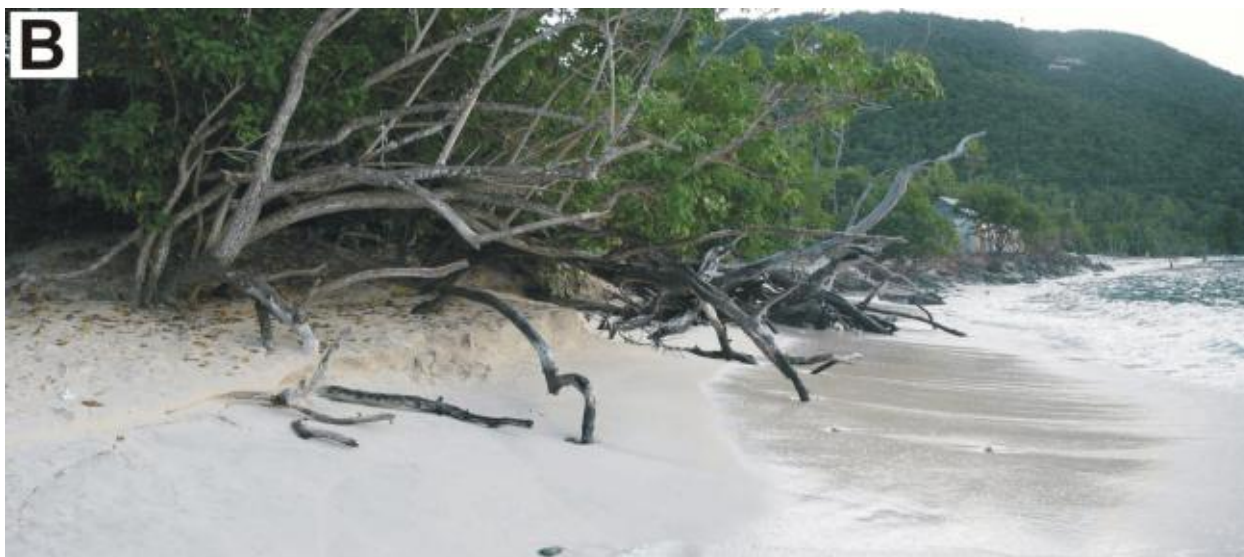
Figure 5. B) The shoreline at Cinnamon Bay is experiencing erosion, very high vulnerability.

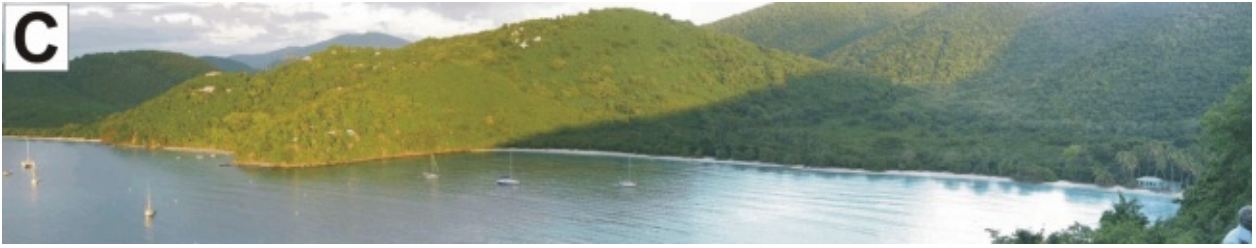
Figure 5. C) A view of Maho Bay from the east, very high vulnerability.

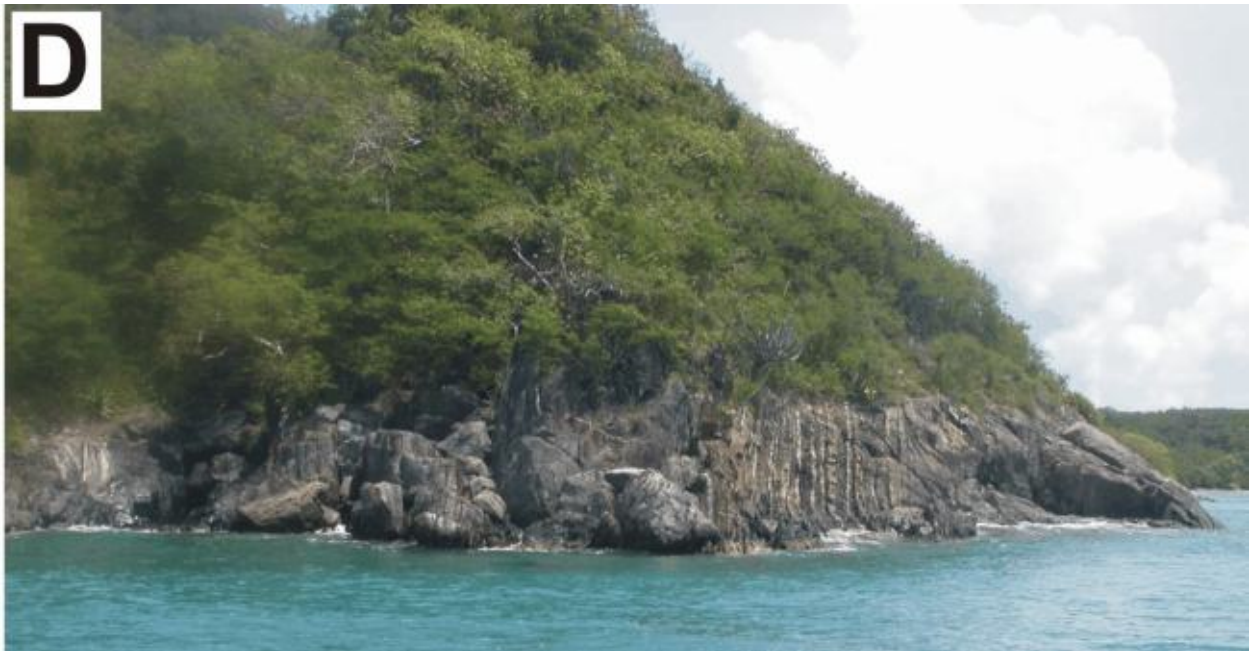
Figure 5. D) Mary Point was ranked as low vulnerability (photo by Rebecca Beavers).

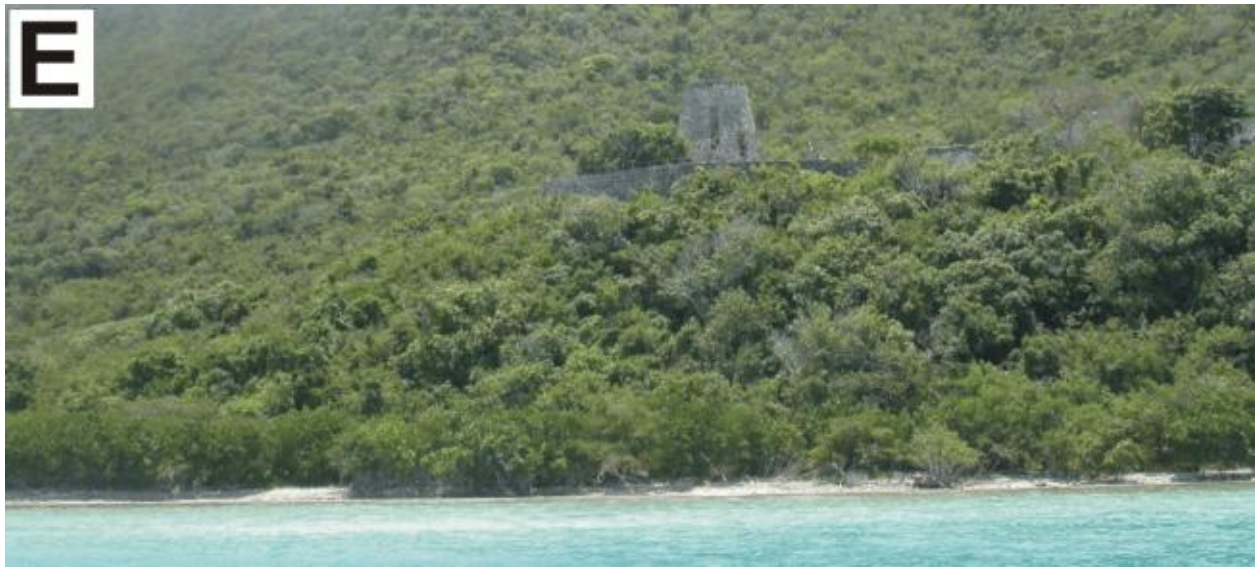
Figure 5. E) The Annaberg Mill ruins are in an area ranked as high vulnerability with respect to geomorphology (photo by Rebecca Beavers).

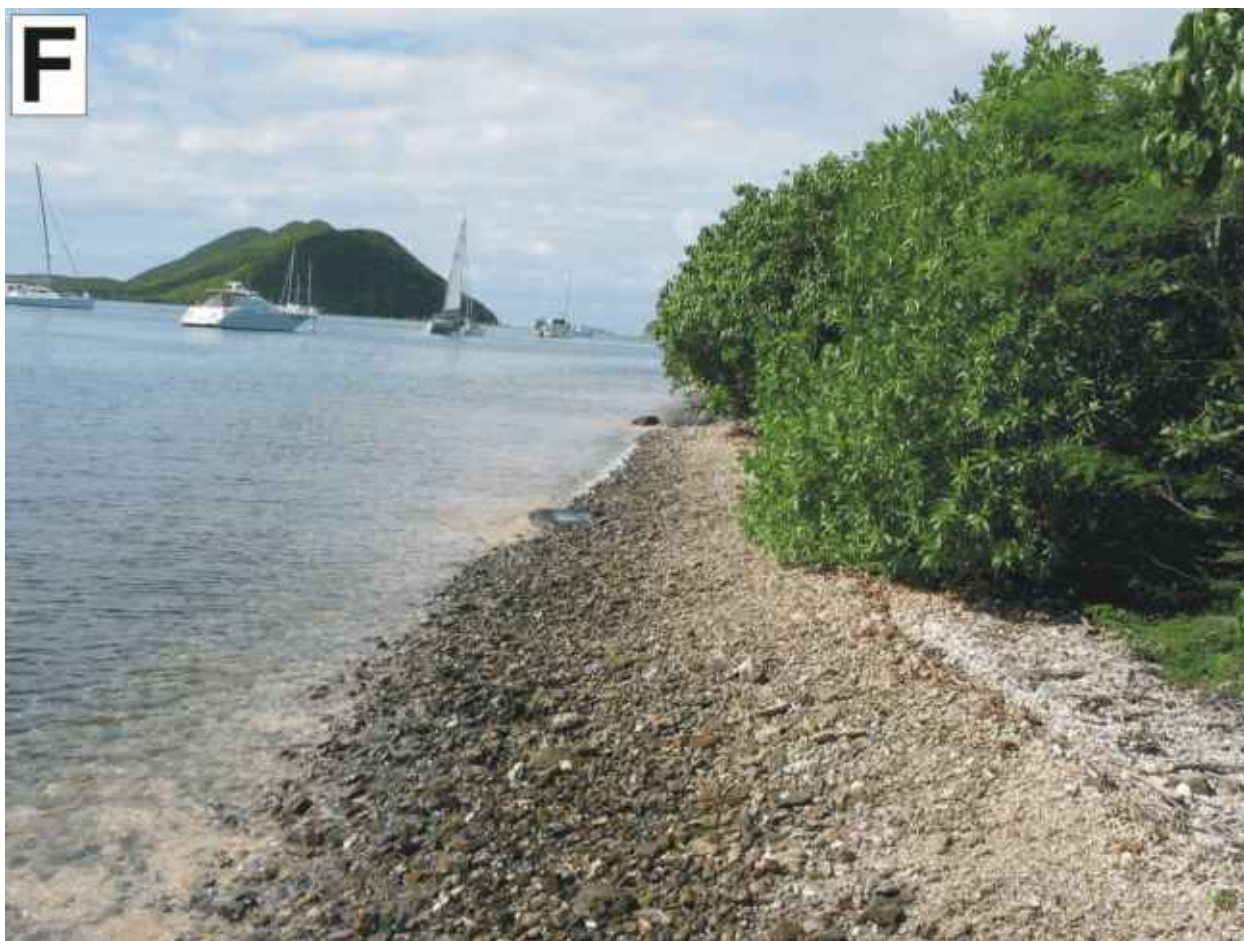
Figure 5. F) The shoreline surrounding Waterlemon Bay is a cobble beach, high vulnerability

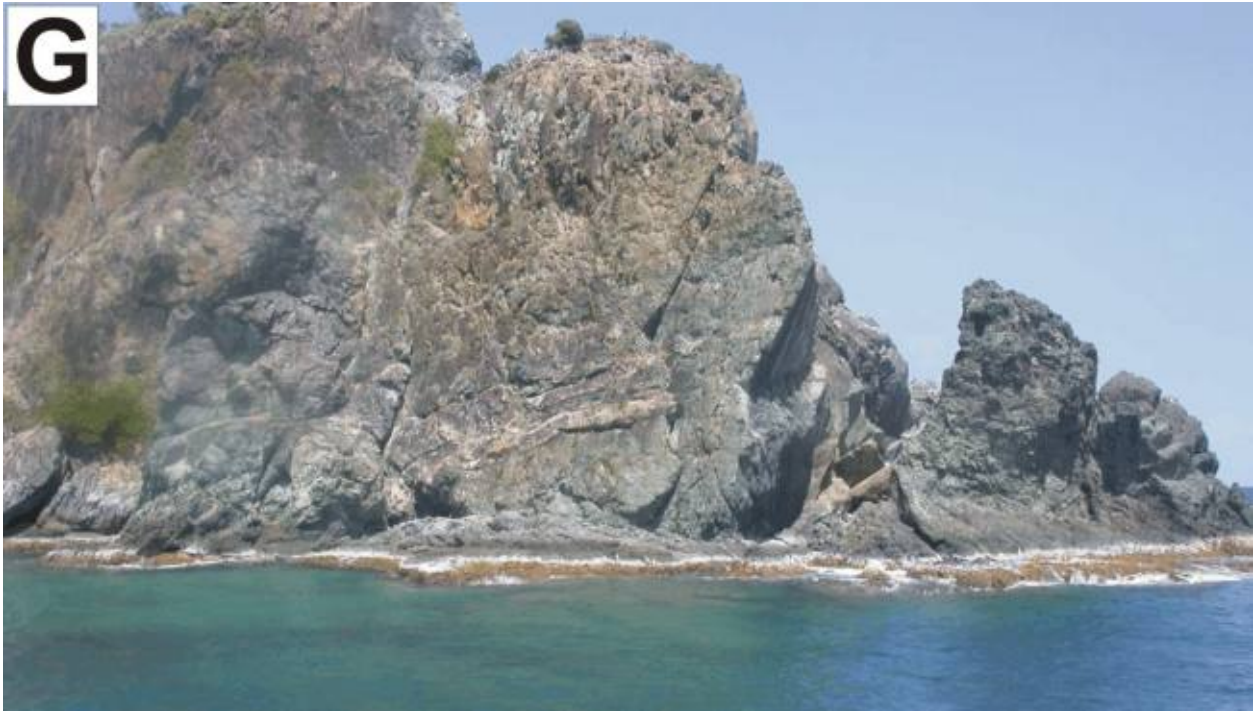
Figure 5. G) Ram Head is a rocky headland, low vulnerability (photo by Rebecca Beavers). H) The white cliffs near Reef Bay were ranked as low vulnerability (photo by Rebecca Beavers).

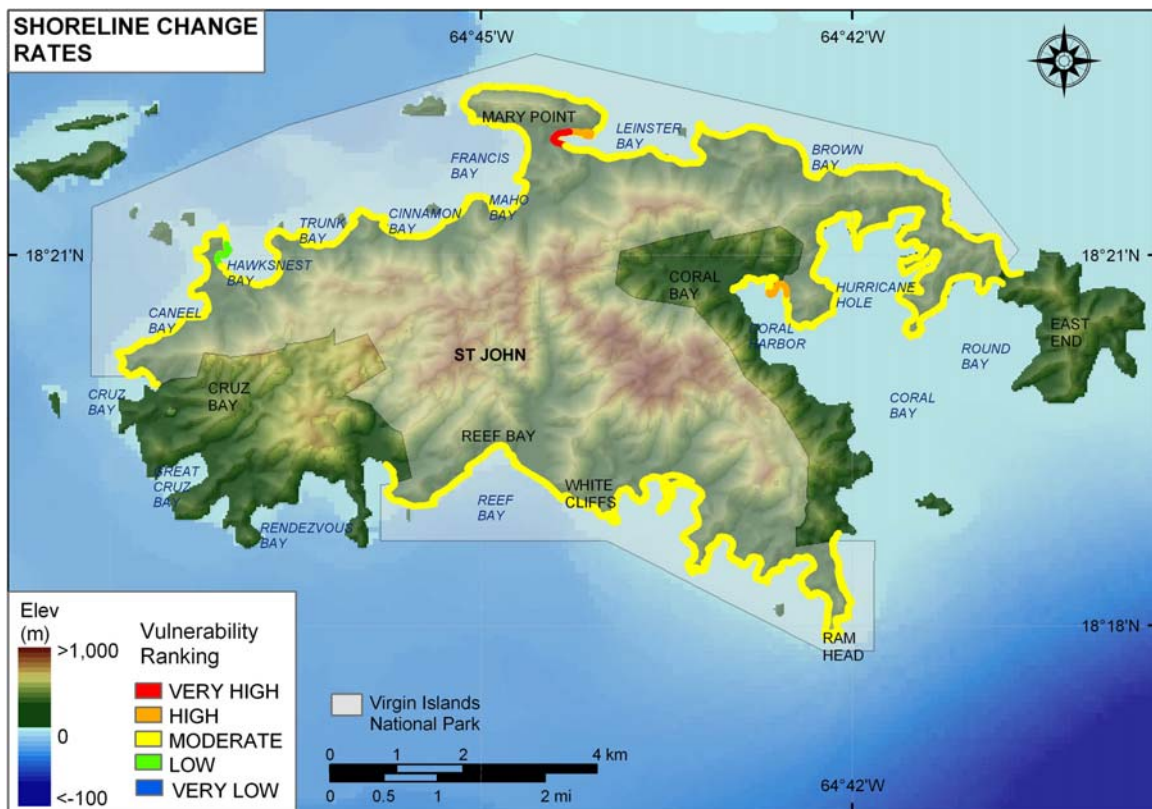
Figure 6. Shoreline change rates for Virgin Islands National Park. The colored shoreline represents the rate of shoreline erosion or accretion. Most of Virgin Islands National Park is moderate vulnerability (-1m/yr - +1m/yr) with respect to shoreline change, there are a few small sandy areas of locally higher erosion rates.

Shoreline erosion and accretion rates for Virgin Islands National Park were calculated using digitized shorelines from 1971 and 1983 NOAA Coastal Survey Charts and 1999 aerial photography (Table 2). Shoreline rates of change (m/yr) were calculated at 50 m intervals (transects) along the coast using Digital Shoreline Analysis System (DSAS) software (<http://woodshole.er.usgs.gov/project-pages/dsas/>) to derive the rate of shoreline change. The change rates for each transect within each grid cell were averaged to determine the shoreline change value used here, with positive numbers indicating accretion and negative numbers indicating erosion. Shoreline change rates for St. John fall almost completely within the moderate vulnerability category, which is between -1 m/yr and +1 m/yr. Consolidated sections of the shoreline have not changed. There has been some erosion/accretion within bays and sandy areas such as Cinnamon Bay and Coral Bay. However, most of the rates still lie within +/- 1 m/yr (Figure 6).

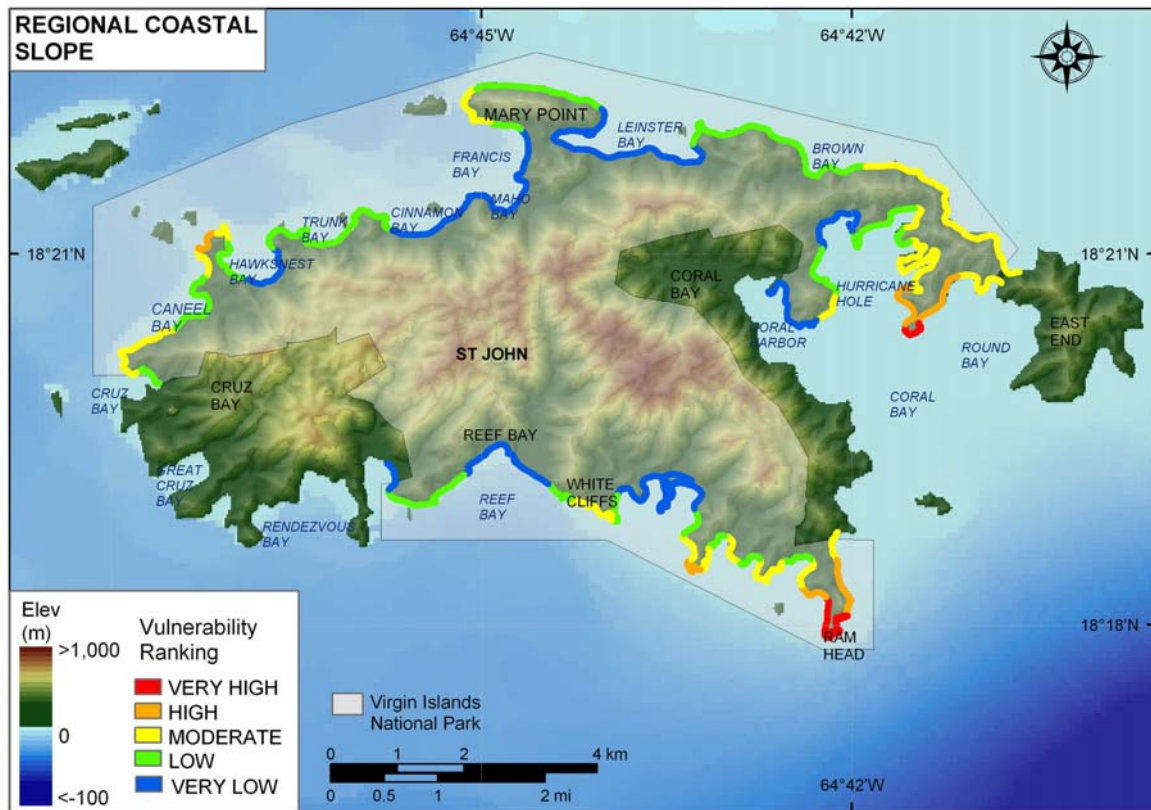
Figure 7. Regional coastal slope for Virgin Islands National Park. The colored shoreline represents the regional slope of the land, 5 km landward and seaward of the shoreline. Very low vulnerability coastal slope areas are where high mountains are adjacent to the coast. High vulnerability slopes are generally around the shallow bay areas or less mountainous regions towards East End.

Regional coastal slope is an indication of the relative vulnerability to inundation and the potential rapidity of shoreline retreat because low-sloping coastal regions should retreat faster than steeper regions (Pilkey and Davis, 1987). The regional slope of the coastal zone was calculated from a grid of topographic and bathymetric elevations extending 5 km landward and seaward of the shoreline. Elevation data were obtained from the National Geophysical Data Center (NGDC) as gridded topographic and bathymetric elevations at 0.1-meter vertical resolution for 90-meter cells. Regional coastal slopes for Virgin Islands National Park fall within the very low to very high vulnerability category (< 4.55% - > 14.7%) (Figure 7).

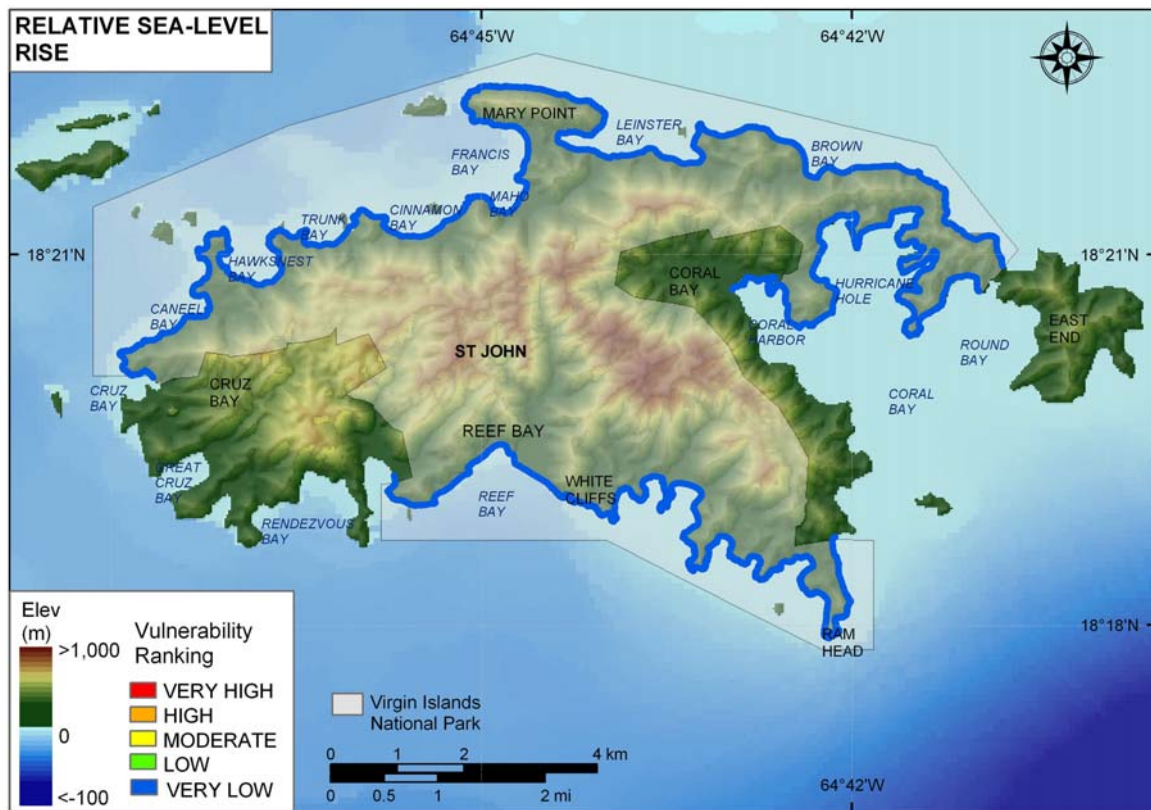
Figure 8. Rate of relative sea-level rise for Virgin Islands National Park. The colored shoreline represents the ranked rate of rise for Charlotte Amalie, St. Thomas. All of Virgin Islands National Park is ranked as very low vulnerability with respect to relative sea-level rise.

The **relative sea-level change** variable is derived from the change in annual mean water elevation over time as measured at tide gauge stations along the coast. The rate of sea-level rise for the US Virgin Islands is 0.5 +/- 0.74 mm/yr based on 25 years of data at Charlotte Amalie, St. Thomas (Zervas, 2001). This variable inherently includes both eustatic sea-level rise as well as regional sea-level rise due to isostatic and tectonic adjustments of the land surface. Relative sea-level change data are a historical record, and thus portray only the recent sea-level trend (< 150 years). Relative sea-level rise for Virgin Islands falls within very low vulnerability based on water elevation data on St. Thomas (Figure 8).

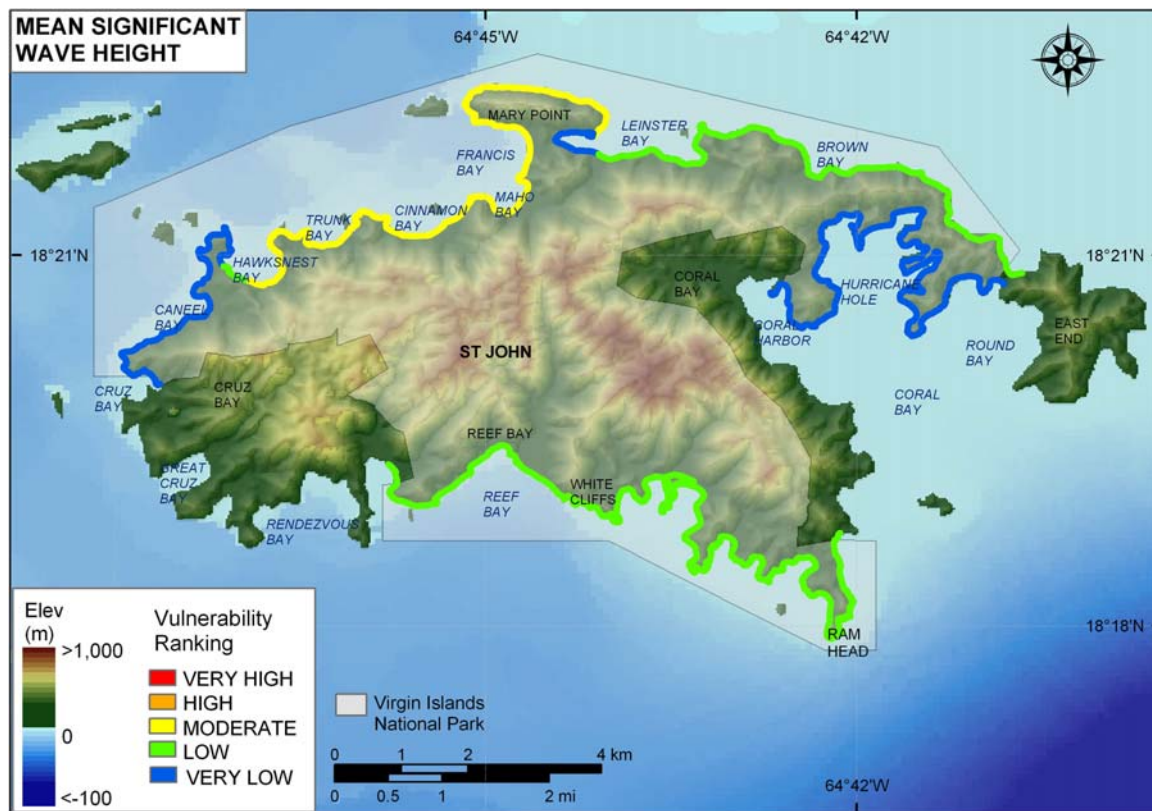
Figure 9. Mean significant wave heights for Virgin Islands National Park based on WIS data. The colored shoreline represents the significant wave heights within the park. Very high wave energy areas are located along the open Atlantic Coast. Significant wave heights are lower along the Caribbean Sea shoreline and vulnerability is moderate where the shoreline is protected from direct wave approach.

where E is energy density, H is wave height, ρ is water density and g is acceleration due to gravity. Thus, the ability to mobilize and transport coastal sediments is a function of wave height squared. In this report, we use hindcast nearshore mean significant wave height data for the period 1990-1999 obtained from the USACE Wave Information Study (WIS) (see references in Hubertz and others, 1996). The model wave heights were compared to historical measured wave height data obtained from the NOAA National Data Buoy Center to ensure that model values were representative of the study area. For the Virgin Islands, wave heights ranged from 1.0 m (moderate vulnerability) to 1.9 m (very high vulnerability) (Figure 9).

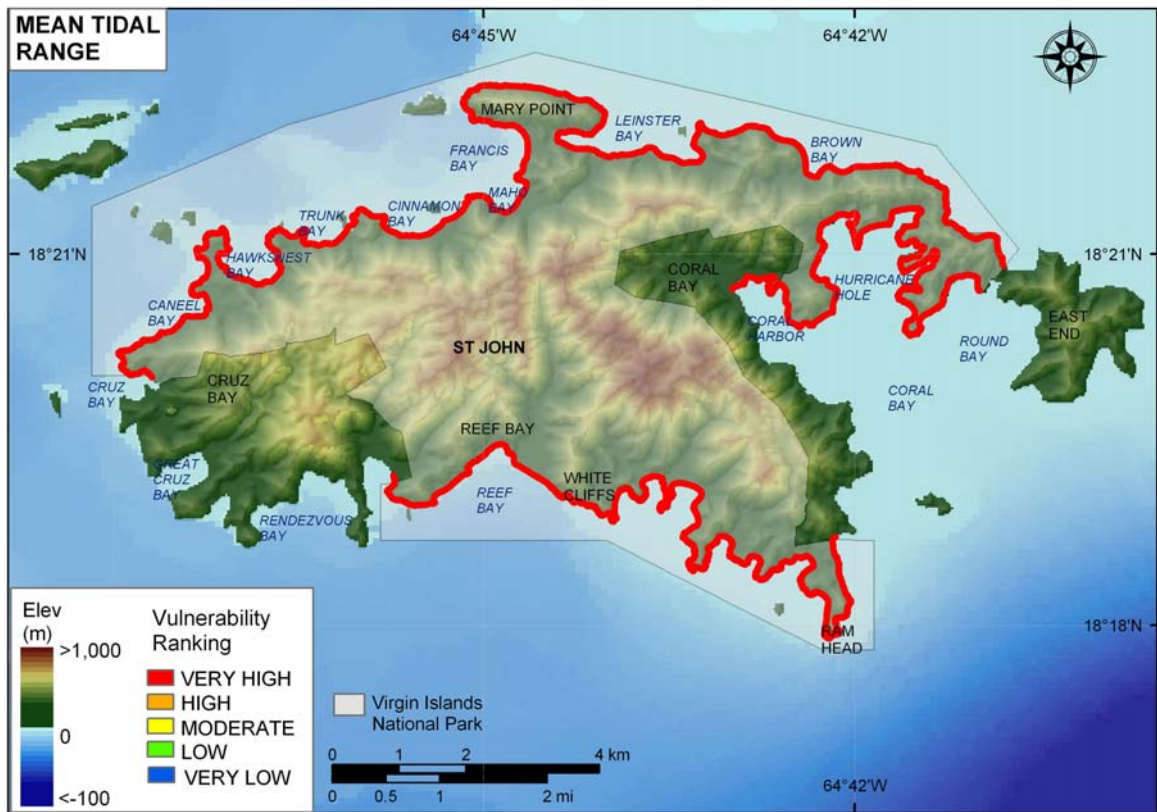
Figure 10. Mean Tidal Range for Virgin Islands National Park. The colored shoreline represents the ranked mean tidal range for Virgin Islands. All of Virgin Islands National Park is ranked as very high vulnerability with respect to tidal range.

Tidal range is linked to both permanent and episodic inundation hazards. Tide range data were obtained from a NOAA/NOS published benchmark on St. John Island in Coral Harbor. Mean tidal range here is 0.262 m; therefore Virgin Islands National Park is classified as very high vulnerability (> 1meter) with respect to tidal range (Figure 10).

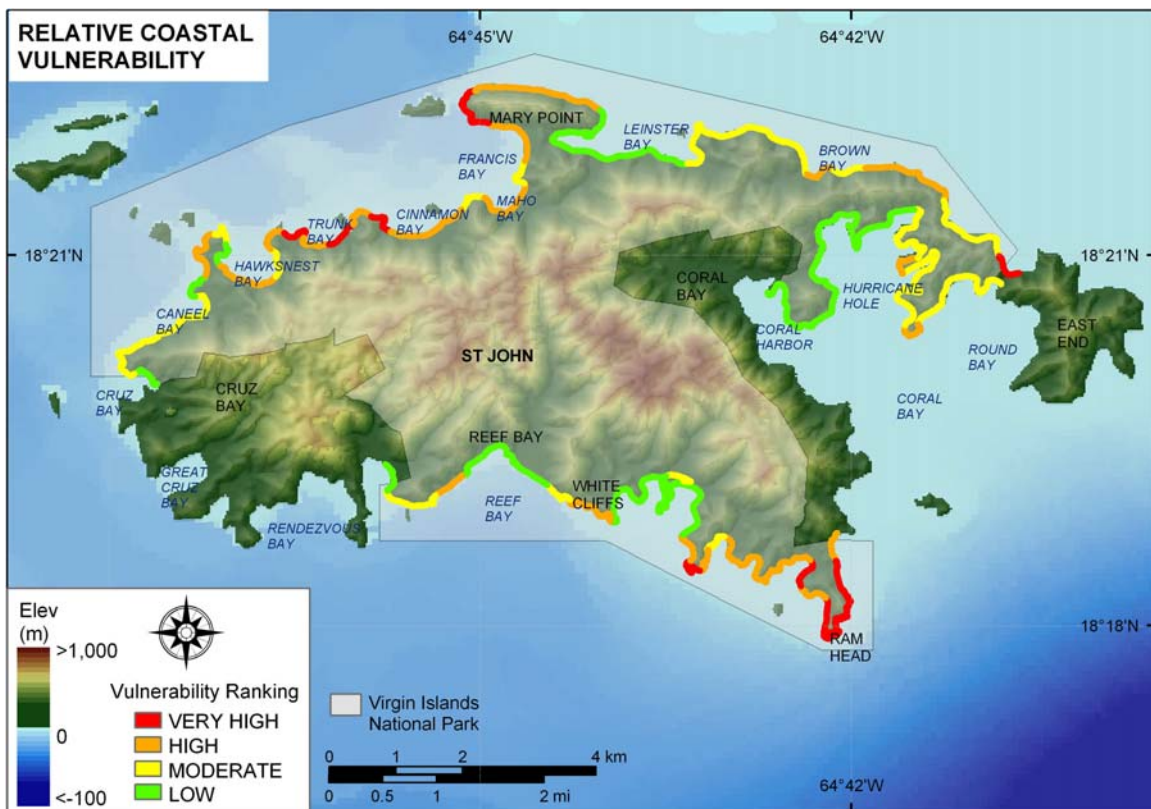
Figure 11. Relative Coastal Vulnerability for Virgin Islands National Park. The colored shoreline represents the relative coastal vulnerability index (CVI) determined from the six variables. The very high vulnerability shoreline is located along sandy pocket beaches where coastal slope is low and significant wave heights are high. The low vulnerability shoreline is generally located along rock cliffs or in sheltered areas such as in Hurricane Hole.

Figure 11 shows a map of the coastal vulnerability index for Virgin Islands National Park. The CVI scores are divided into low, moderate, high, and very high-vulnerability categories based on the quartile ranges and visual inspection of the data. CVI values below 6.5 are assigned to the low vulnerability category. Values from 6.51 to 7.8 are considered moderate vulnerability. High-vulnerability values lie between 7.81 and 9.0. CVI values above 9.0 are classified as very high vulnerability. Figure 12 shows the percentage of Virgin Islands shoreline in each vulnerability category. Nearly all of the shoreline of St. John is evaluated for the Virgin Islands National Park. Thirteen percent of the mapped shoreline is classified as being at very high vulnerability due to future sea-level rise. Twenty-nine percent is classified as high vulnerability, twenty-eight percent as moderate vulnerability, and twenty-nine percent as low vulnerability.

The geologic variables show the most spatial variability and thus have the most influence on CVI variability (Figure 11). Geomorphology in the park includes very high vulnerability sandy beach shoreline, high vulnerability gravel beaches, moderate vulnerability alluvium or cliffs with fringing reefs, and low vulnerability rock and cliff features (Figure 4 and Figure 5 A-H). Vulnerability assessment based on shoreline change remains constant at moderate vulnerability for all of Virgin Islands NP (Figure 6). Regional coastal slope is in the very low to very high vulnerability range for Virgin Islands.

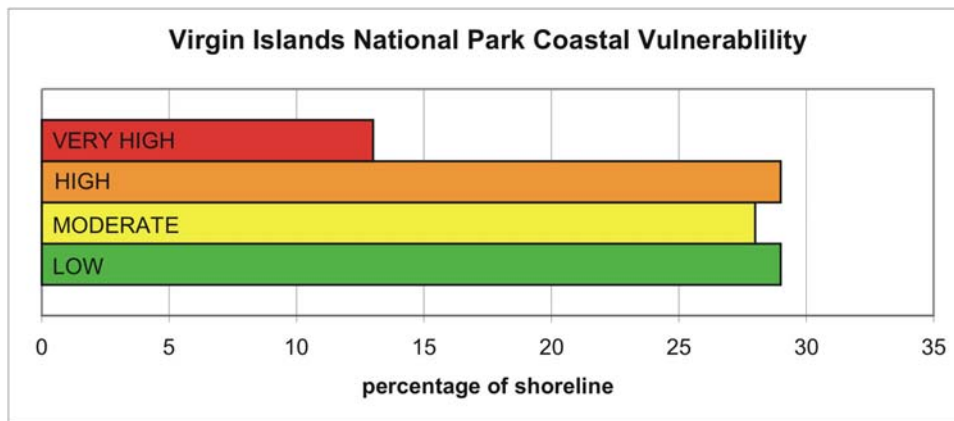
Figure 12. Percentage of Virgin Islands shoreline in each CVI category.
