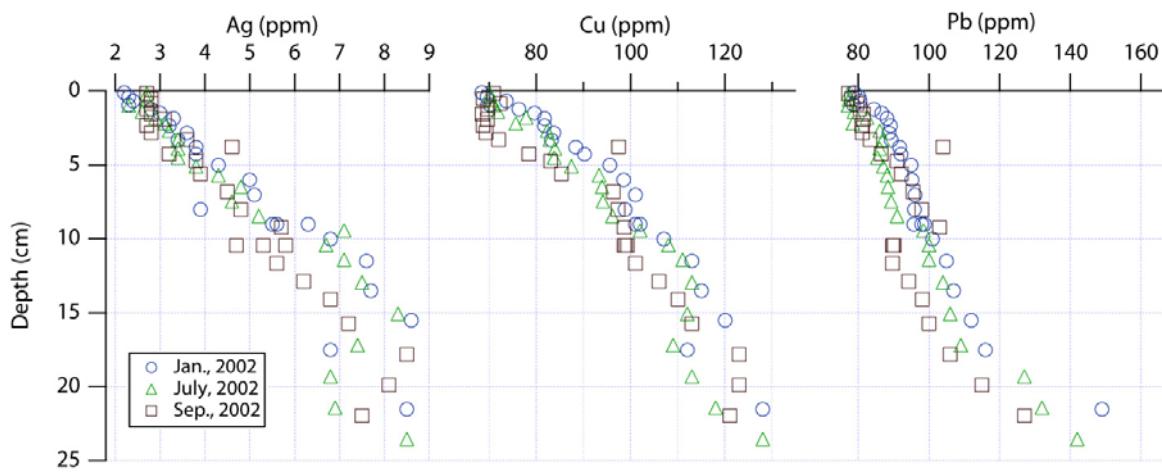
**Figure 10.4.** Solid phase metal profiles from the Hingham Bay site. Metal concentrations at ~15cm are similar to surface concentrations measured at the same site in 1978 (Bothner and others, 1998). Present concentrations in surface sediments are much lower, but remain high enough to risk negative impacts.
