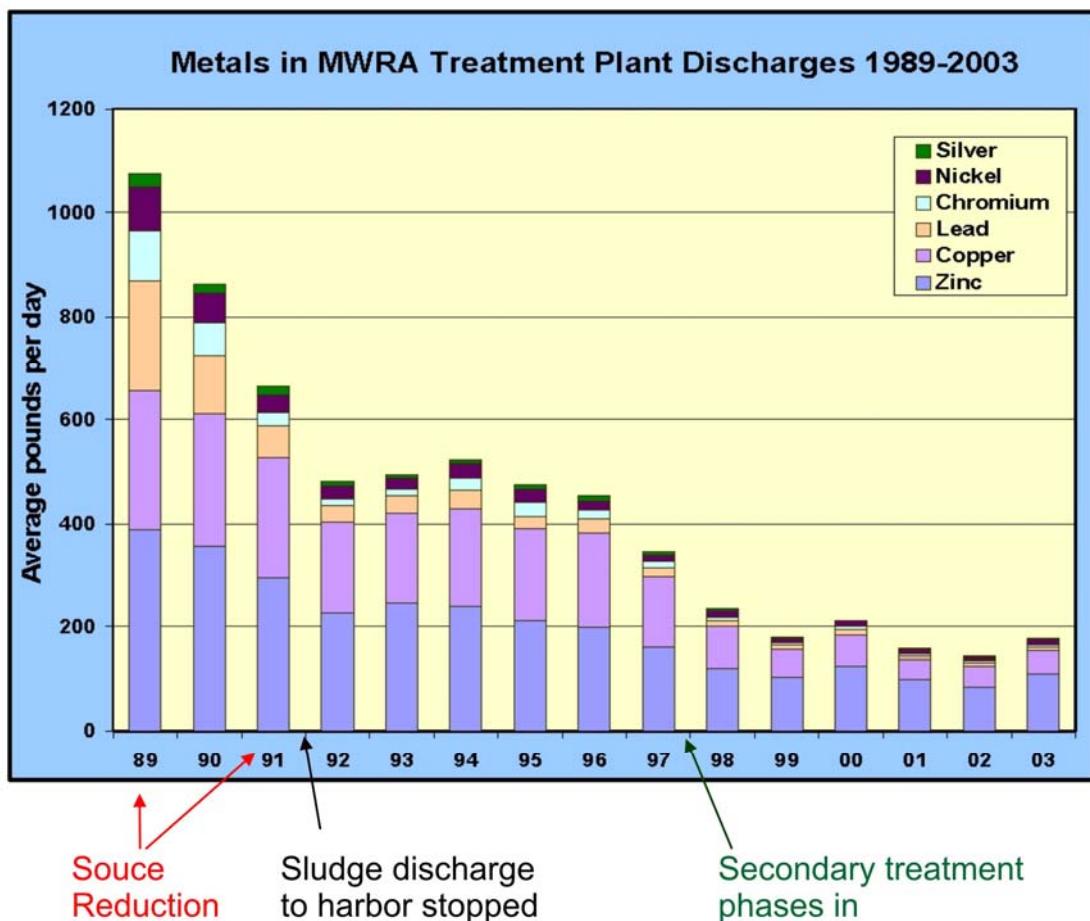
**Figure 7.2.** Histogram showing the decrease in discharge of metals by the MWRA sewage treatment plants from 1989 to 2003 (Werme and Hunt, 2004).
