Preliminary Investigation of Wastewater-Related Contaminants near Home Sewage Treatment Systems in Ohio

Open-File Report 2005–1282

By D.H. Dumouchelle and D.M. Stoeckel

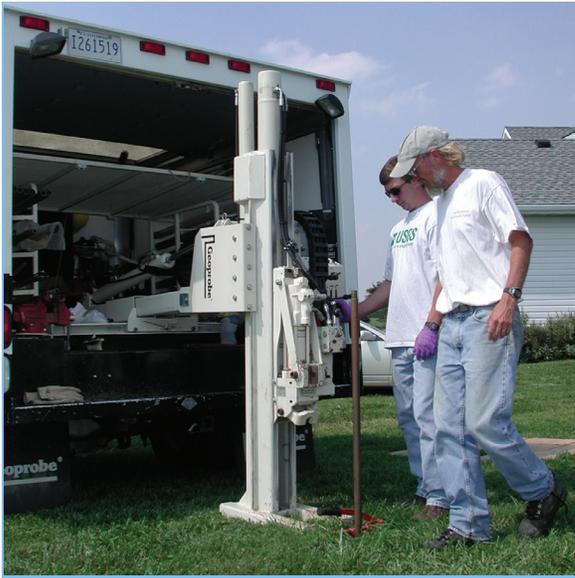
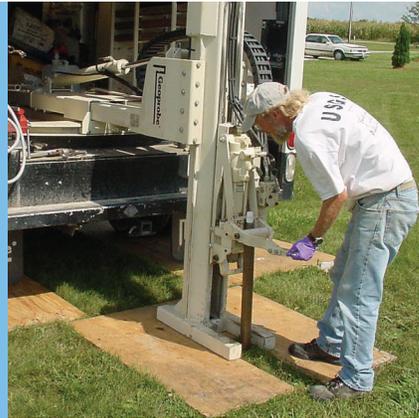
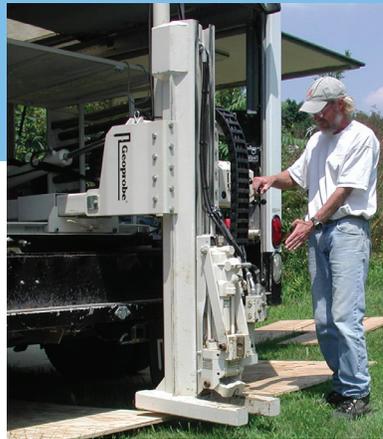
Cover images: USGS employees installing piezometers (photos by D.H. Dumouchelle, U.S.Geological Survey).

The 1-in.-diameter piezometers were driven with either a truck-mounted rig or with a manual weight. To avoid clogging the stainless-steel screens during installation, a steel drive casing was used. The drive casing was pulled back to expose the 4-ft-long screens once the desired depth was reached. Piezometers were installed to (total) depths ranging from 7 to 16 ft beneath the surface; hand-driven piezometers could be installed to a total depth of about 8 ft.
