Channel Change and Bed-Material Transport in the Lower Chetco River, Oregon

By J. Rose Wallick, Scott W. Anderson, Charles Cannon, and Jim E. O'Connor

Open-File Report 2009–1163

U.S. Department of the Interior
U.S. Geological Survey

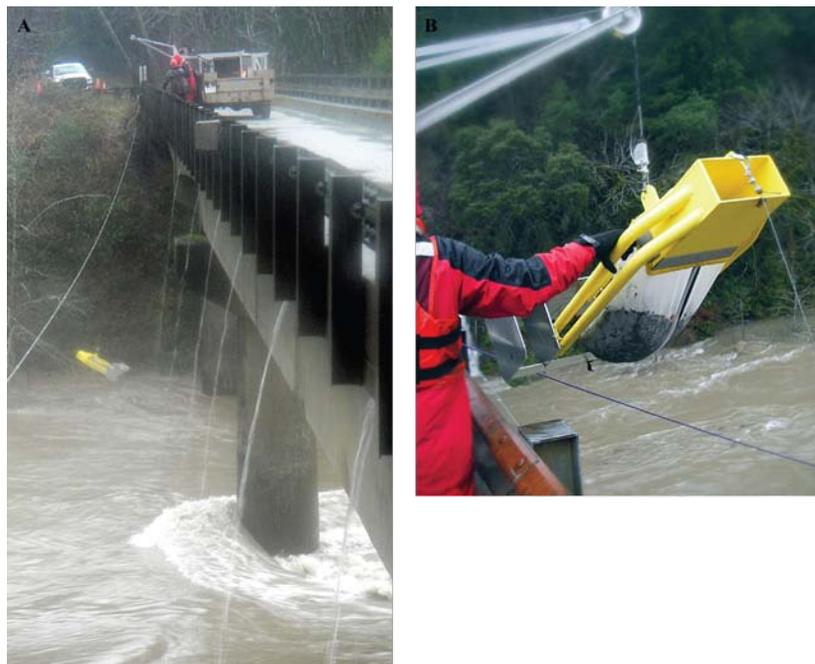
Figure 26. Photographs showing bedload sampling at USGS streamflow gaging station Chetco River near Brookings, Oregon (14400000), Chetco River, Oregon, December 28, 2008. Streamflow was 1,170 cubic meters per second. (Photographs by Jim O'Connor, U.S. Geological Survey, December 28, 2008.) A. View of sampling equipment, including truck and sampler, during deployment; cable in view is for discharge measurements and was not used for bedload sampling. B. TR-2 sampler after sample collection.
