2018 U.S. Geological Survey–California Geological Survey Fault-Imaging Surveys Across the Hollywood and Santa Monica Faults, Los Angeles County, California

By Rufus D. Catchings, Janis Hernandez, Mark R. Goldman, Joanne H. Chan, Robert R. Sickler, Brian Olson, and
Coyne J. Criley

Open-File Report 2020–1049

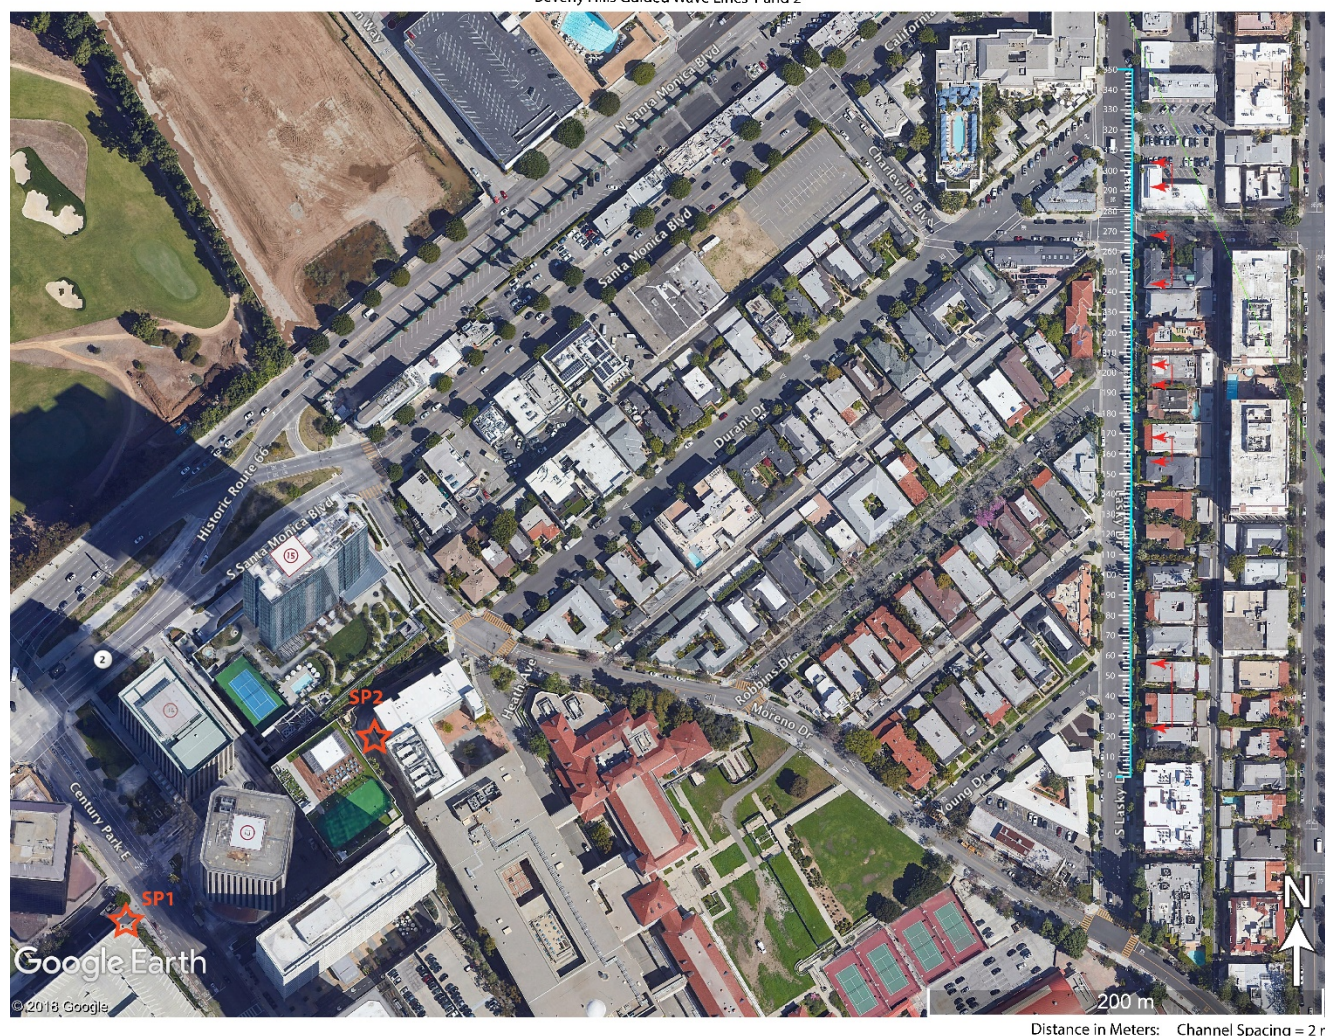
Figure 26. Google Earth image of Santa Monica Fault in our study area in Beverly Hills, showing locations of seismic surveys (BHW1, BHW2) recorded along Profile BH1 (cyan line). Scale (in meters [m]) is included along Profile BH1. Seismic sources were generated at SP1 and SP2 (red stars) at the near-surface trace of Santa Monica Fault, as inferred from geologic mapping. Recording arrays for BHW1 and BHW2 surveys were located in same place, except that BHW2 survey extended farther north by about 50 m. Red arrows show zones where high PGV values (that have travel times consistent with guided waves) were recorded.

BHGW2 survey as was used for the BHGW1 survey. However, the seismic source (SP2) for the BHGW2 survey was located at SP2, about 80 m southwest of Heath Avenue and about 130 m southeast of Santa Monica Boulevard (fig. 26). The first shot started on June 6, 2018, at 22:05:42:36 (local time; 05:42:36 UTC), and the last shot was completed at 23:01:37 (local time; 06:01:37 UTC). A total of about 198 AWD shots were generated. Owing to instrumental failures, we did not obtain data from 19 of the 174 seismic recorders.
