Continuous Stream Discharge, Salinity, and Associated Data Collected in the Lower St. Johns River and Its Tributaries, Florida, 2023

Open-File Report 2026–1012

By Jennifer N. Carson and Matthew T. Benacquisto

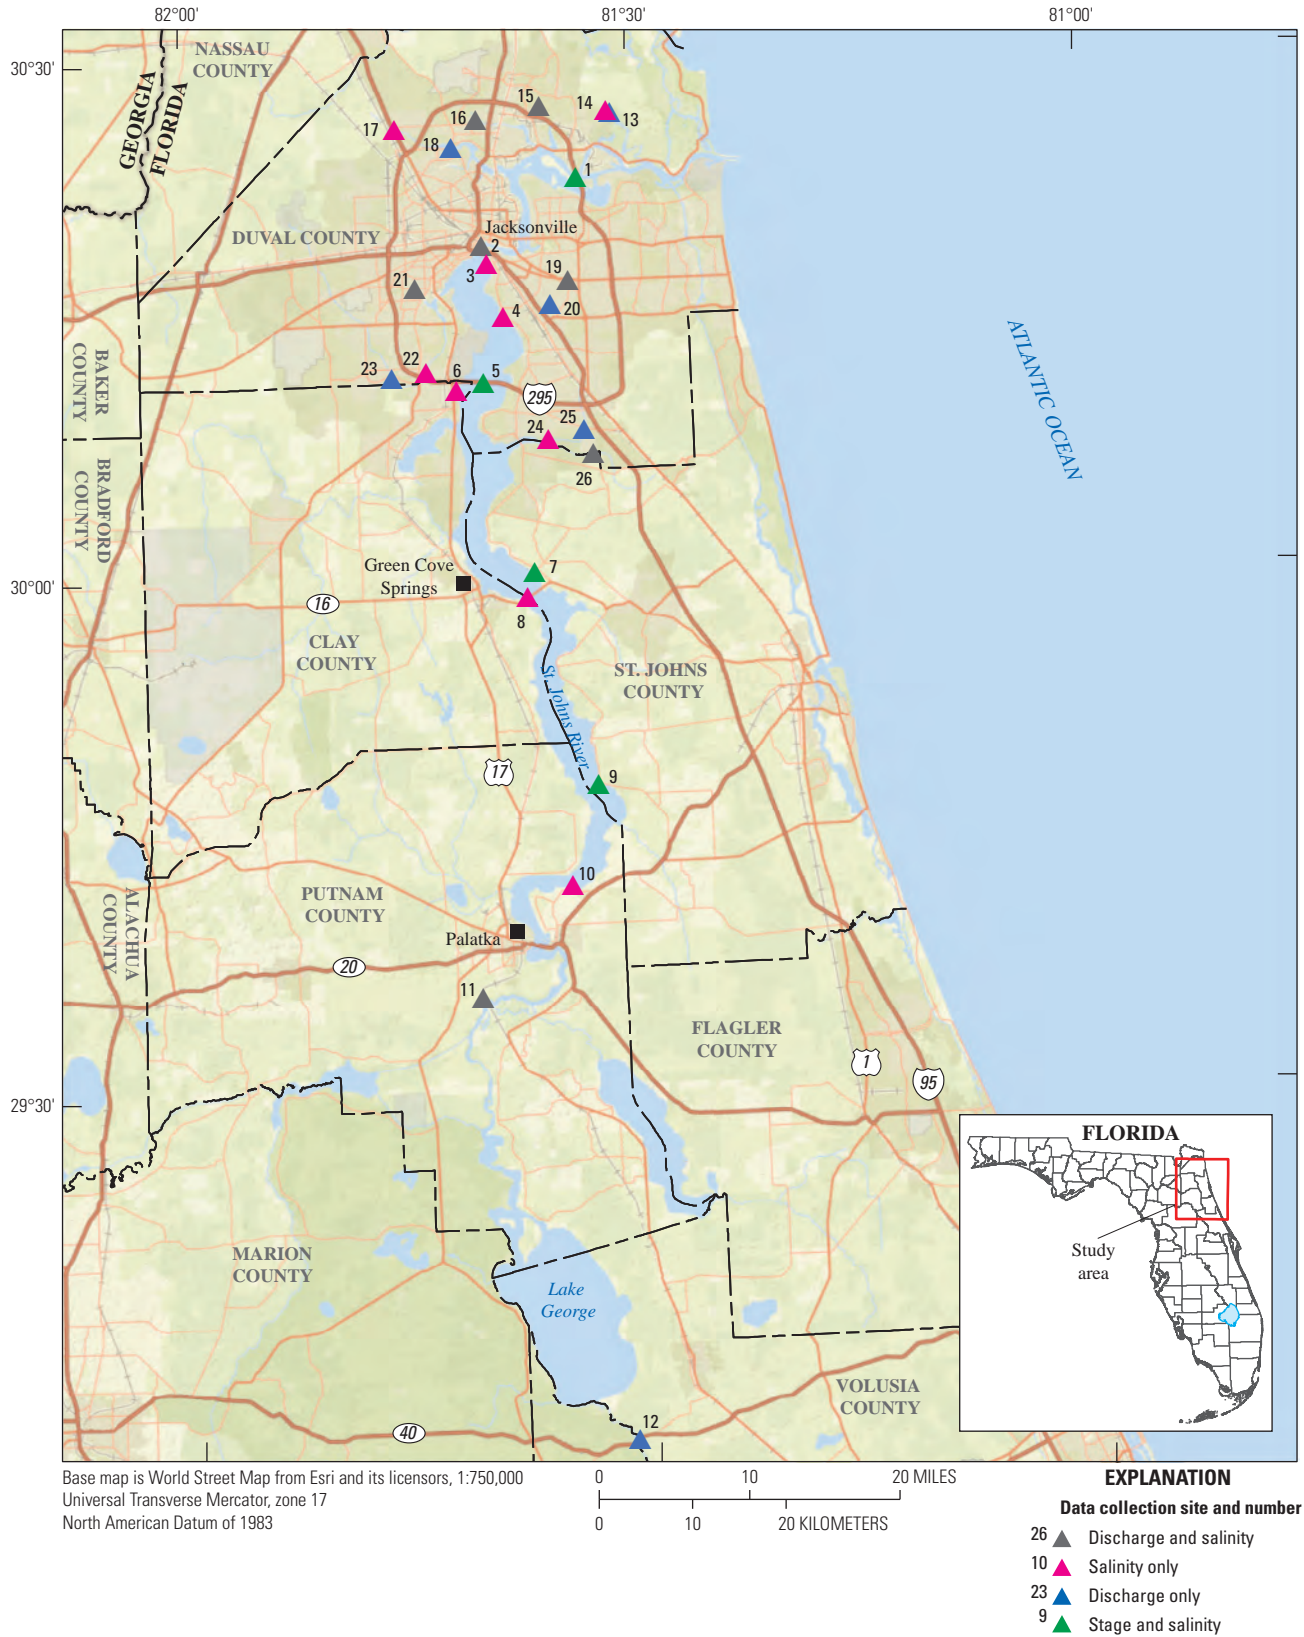
Figure 1. U.S. Geological Survey data collection sites on the St. Johns River and its tributaries. Map image is the intellectual property of Esri and is used herein under license. Copyright 2021 Esri and its licensors. All rights reserved.

streamflow and water-quality monitoring network was used to collect baseline data in the St. Johns River and its tributaries prior to dredging and can be used to discern changes, if any, during and after dredging.

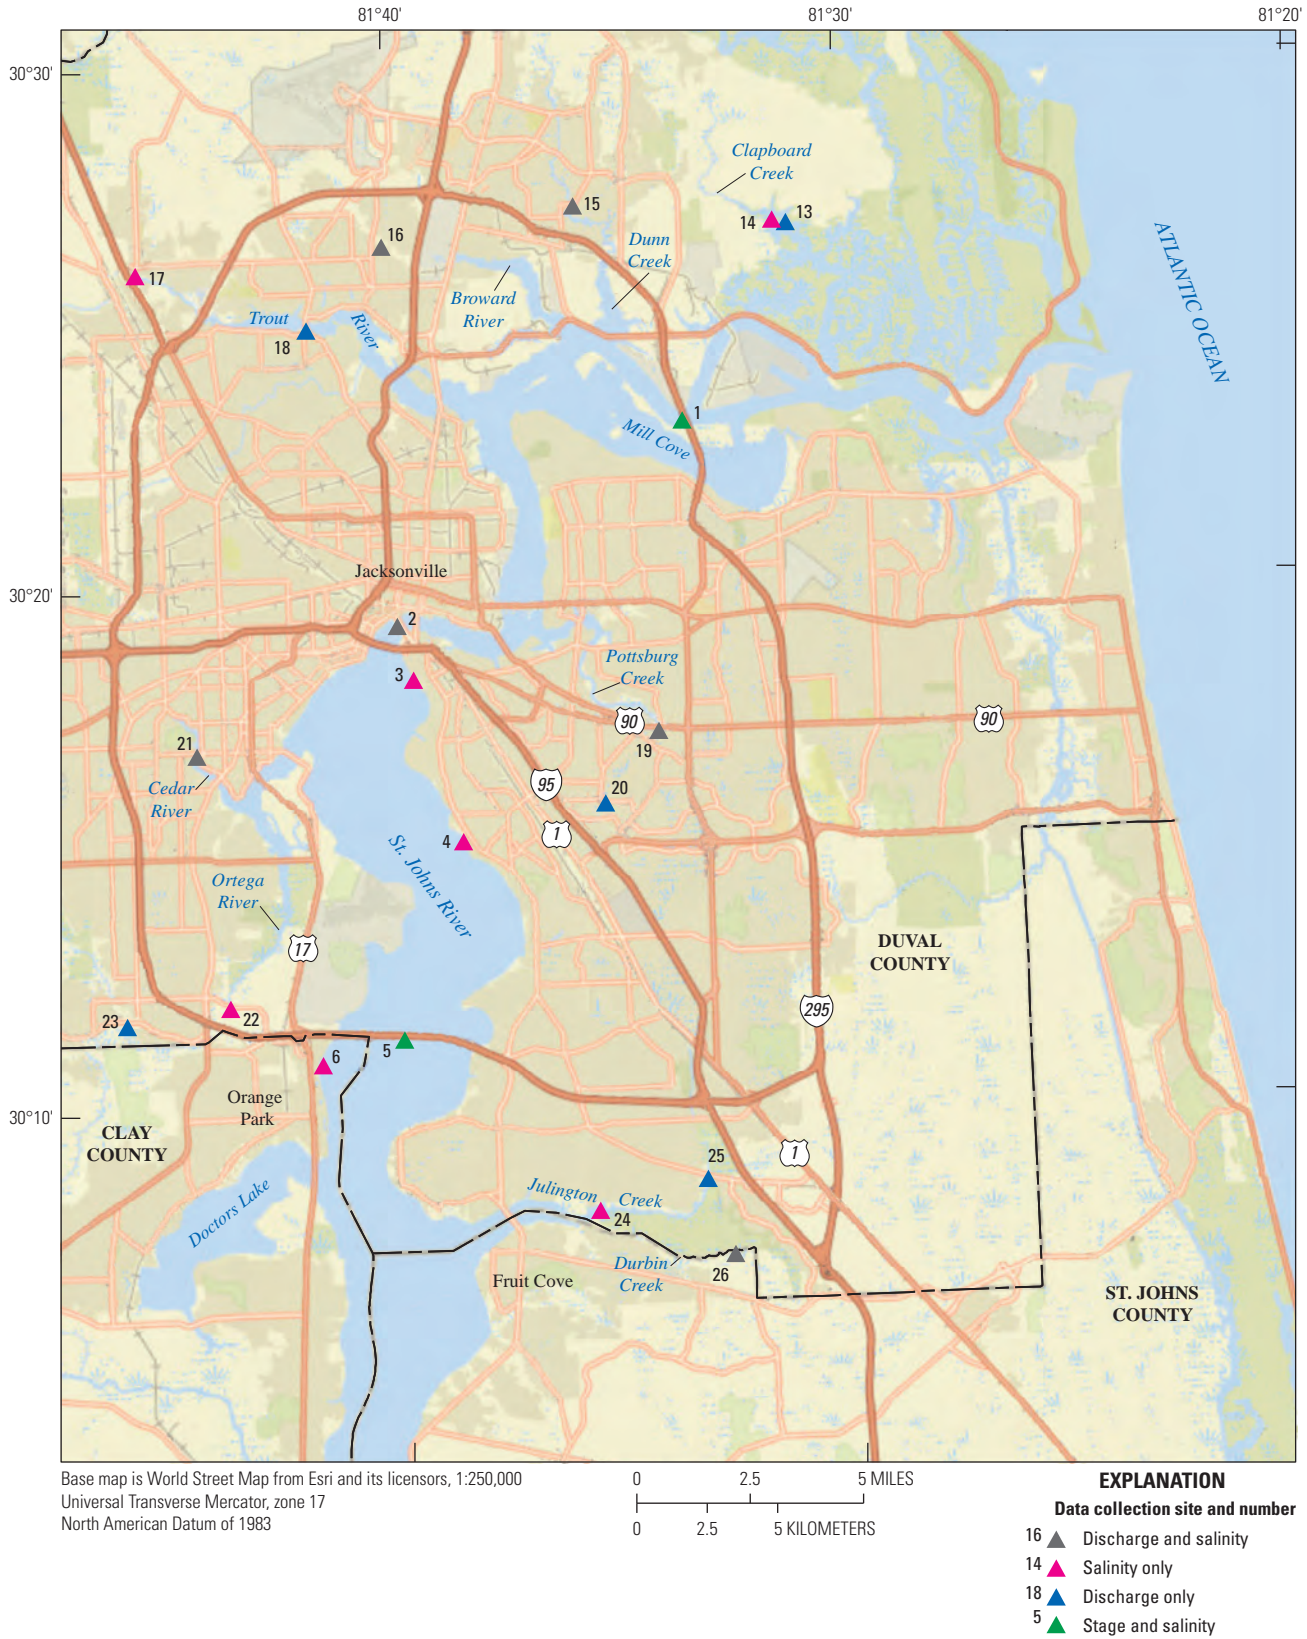
Figure 2. U.S. Geological Survey data collection sites in Clay, Duval, and St. Johns Counties, Florida. Map image is the intellectual property of Esri and is used herein under license. Copyright 2021 Esri and its licensors. All rights reserved.

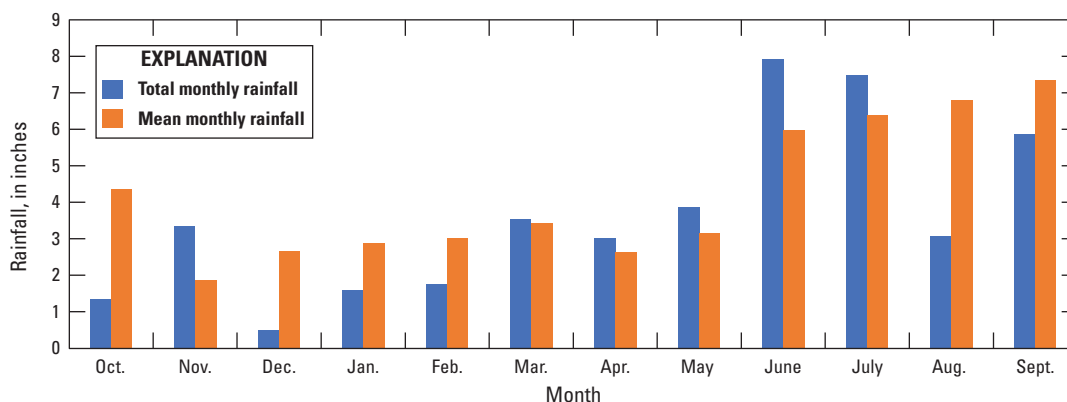
Figure 3. Graph showing 2023 water year monthly rainfall and mean monthly rainfall for Duval County (SJRWMD, 2024).

Trout River near Jacksonville, Florida.—Daily tidally filtered discharge at Trout River near Jacksonville, Fla. (USGS site number 02246621, map number 18) ranged from -236 to 860 ft^3/s during the 2023 water year, with an annual mean flow of 56.5 ft^3/s (fig. 59). The daily discharge peaked at over 800 ft^3/s in November when above-average rainfall occurred in Duval County (fig. 3).

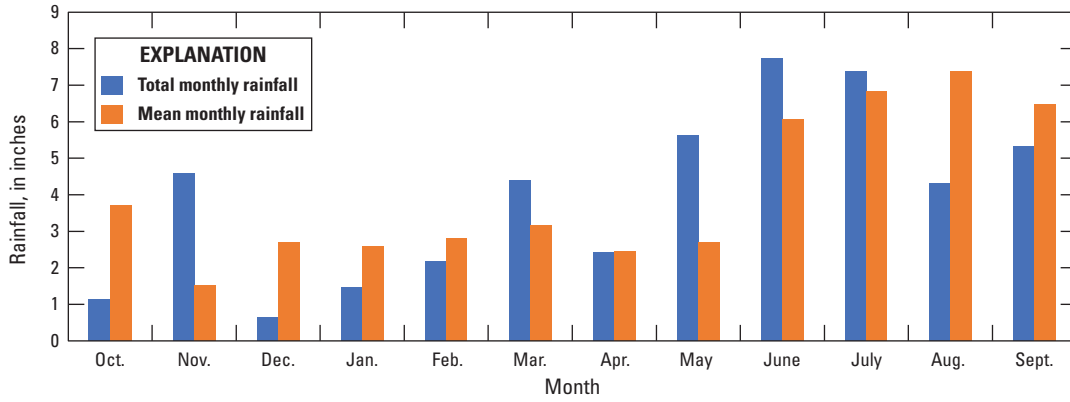
Figure 4. Graph showing 2023 water year monthly rainfall and mean monthly rainfall for Clay County (SJRWMD, 2024).

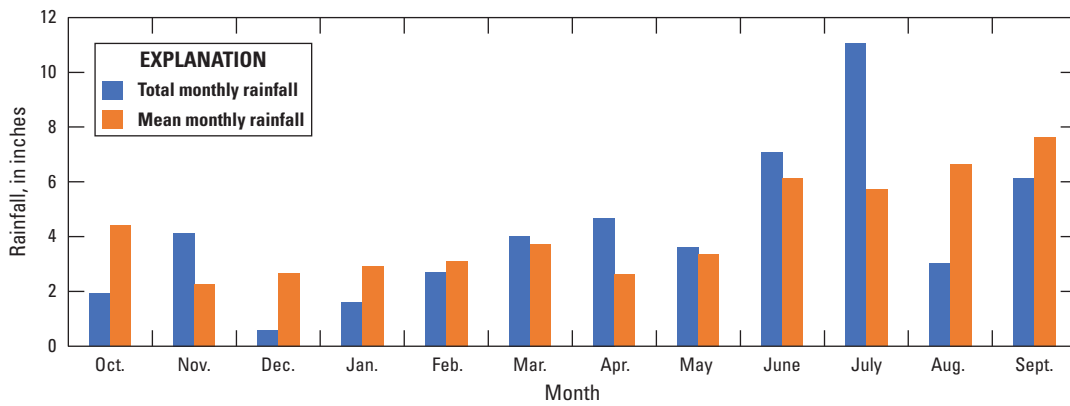
Figure 5. Graph showing 2023 water year monthly rainfall and mean monthly rainfall for St. Johns County (SJRWMD, 2024).

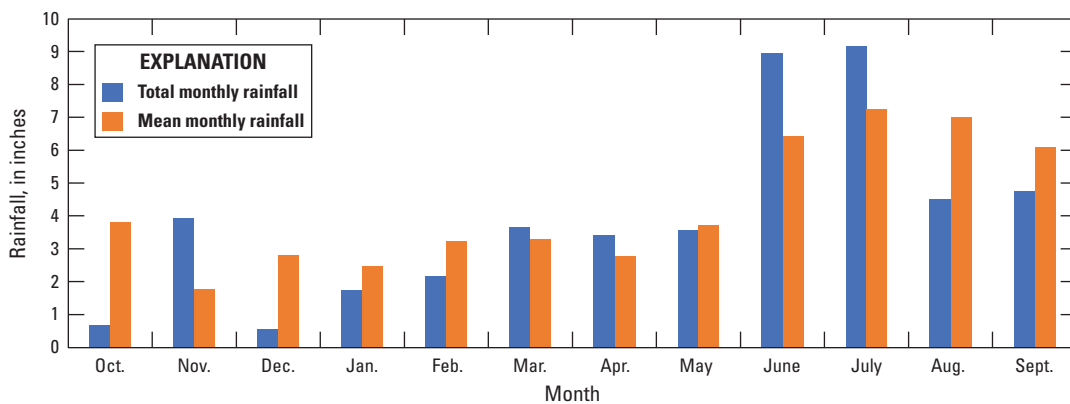
Figure 6. Graph showing 2023 water year monthly rainfall and mean monthly rainfall for Putnam County (SJRWMD, 2024).

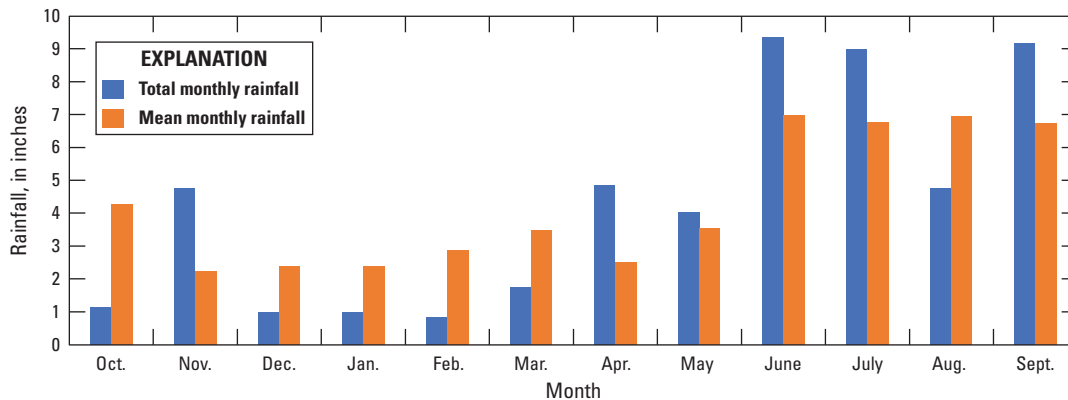
Figure 7. Graph showing 2023 water year monthly rainfall and mean monthly rainfall for Volusia County (SJRWMD, 2024).

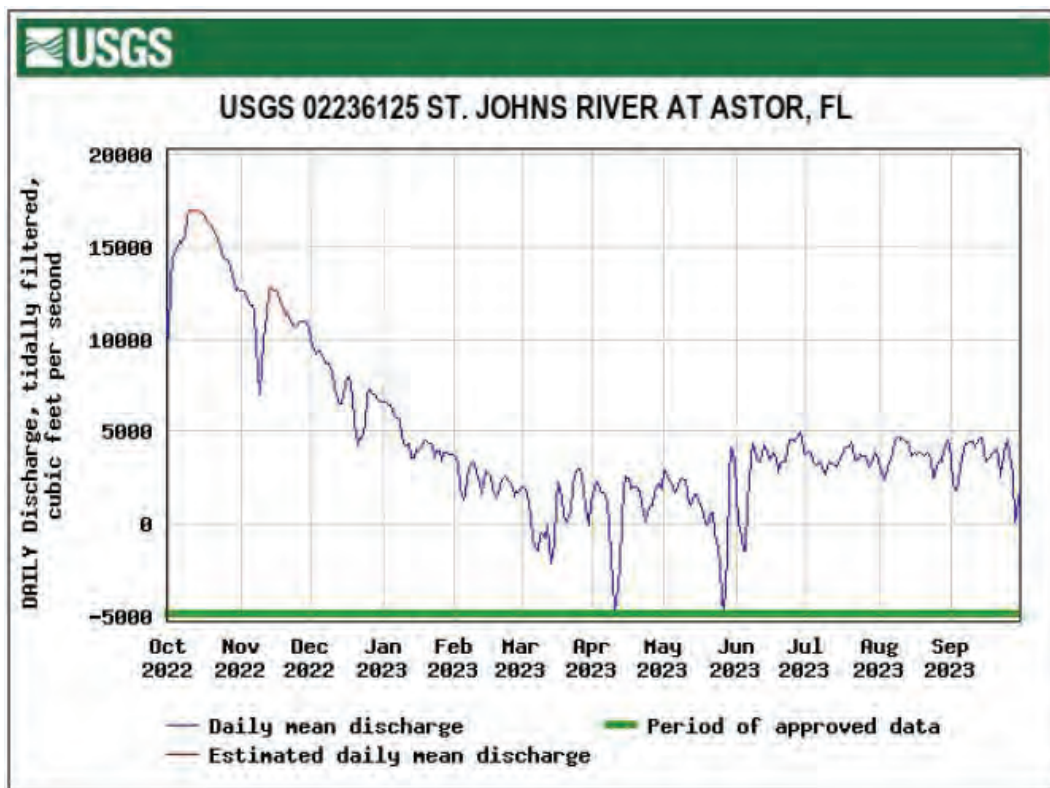
Figure 8. Daily mean tidally filtered discharge for St. Johns River at Astor, Florida.

17,000 cubic feet per second (ft³/s) during the 2023 water year (fig. 8), with an annual mean of 4,750 ft³/s (fig. 9). A comparison of historical annual mean tidally filtered flows indicated that 2023 streamflow ranked in the 91st percentile for the 29 years of record; the median tidally filtered annual mean flow for the period of record was 2,870 ft³/s (fig. 9). The high percentile for the 2023 water year mostly was due to rainfall from Hurricane Ian. The peak for the year occurred in October 2022 after Hurricane Ian passed through at the end of September 2022 (fig. 8). This peak was the highest daily mean

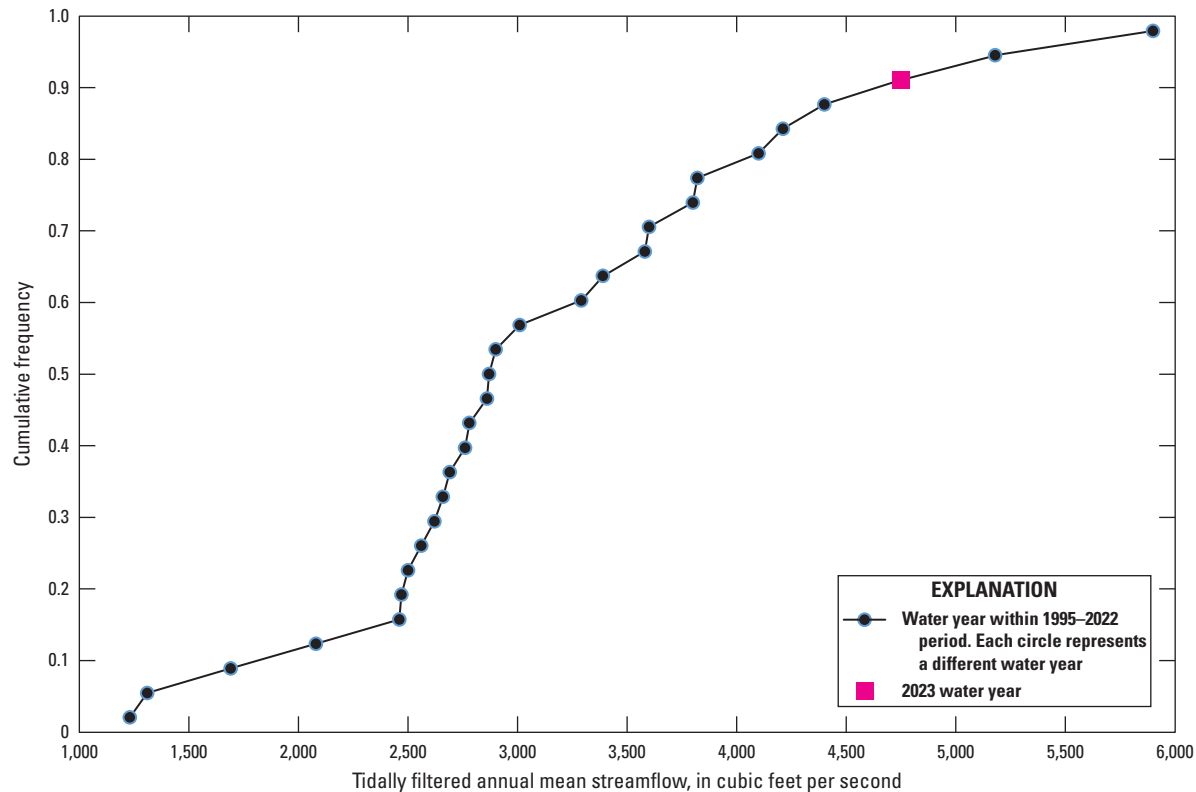
Figure 9. Annual mean tidally filtered streamflow data for St. Johns River at Astor, Florida.

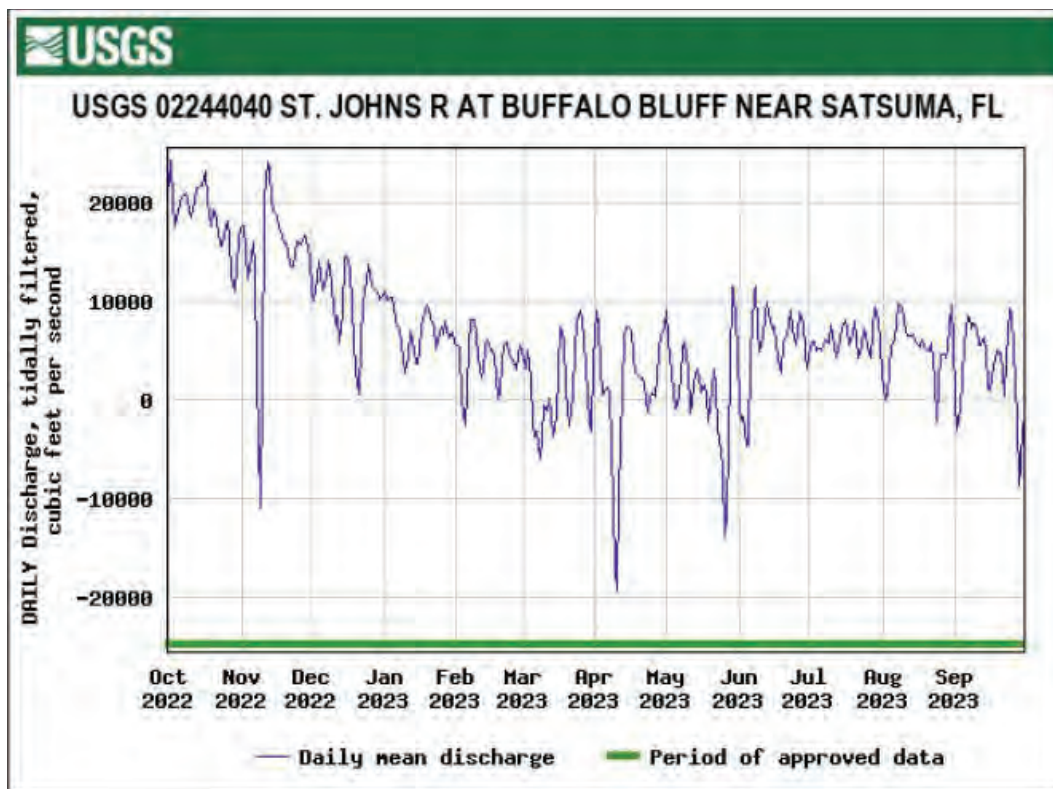
Figure 10. Daily mean tidally filtered discharge for St. Johns River at Buffalo Bluff near Satsuma, Florida.

St. Johns River at Buffalo Bluff near Satsuma, Florida.—Daily tidally filtered discharge at St. Johns River at Buffalo Bluff near Satsuma, Fla. (USGS site number 02244040, map number 11) ranged from –19,400 to 24,400 ft³/s during the 2023 water year, with an annual mean of 6,570 ft³/s (figs. 10 and 11). Salinity ranged from 0.2 to 0.6 parts per thousand (ppt) over this same period (fig. 12), with a median and mean

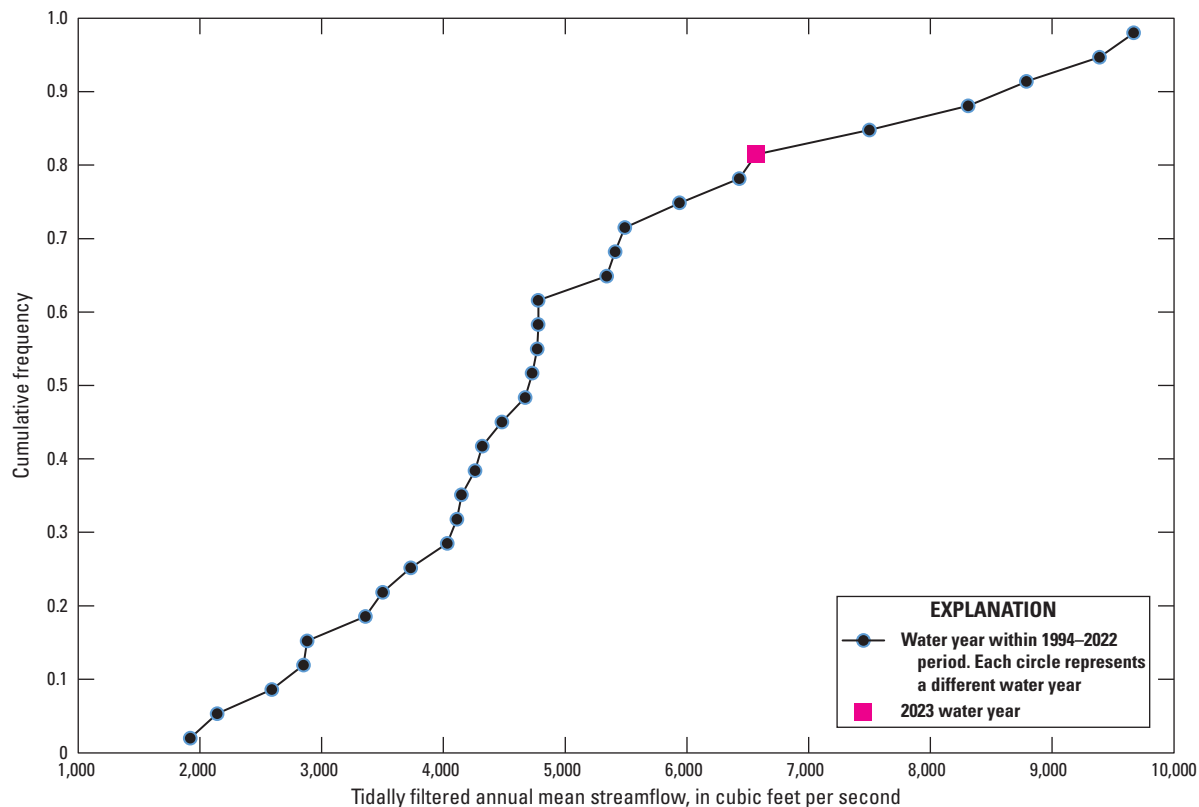
Figure 11. Annual mean tidally filtered streamflow data for St. Johns River at Buffalo Bluff near Satsuma, Florida.

of 0.4 ppt (fig. 13). A comparison of historical annual mean tidally filtered flows indicated that 2023 streamflow ranked in the 81st percentile for the 30 years of record; the median tidally filtered flow for the period of record was 4,700 ft³/s (fig. 11). The above-average percentile for the 2023 water year mostly was due to rainfall from Hurricanes Ian and Nicole. The daily mean tidally filtered peaks after these hurricanes were the second highest peaks on record, only exceeded by peaks from Hurricane Irma in 2017. The annual mean and median salinity only have a 0.2-ppt range (0.3–0.5 ppt) for each of the 7 years that salinity was calculated in the study (fig. 13).

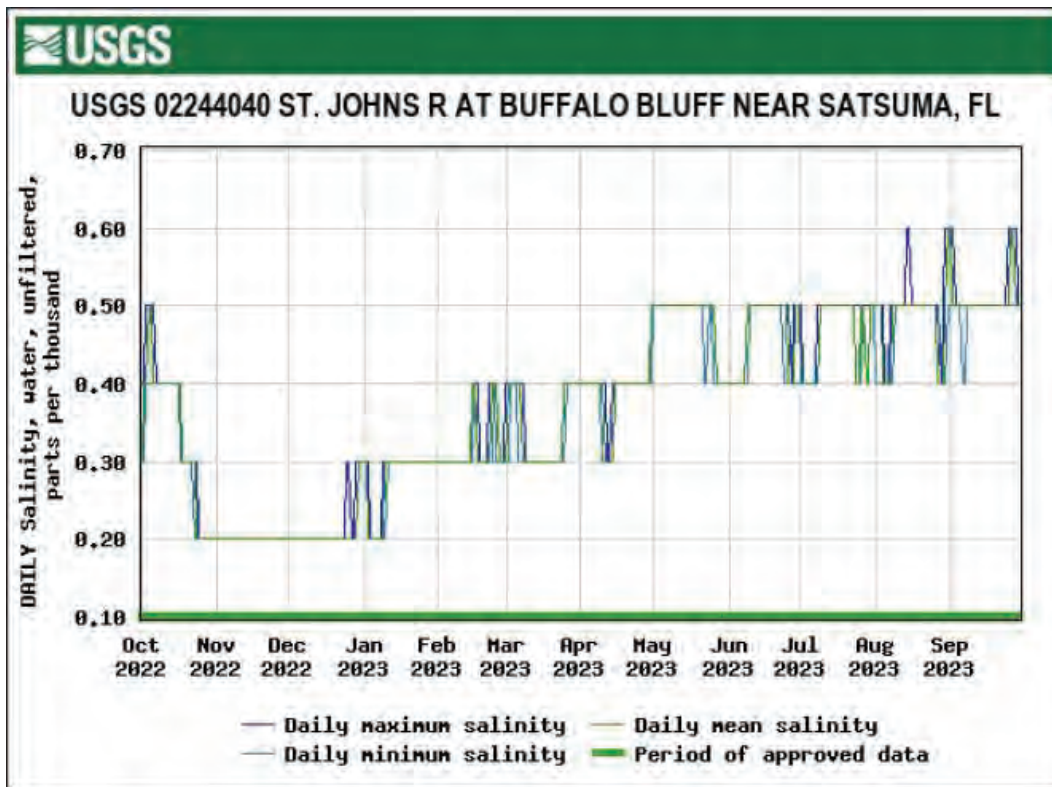
Figure 12. Daily maximum, minimum, and mean salinity for St. Johns River at Buffalo Bluff near Satsuma, Florida.

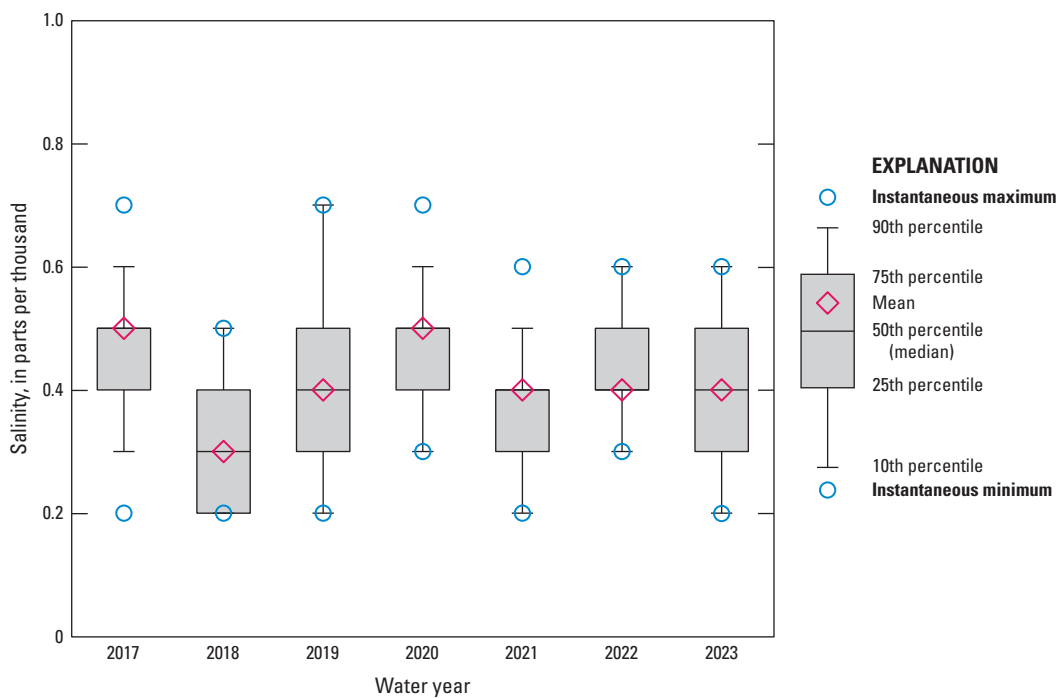
Figure 13. Salinity data for St. Johns River at Buffalo Bluff near Satsuma, Florida.

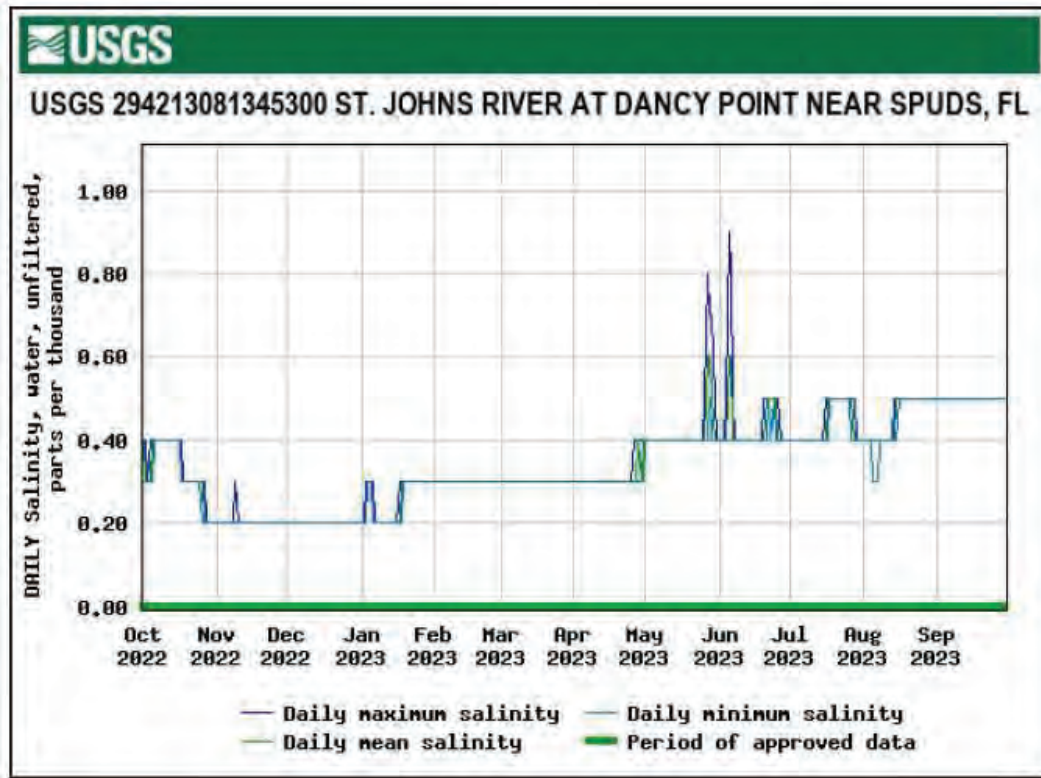
Figure 14. Daily maximum, minimum, and mean salinity for St. Johns River at Dancy Point near Spuds, Florida.

St. Johns River at Dancy Point near Spuds, Florida.—Salinity on the St. Johns River at Dancy Point near Spuds, Fla. (USGS site number 294213081345300, map number 10) ranged from 0.2 to 0.9 ppt during the 2023 water year, with a median and mean of 0.3 ppt (figs. 14 and 15). The salinity data showed fluctuations caused by tidal effects and rainfall. The annual mean and median salinity only have a 0.2-ppt range (0.3–0.5 ppt) for each of the 7 years salinity was calculated in the study (fig. 15).

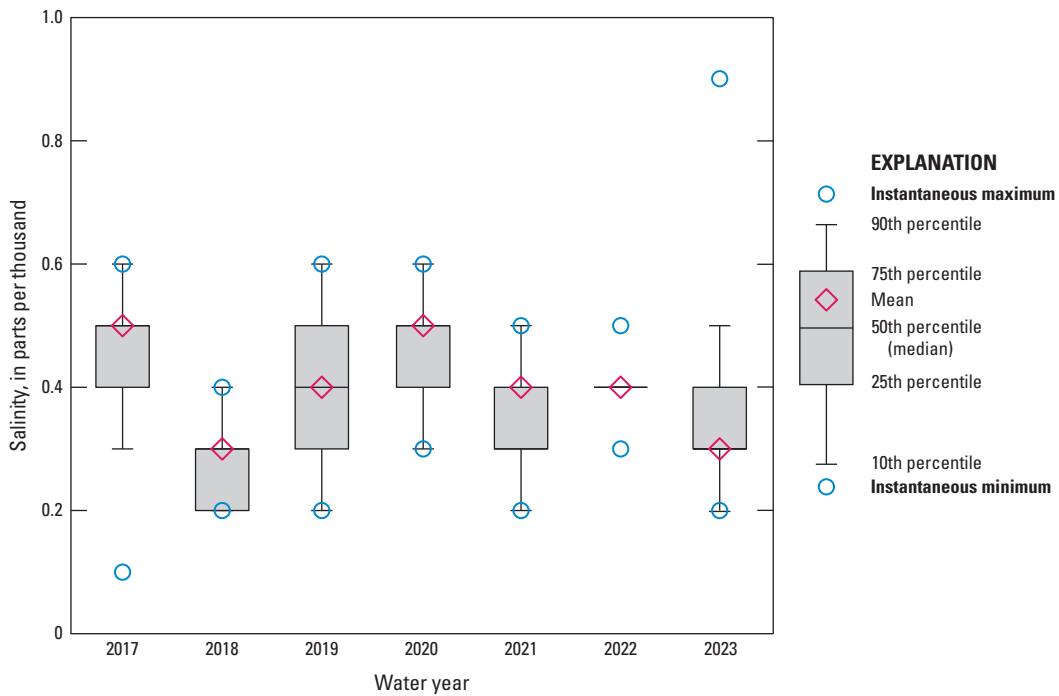
Figure 15. Salinity data for St. Johns River at Dancy Point near Spuds, Florida.

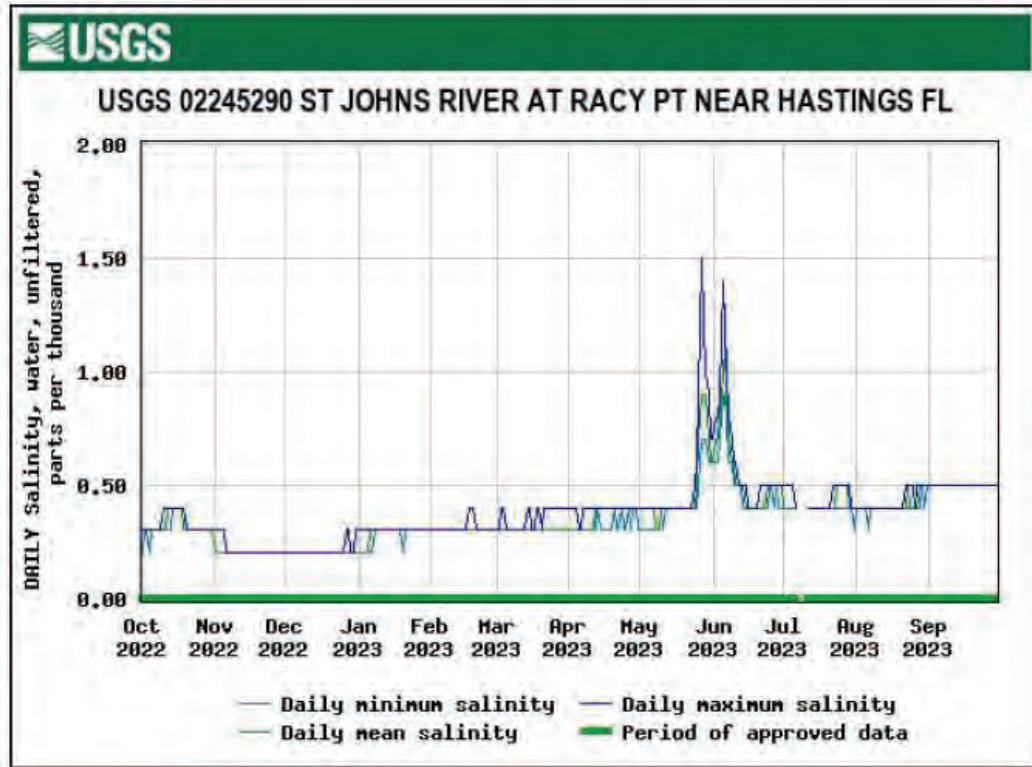
Figure 16. Daily maximum, minimum, and mean salinity for St. Johns River at Racy Point near Hastings, Florida.

St. Johns River at Racy Point near Hastings, Florida.—Salinity on the St. Johns River at Racy Point near Hastings, Fla. (USGS site number 02245290, map number 9) ranged from 0.2 to 1.5 ppt during the 2023 water year, with a median of 0.3 ppt and a mean of 0.4 ppt (figs. 16 and 17). There were 4 days of missing salinity data in July caused by an equipment

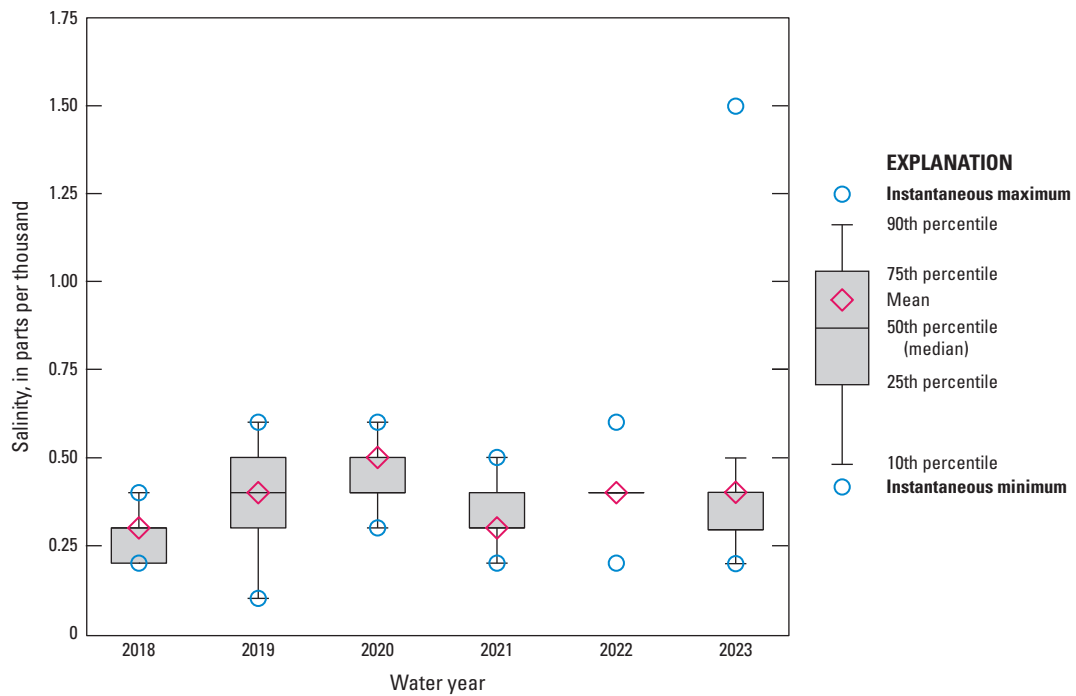
Figure 17. Salinity data for St. Johns River at Racy Point near Hastings, Florida.

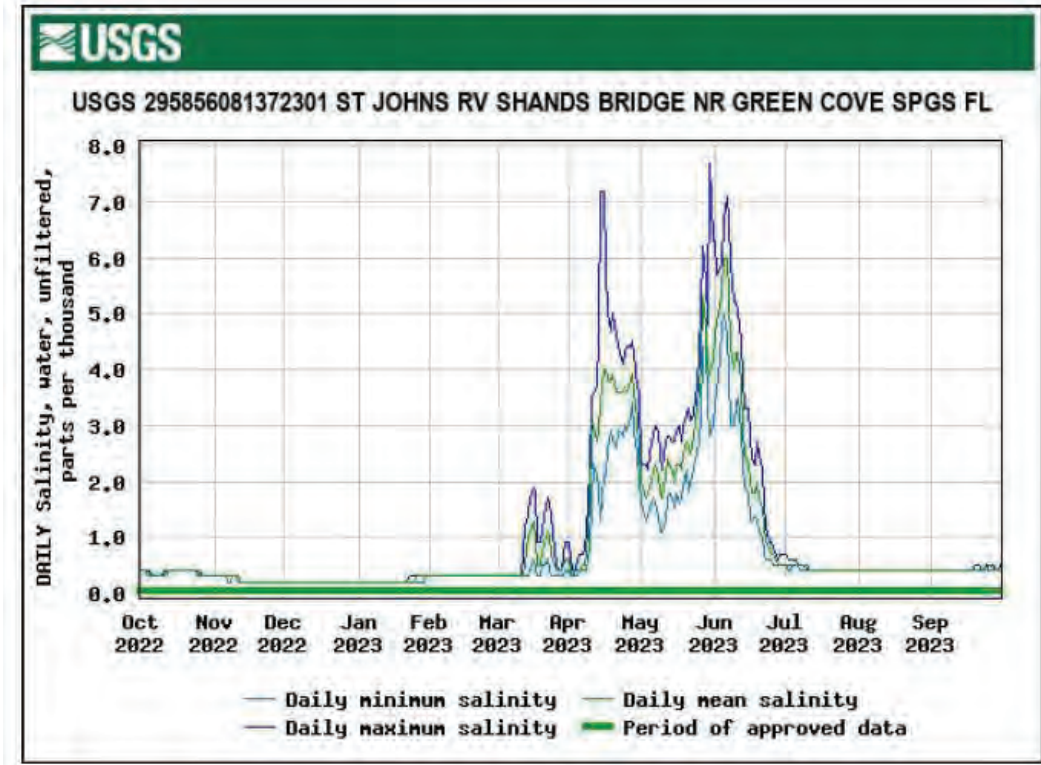
Figure 18. Daily maximum, minimum, and mean salinity for St. Johns River Shands Bridge near Green Cove Springs, Florida.

St. Johns River Shands Bridge near Green Cove Springs, Florida.—Salinity on the St. Johns River Shands Bridge near Green Cove Springs, Fla. (USGS site number 295856081372301, map number 8) ranged from 0.2 to 7.7 ppt during the 2023 water year, with a median of 0.4 ppt and a mean of 0.9 ppt (figs. 18 and 19). A boxplot of salinity data for the 6 years of data collection shows the highest mean salinity occurred in 2023 (fig. 19).

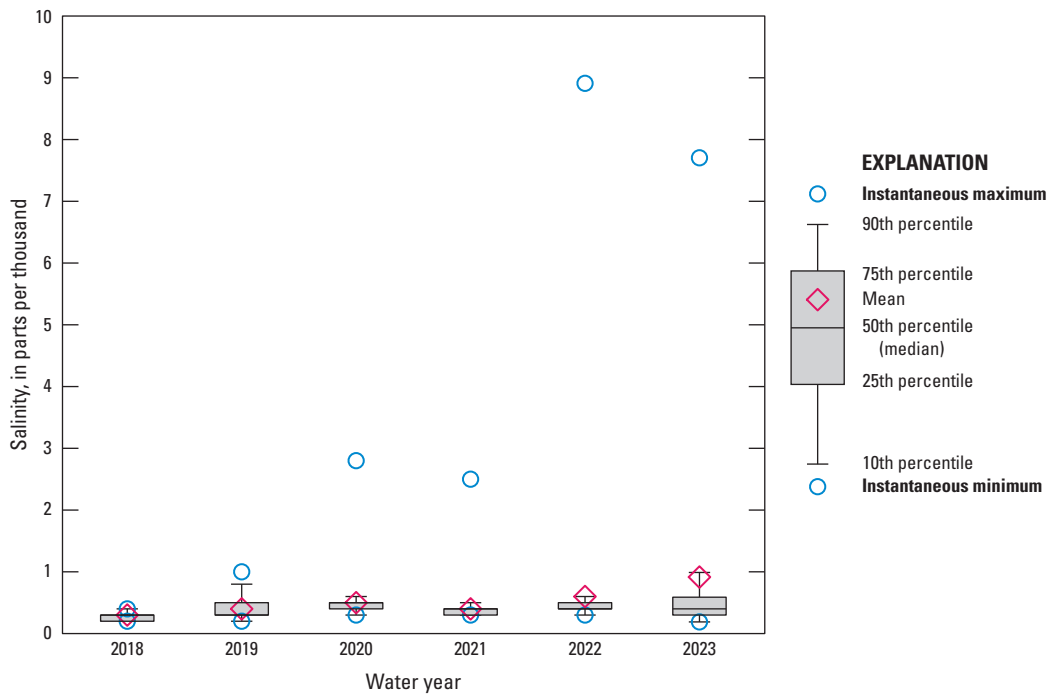
Figure 19. Salinity data for St. Johns River Shands Bridge near Green Cove Springs, Florida.

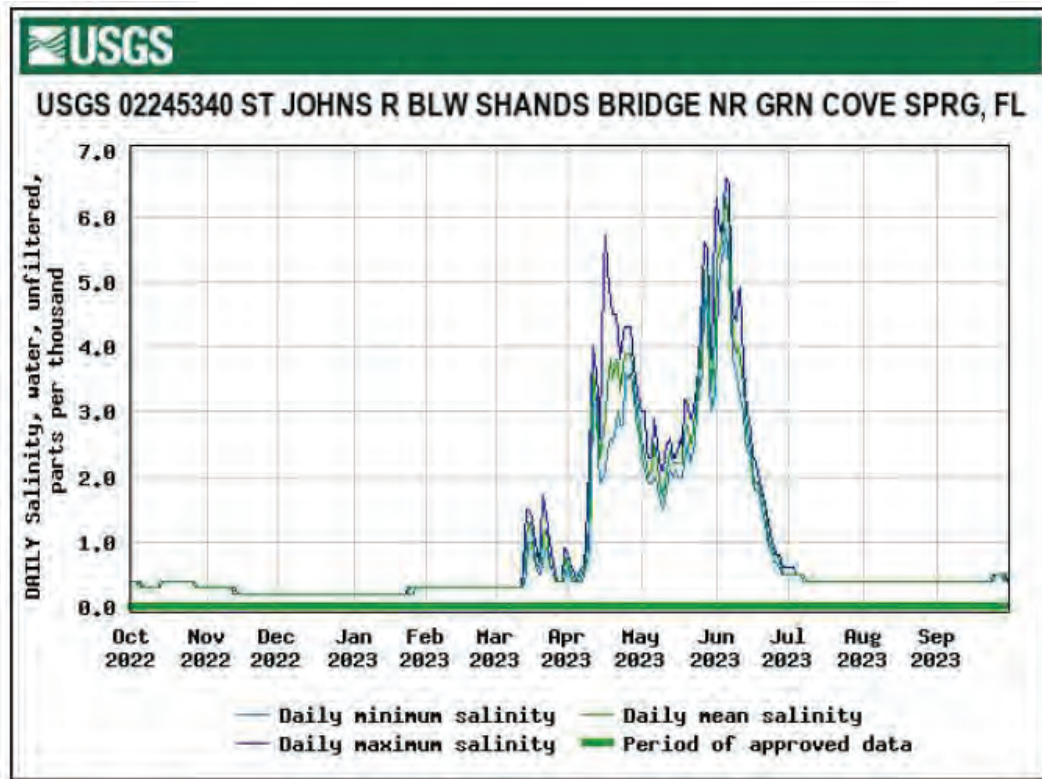
Figure 20. Daily maximum, minimum, and mean salinity for St. Johns River below Shands Bridge near Green Cove Springs, Florida.

St. Johns River below Shands Bridge near Green Cove Springs, Florida.—Salinity on the St. Johns River below Shands Bridge near Green Cove Springs, Fla. (USGS site number 02245340, map number 7) ranged from 0.2 to 6.6 ppt during the 2023 water year, with a median of 0.4 ppt and a mean of 0.9 ppt (figs. 20 and 21). The 2023 mean and maximum salinity were second highest among those computed for the 7 years of data collection at this site (fig. 21).

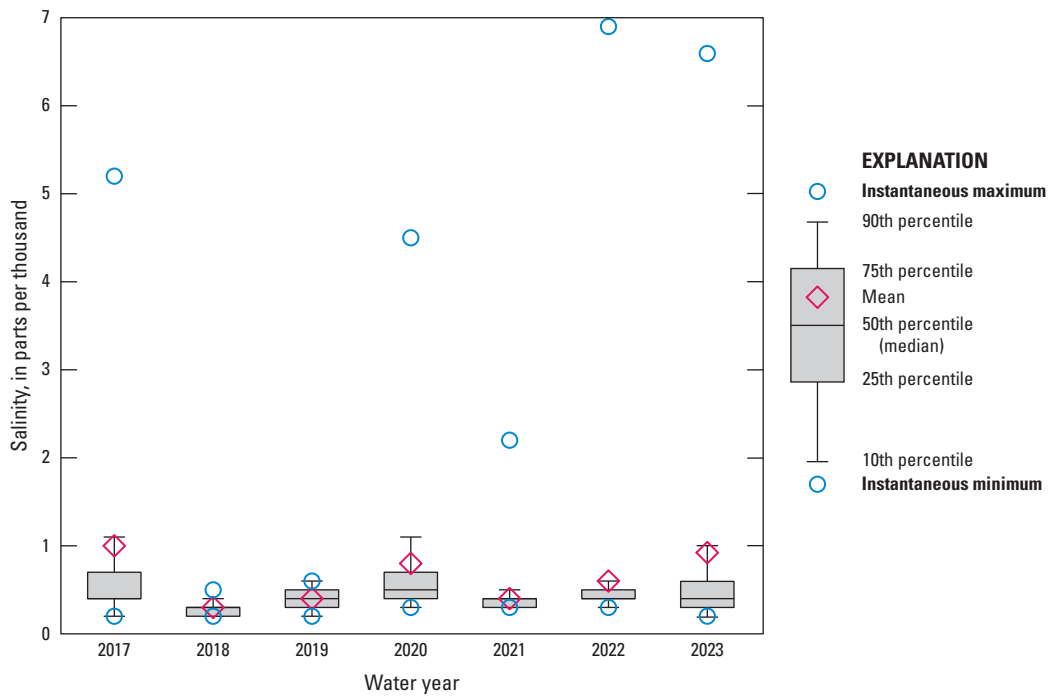
Figure 21. Salinity data for St. Johns River below Shands Bridge near Green Cove Springs, Florida.

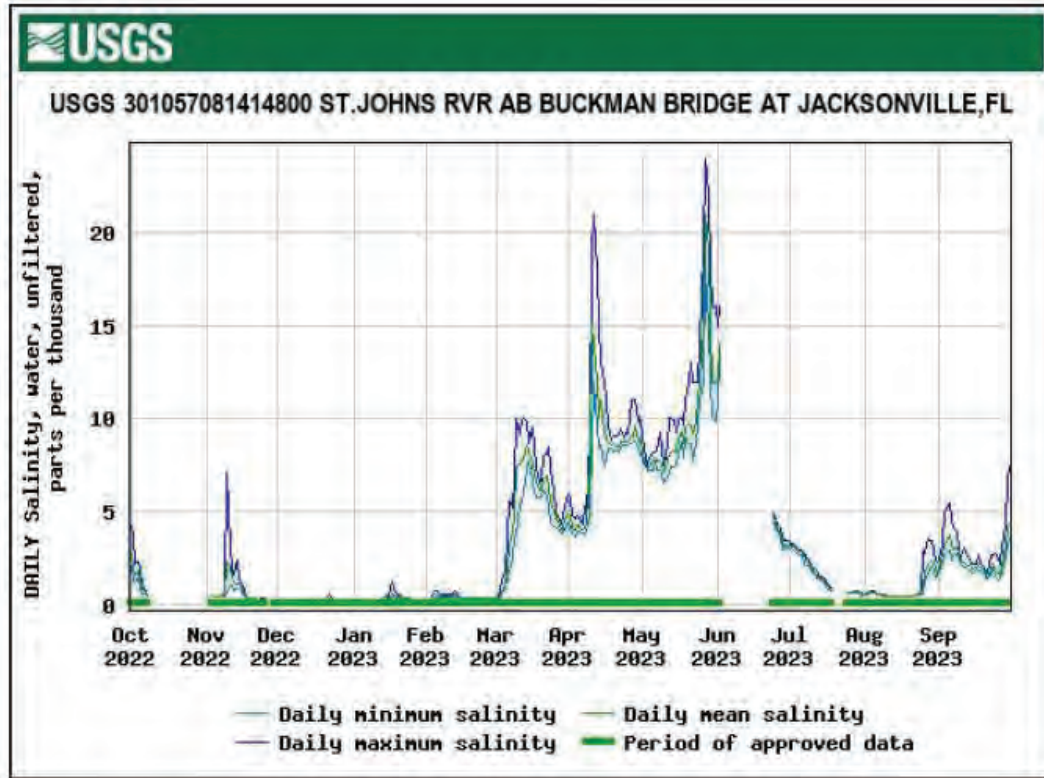
Figure 22. Daily maximum, minimum, and mean salinity for St. Johns River above Buckman Bridge at Jacksonville, Florida.

St. Johns River above Buckman Bridge at Jacksonville, Florida.—Salinity on the St. Johns River above Buckman Bridge at Jacksonville, Fla. (USGS site number 301057081414800, map number 6) ranged from 0.2 to 24 ppt during the 2023 water year, with a median of 1.2 ppt and mean of 3.1 ppt (figs. 22 and 23). There were 22 days of missing salinity data in October, 5 days of missing salinity data in November, 20 days of missing salinity data in June, and 5 days of missing salinity data in July, all caused by equipment malfunctions and (or) fouling on the meter. Daily maximum salinity peaked above 24 ppt in May, which is the highest value computed over the 6 years of the study. The median salinity was second highest and the mean salinity for 2023 ranked highest among those computed for the 6 years of data collection, although the 2018 record is incomplete because the monitoring site was installed that year (fig. 23).

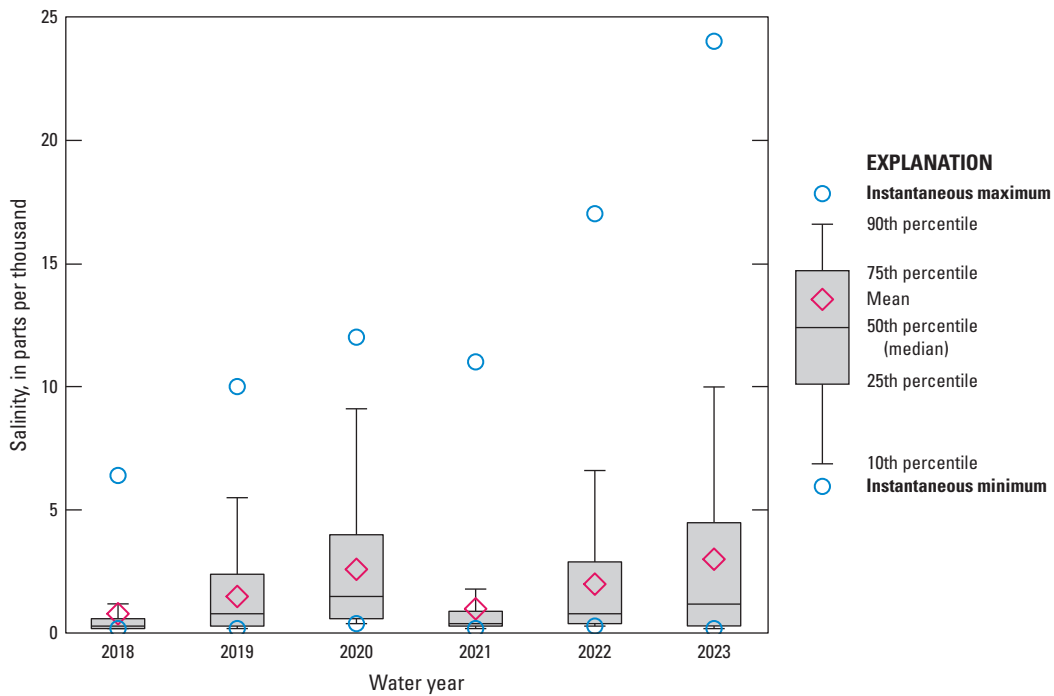
Figure 23. Salinity data for St. Johns River above Buckman Bridge at Jacksonville, Florida.

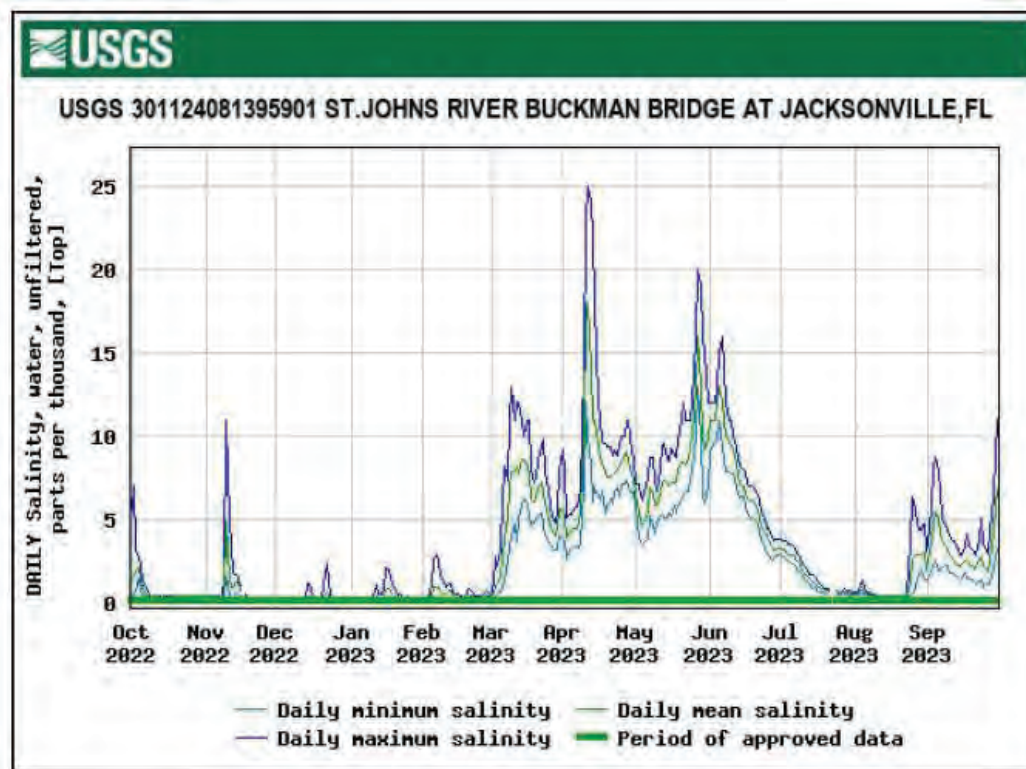
Figure 24. Daily maximum, minimum, and mean salinity for top location of St. Johns River Buckman Bridge at Jacksonville, Florida.

St. Johns River Buckman Bridge at Jacksonville, Florida.—Salinity on the St. Johns River Buckman Bridge at Jacksonville, Fla. (USGS site number 301124081395901, map number 5) ranged from 0.2 to 25 ppt for the top location during the 2023 water year, with a median of 1.0 ppt and mean of 3.1 ppt, and from 0.2 to 27 ppt for the bottom location, with a median of 1.3 ppt and mean of 3.7 ppt (figs. 24–27). The monitoring site did not record water-quality data at the top location for 1 day in November and 2 days in July or at the bottom location for 1 day in November, 2 days in December, 1 day in February, and 2 days in September because of
