Continuous Stream Discharge, Salinity, and Associated Data Collected in the Lower St. Johns River and Its Tributaries, Florida, 2023

Open-File Report 2026–1012

By Jennifer N. Carson and Matthew T. Benacquisto

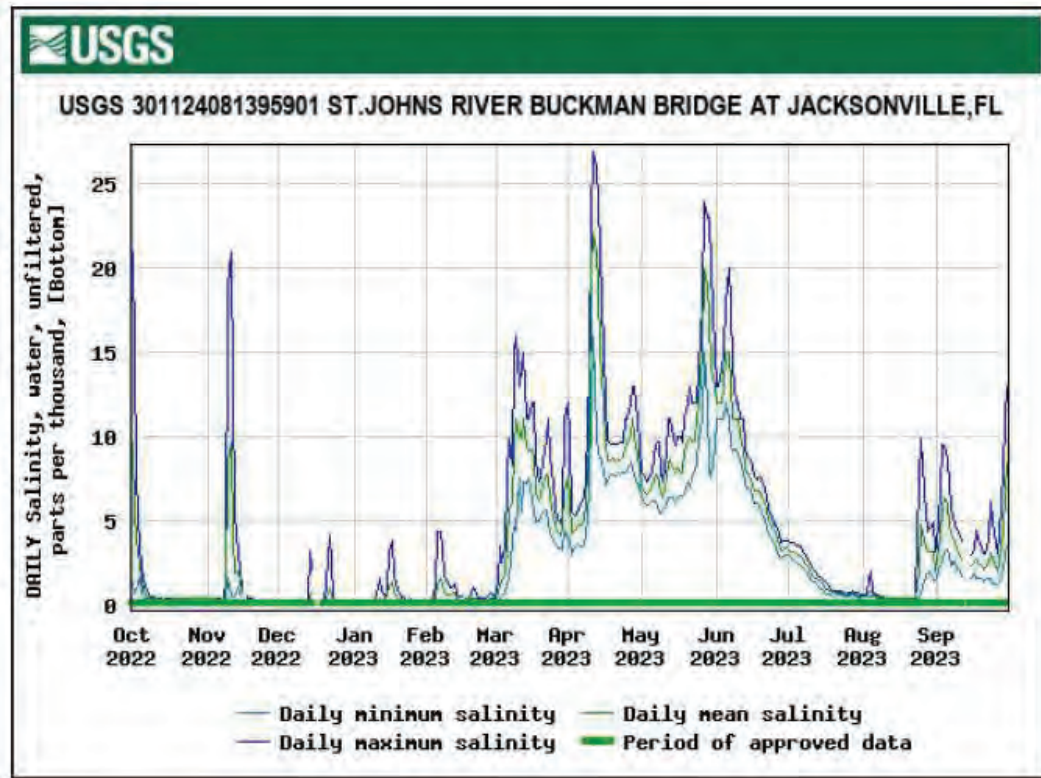
Figure 25. Daily maximum, minimum, and mean salinity for bottom location of St. Johns River Buckman Bridge at Jacksonville, Florida.

St. Johns River Buckman Bridge at Jacksonville, Florida.—Salinity on the St. Johns River Buckman Bridge at Jacksonville, Fla. (USGS site number 301124081395901, map number 5) ranged from 0.2 to 25 ppt for the top location during the 2023 water year, with a median of 1.0 ppt and mean of 3.1 ppt, and from 0.2 to 27 ppt for the bottom location, with a median of 1.3 ppt and mean of 3.7 ppt (figs. 24–27). The monitoring site did not record water-quality data at the top location for 1 day in November and 2 days in July or at the bottom location for 1 day in November, 2 days in December, 1 day in February, and 2 days in September because of

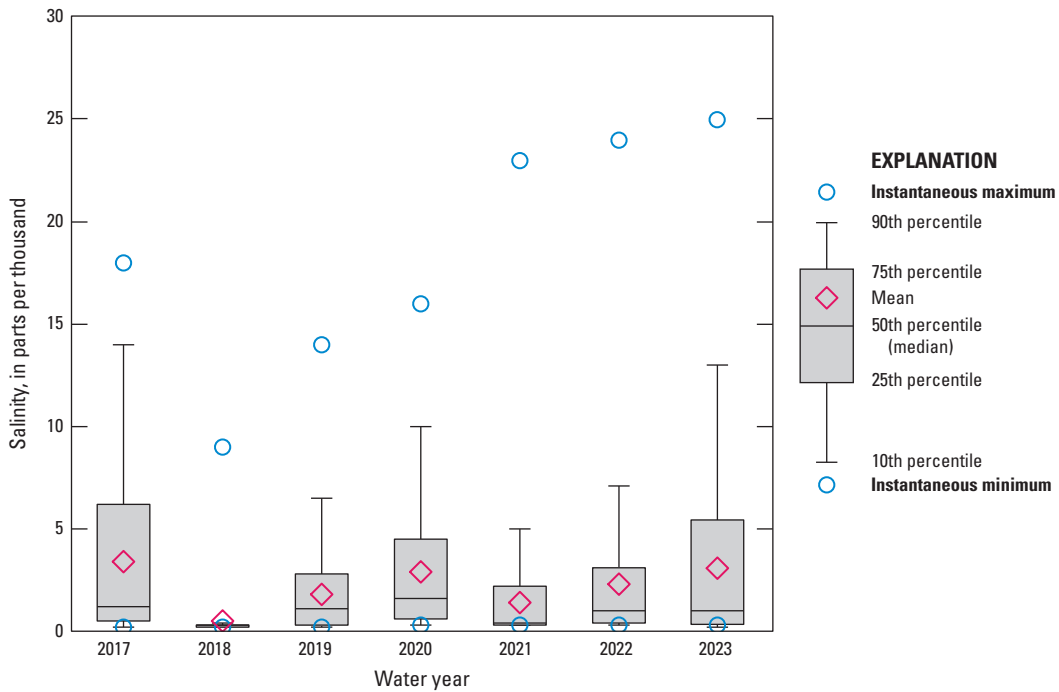
Figure 26. Salinity data for top location of St. Johns River Buckman Bridge at Jacksonville, Florida.

equipment malfunctions. Salinity at both locations peaked in April. This was the highest maximum salinity at both locations for the 7 years of data collection at this site. The 2023 median salinity at the top location tied for fourth highest while the bottom location ranked third highest among those computed for the 7 years of data collection (figs. 26 and 27). The mean salinity at the top and bottom locations were the second highest among those computed for the 7 years of data collection (figs. 26 and 27).

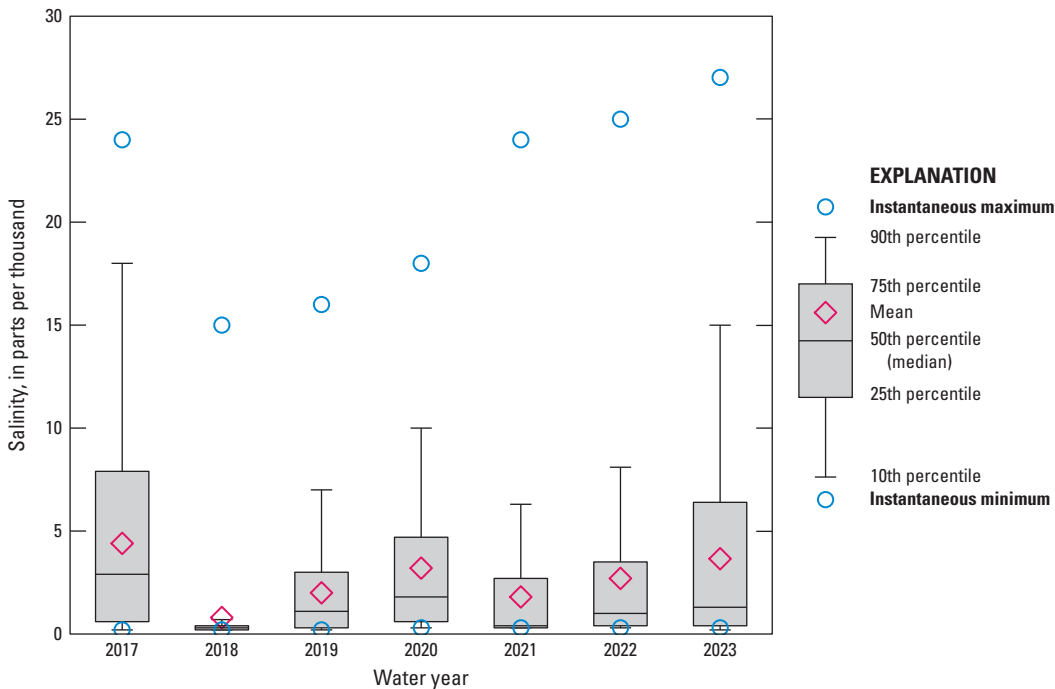
Figure 27. Salinity data for bottom location of St. Johns River Buckman Bridge at Jacksonville, Florida.

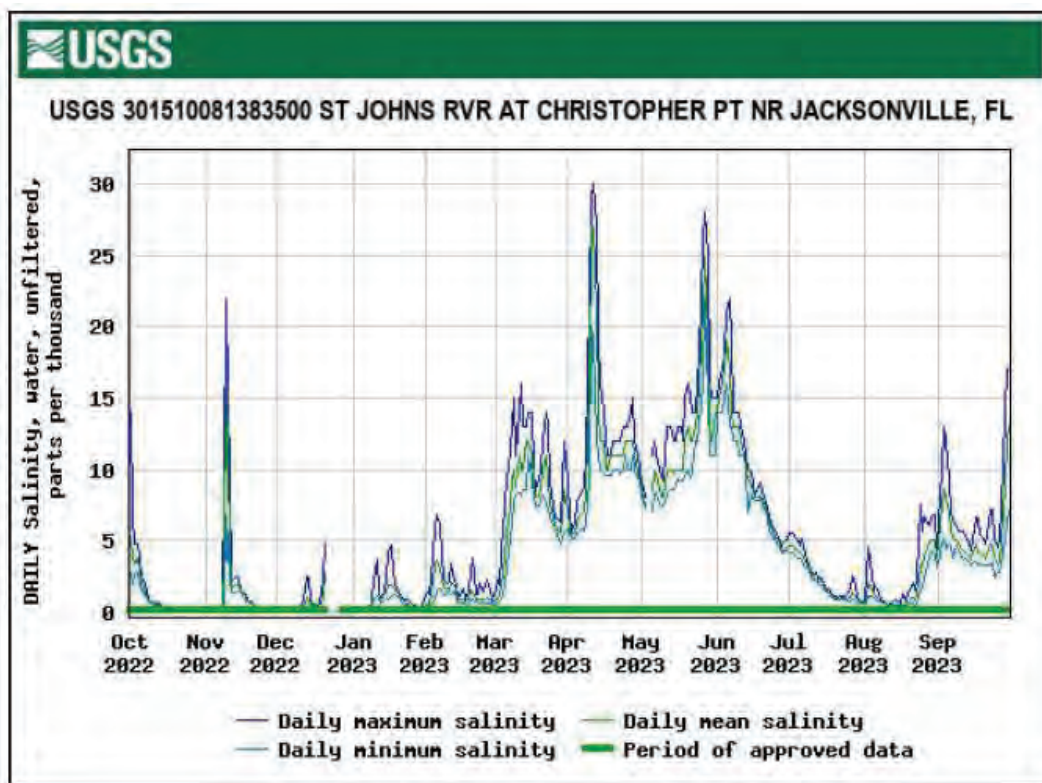
Figure 28. Daily maximum, minimum, and mean salinity for St. Johns River at Christopher Point near Jacksonville, Florida.

St. Johns River at Christopher Point near Jacksonville, Florida.—Salinity at St. Johns River at Christopher Point near Jacksonville, Fla. (USGS site number 301510081383500, map number 4) ranged from 0.2 to 30 ppt during the 2023 water year, with a median of 3.2 ppt and mean of 4.6 ppt (figs. 28 and 29). The monitoring site did not record water-quality data for 5 days in December and 1 day in May because of equipment malfunctions. The 2023 maximum salinity was the highest among those computed for the 8 years of data collection, while the mean salinity ranked second highest and median salinity ranked third highest (fig. 29).

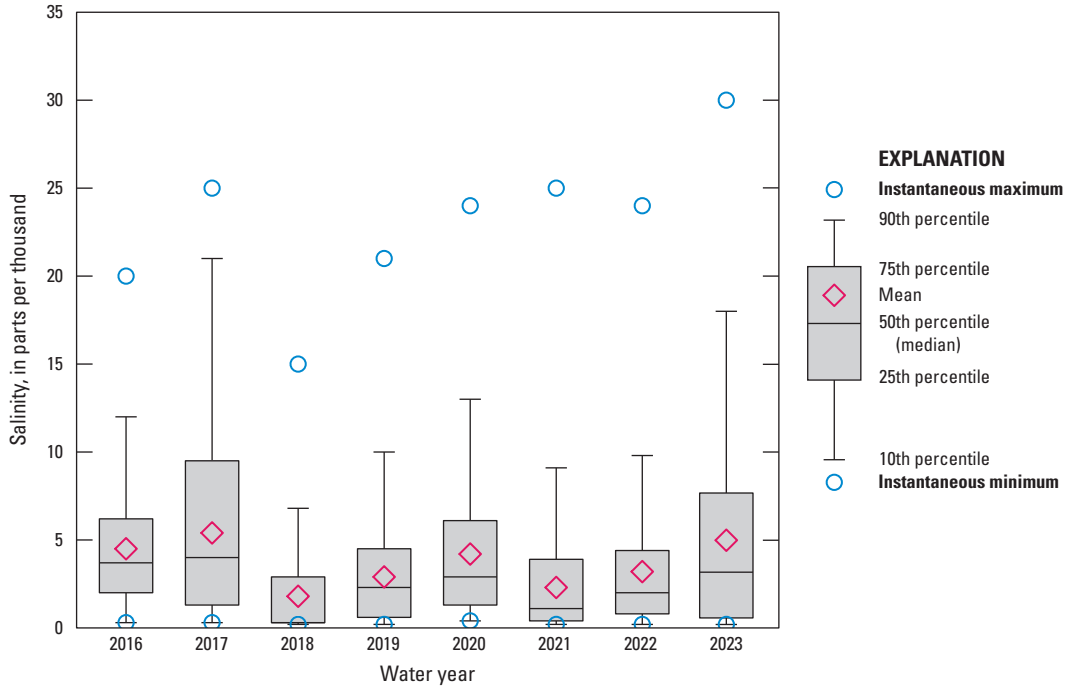
Figure 29. Salinity data for St. Johns River at Christopher Point near Jacksonville, Florida.

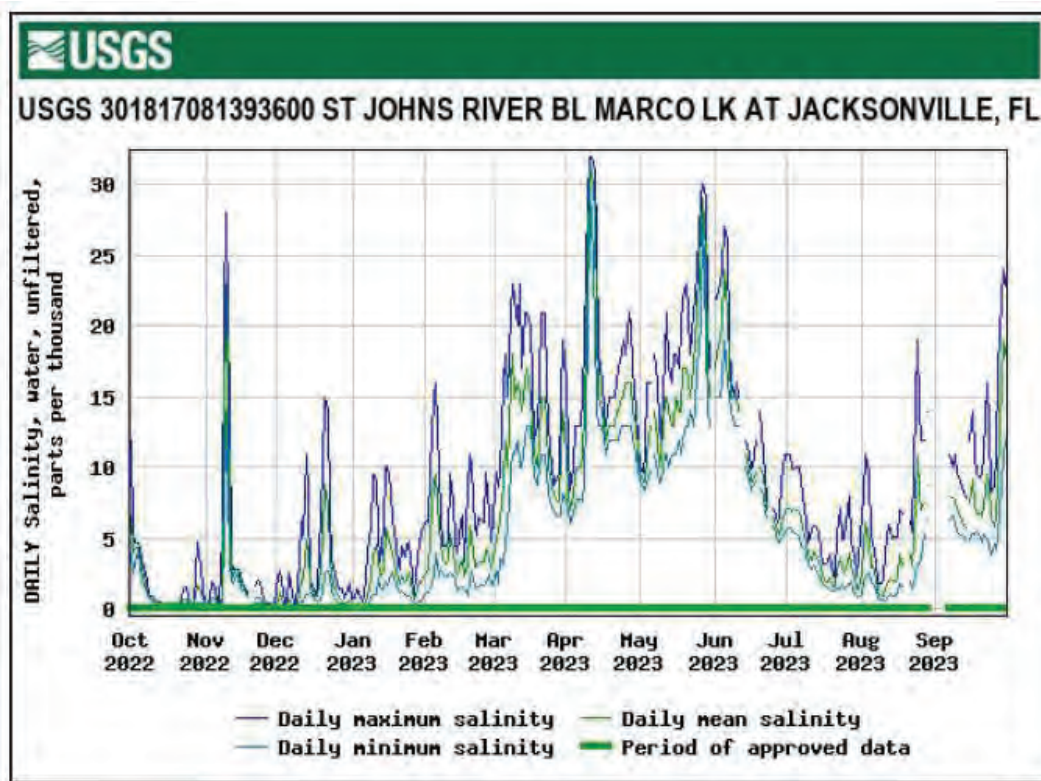
Figure 30. Daily maximum, minimum, and mean salinity for St. Johns River below Marco Lake at Jacksonville, Florida.

St. Johns River below Marco Lake at Jacksonville, Florida.—Salinity at St. Johns River below Marco Lake at Jacksonville, Fla. (USGS site number 301817081393600, map number 3) ranged from 0.2 to 32 ppt during the 2023 water year, with a median of 4.9 ppt and mean of 6.9 ppt (figs. 30 and 31). Salinity was not computed for 2 days in November, 2 days in May, 5 days in June, 6 days in August, and 7 days in

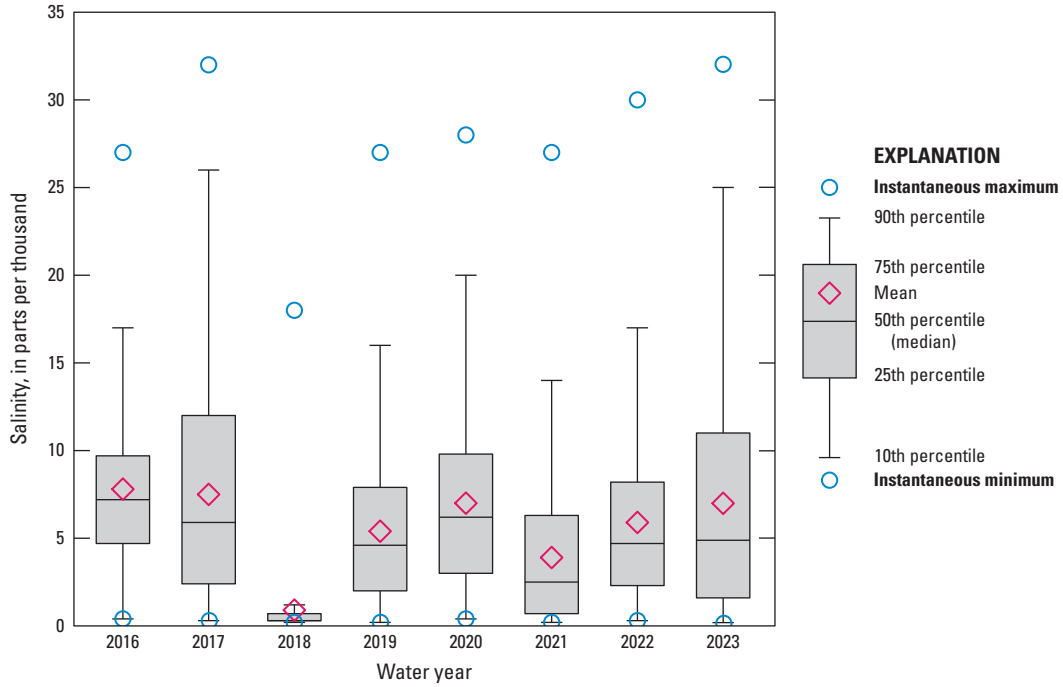
Figure 31. Salinity data for St. Johns River below Marco Lake at Jacksonville, Florida.

September because of equipment malfunctions. The maximum salinity was tied with 2017 for the highest salinity recorded for the 8 years of data collection. The 2023 median and mean salinity ranked fourth highest among those computed for the 8 years of data collection (fig. 31).

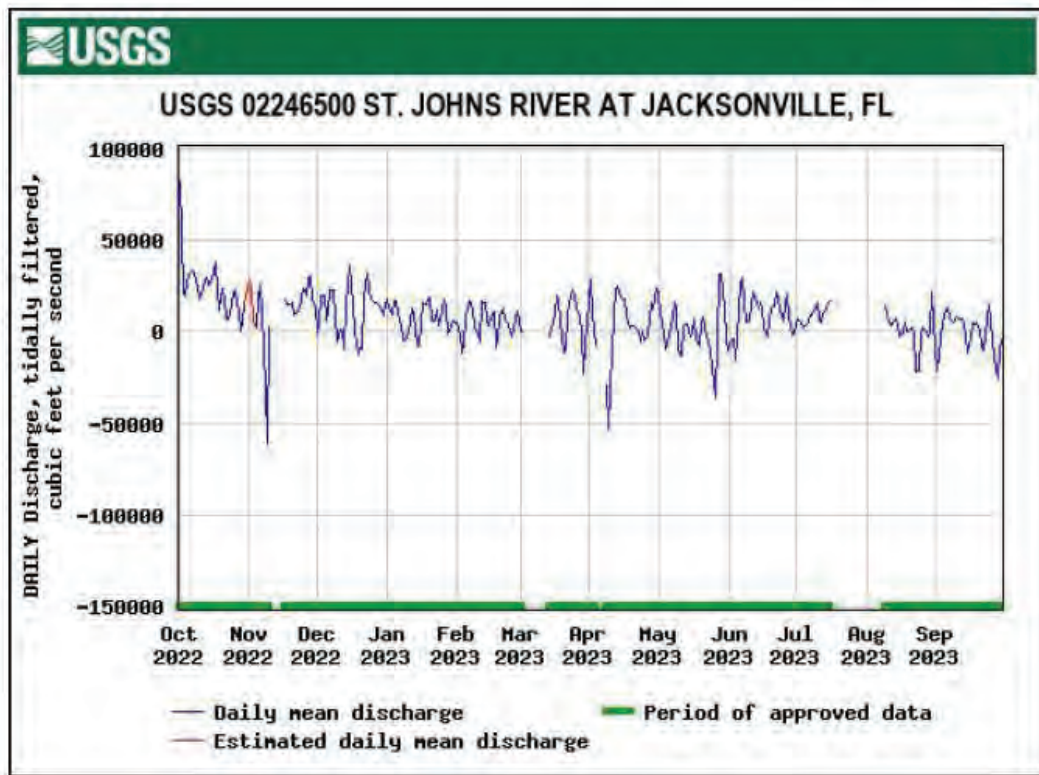
Figure 32. Daily mean tidally filtered discharge for St. Johns River at Jacksonville, Florida.

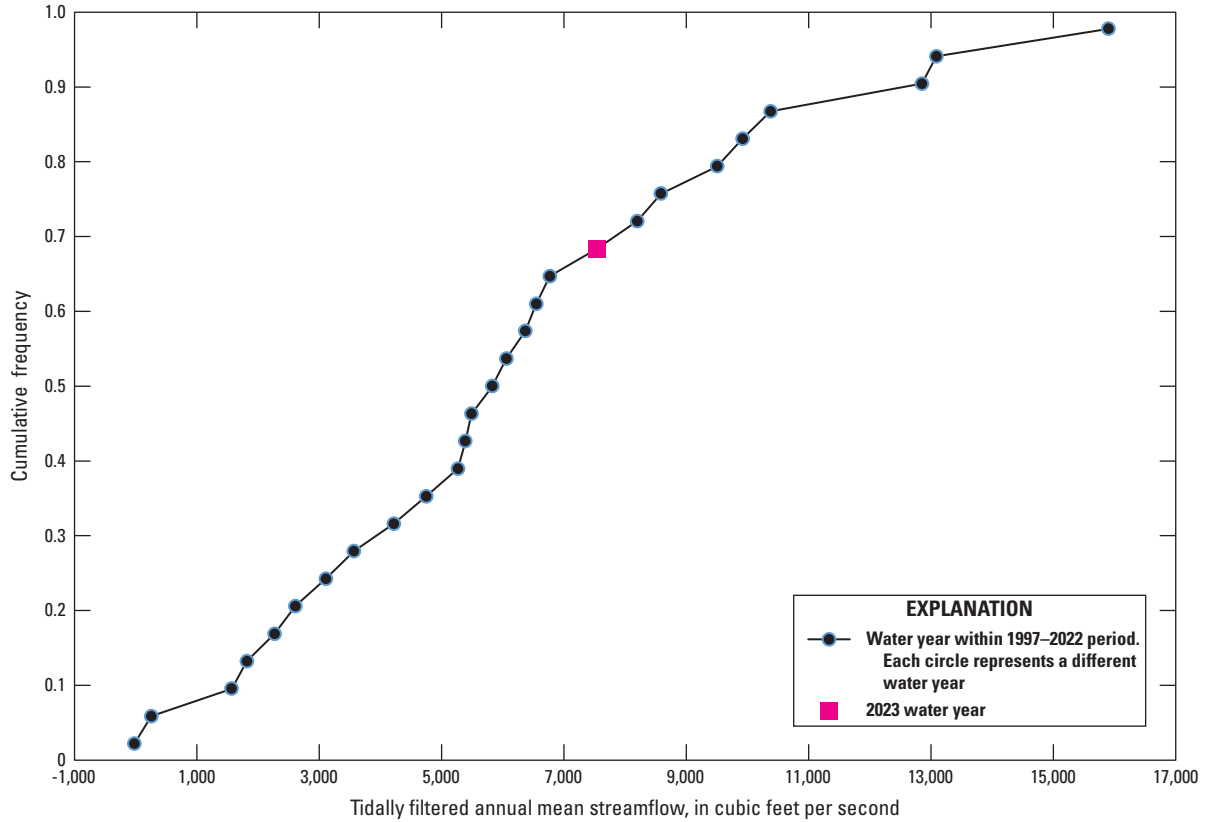
Figure 33. Annual mean tidally filtered streamflow data for St. Johns River at Jacksonville, Florida.

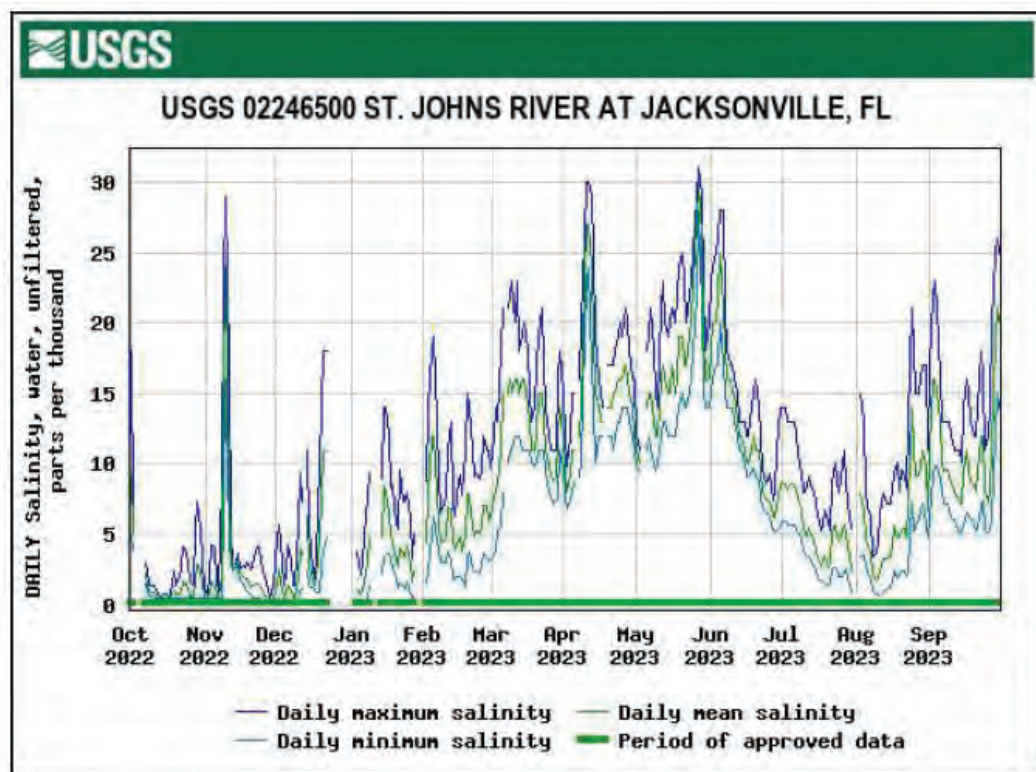
Figure 34. Daily maximum, minimum, and mean salinity for St. Johns River at Jacksonville, Florida.

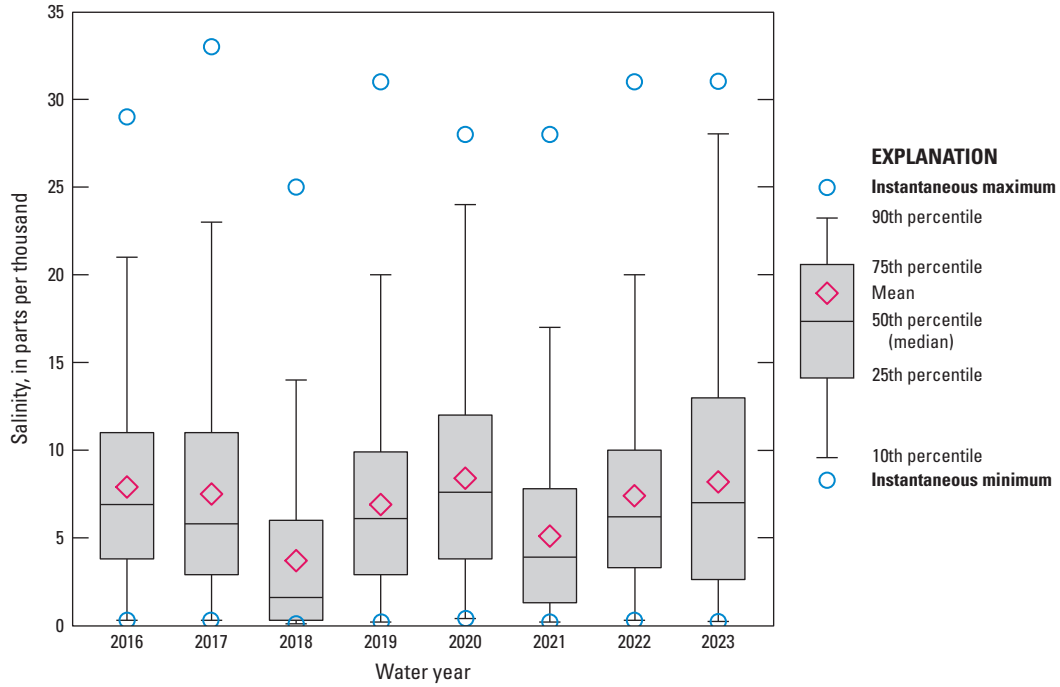
Figure 35. Salinity data for St. Johns River at Jacksonville, Florida.

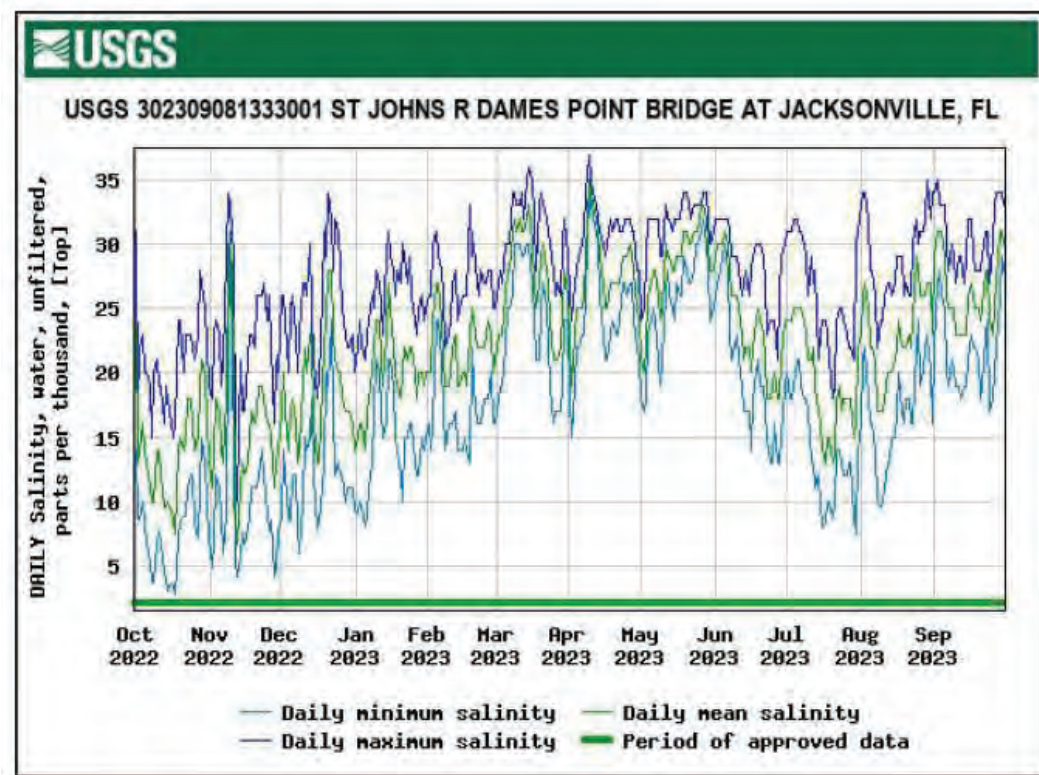
Figure 36. Daily maximum, minimum, and mean salinity for top location of St. Johns River Dames Point Bridge at Jacksonville, Florida.

St. Johns River Dames Point Bridge at Jacksonville, Florida.—Salinity on the St. Johns River Dames Point Bridge at Jacksonville, Fla. (USGS site number 302309081333001, map number 1) ranged from 2.8 to 37 ppt for the top location during the 2023 water year, with a median of 23 ppt and mean of 22 ppt, and from 4 to 34 ppt for the bottom location, with a median of 24 ppt and mean of 23 ppt (figs. 36–39). Salinity at the bottom location was not computed for 4 days in April because of an equipment malfunction. Salinity during the year was generally lower at the top location relative to the bottom and fluctuated weekly at both locations because of upstream conditions. At both locations, the 2023 median salinity tied for highest, and the mean salinity ranked third highest, among those calculated for the 7 years of data collection (figs. 38 and 39). The top location had the highest salinity for the 7 years of data collection (fig. 38).

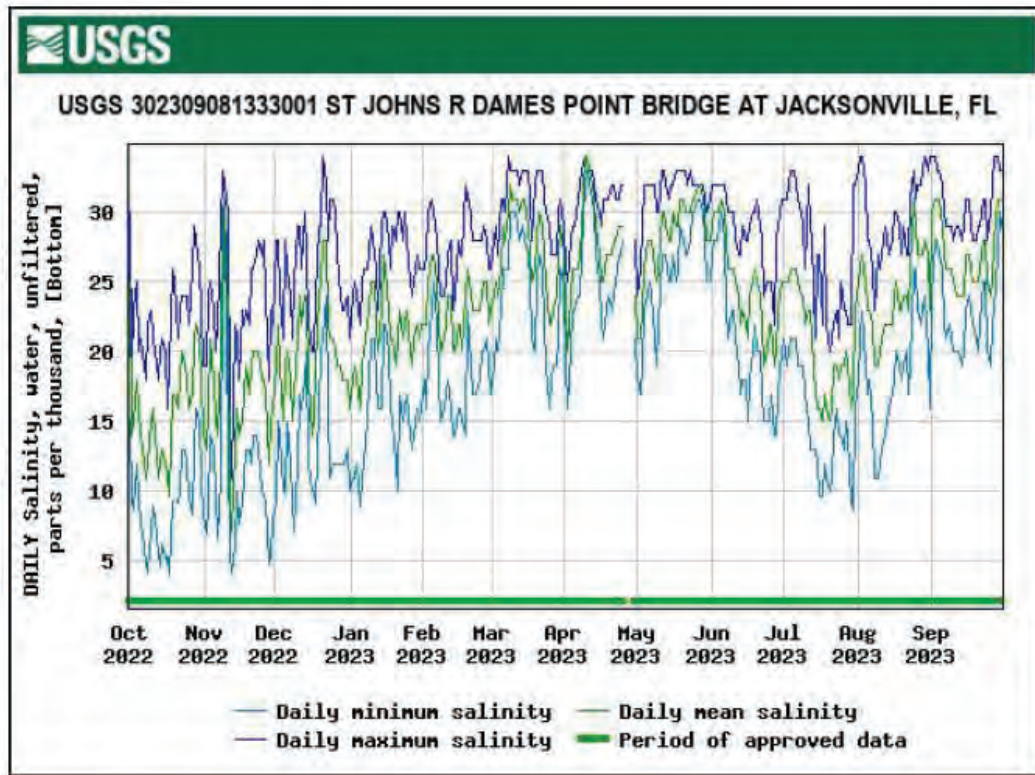
Figure 37. Daily maximum, minimum, and mean salinity for bottom location of St. Johns River Dames Point Bridge at Jacksonville, Florida.

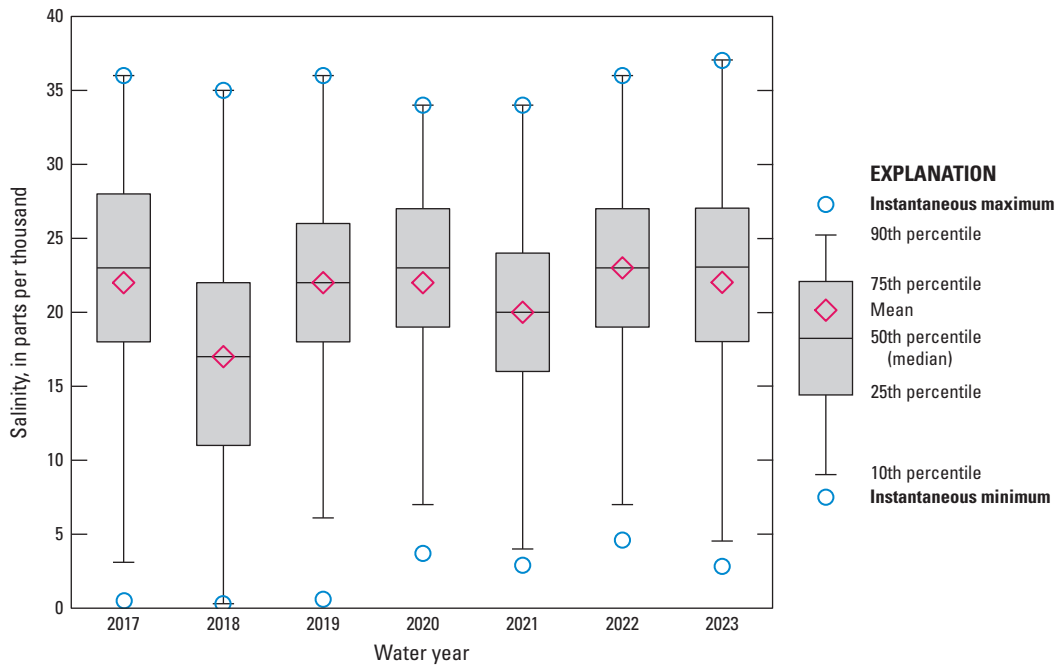
Figure 38. Salinity data for top location of St. Johns River at Dames Point Bridge at Jacksonville, Florida.

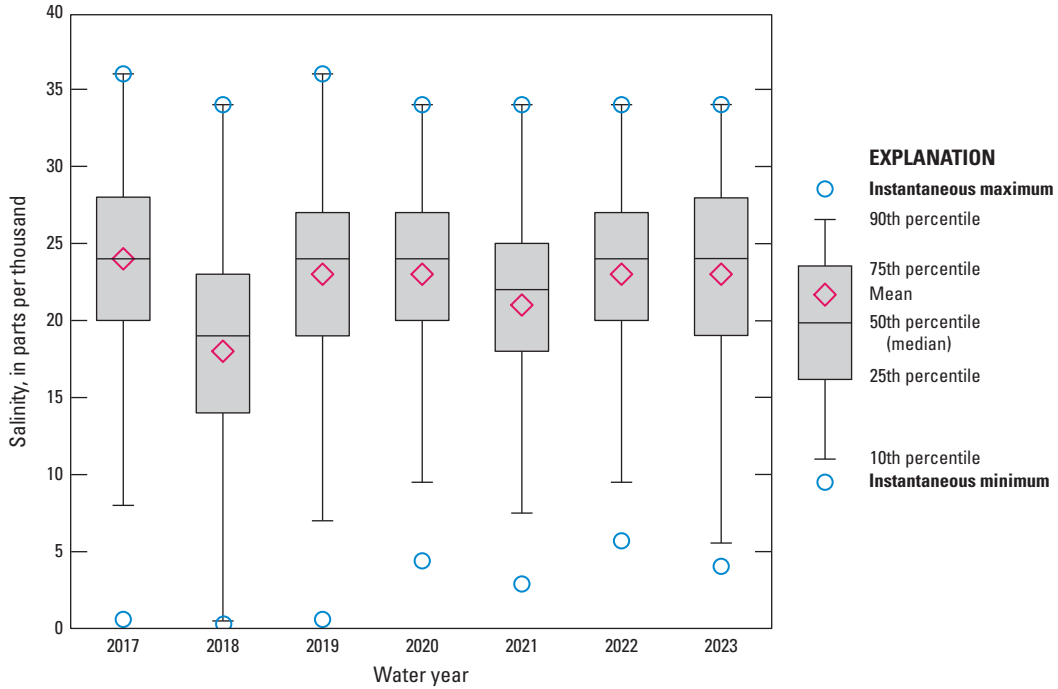
Figure 39. Salinity data for bottom location of St. Johns River at Dames Point Bridge at Jacksonville, Florida.

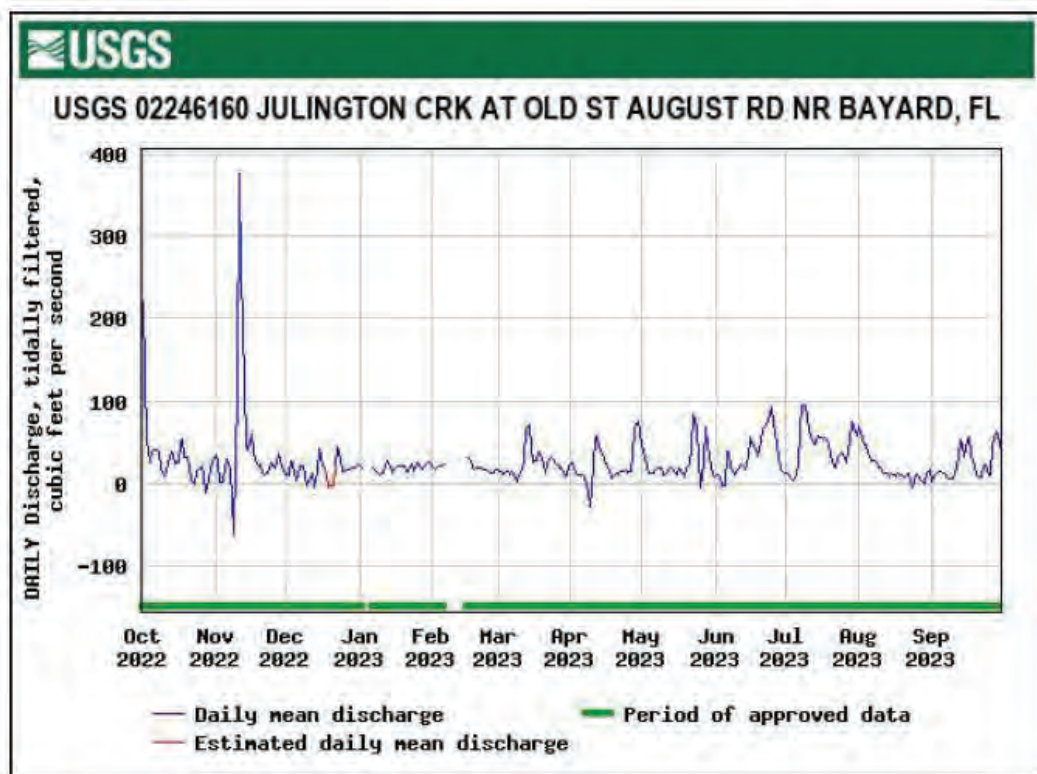
Figure 40. Daily mean tidally filtered discharge for Julington Creek at Old St. Augustine Road near Bayard, Florida.

Julington Creek at Old St. Augustine Road near Bayard, Florida.—Daily tidally filtered discharge at Julington Creek at Old St. Augustine Road near Bayard, Fla. (USGS site number 02246160, map number 25) ranged from -60.0 to 376 ft^3/s during the 2023 water year (fig. 40), with an annual mean flow of 27.2 ft^3/s . The lowest daily tidally filtered discharge in 2023 occurred in November just before Hurricane Nicole. This is the lowest discharge on record at this site. Discharge data were not calculated for 5 days in January and 10 days in February because of equipment malfunctions. Discharge was also estimated for 4 days in December.

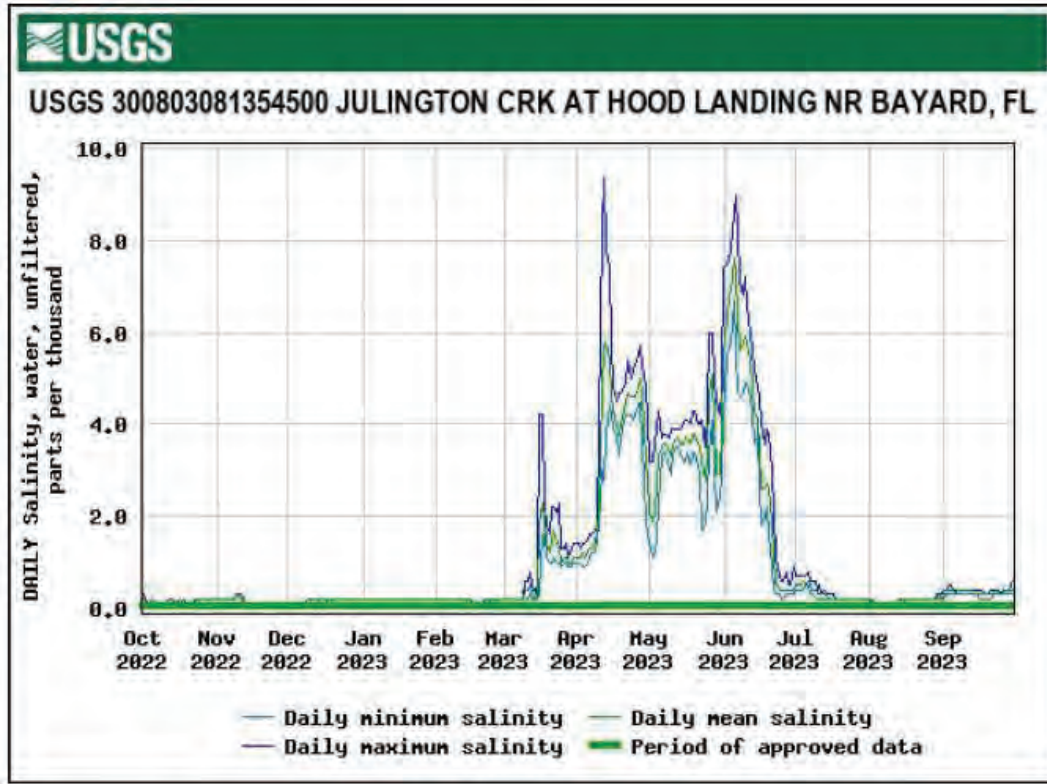
Figure 41. Daily maximum, minimum, and mean salinity for Julington Creek at Hood Landing near Bayard, Florida.

Julington Creek at Hood Landing near Bayard, Florida.—Salinity at Julington Creek at Hood Landing near Bayard, Fla. (USGS site number 300803081354500, map number 24) ranged from 0.1 to 9.4 ppt during the 2023 water year, with a median of 0.2 ppt and mean of 1.1 ppt (figs. 41 and 42). The maximum salinity for the 2023 water year was the highest among those computed for the 8 years of data collection so far. The 2023 median tied for second highest and the mean salinity was the highest among those computed for the 8 years of data collection (fig. 42).

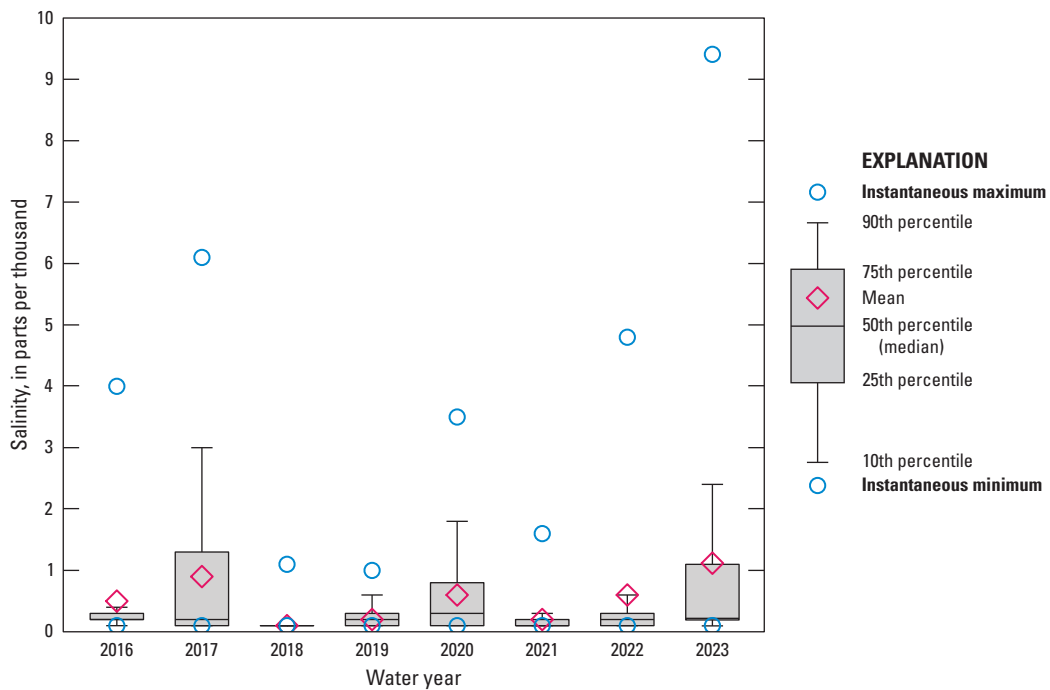
Figure 42. Salinity data for Julington Creek at Hood Landing near Bayard, Florida.

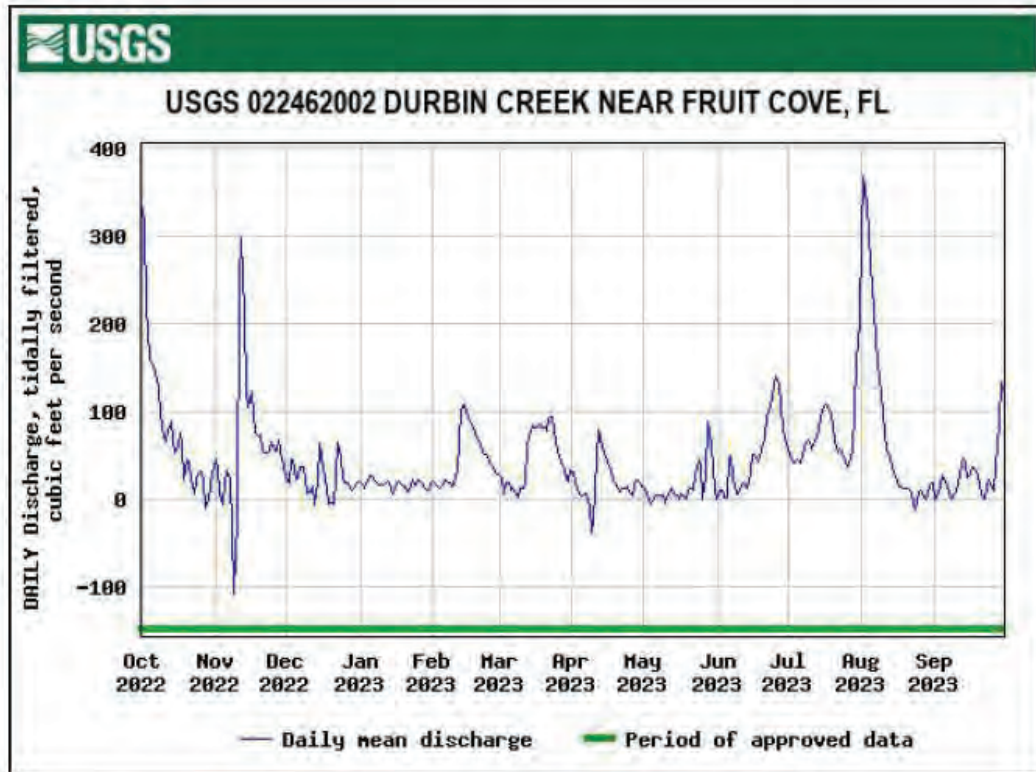
Figure 43. Daily mean tidally filtered discharge for Durbin Creek near Fruit Cove, Florida.

-107 to 367 ft^3/s during the 2023 water year, with an annual mean of 46.5 ft^3/s (fig. 43). The lowest daily tidally filtered discharge in 2023 was the lowest on record at this site and occurred in November just before Hurricane Nicole. Salinity ranged from 0.1 to 5.0 ppt, with a median of 0.1 ppt and mean of 0.2 ppt (figs. 44 and 45). The boxplot for Durbin Creek near Fruit Cove, Fla. (USGS site number 022462002, map number 26) salinity data in 2023 shows the same median for all 8 years of data collection, while the maximum salinity was the highest (fig. 45). The boxplot includes no whiskers because of the low and steady salinities of freshwater flows through the creek. Salinity is missing for 1 day in July and 2 days in August because of equipment malfunctions.

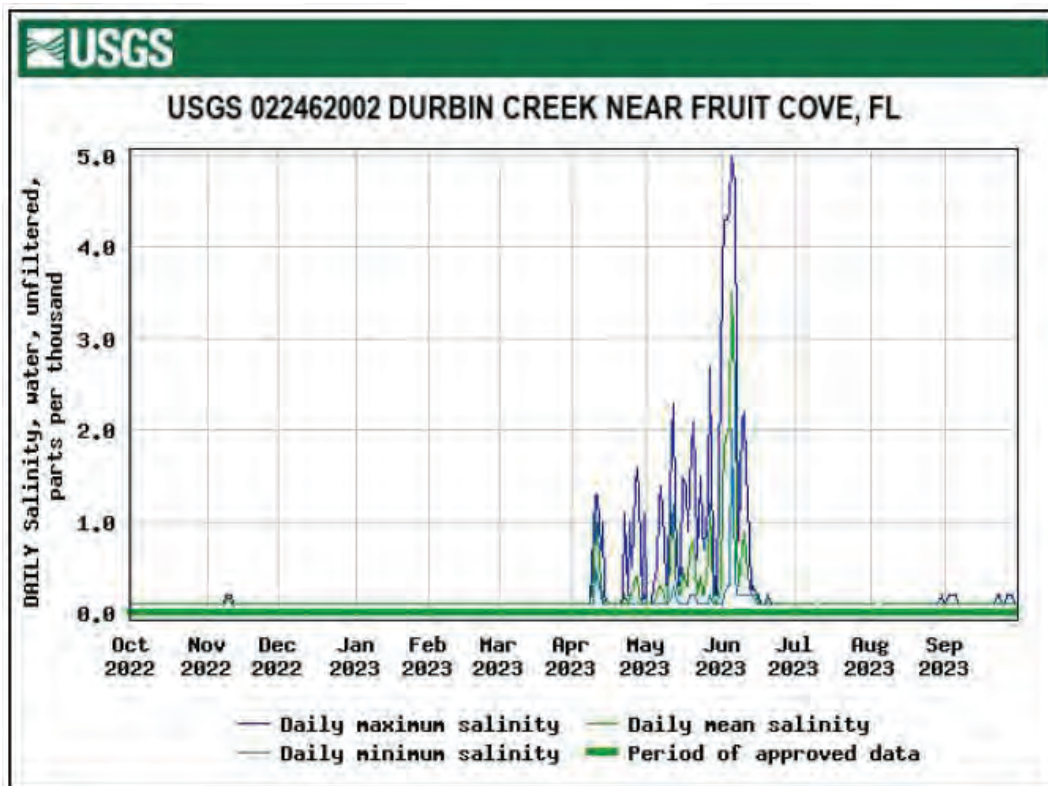
Figure 44. Daily maximum, minimum, and mean salinity for Durbin Creek near Fruit Cove, Florida.

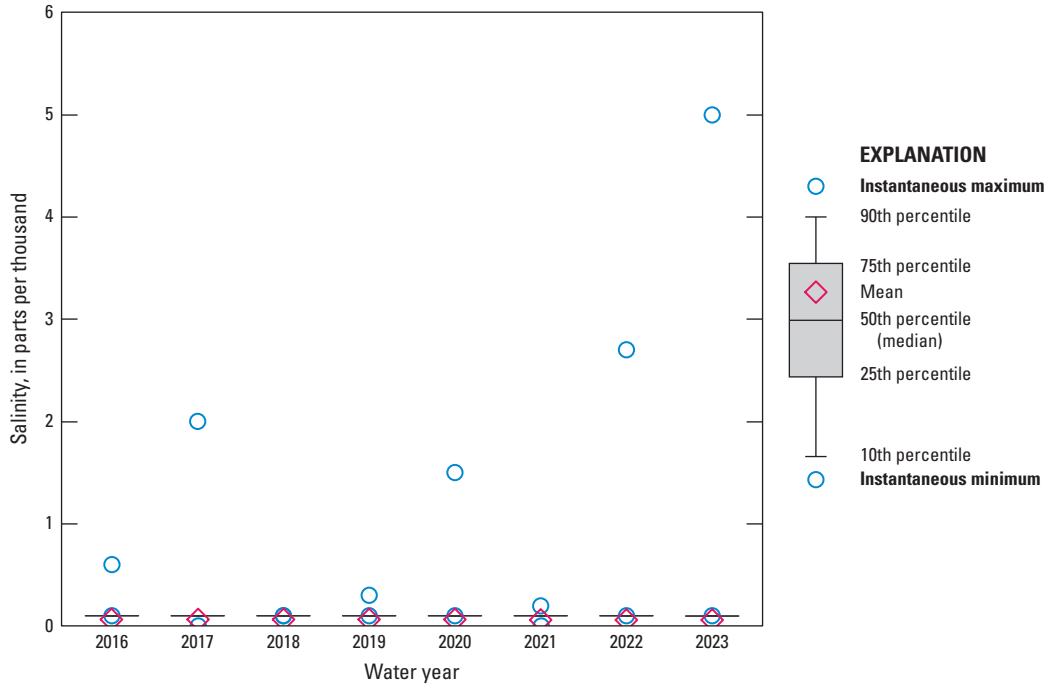
Figure 45. Salinity data for Durbin Creek near Fruit Cove, Florida.

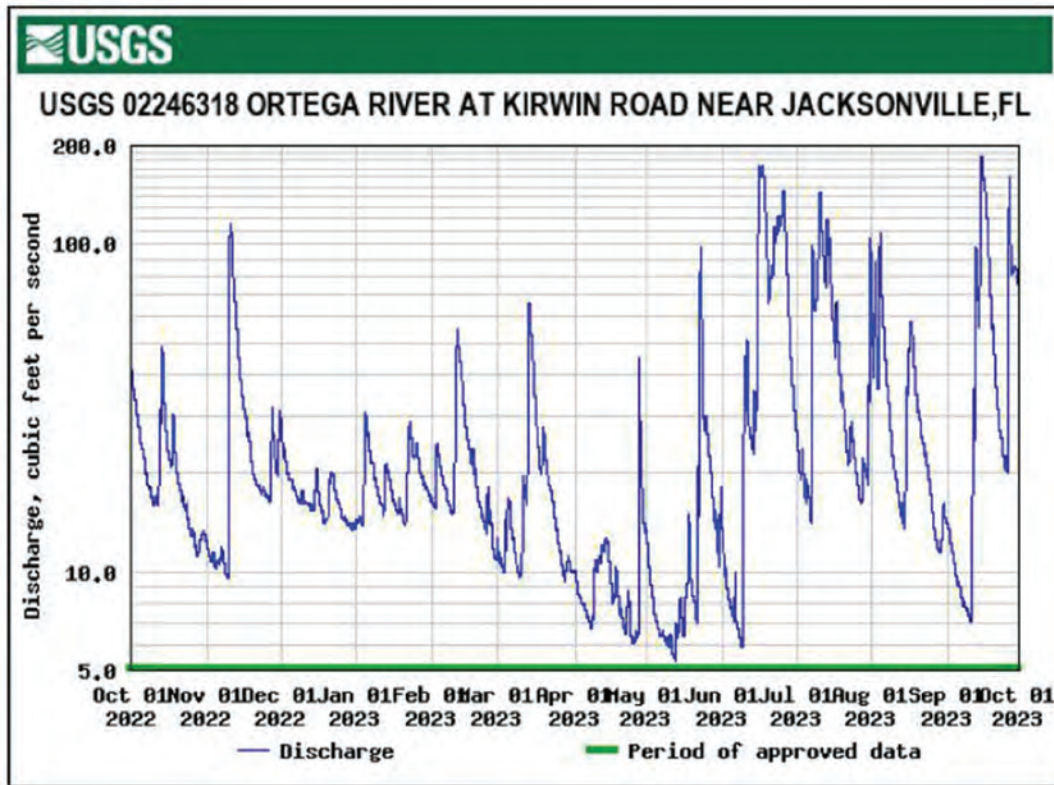
Figure 46. Instantaneous discharge for Ortega River at Kirwin Road near Jacksonville, Florida.

Ortega River at Kirwin Road near Jacksonville, Florida.—Discharge for Ortega River at Kirwin Road near Jacksonville, Fla. (USGS site number 02246318, map number 23) ranged from 5.35 to 185 ft^3/s during the 2023 water year, with an annual mean of 27.9 ft^3/s (figs. 46 and 47). The largest discharge peak at Ortega River at Kirwin Road near Jacksonville, Fla. (USGS site number 02246318, map number 23) in the 2023 water year occurred in September. The peak streamflow for the period of record ranked in the 10th percentile for the 16 years of record (fig. 47). The peak streamflow record does not include 2016, which has an incomplete record because the monitoring site was installed that year.

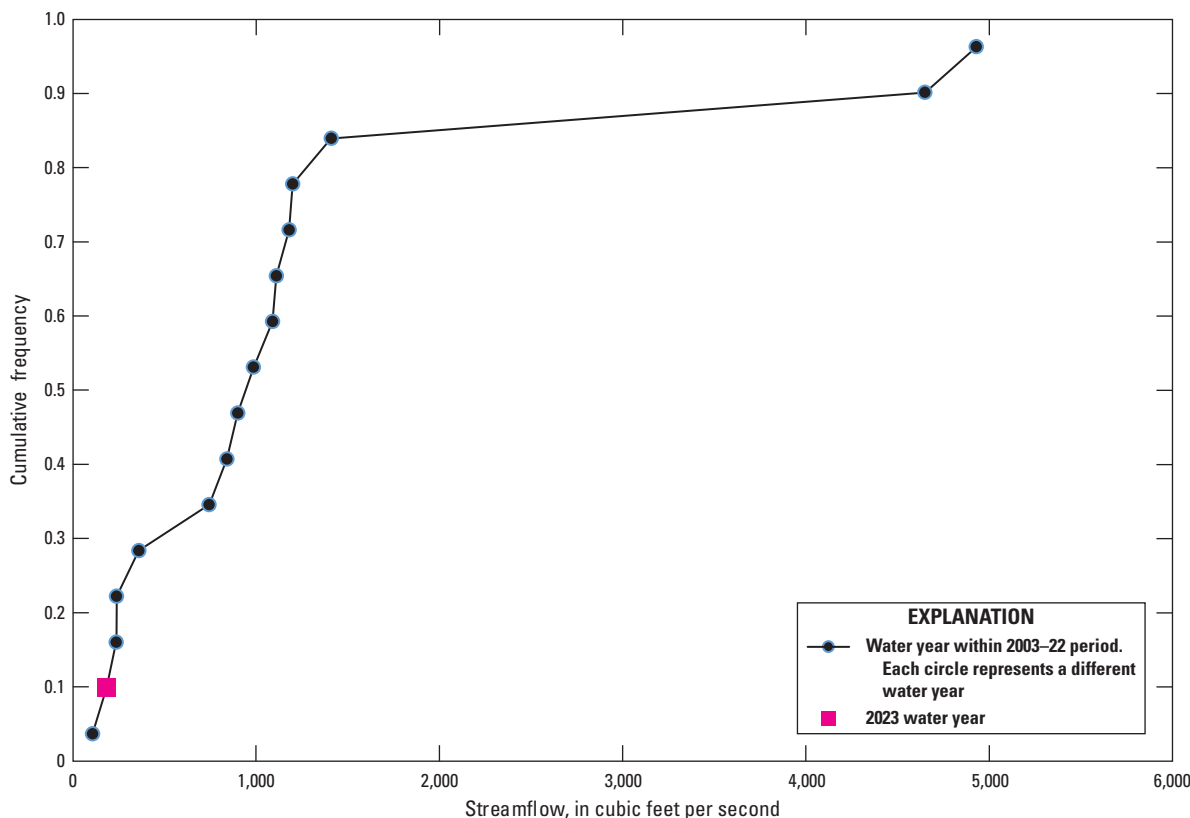
Figure 47. Peak streamflow at Ortega River at Kirwin Road near Jacksonville, Florida.

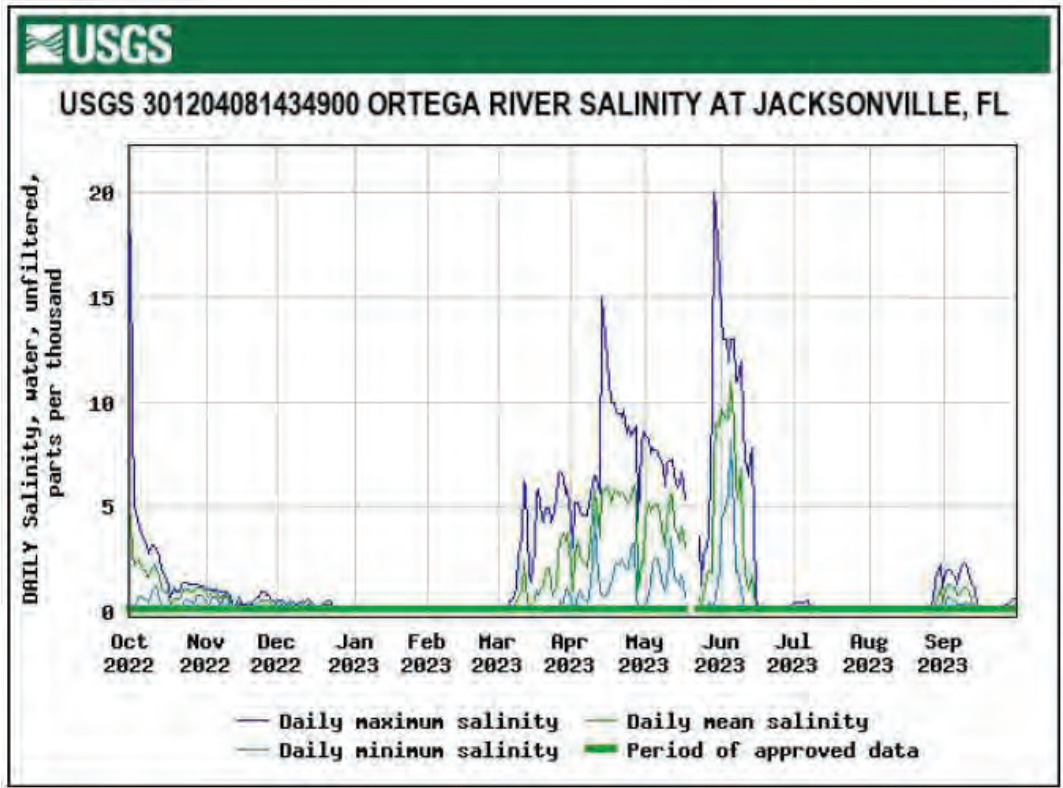
Figure 48. Daily maximum, minimum, and mean salinity for Ortega River salinity at Jacksonville, Florida.

Ortega River salinity at Jacksonville, Florida.—Salinity at the Ortega River salinity at Jacksonville, Fla. site (USGS site number 301204081434900, map number 22) ranged from 0.1 to 20 ppt during the 2023 water year, with a median of 0.2 ppt and mean of 1.3 ppt (figs. 48 and 49). Salinity was not computed for 2 days in February and 4 days in May because of equipment malfunctions. The 2023 maximum salinity and median salinity ranked highest among those calculated for the 8 years of data collection and the mean salinity tied for highest (fig. 49).

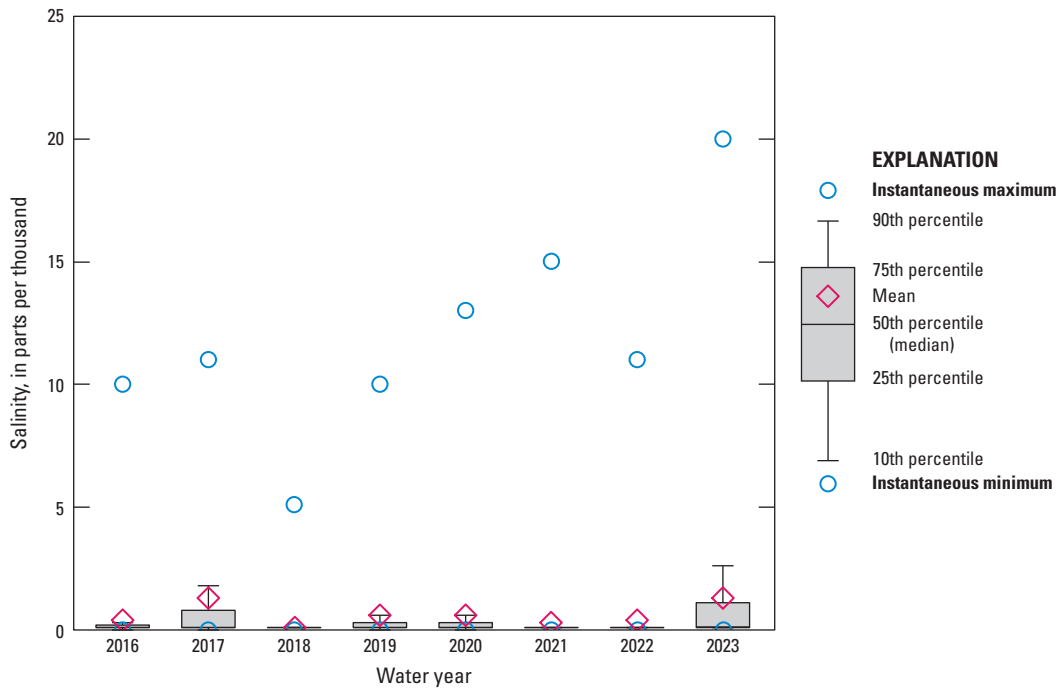
Figure 49. Salinity data for the Ortega River salinity at Jacksonville, Florida site.
