Continuous Stream Discharge, Salinity, and Associated Data Collected in the Lower St. Johns River and Its Tributaries, Florida, 2023

Open-File Report 2026–1012

By Jennifer N. Carson and Matthew T. Benacquisto

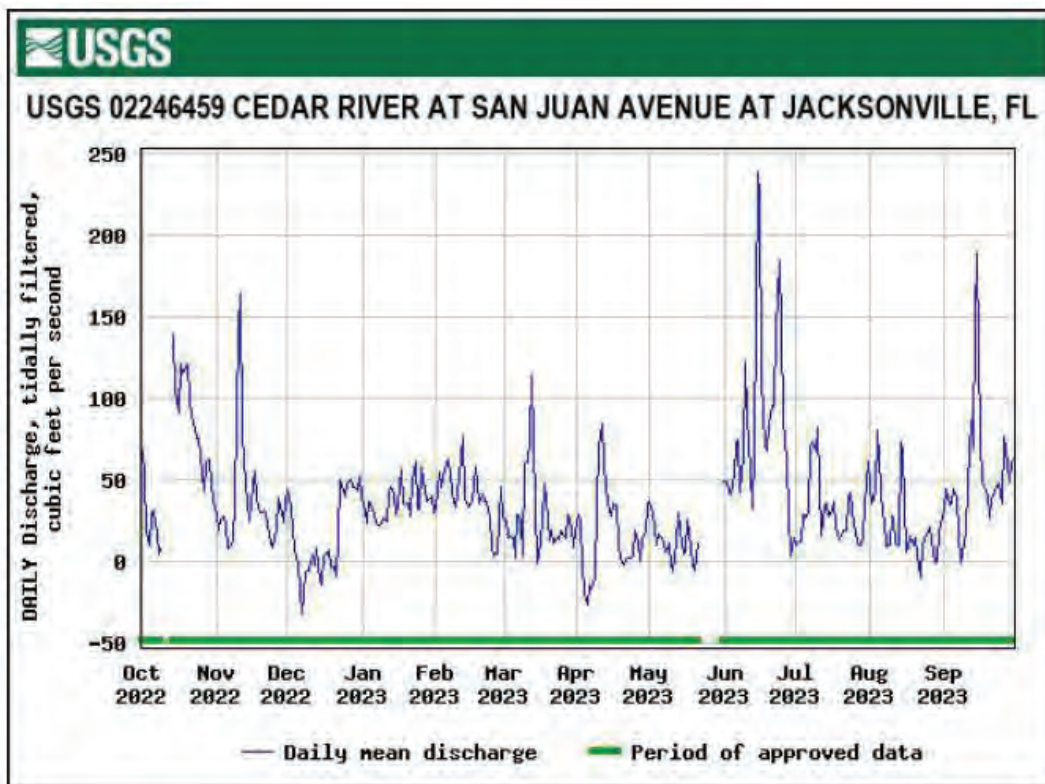
Figure 50. Daily mean tidally filtered discharge for Cedar River at San Juan Avenue at Jacksonville, Florida.

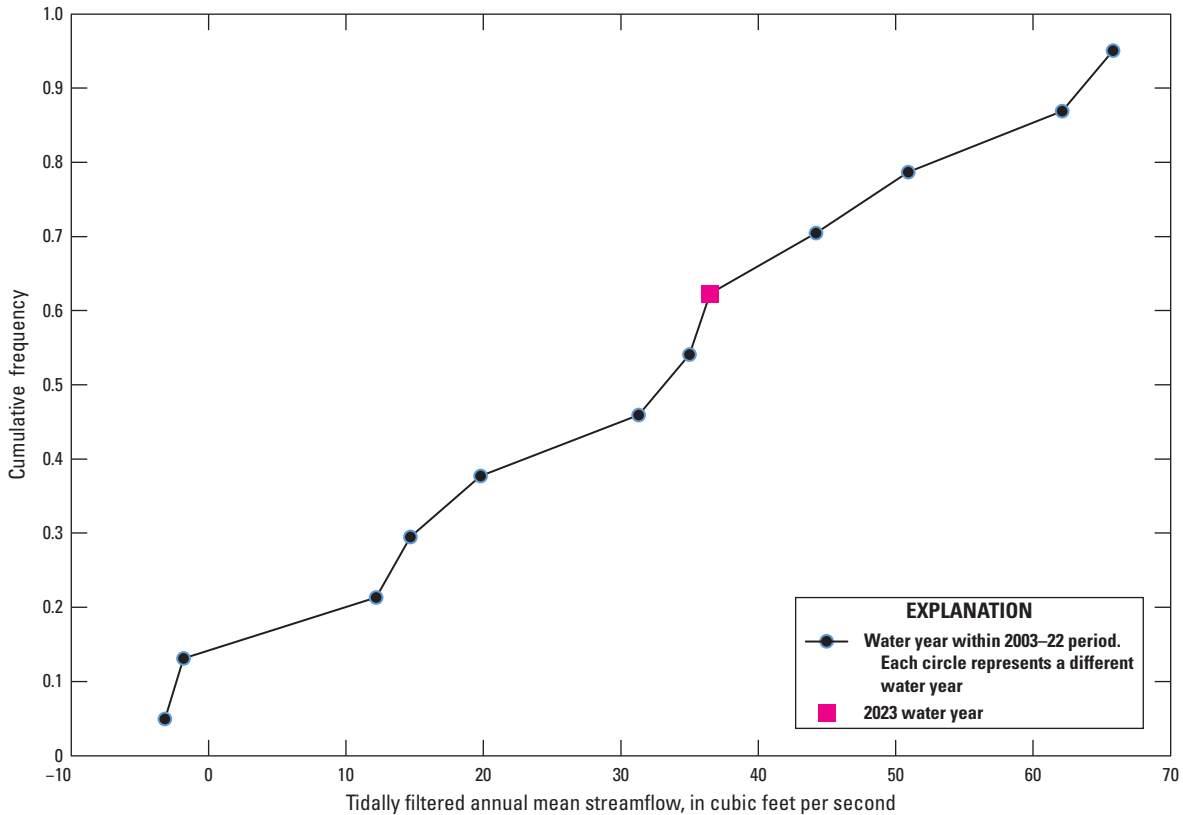
Figure 51. Annual mean tidally filtered streamflow data for Cedar River at San Juan Avenue at Jacksonville, Florida.

(fig. 51). The 2023 median salinity ranked fourth highest among those computed for the 8 years of data collection, and the mean and maximum salinity tied for highest (fig. 53).

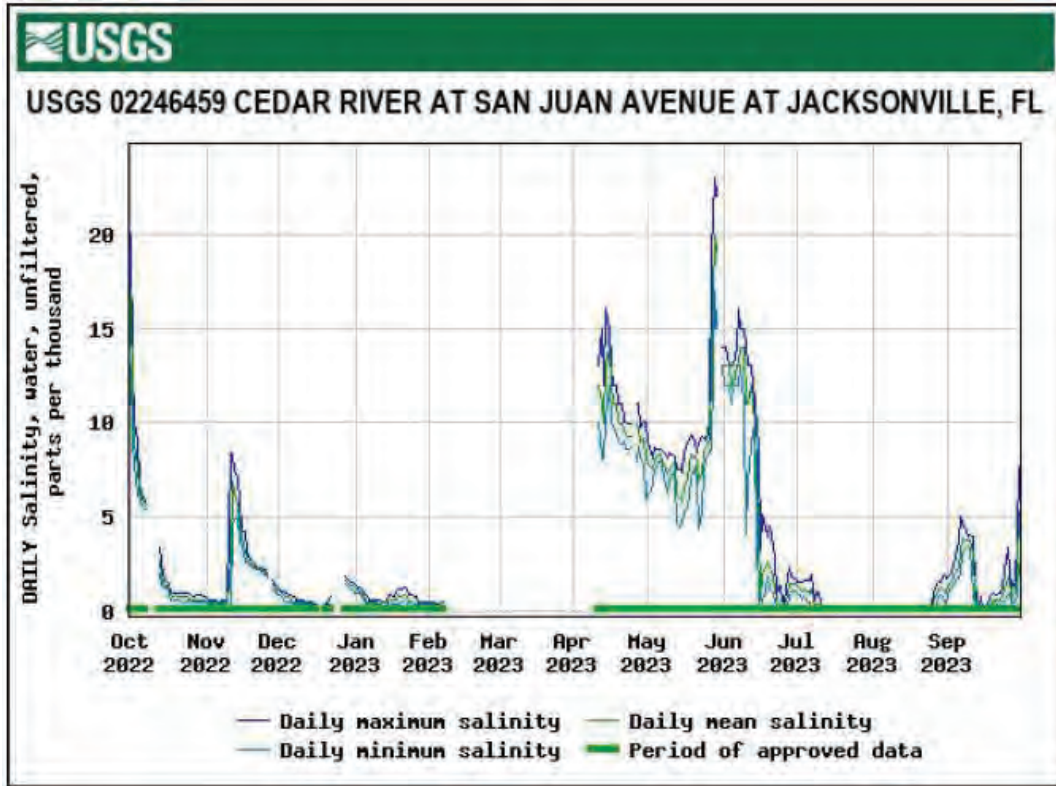
Figure 52. Daily maximum, minimum, and mean salinity for Cedar River at San Juan Avenue at Jacksonville, Florida.

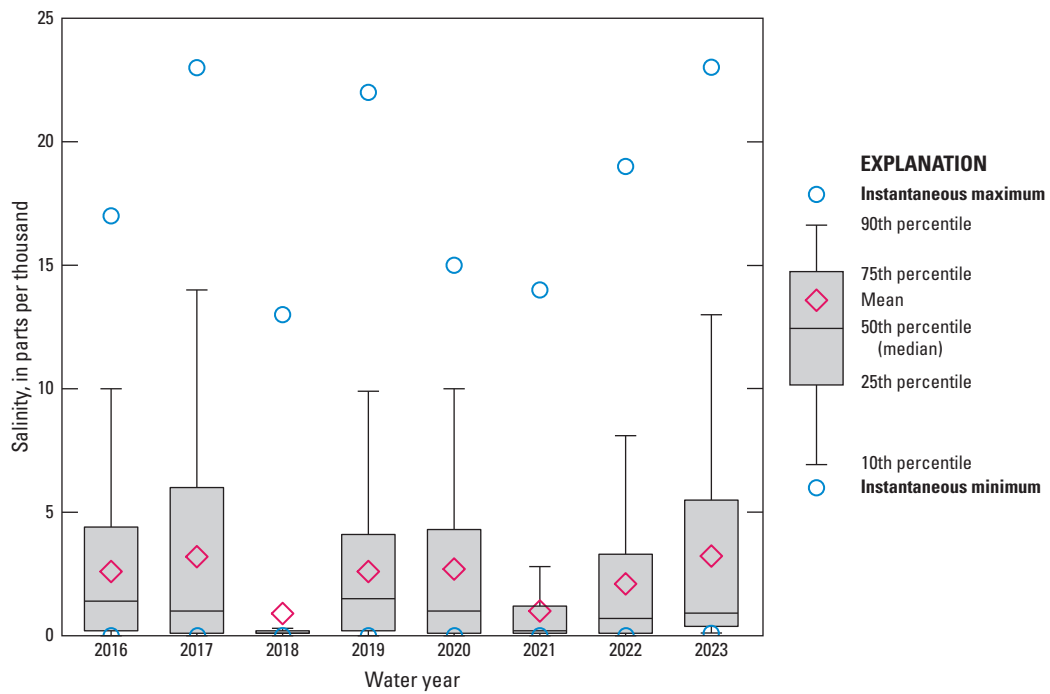
Figure 53. Salinity data for Cedar River at San Juan Avenue at Jacksonville, Florida.

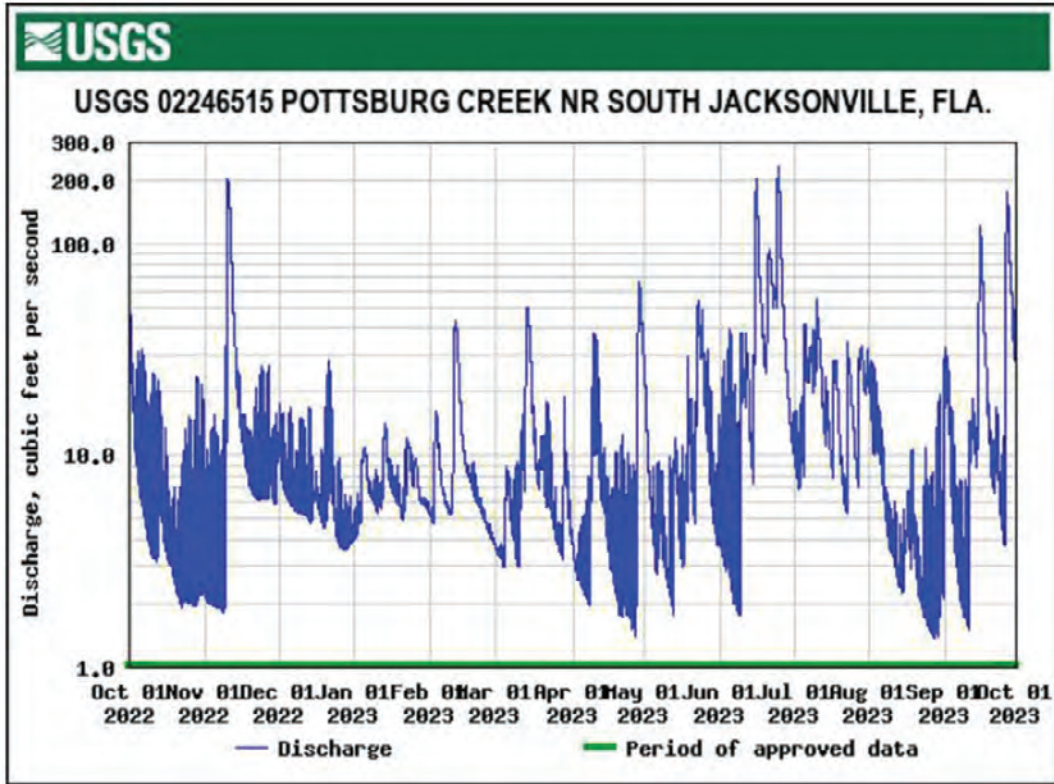
Figure 54. Instantaneous discharge for Pottsburg Creek near South Jacksonville, Florida.

Pottsborg Creek near South Jacksonville, Florida.—Discharge for Pottsborg Creek near South Jacksonville, Fla. (USGS site number 02246515, map number 20) ranged from 1.36 to 230 ft³/s during the 2023 water year, with an annual mean flow of 14.6 ft³/s (figs. 54 and 55). Similar to Cedar River at San Juan Avenue at Jacksonville, Fla. (USGS site number 02246459, map number 21), the highest discharge during the 2023 water year was in June when Duval County had above-average rainfall (fig. 3). The peak streamflow for the 2023 water year was 230 ft³/s and ranked in the 20th percentile for the 13 years of record (fig. 55).

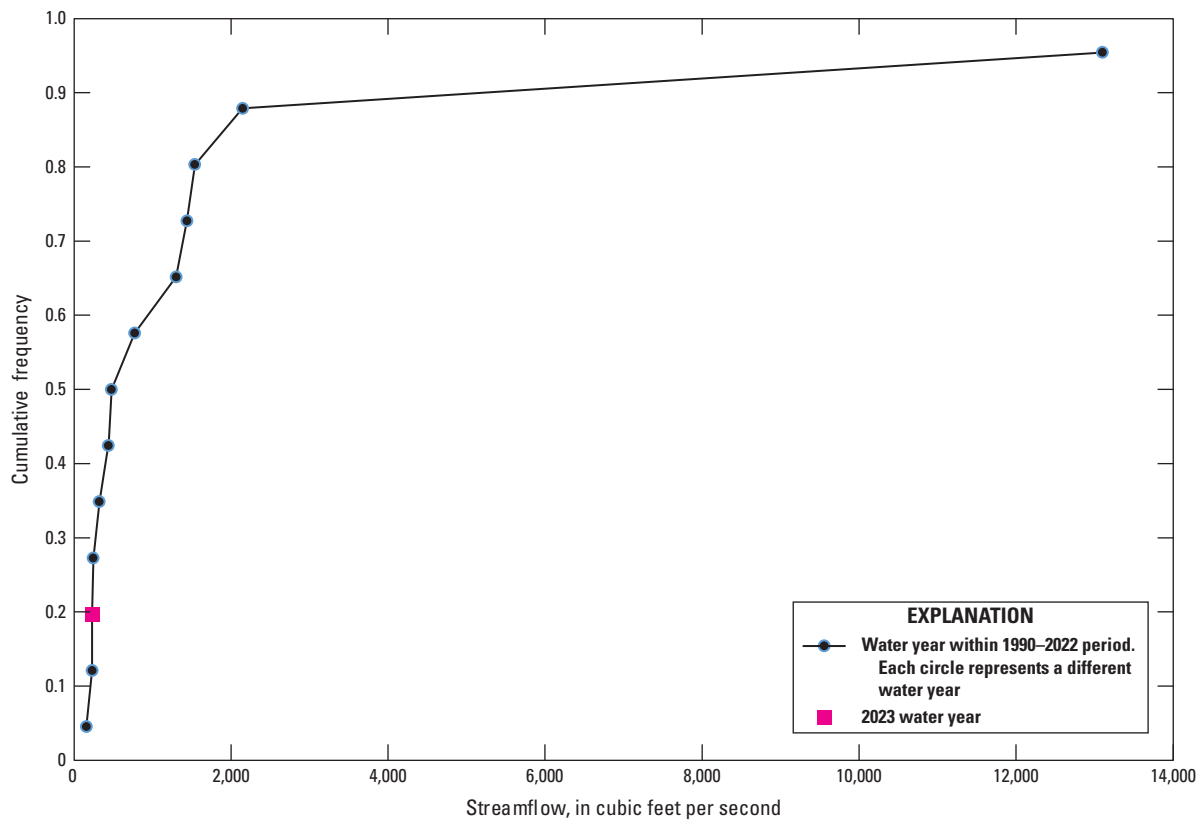
Figure 55. Peak streamflow at Pottsburg Creek near South Jacksonville, Florida.

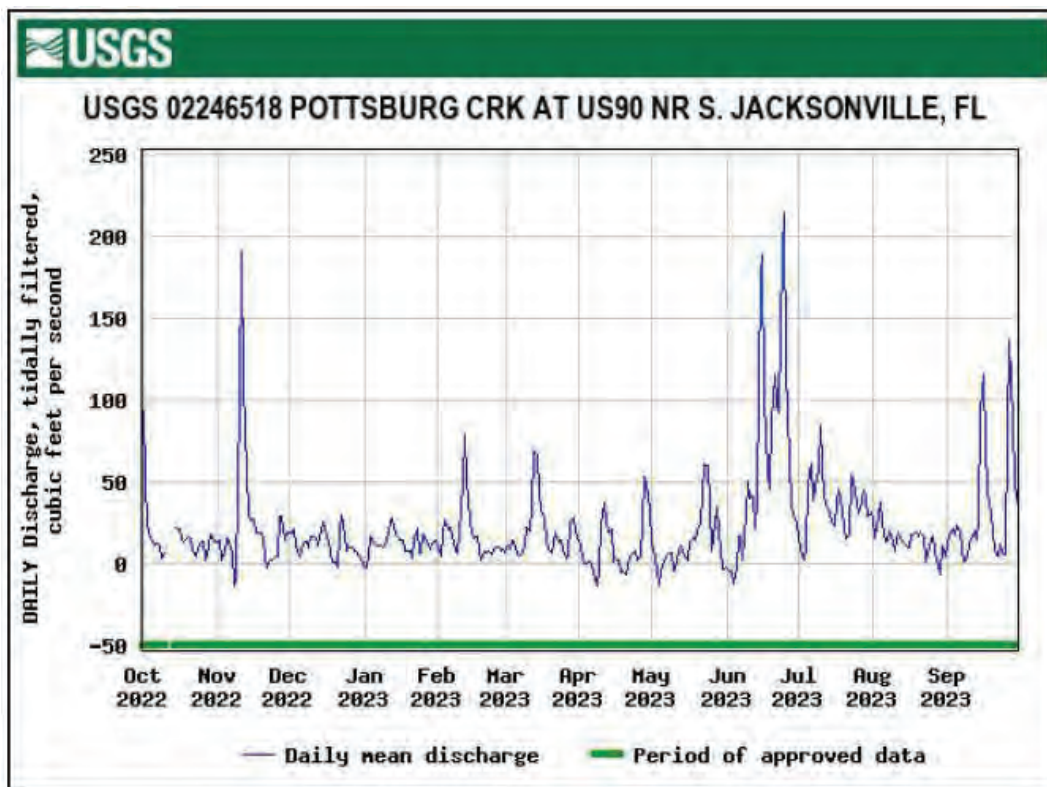
Figure 56. Daily mean tidally filtered discharge for Pottsburg Creek at U.S. 90 near South Jacksonville, Florida.

Pottsborg Creek at U.S. 90 near South Jacksonville, Florida.—Daily tidally filtered discharge at Pottsborg Creek at U.S. 90 near South Jacksonville, Fla. (USGS site number 02246518, map number 19) ranged from -13.5 to 214 ft³/s during the 2023 water year, with an annual mean flow of 22.7 ft³/s (fig. 56). The daily discharge peaked at over 200 ft³/s in June when above-average rainfall occurred in Duval County (fig. 3). Discharge was not computed for 5 days in October because of an equipment malfunction. Salinity ranged from 0.1 to 15 ppt, with a median of 0.8 ppt and mean of 2.0 ppt (figs. 57 and 58). The 2023 median and mean were the highest computed for the 8 years of recorded data (fig. 58). Salinity data were not computed for 3 days in September because of equipment malfunctions.

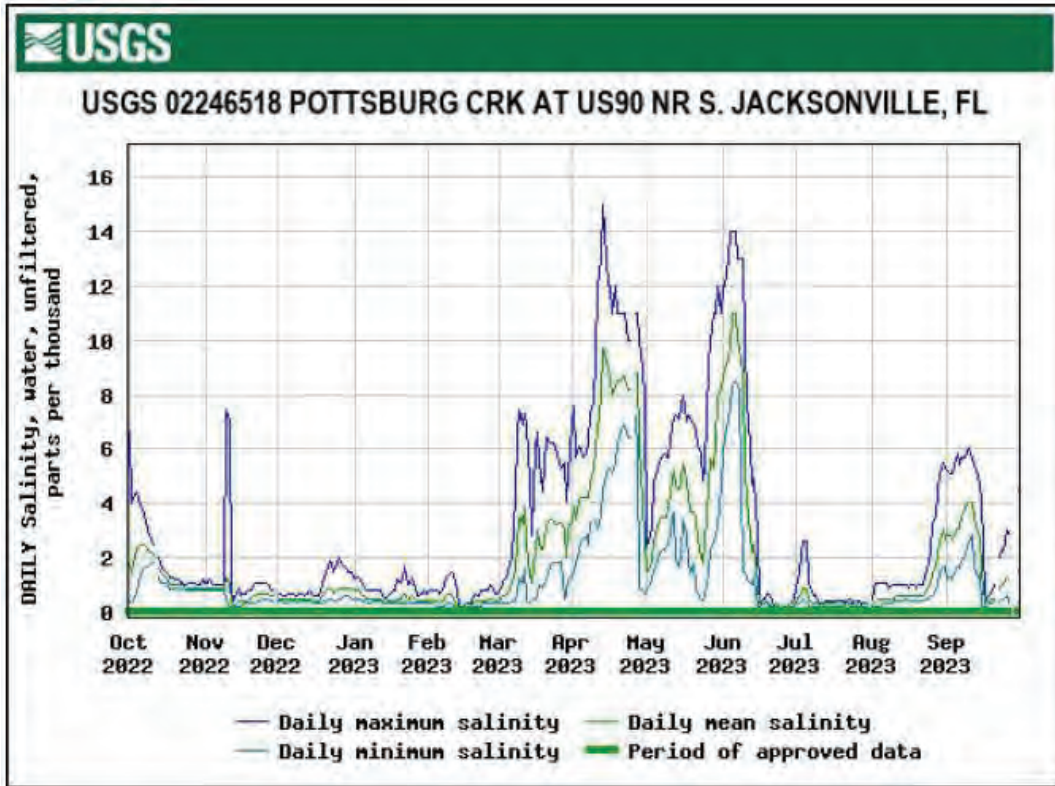
Figure 57. Daily maximum, minimum, and mean salinity for Pottsburg Creek at U.S. 90 near South Jacksonville, Florida.

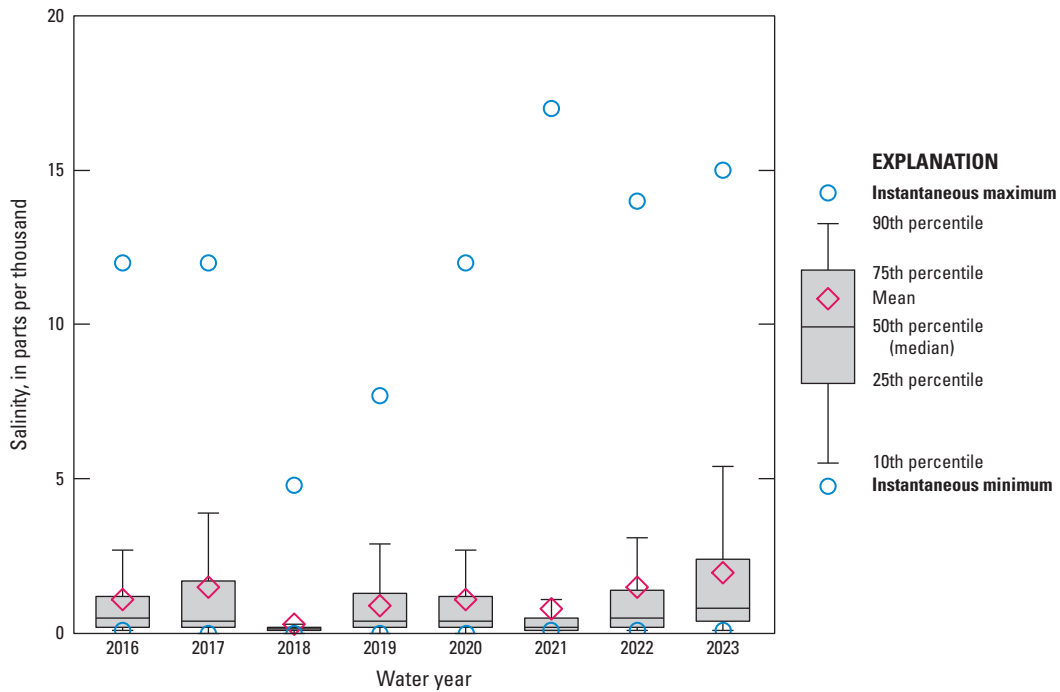
Figure 58. Salinity data for Pottsburg Creek at U.S. 90 near South Jacksonville, Florida.

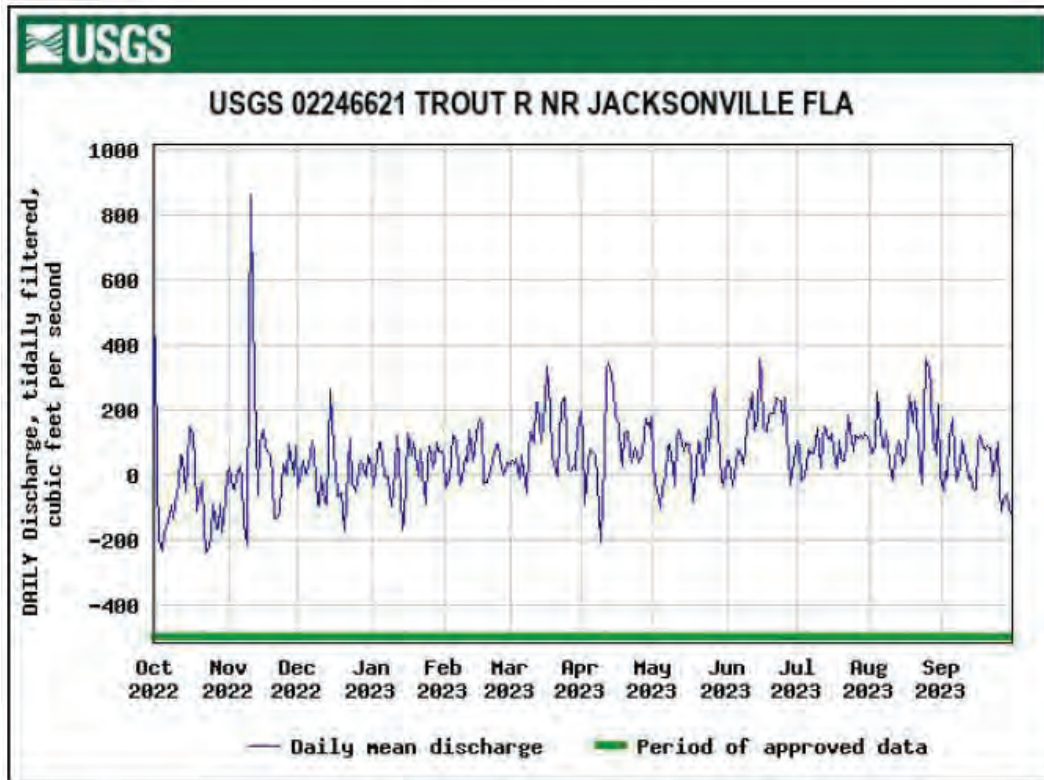
Figure 59. Daily mean tidally filtered discharge for Trout River near Jacksonville, Florida.

Trout River near Jacksonville, Florida.—Daily tidally filtered discharge at Trout River near Jacksonville, Fla. (USGS site number 02246621, map number 18) ranged from -236 to 860 ft^3/s during the 2023 water year, with an annual mean flow of 56.5 ft^3/s (fig. 59). The daily discharge peaked at over 800 ft^3/s in November when above-average rainfall occurred in Duval County (fig. 3).

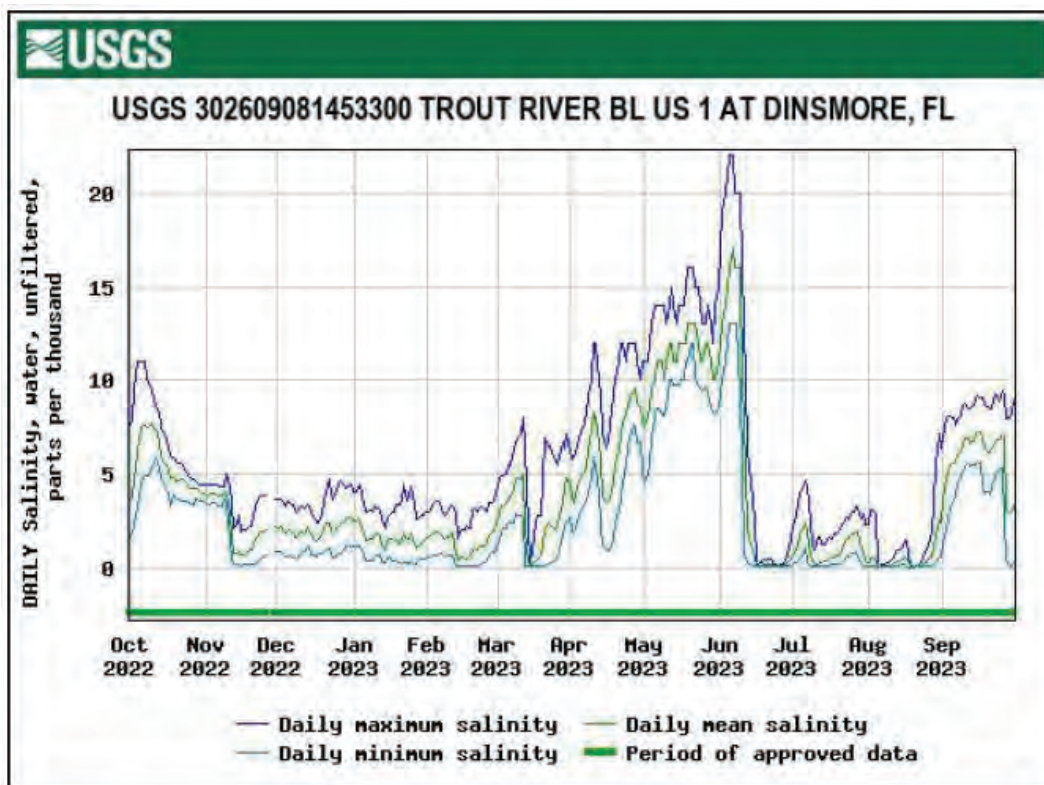
Figure 60. Daily maximum, minimum, and mean salinity for Trout River below U.S. 1 at Dinsmore, Florida.

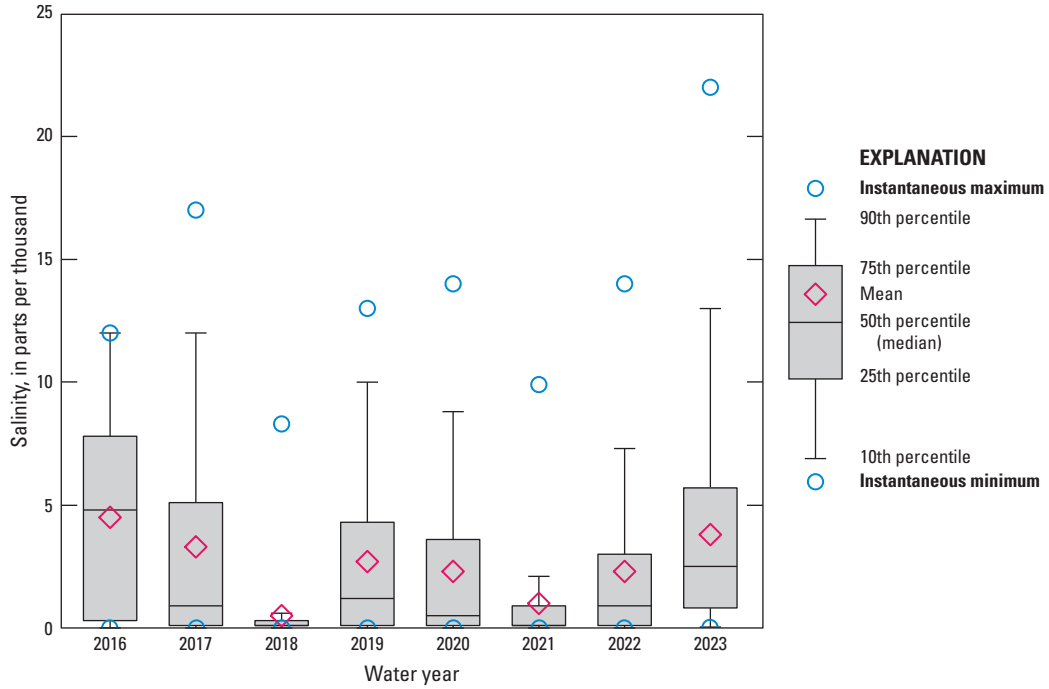
Figure 61. Salinity data for Trout River below U.S. 1 at Dinsmore, Florida.

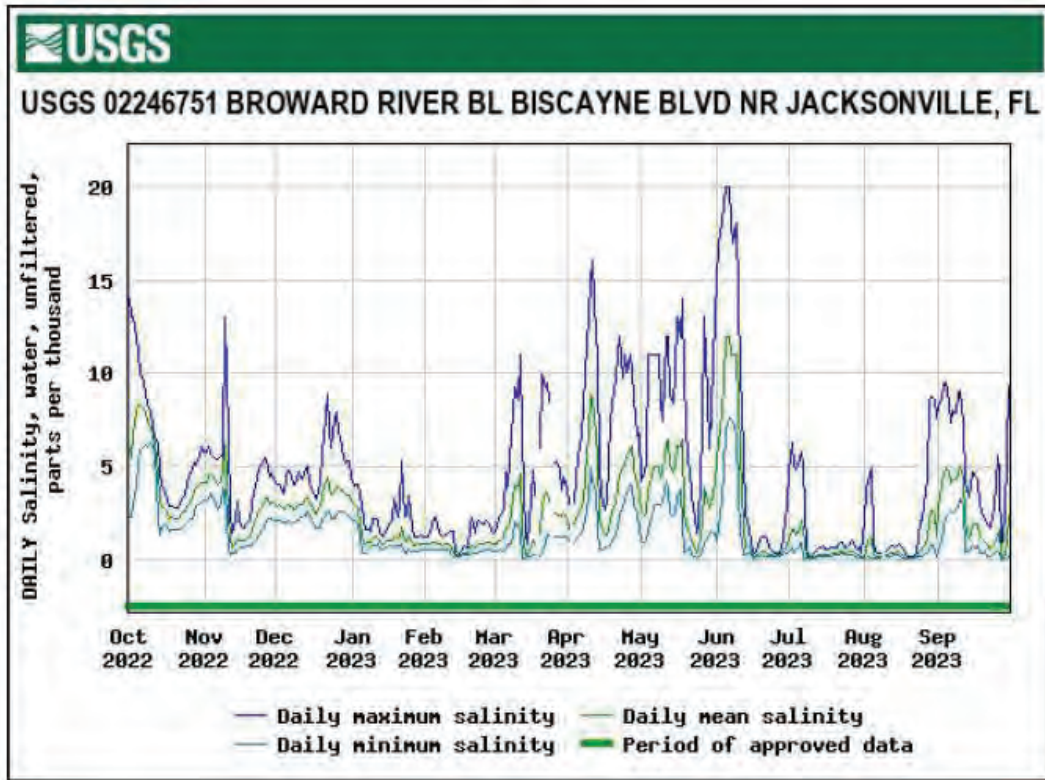
Figure 62. Daily mean tidally filtered discharge for Broward River below Biscayne Boulevard near Jacksonville, Florida.

Broward River below Biscayne Blvd. near Jacksonville, Florida.—Daily tidally filtered discharge at Broward River below Biscayne Boulevard near Jacksonville, Fla. (USGS site number 02246751, map number 16) ranged from -37.3 to 143 ft^3/s during the 2023 water year (fig. 62), with an annual mean flow of 4.31 ft^3/s . Daily tidally filtered discharge was not calculated for 9 days in May, 24 days in June, and 6 days in September because of equipment malfunctions. Discharge was relatively consistent during the period, with a peak in July. Salinity ranged from 0.0 to 20 ppt, with a median of 1.7 ppt

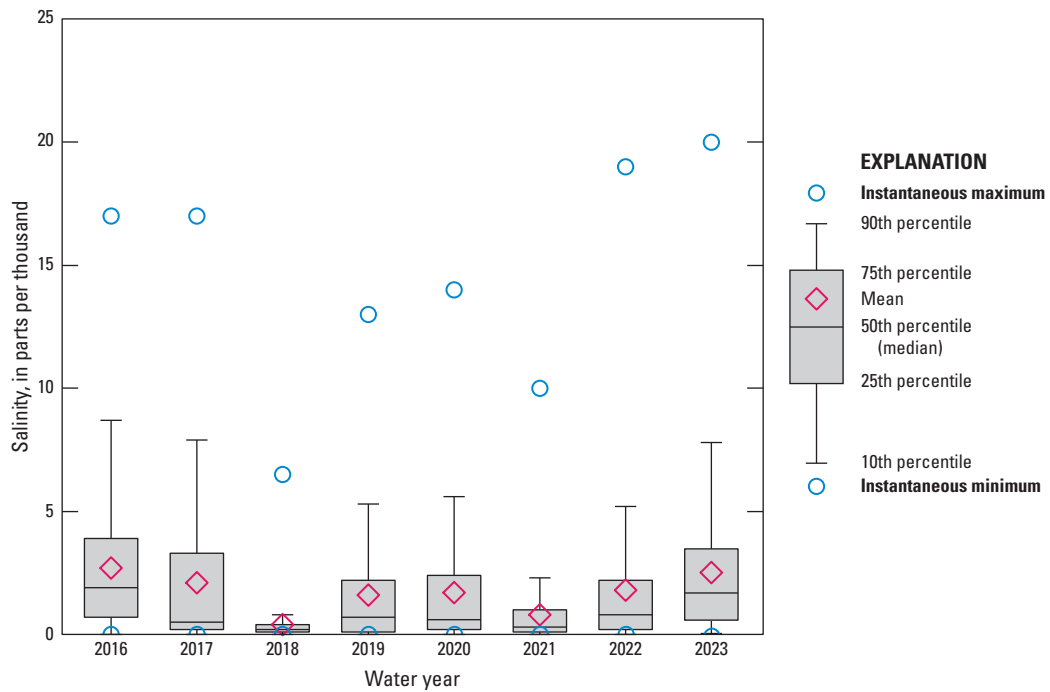
Figure 63. Daily maximum, minimum, and mean salinity for Broward River below Biscayne Boulevard near Jacksonville, Florida.

and mean of 2.5 ppt (figs. 63 and 64). Peak salinity occurred in June and was the highest salinity recorded for the 8 years of data collection. The 2023 median and mean salinities ranked second highest among those calculated for the 8 years of data collection (fig. 64). Salinity data were not computed for 2 days in March and 1 day in April because of equipment malfunctions.

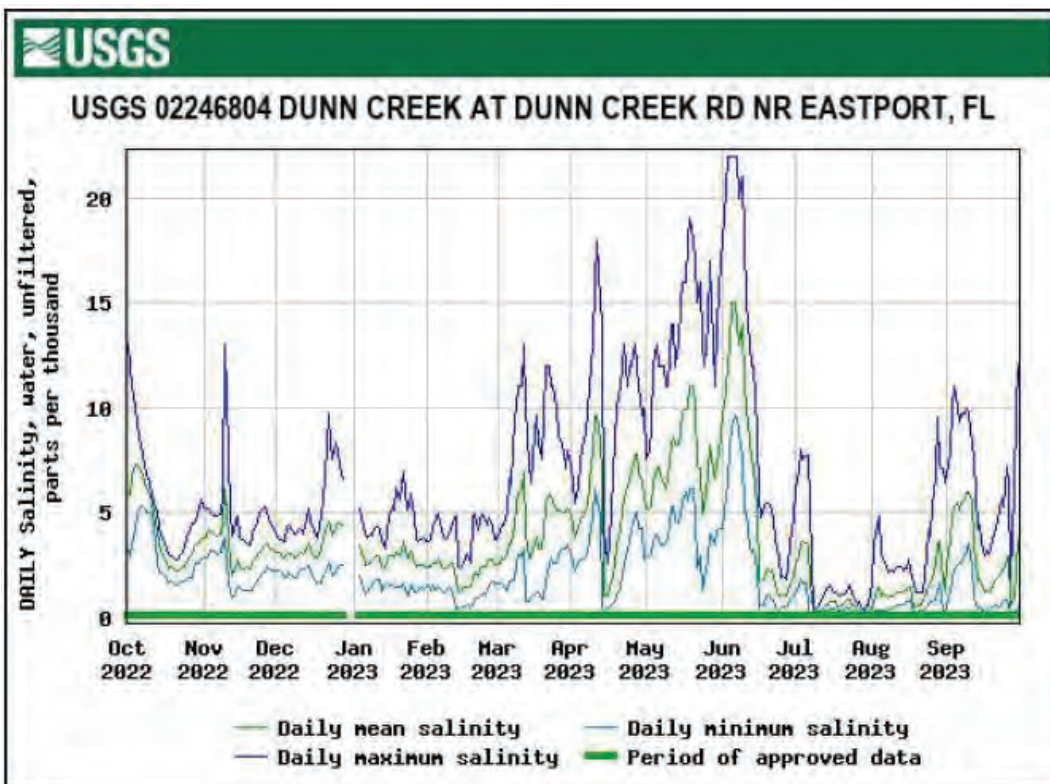
Figure 65. Daily mean tidally filtered discharge for Dunn Creek at Dunn Creek Road near Eastport, Florida.

Dunn Creek at Dunn Creek Road near Eastport, Florida.—Daily tidally filtered discharge at Dunn Creek at Dunn Creek Road near Eastport, Fla. (USGS site number 02246804, map number 15) ranged from -37.7 to 107 ft^3/s during the 2023 water year (fig. 65), with an annual mean of 12.8 ft^3/s . Daily tidally filtered discharge was not calculated for 5 days in December, 4 days in January, and 7 days in April because of equipment malfunctions. Salinity during the 2023 water year ranged from 0.1 to 22 ppt, with a median of 3.0 ppt and mean of 3.7 ppt (figs. 66 and 67). The 2023 maximum, median, and mean salinities ranked highest among those calculated for the 8 years of data collection (fig. 67).

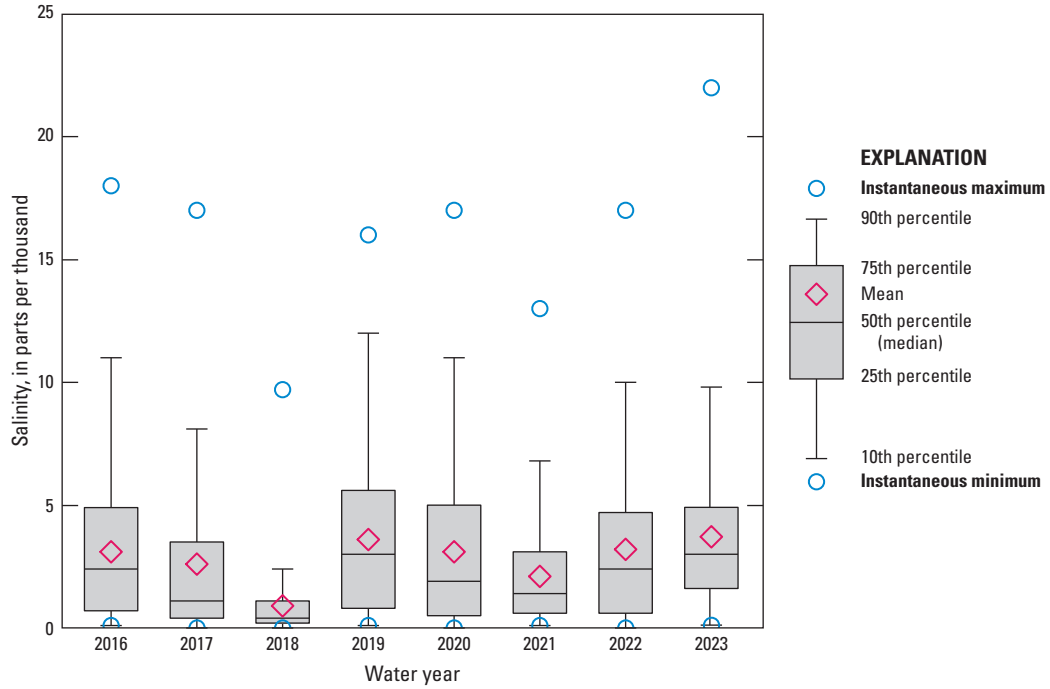
Figure 66. Daily maximum, minimum, and mean salinity for Dunn Creek at Dunn Creek Road near Eastport, Florida.

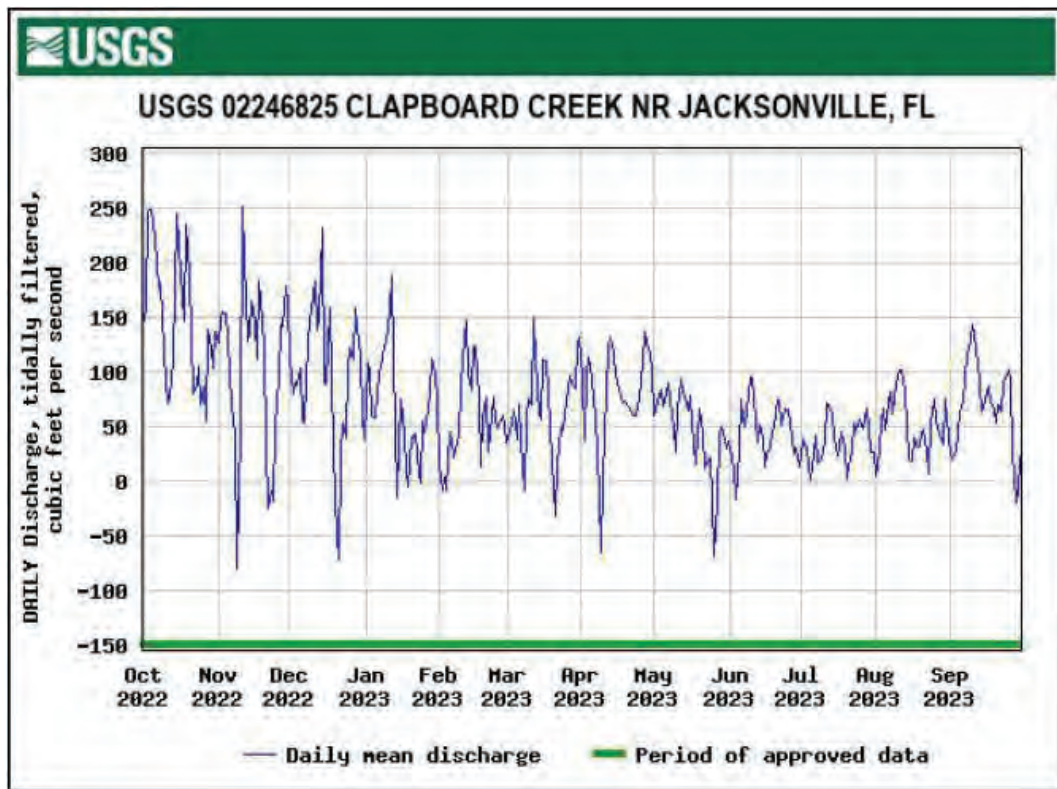
Figure 68. Daily mean tidally filtered discharge for Clapboard Creek near Jacksonville, Florida.

Clapboard Creek near Jacksonville, Florida.—Daily tidally filtered discharge at Clapboard Creek near Jacksonville, Fla. (USGS site number 02246825, map number 13) ranged from -80.6 to 252 ft^3/s during the 2023 water year (fig. 68), with an annual mean flow of 72.7 ft^3/s . The peak daily tidally filtered discharge of 252 ft^3/s occurred in November just after Hurricane Nicole.

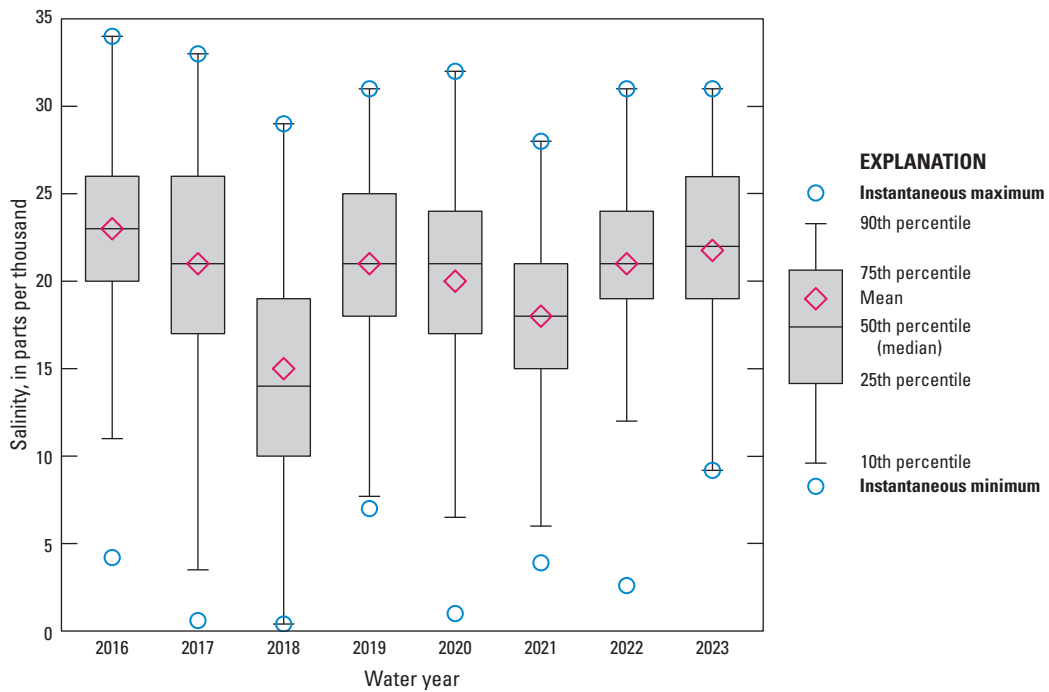
Figure 70. Salinity data for Clapboard Creek above Buckhorn Bluff near Jacksonville, Florida.

Clapboard Creek above Buckhorn Bluff near Jacksonville, Florida.—Salinity at Clapboard Creek above Buckhorn Bluff near Jacksonville, Fla. (USGS site number 302657081312400, map number 14) ranged from 9.2 to 31 ppt during the 2023 water year, with a median and mean of 22 ppt (figs. 69 and 70). Salinity was missing for 12 days in October, 15 days in November, 6 days in June, and 2 days in July because of equipment malfunctions. The 2023 median and mean salinities both ranked second highest among those calculated for the 8 years of data collection (fig. 70).

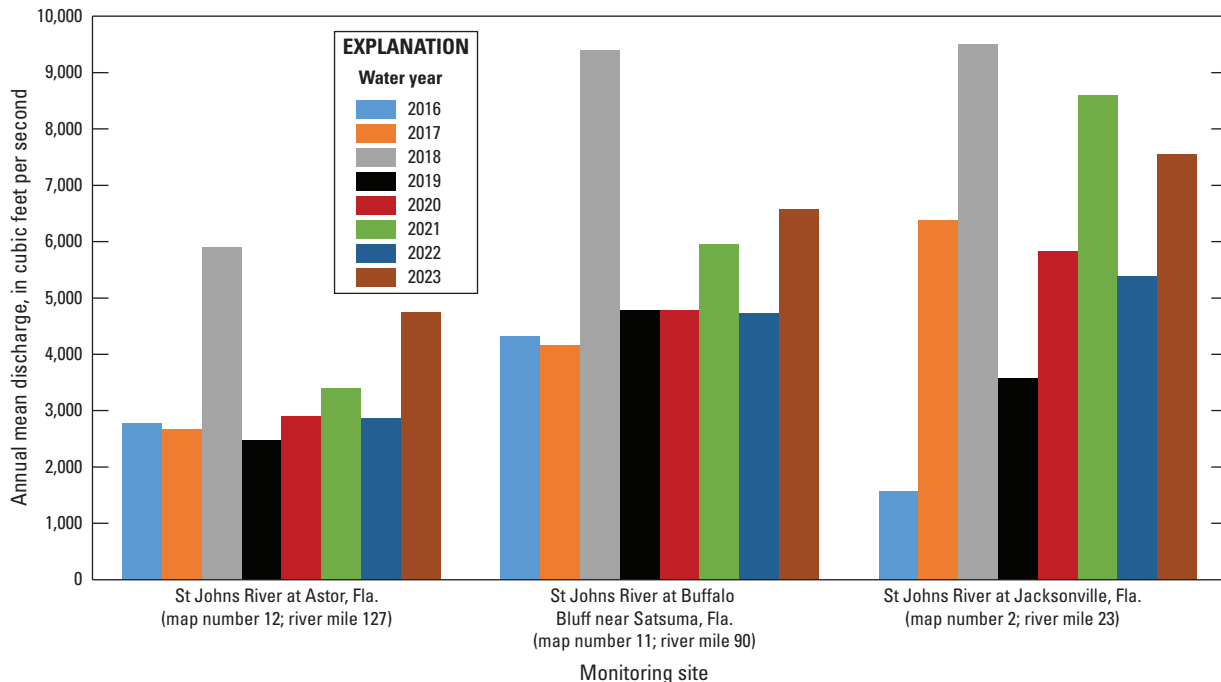
Figure 71. Annual mean tidally filtered discharge at St. Johns River main-stem monitoring sites.

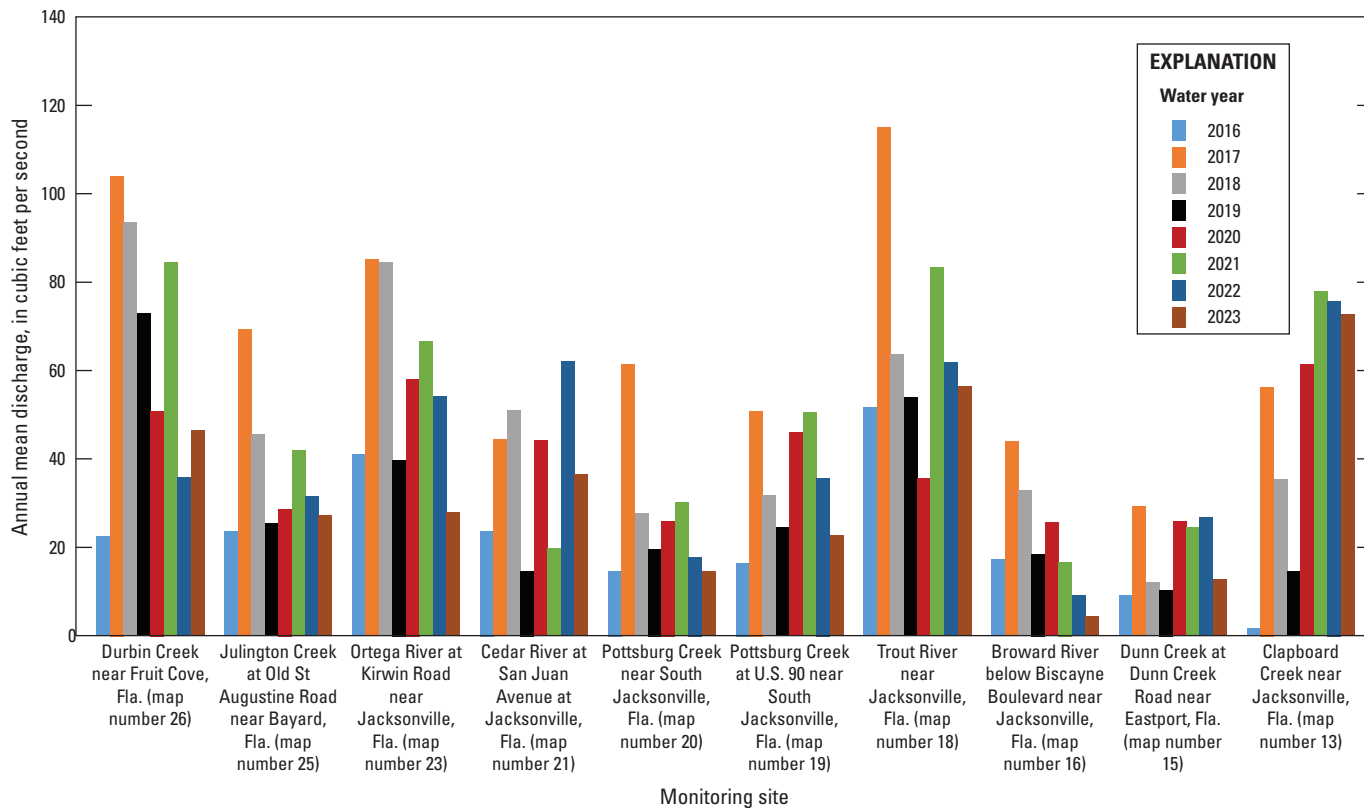
Figure 72. Annual mean discharge at St. Johns River tributary monitoring sites.

that site. Among the tributaries compared to one another, annual mean discharge in 2023 was highest at Clapboard Creek near Jacksonville, Fla. (USGS site number 02246825, map number 13); followed by Trout River near Jacksonville, Fla. (USGS site number 02246621, map number 18); Durbin Creek near Fruit Cove, Fla. (USGS site number 022462002, map number 26); Cedar River at San Juan Avenue at Jacksonville, Fla. (USGS site number 02246459, map number 21); Ortega River at Kirwin Road near Jacksonville, Fla. (USGS site number 02246318, map number 23); Julington Creek at Old St. Augustine Road near Bayard, Fla. (USGS site number 02246160, map number 25); Pottsborg Creek at U.S. 90 near South Jacksonville, Fla. (USGS site number 02246518, map number 19); Pottsborg Creek near South Jacksonville, Fla. (USGS site number 02246515, map number 20); Dunn Creek at Dunn Creek Road near Eastport, Fla. (USGS site number 02246804, map number 15); and Broward River below Biscayne Boulevard near Jacksonville, Fla. (USGS site number 02246751, map number 16), whose annual mean was lowest (fig. 72). Annual mean discharge at 9 of the 10 tributary monitoring sites was lower for the 2023 water year than for the 2022 water year, with Durbin Creek near Fruit Cove, Fla. (USGS site number 022462002, map number 26) being the only site with a higher annual mean discharge in 2023 than 2022. Furthermore, the computed annual mean flow at Broward River below

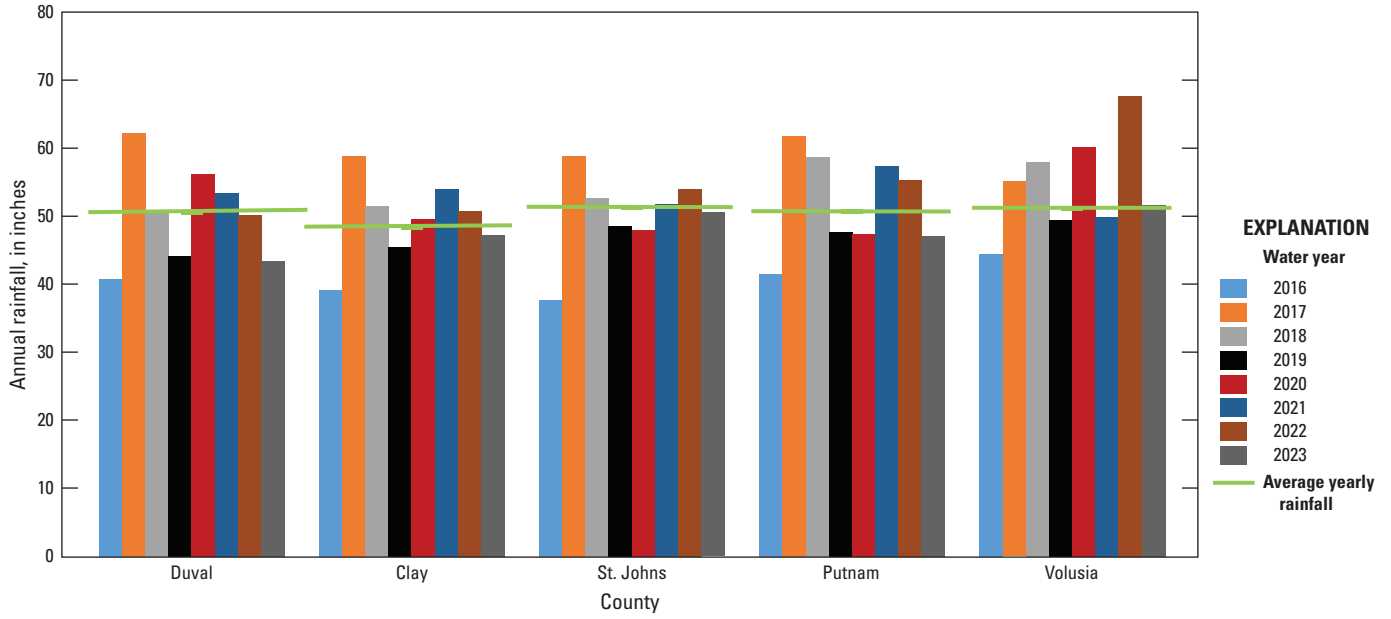
Figure 73. Annual rainfall for Duval, Clay, St. Johns, Putnam, and Volusia Counties.

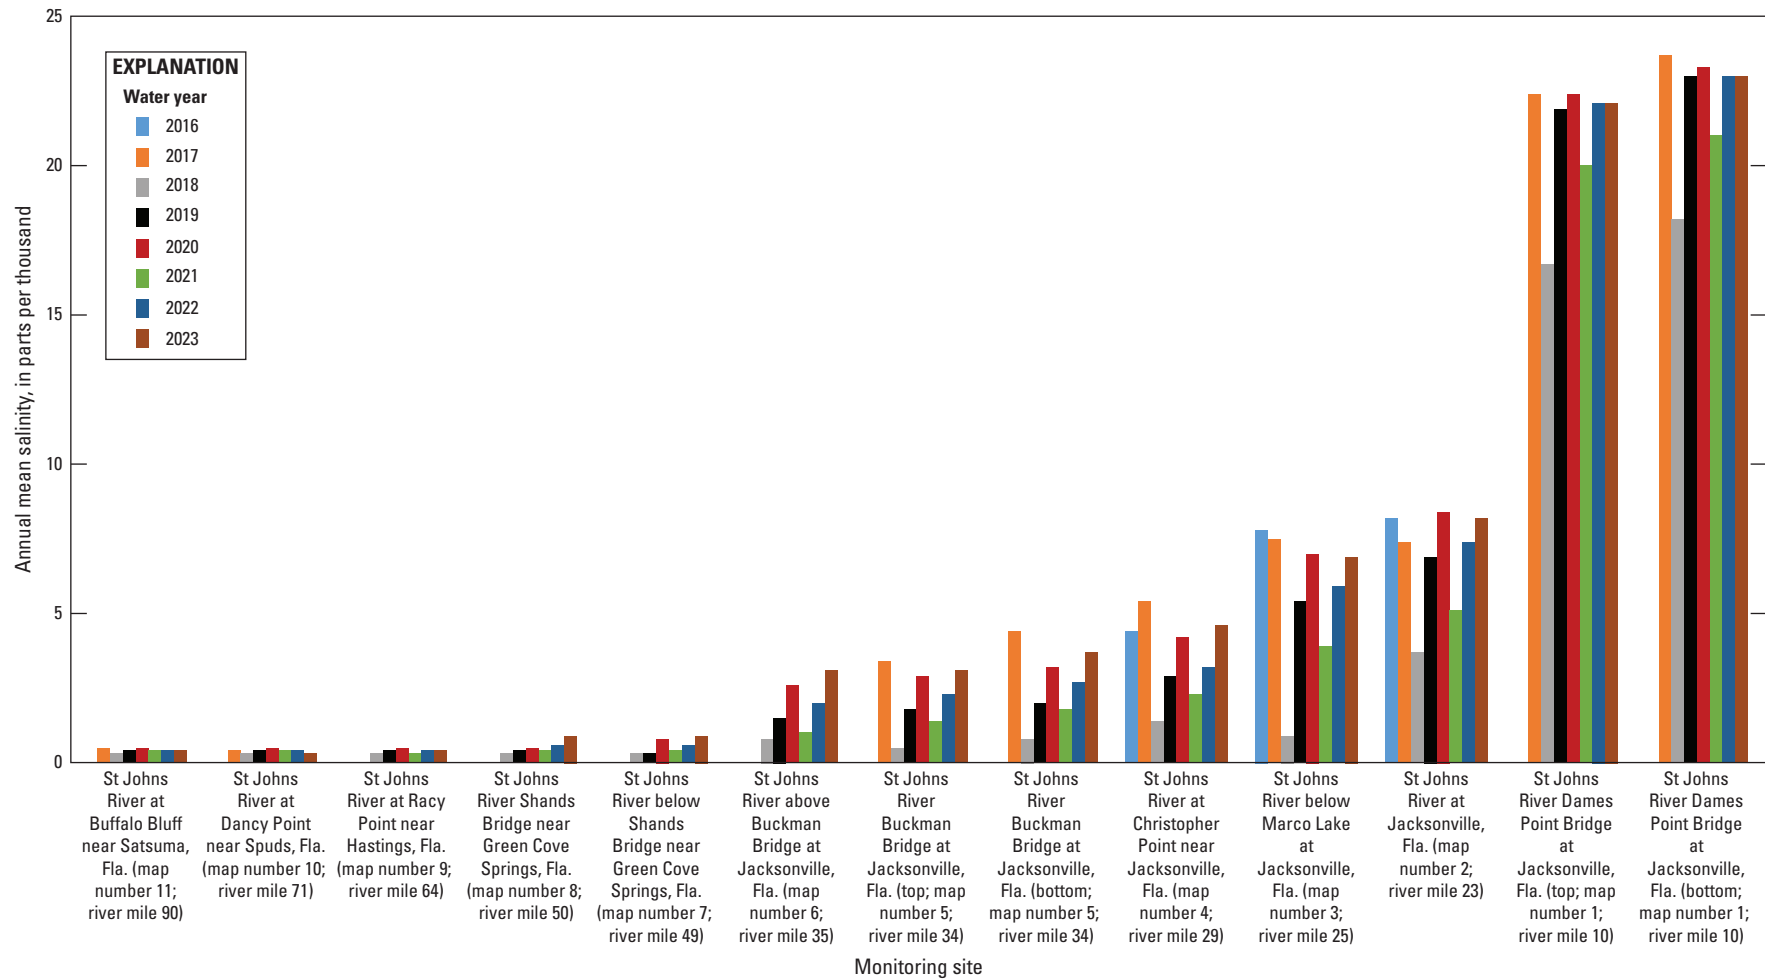
Figure 74. Annual mean salinity at St. Johns River main-stem monitoring sites.

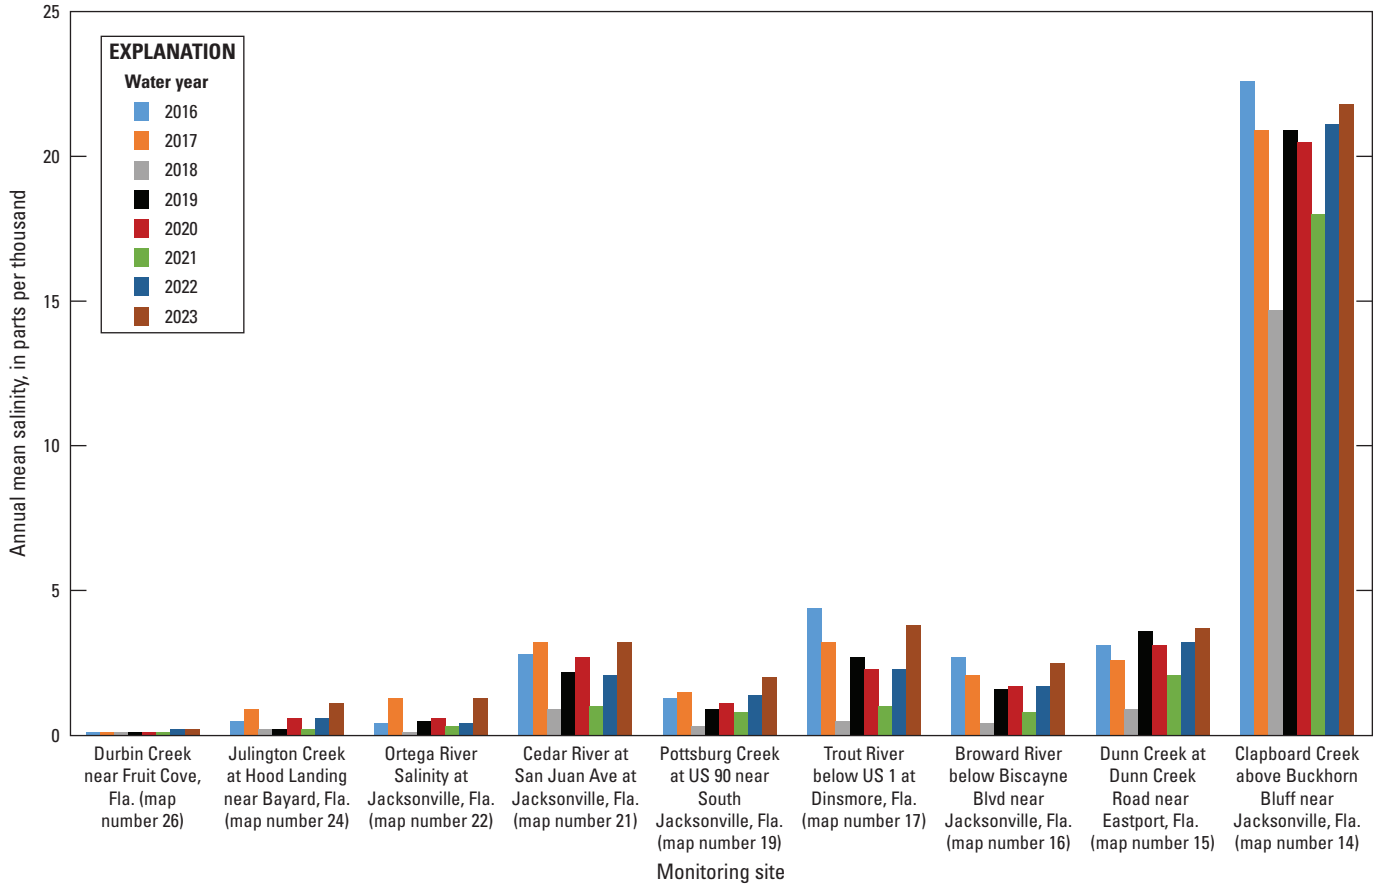
Figure 75. Annual mean salinity at St. Johns River tributary monitoring sites.

Clapboard Creek above Buckhorn Bluff near Jacksonville, Fla. (USGS site number 302657081312400, map number 14) had the highest annual mean salinity (22 ppt) of all tributaries in 2023 because of its proximity to the Atlantic Ocean. Durbin Creek near Fruit Cove, Fla. (USGS site number 022462002, map number 26) salinity (0.2 ppt) was the lowest of all monitoring locations (fig. 75). A visual comparison of annual mean salinity at tributary sites between the 2023 and 2022 water years indicates salinity was higher in 2023 at all locations, except for Durbin Creek near Fruit Cove, Fla. (USGS site number 022462002, map number 26), which was the same (fig. 75). The 2023 annual mean salinity at 6 of the 9 tributary sites was either the highest or tied for the highest for the 8 years of data collection (fig. 75), while the annual mean salinity at the remaining 3 tributary sites ranked second highest (fig. 75).
