FILLED CRACKS EXPOSED IN THE SAN LUIS CANAL

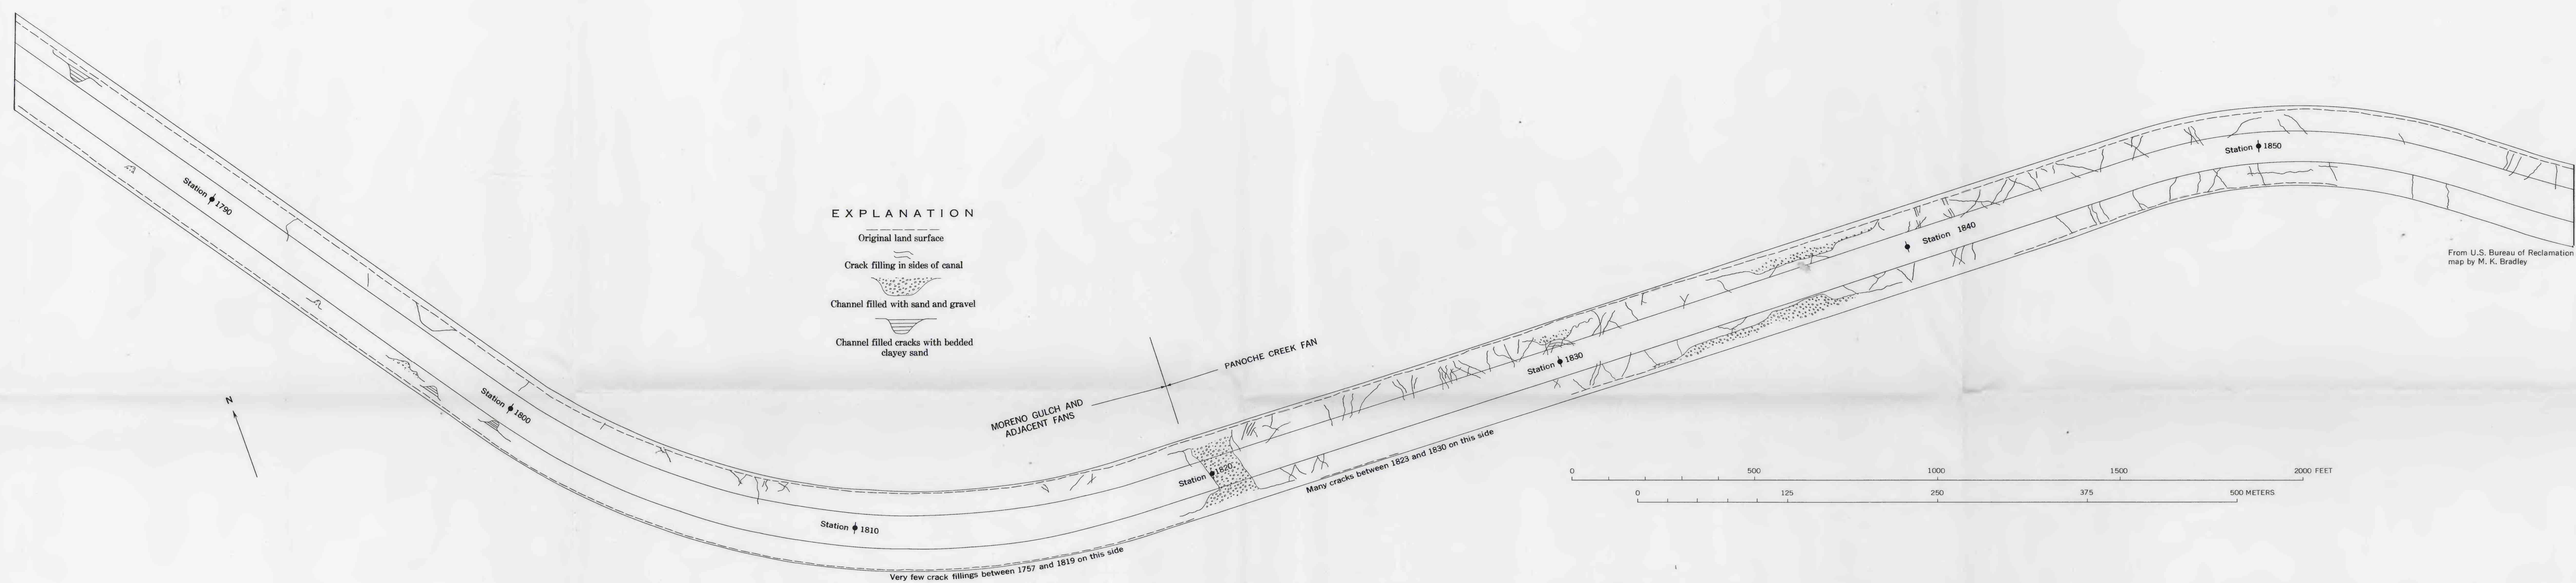
A. COMPARISON OF DENSITY OF SPACING OF CRACK FILLINGS IN THE PANOCHÉ CREEK AND MORENO GULCH FANS

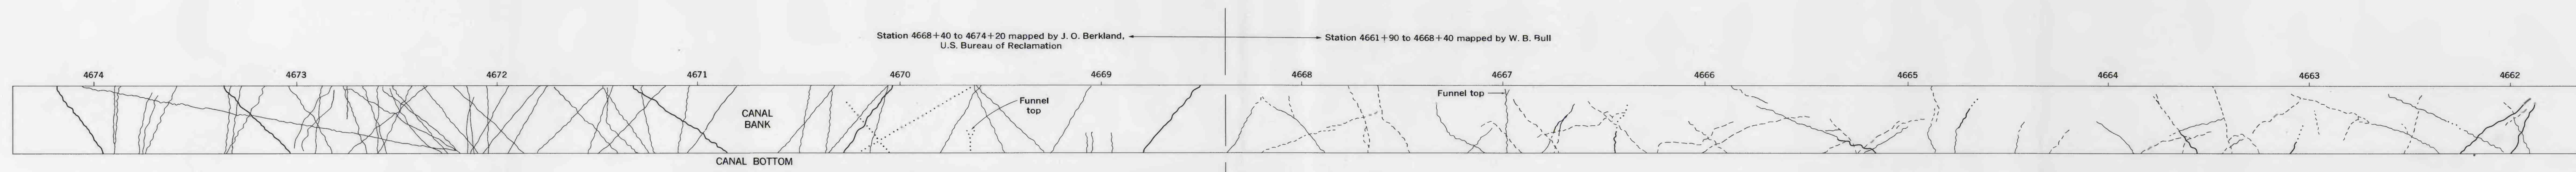
B. LOS GATOS CREEK FAN. RIGHT BANK OF CANAL FROM STATION 4661+90 TO 4674+20; FROM 8 1/2 FEET ABOVE THE BASE OF THE TRIMMED SLOPE TO THE BASE OF THE TILLED ZONE

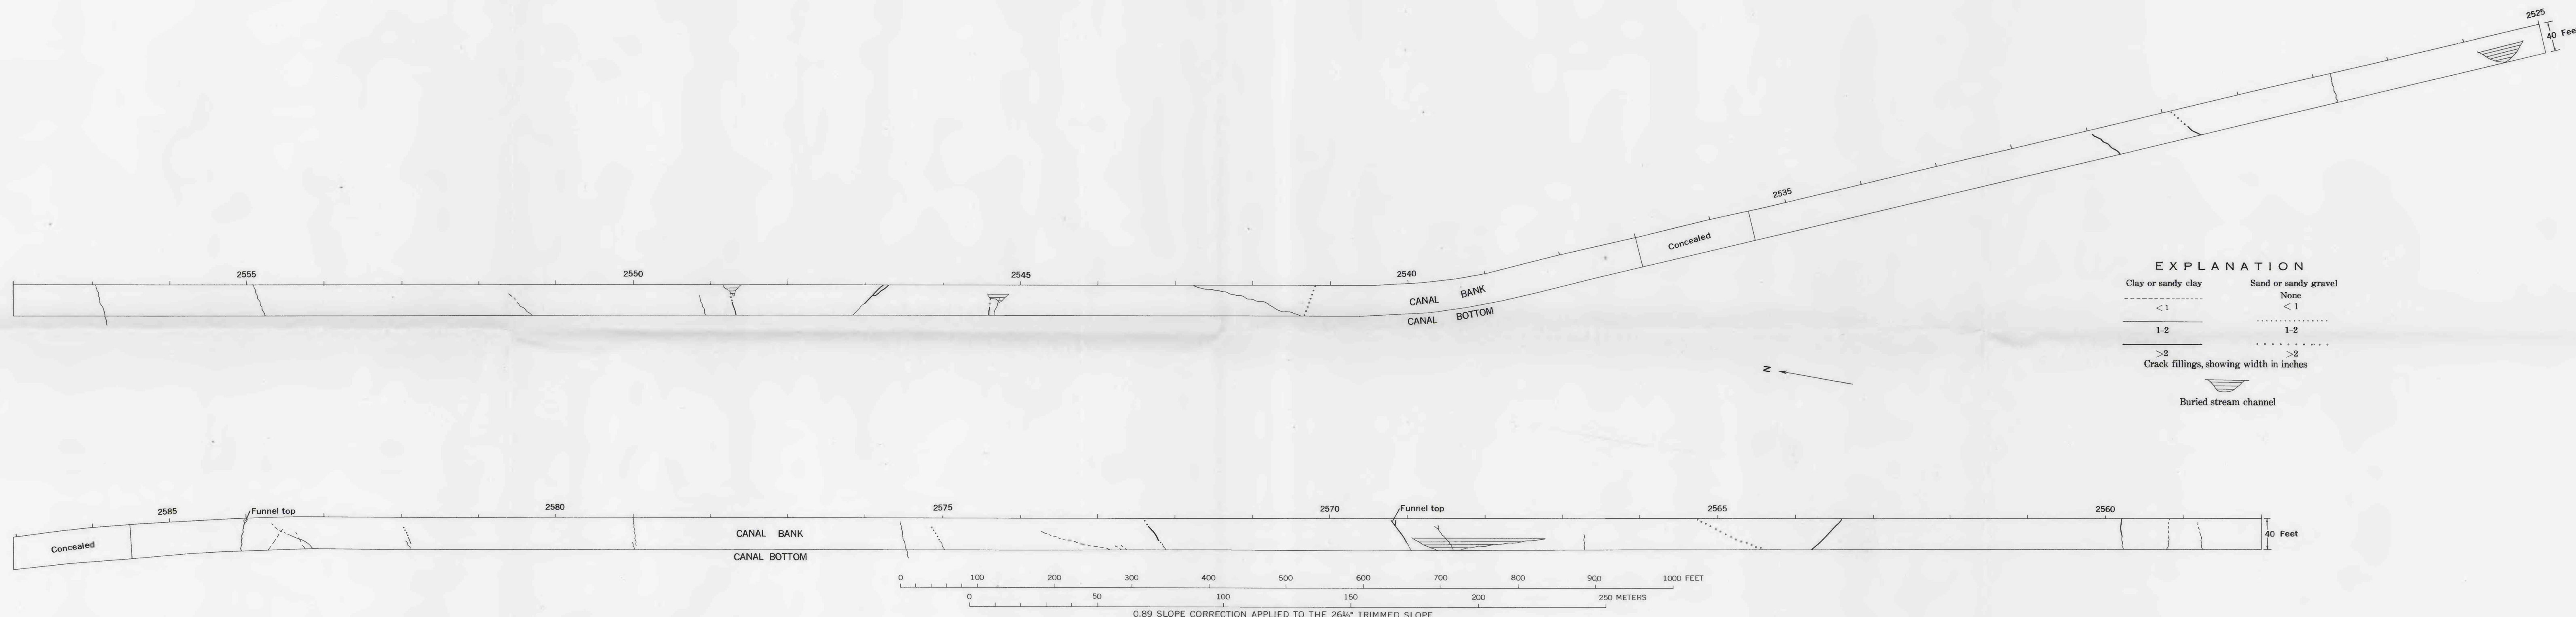
C. TUMEY GULCH FAN. RIGHT BANK OF CANAL FROM STATION 2525+00 TO 2585+50; FROM THE BASE OF THE TRIMMED SLOPE TO THE TOP OF THE BEDDED FAN
