The Alaska Earthquake

March 27, 1964

Effects on Hydrologic Regimen

Effects of the March 1964 Alaska Earthquake On the Hydrology Of South-Central Alaska

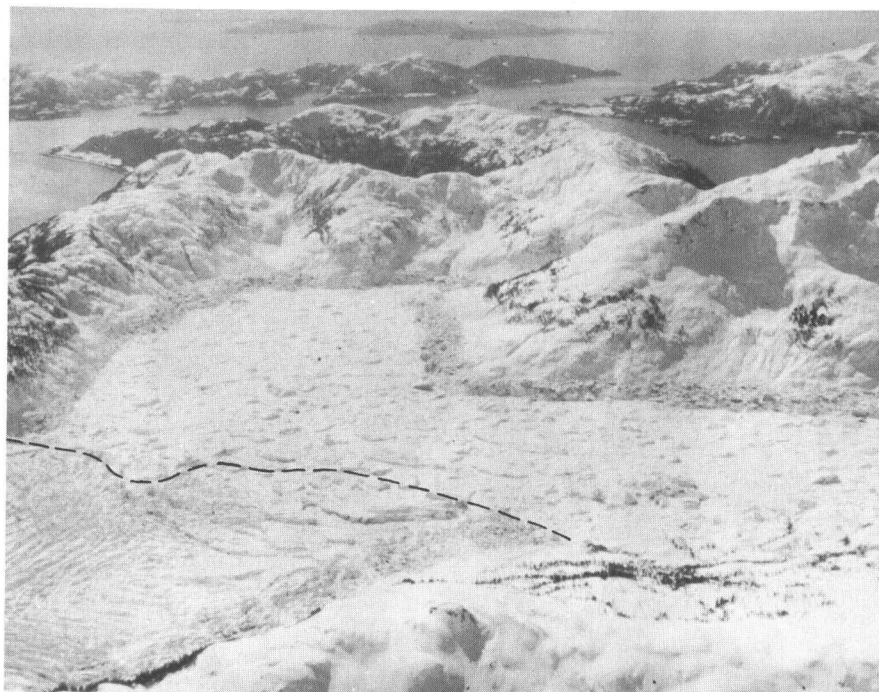
4.—Earthquake-induced features on lakes. A, Pressure ridges on Kenai Lowland lake. B, Broken ice on a lake fronting Columbia Glacier; dashed line indicates front of glacier; photograph by C. H. Hembree, April 4, 1964.

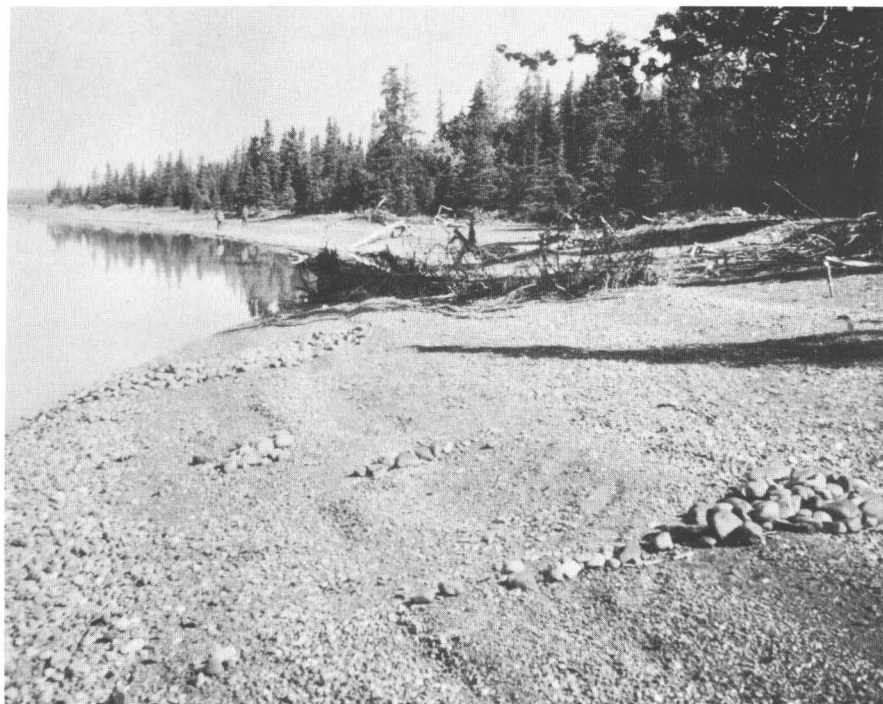
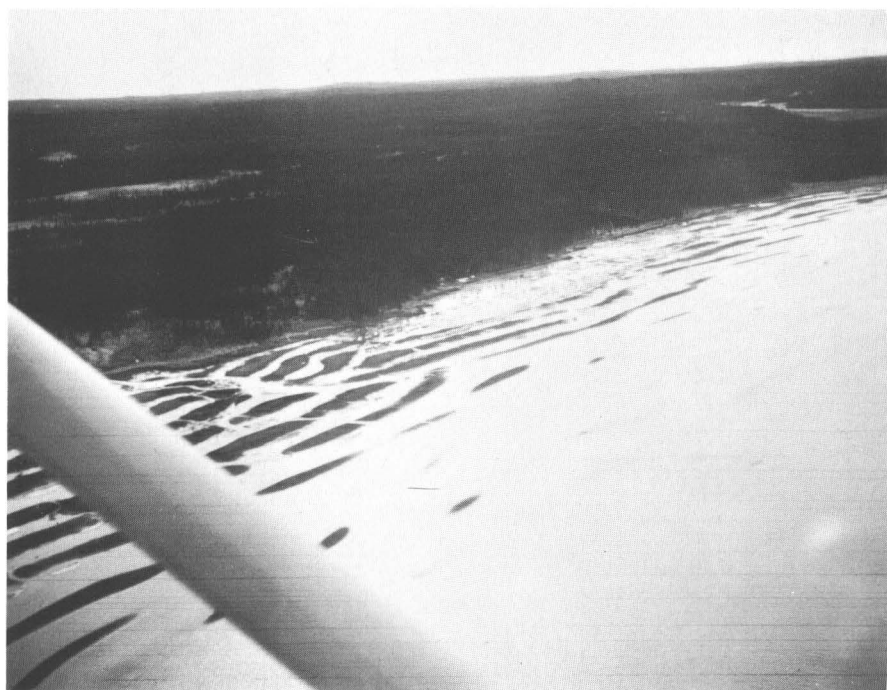
5.—Seiche-induced features on lakes. A, Deposits of iron-stained gravel derived from nearshore lake ice washed up on the beach by seiche waves. B, Lake-bottom ripples possibly formed by organic material sorted by seiche waves.

Some effects of wave action continued to be visible long after the earthquake. At Tustumena Lake, isolated piles of gravel and cobbles on the beach (fig. 5A) were obviously foreign to the beach and were probably derived from the underside of ice blocks that had been washed up on shore by wave action. The nearshore lake ice had frozen into the beach prior to the quake. Other investigators noted similar deposits on other lake-shores. In the Copper River basin the Alaska Department of Fish and Game (1965, p. 35) reported that ridges of sand and gravel, deposited from ice, blocked some lake outlets. Ripples composed of organic material, probably derived from the beach, formed in a shallow embayment of Tustumena Lake at low lake level (fig. 5B). The ripples were about 1–2 feet high and about 50 feet between crests. These ripples may have been formed by the extended seiche action after the quake. Local residents did not recall having seen such ripples prior to the quake.

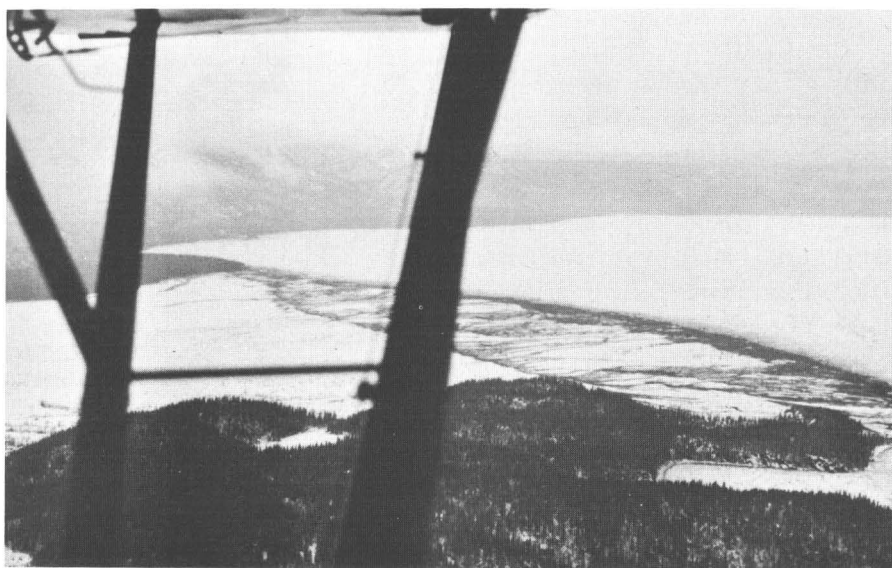
6.—Fractured outwash delta and sand flows at head of Tustumena Lake. Photograph by U.S. Fish and Wildlife Service.

The earth slumps were the most destructive slides. The delta fronts along large lakes usually slumped and fractured (fig. 6). Trees growing along such delta fronts and bordering alluvial fans

Fissures on deltas also occurred only on the lower slopes. In those areas, however, the fissures are undoubtedly tensional features formed behind the free face of the delta front (fig. 6). Furthermore, the hydrostatic pressures in the aquifers are less confined because the water table is very near the surface on the lower slopes. A typical fissure parallel to the shore of the delta in the Skilak River

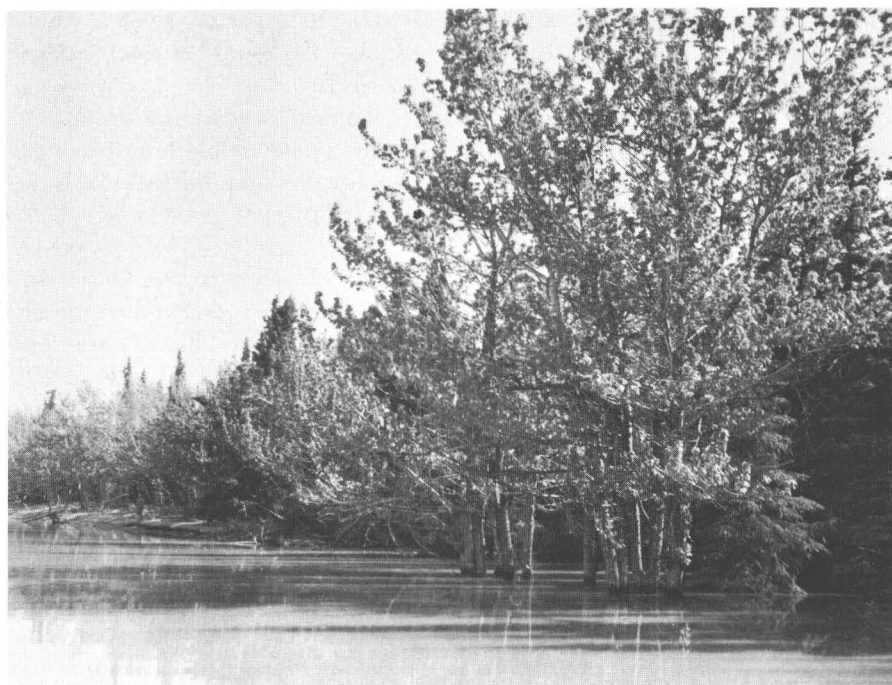
7.—Trees submerged by minor earth slump along lakeshore.

were submerged (fig. 7) as the land subsided. McCulloch (1966) reported that the earthquake-induced slides in Kenai Lake generated waves that washed back into the slide area and also waves that hit the opposite shore. These waves destroyed buildings and scarred the trees several feet above ground level.

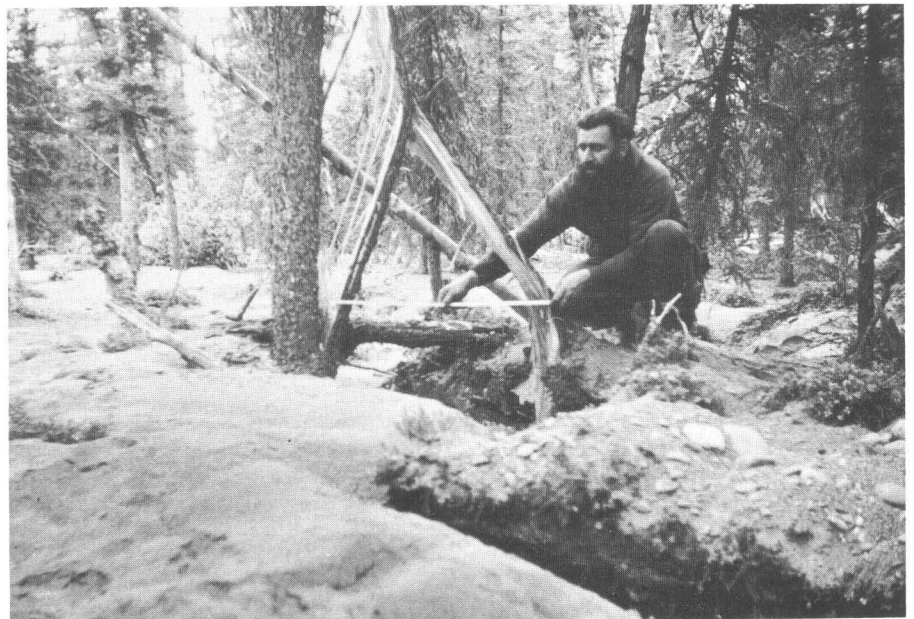
15.—Large fissure and sand flow in the Skilak River valley near Tustumena Lake. Split tree indicates about 3-foot displacement. Note 6- and 8-inch rocks ejected upslope.

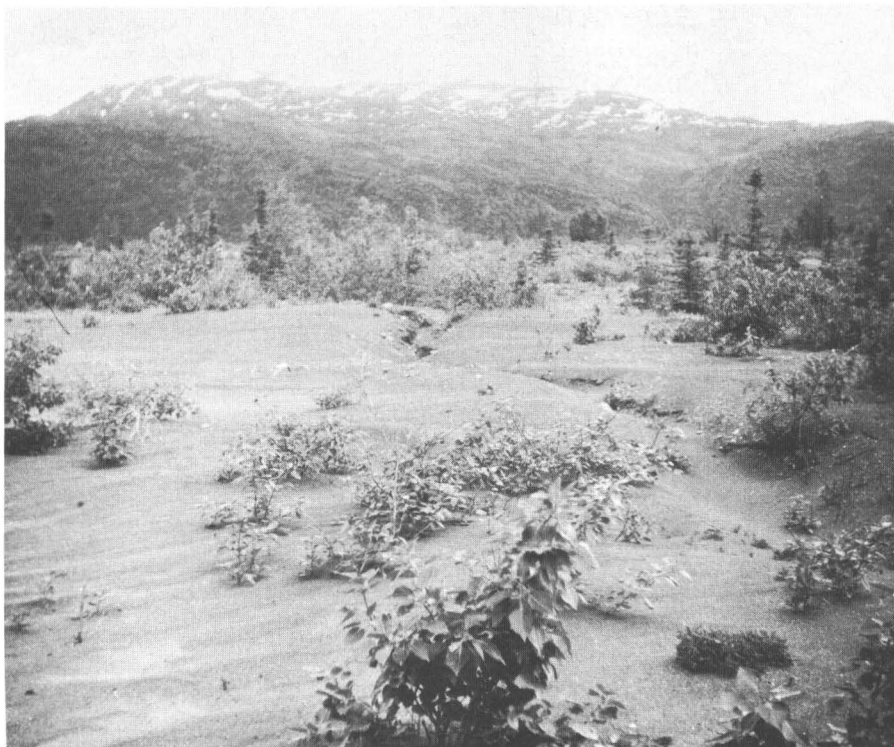
17.—Sand flow from 2-foot fissure more than 200 feet long, parallel to Tustumena Lake shore. Sand flowed mainly to left toward the lake.
