MAP OF COTTONWOOD LAKE AREA, SHOWING POTHOLES AND VEGETATION ZONES, TPS. 141, 142 N., R. 66 W., STUTSMAN COUNTY, NORTH DAKOTA

Compiled by U.S. Geological Survey from aerial photographs made by Bureau of Sport Fisheries and Wildlife for this study

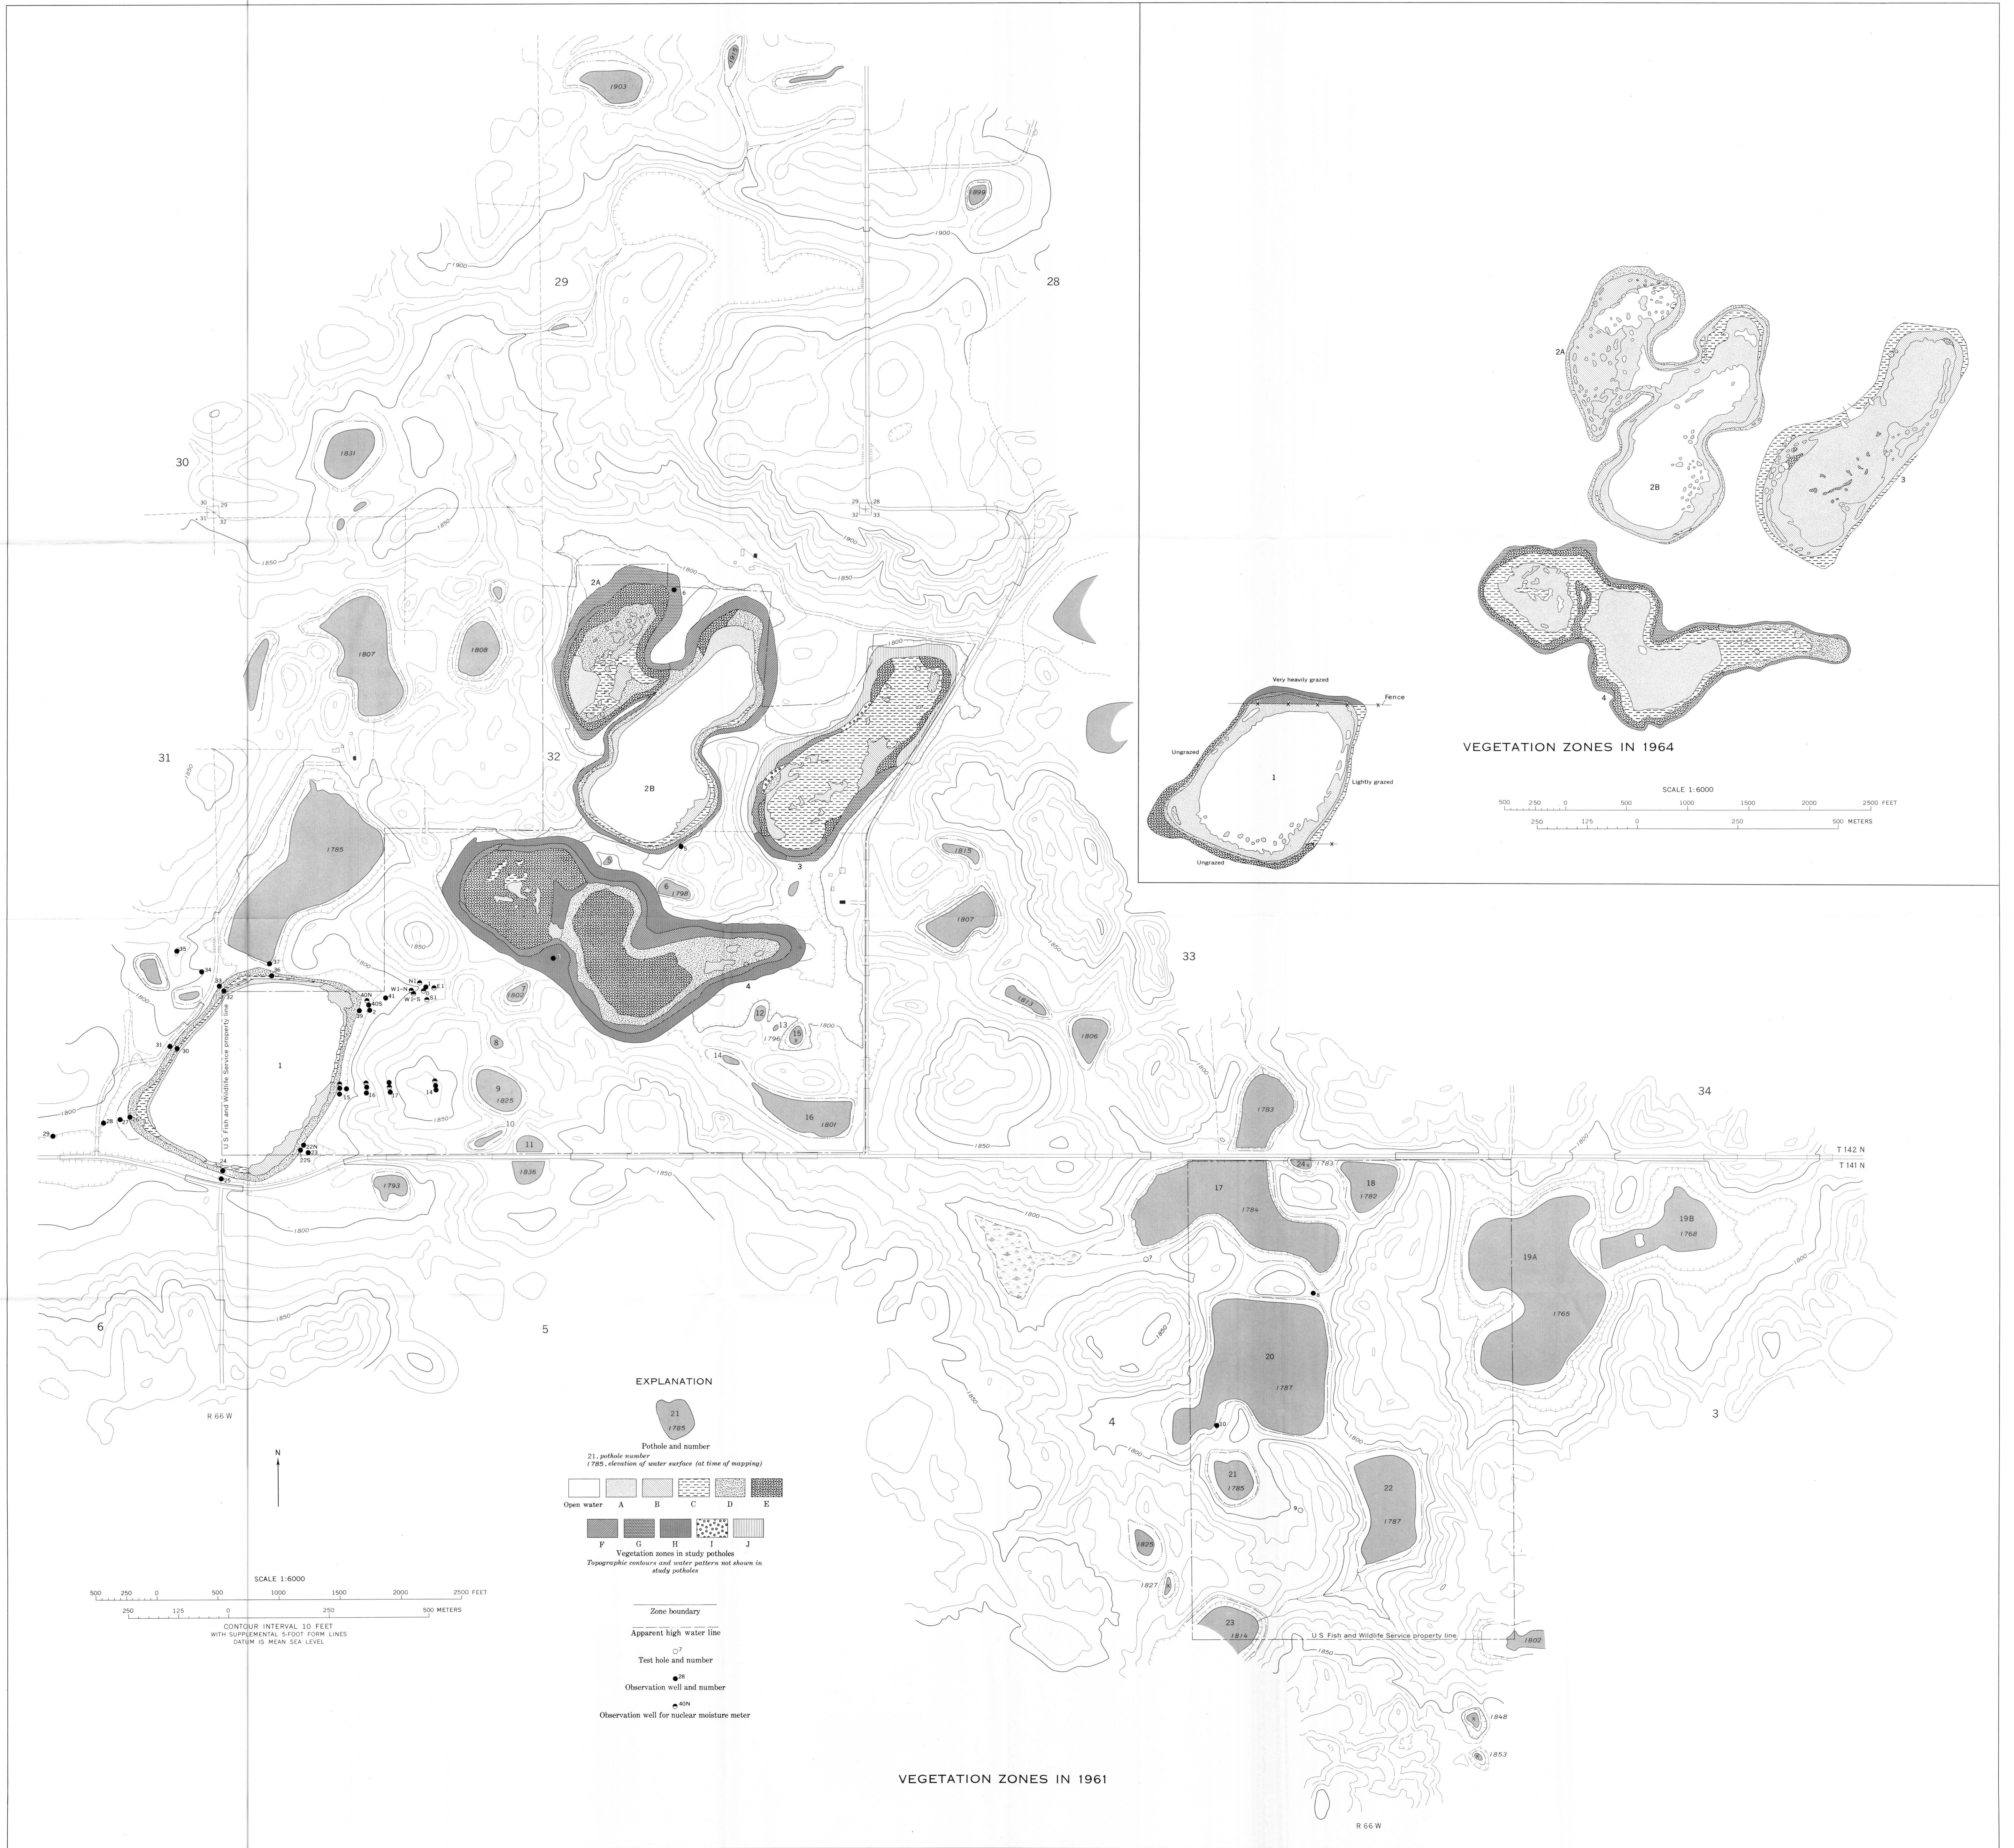
Pothole and number  
21, pothole number  
1795, elevation of water surface (at time of mapping)
- Open water
  - A
  - B
  - C
  - D
  - E
- F
  - G
  - H
  - I
  - J

Vegetation zones in study potholes  
Topographic contours and water patterns not shown in study potholes
- Zone boundary
- Apparent high water line
- 7

Test hole and number
- 28

Observation well and number
- 40N

Observation well for nuclear moisture meter

CONTOUR INTERVAL 10 FEET  
WITH SUPPLEMENTAL 5 FOOT FORM LINES  
DATUM IS MEAN SEA LEVEL
