# Channel Changes of the Gila River in Safford Valley, Arizona 1846-1970

GEOLOGICAL SURVEY PROFESSIONAL PAPER 655-G

*By* D. E. BURKHAM

GILA RIVER PHREATOPHYTE PROJECT

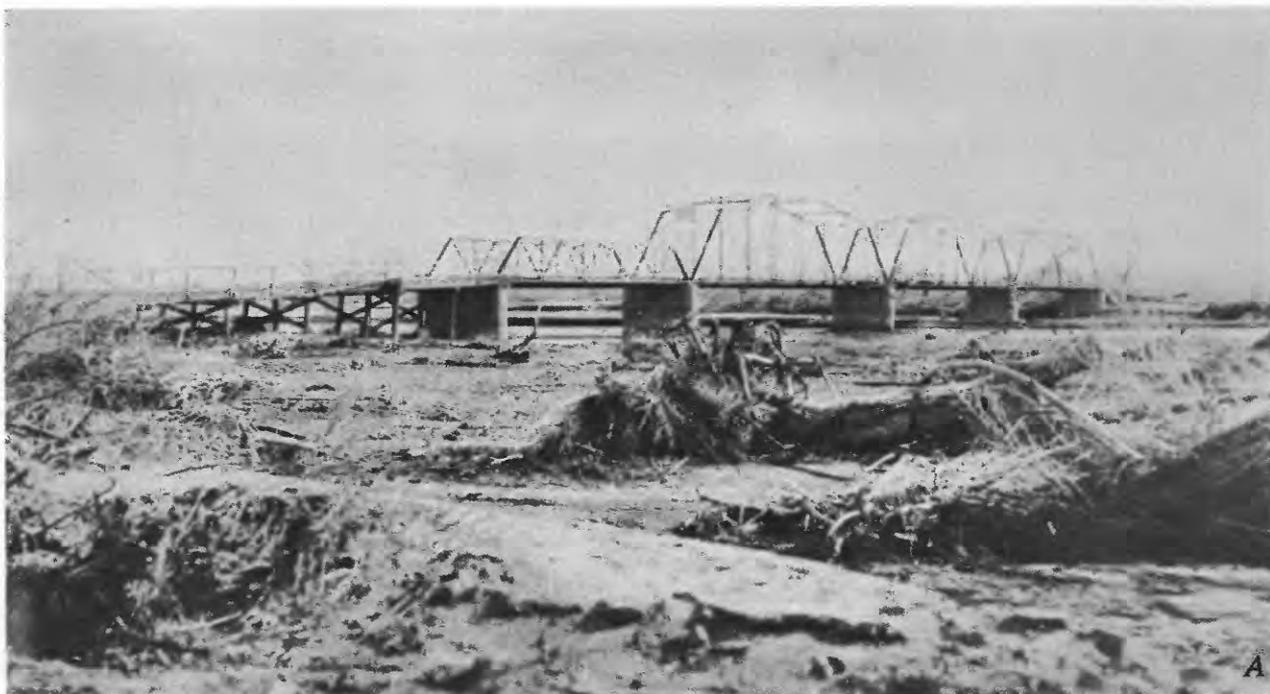
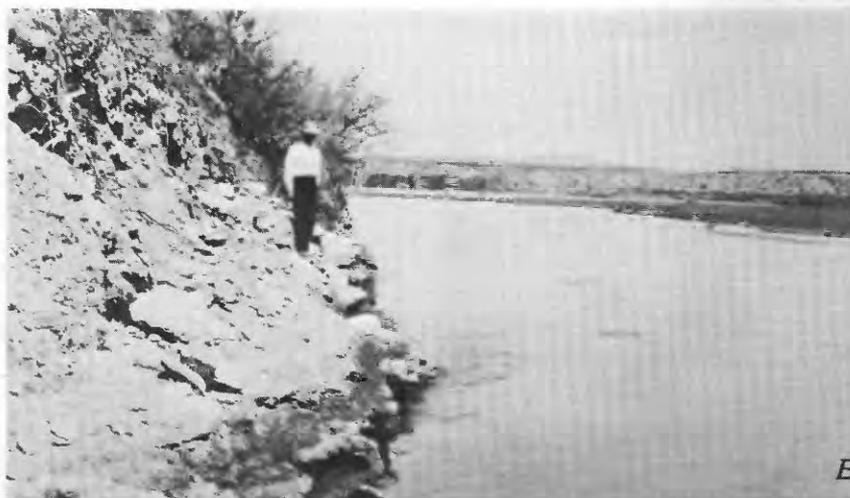
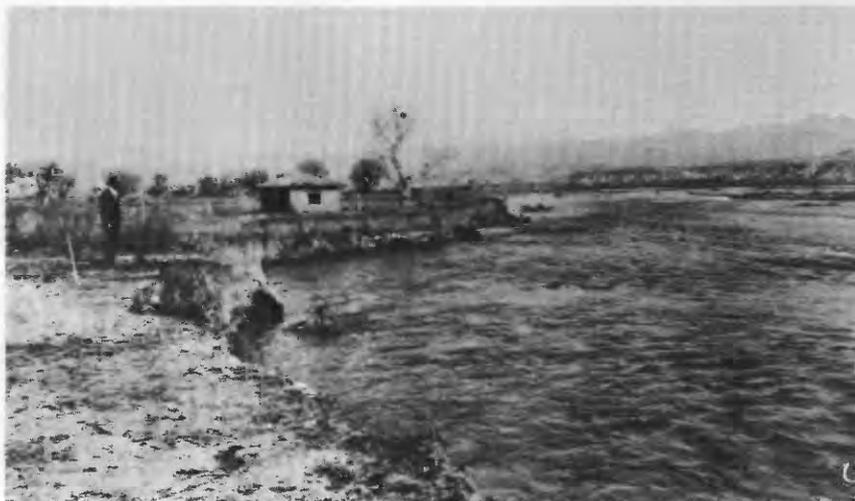
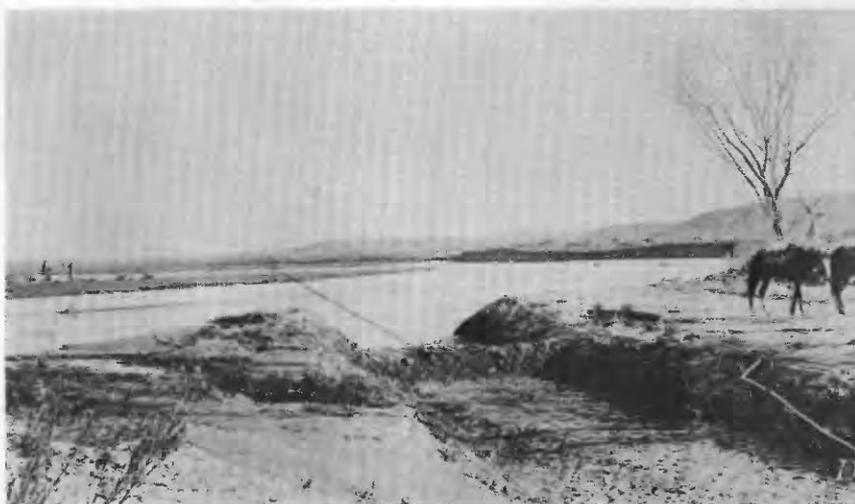
FIGURE 3.—Gila River in 1916. *A*, Looking upstream at the bridge at Pima; the drift in the foreground probably is cottonwood. *B*, Looking downstream at Black Point near Bylas; the trees in the background across the river probably are cottonwood. *C*, Erosion on the left bank of the river at Bylas; the alluvial fan on the right side of the river at the mouth of Salt Creek (not shown in photo-

graph; see pl. 1) is causing a realignment of the river. *D*, Gila River near Bylas; debris in the left background is uprooted cottonwood. Photograph *A* is from Olmstead (1919, pl. 11); photographs *B*, *C*, and *D* furnished by the U.S. Bureau of Indian Affairs, Phoenix, Ariz.

Most of the dense stands of willow and cottonwood that grew along the Gila River prior to 1905 were destroyed during 1905-17 (fig. 3). The stream channel was relatively barren in 1909 (fig. 4); therefore, most of the destruction probably occurred during 1905-9.

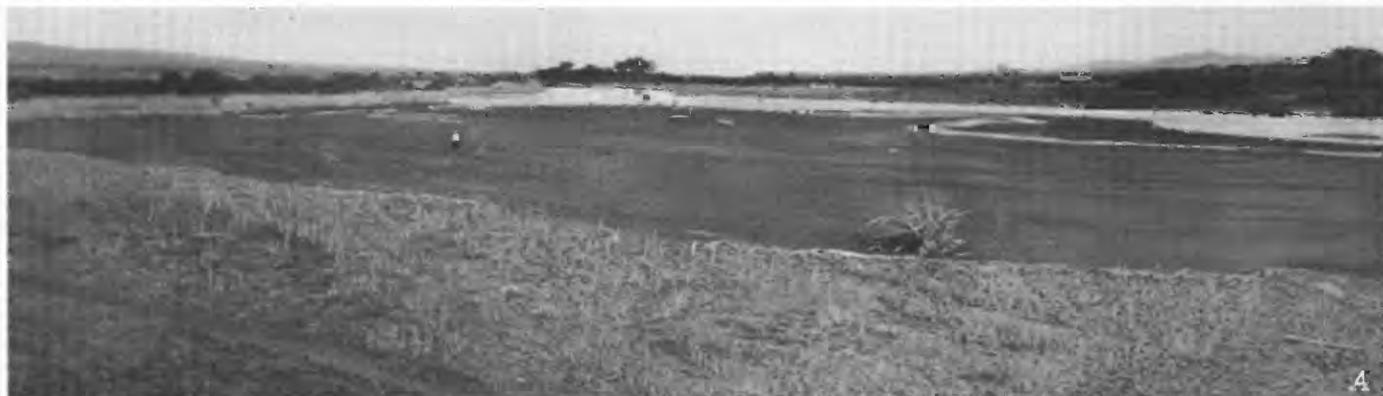
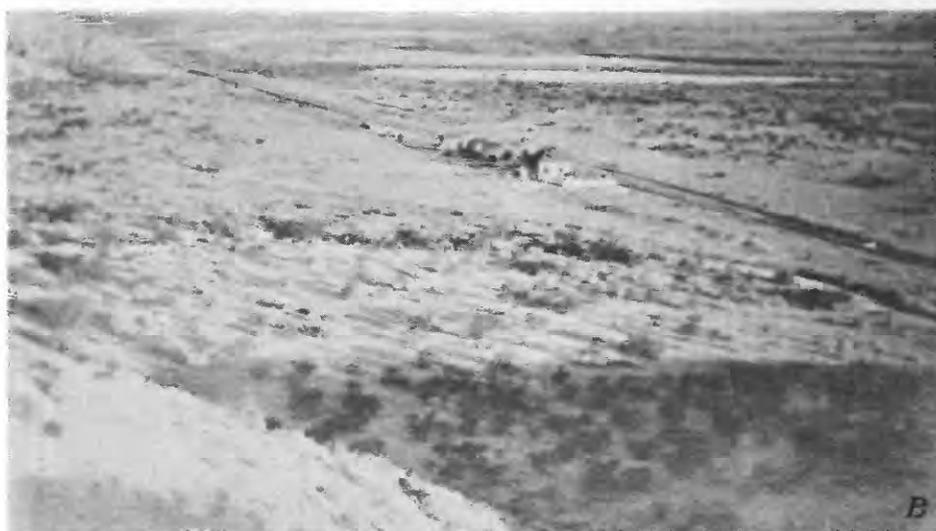
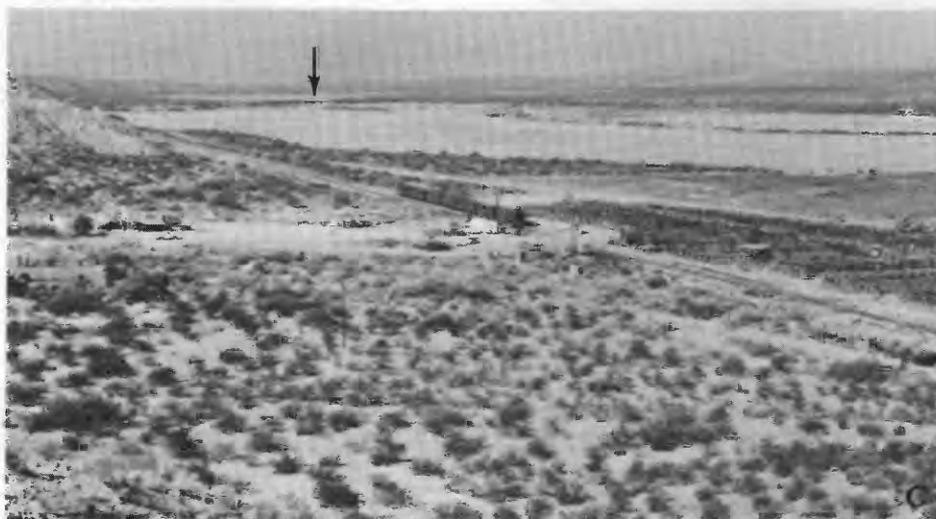
FIGURE 4.—Gila River in 1909 and 1969. *A*, Looking downstream near Geronimo in May 1909. *B*, Looking downstream near the railroad siding at Calva in 1909. *C*, Looking downstream near the railroad siding at Calva in 1969 (arrow indicates location of railroad bridge); the bottom-land vegetation was eradicated in 1966 to control evapotranspiration, and the photograph in figure 6 shows the same area before eradication. Photographs *A* and *B* furnished by the U.S. Bureau of Indian Affairs, Phoenix, Ariz. Photograph *C* furnished by Mr. R. M. Turner, Tucson, Ariz.

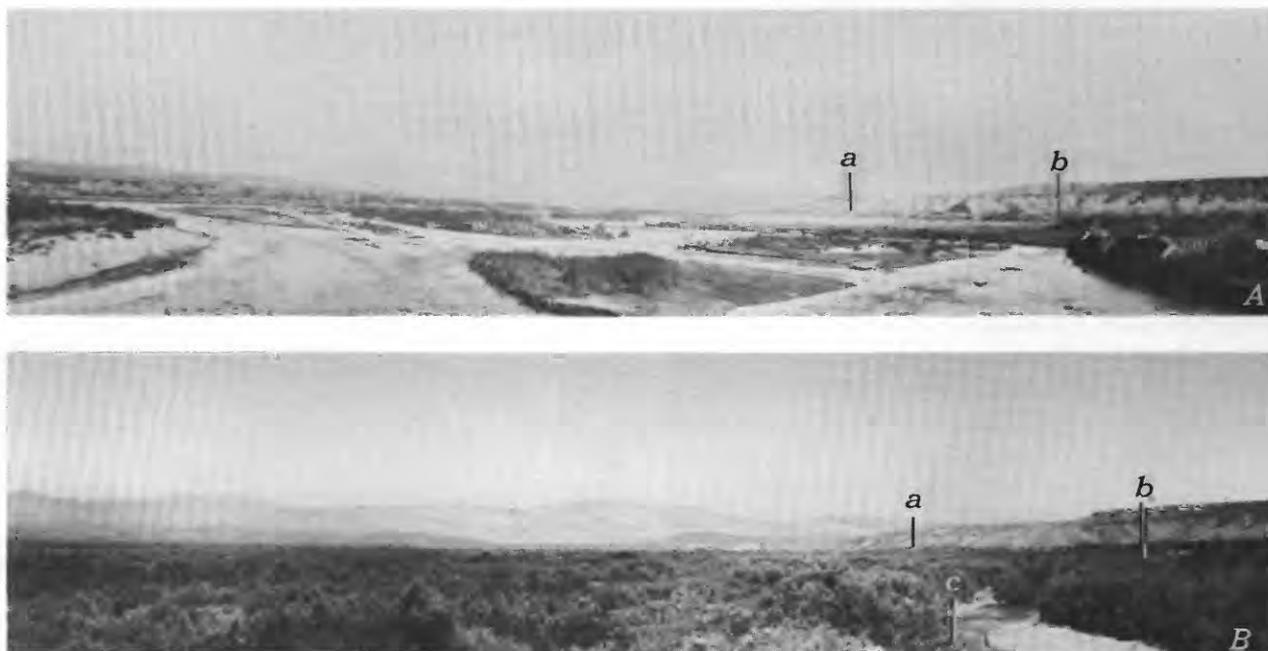
FIGURE 6.—Saltcedar encroachment along the Gila River between 1932 and 1964. *A*, Looking upstream from the railroad bridge near Calva in 1932; the braided stream probably is typical of the Gila River in most of the Safford Valley in the third and early fourth decades of the 20th century. *B*, Looking upstream from the railroad bridge near Calva in 1964. Leaders indicate: *a*, location of railroad siding at Calva (fig. 4*B*, *C*); *b*, location of alluvial fan shown on plate 4; *c*, location of stream channel in 1964.

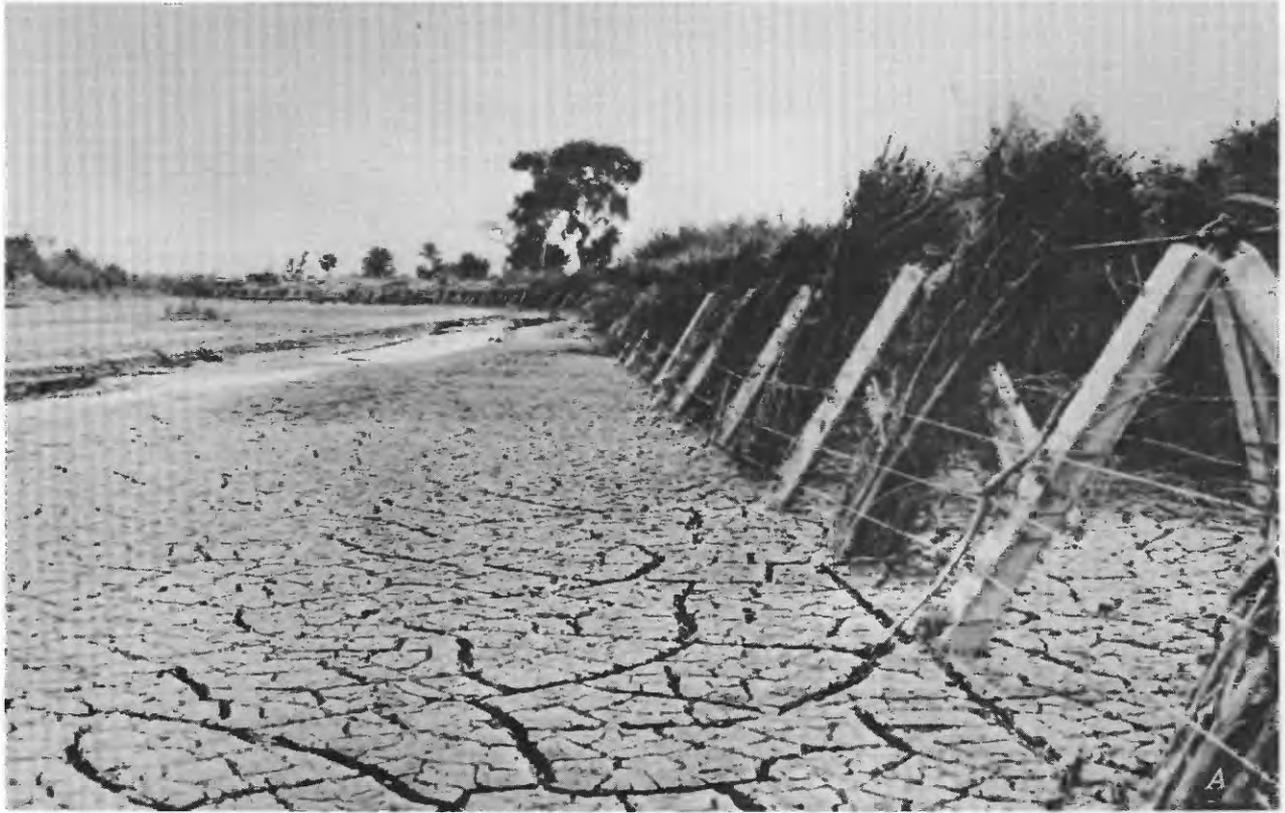
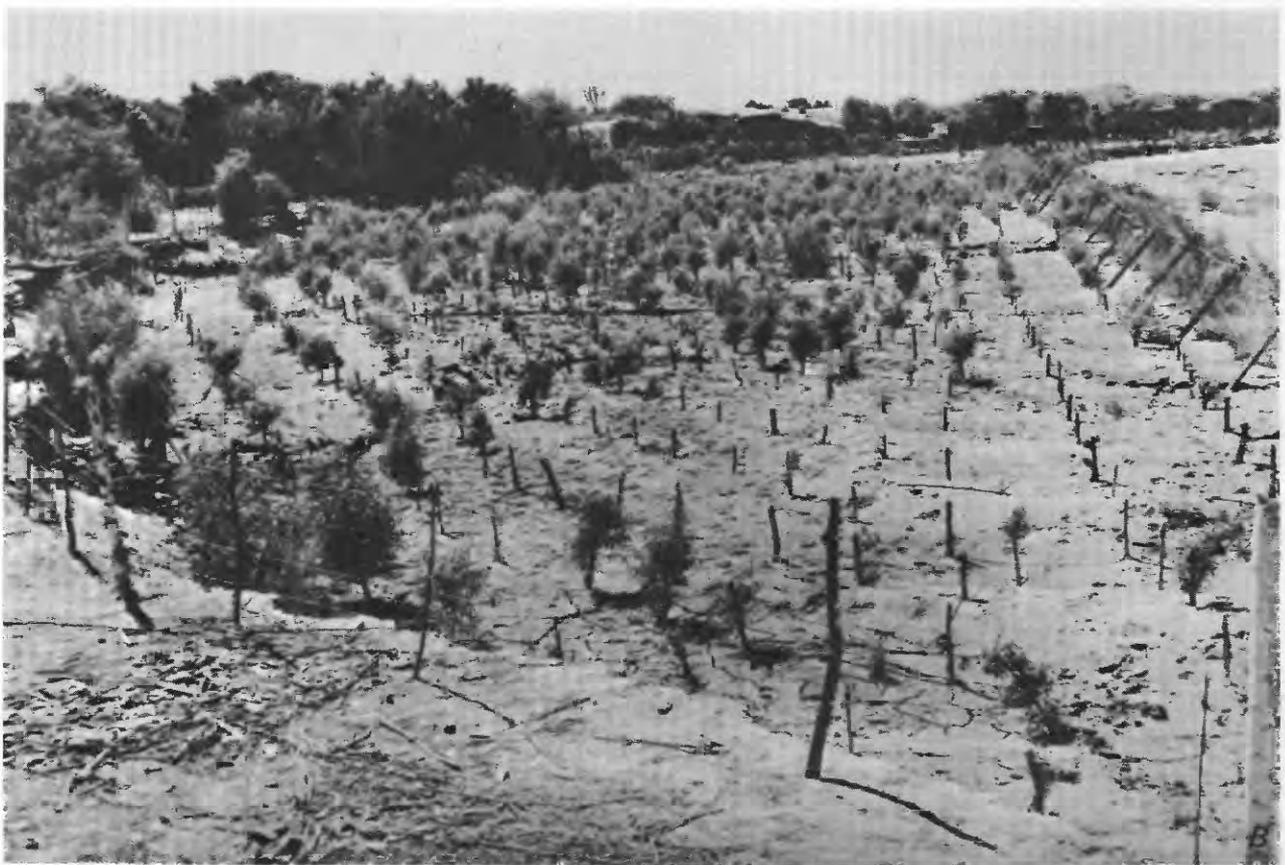
The erosion-control treatment used by the Soil Conservation Service (fig. 8) undoubtedly had some short-term local effects because it was applied during a period having few major floods; however, saltcedar became established naturally, and any reduction in erosion effected by the willow probably would have occurred later as a result of the saltcedar.
