Downstream Effects of Dams on Alluvial Rivers

GEOLOGICAL SURVEY PROFESSIONAL PAPER 1286

By GARNETT P. WILLIAMS *and* M. GORDON WOLMAN

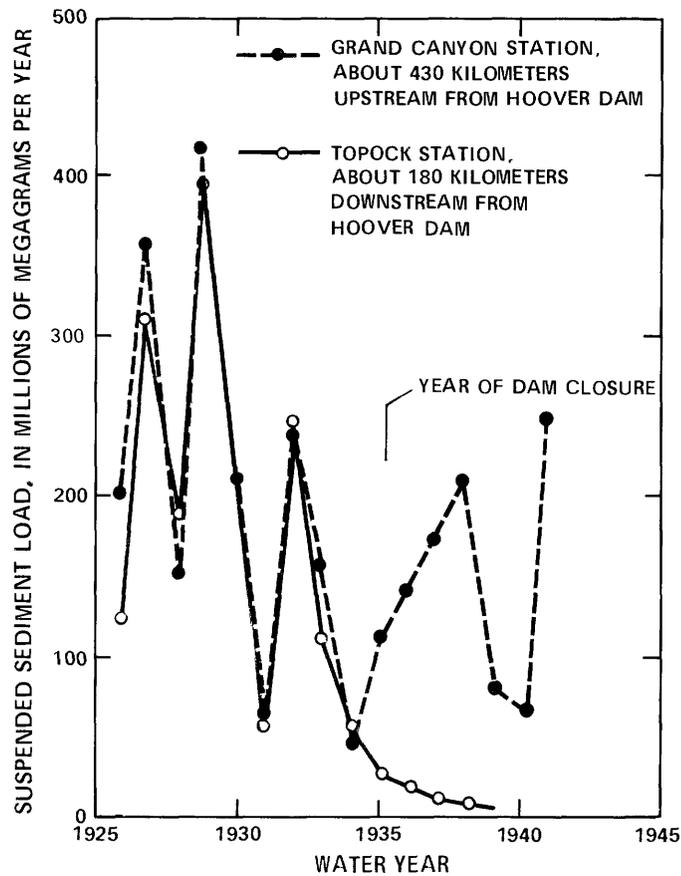
FIGURE 2.—Variation in annual suspended-sediment loads before and after closure of Hoover Dam, Colorado River, Arizona, at a station upstream from the dam (Grand Canyon) and downstream from the dam (Topock).

Hoover Dam on the Colorado River is a good example. Suspended loads in the Colorado River have been measured upstream and downstream from Hoover Dam. The upstream station is near Grand Canyon, Arizona, 430 km from the dam; the downstream station is near Topock, 180 km downstream from the dam. Two characteristics of the suspended load under natural conditions—the large quantities and the very large annual variations—are shown in figure 2. Before closure of Hoover Dam in 1936, annual loads at the two stations were similar. After closure, sediment inflow, represented by the data for the Grand Canyon station, continued to be large and variable. Downstream from the dam, at Topock, however, both the load and the annual variations were markedly decreased.

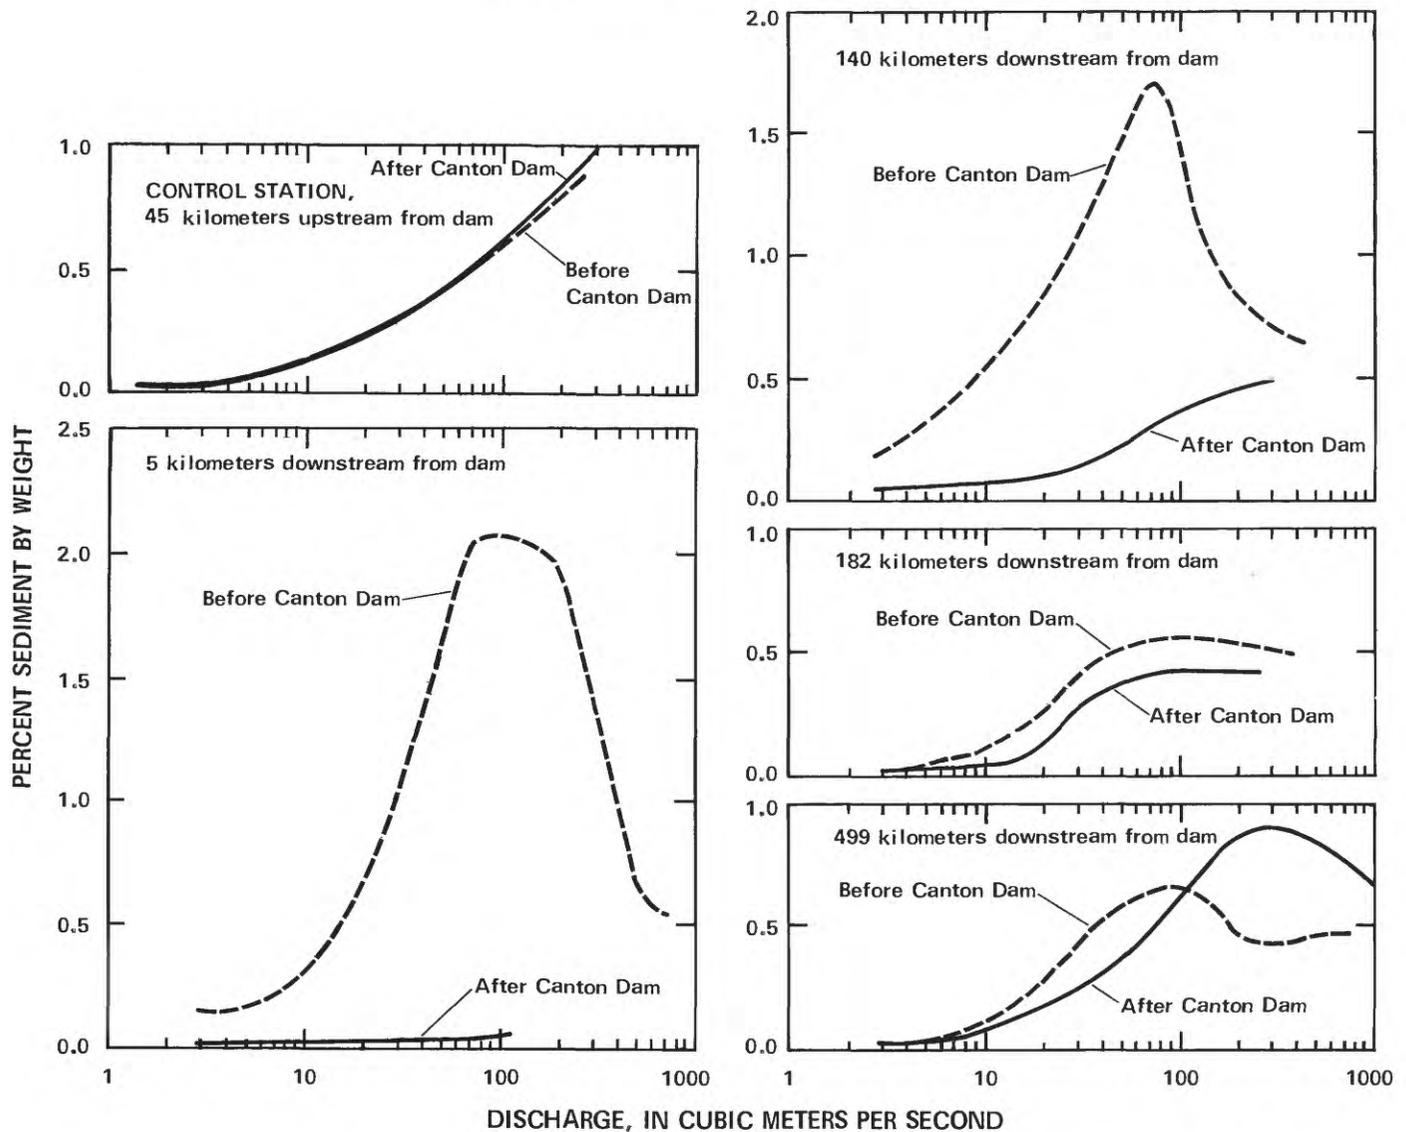
FIGURE 3.—Suspended-sediment loads (concentrations) transported by various discharges at successive downstream stations before and after closure of Canton Dam, North Canadian River, Oklahoma. Control-station curve based on unpublished U.S. Geological Survey data; other curves redrawn from U.S. Army Corps of Engineers, 1958.

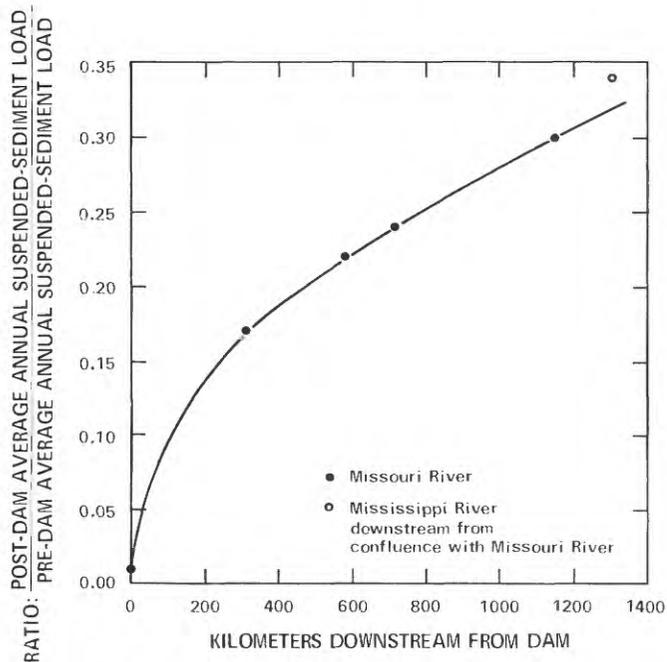
FIGURE 4.—Post-dam/pre-dam ratio of annual suspended-sediment loads versus distance downstream from Gavins Point Dam, Missouri River, South Dakota.

1940–52, 1957–73; St. Joseph, Kansas City, and Hermann—1949–52, 1957–76. These stations are 8 (Yankton), 314 (Omaha), 584 (St. Joseph), 716 (Kansas City), and 1,147 (Hermann) km downstream from Gavins Point Dam. From the annual suspended-sediment loads, an average annual load was computed for the pre-dam period and again for the post-dam period. The ratio of these average loads as a function of distance downstream from the dam is shown in figure 4. At Yankton, just 8 km downstream from the dam, the average post-dam annual load was less than 1 percent of that for the pre-dam period. Even 1,147 km

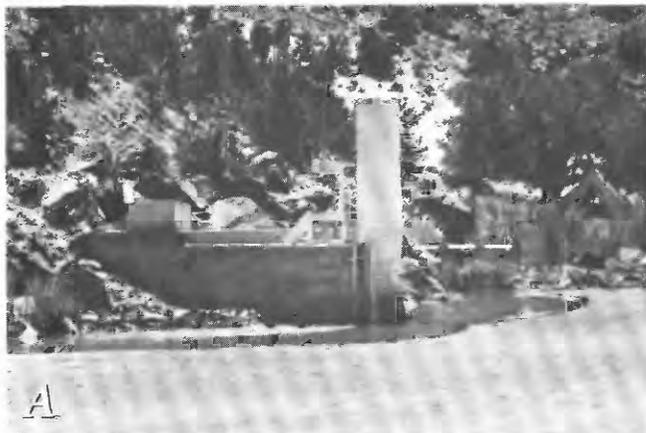
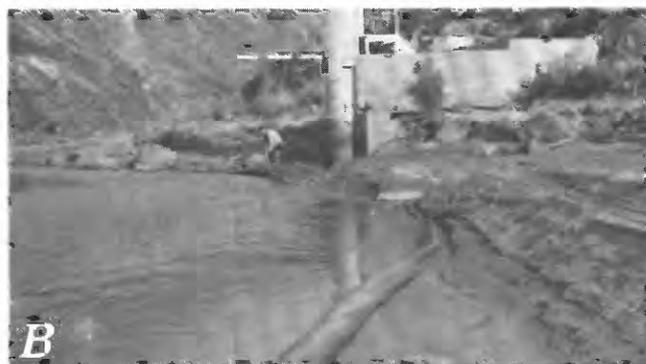
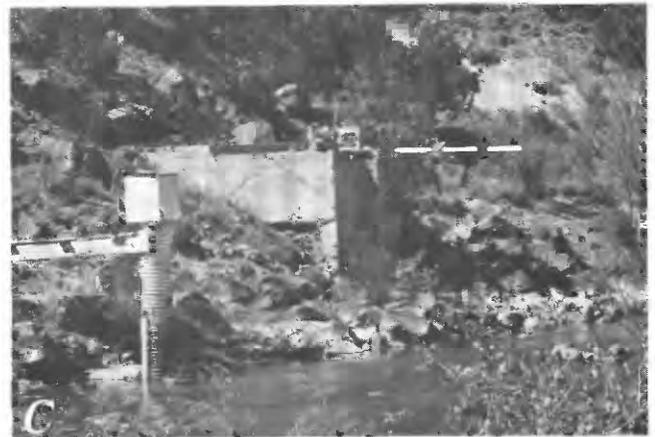
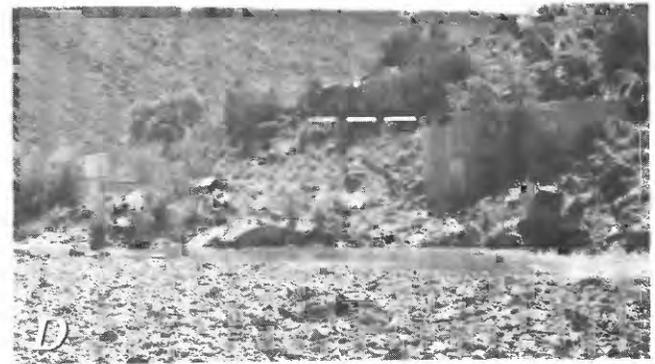
FIGURE 5.—Time progression of bed degradation and channel armoring at the streamflow-gaging station downstream from Jemez Canyon Dam, Jemez River, New Mexico. A, 1952; B, 1957; C and

D, 1980. Dam was closed in 1953. Station is 1.3 kilometers downstream from the dam. White dashed line is at a constant elevation for reference.

For all 21 channels (fig. 1) having resurveyed cross sections, a lowering of the mean bed level—here called degradation—occurred immediately downstream from the dam (figs. 5 and 6), unless constrained by very coarse material or bedrock. Such bed degradation downstream from dams is a well-known phenomenon on alluvial streams (Lane, 1934; Gottschalk, 1964, p. 17–5). Analytical studies of open-channel bed degradation include those by Lane (1948), Mostafa (1957), Tinney (1962), Breusers (1967), Komura and Simons (1967), Aksoy (1970, 1971), Hales and others (1970), Komura (1971), Rzhantzin and others (1971), de Vries (1973), Hwang (1975), and Strand (1977). Special flume studies of bed degradation have been conducted by Schoklitsch (1950), Harrison (1950), Newton (1951), Ahmad (1953), Willis (1965), Garde and Hasan (1967), Ashida and Michiue (1971), and others.

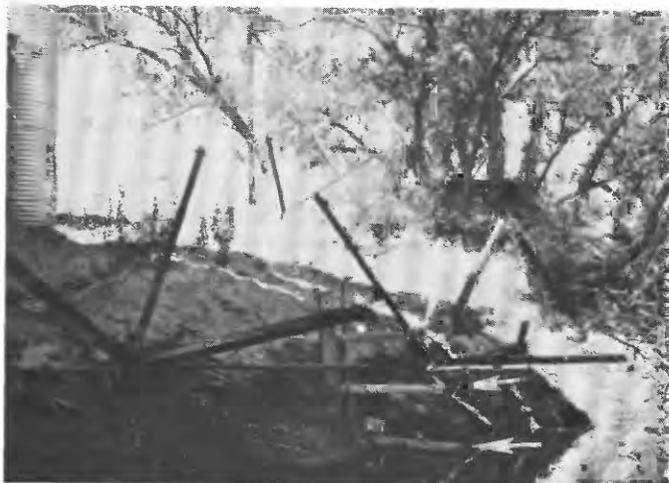
FIGURE 6.—Degradation represented by successively lower water-intake pipes for streamflow-gaging station 2.6 kilometers downstream from Fort Supply Dam, Wolf Creek, Oklahoma. Dam was closed in 1942; photograph was taken in 1951.

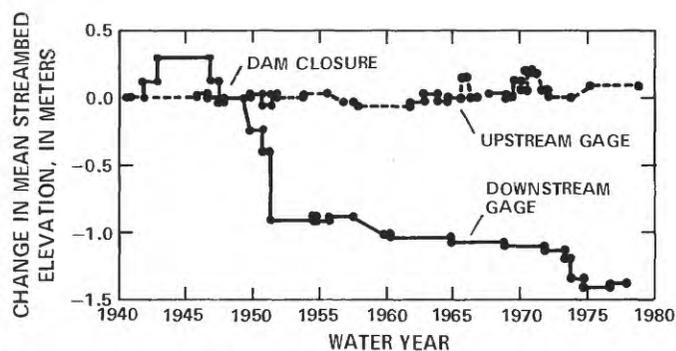
FIGURE 7.—Changes in mean bed elevation with time at streamflow-gaging stations 48 kilometers upstream and 1.3 kilometers downstream from Kanopolis Dam, Smoky Hill River, Kansas. Bed elevations assumed proportional to the gage height that corresponds to a constant low discharge of 0.42 cubic meter per second at the upstream gage and 0.51 cubic meter per second at the downstream gage.

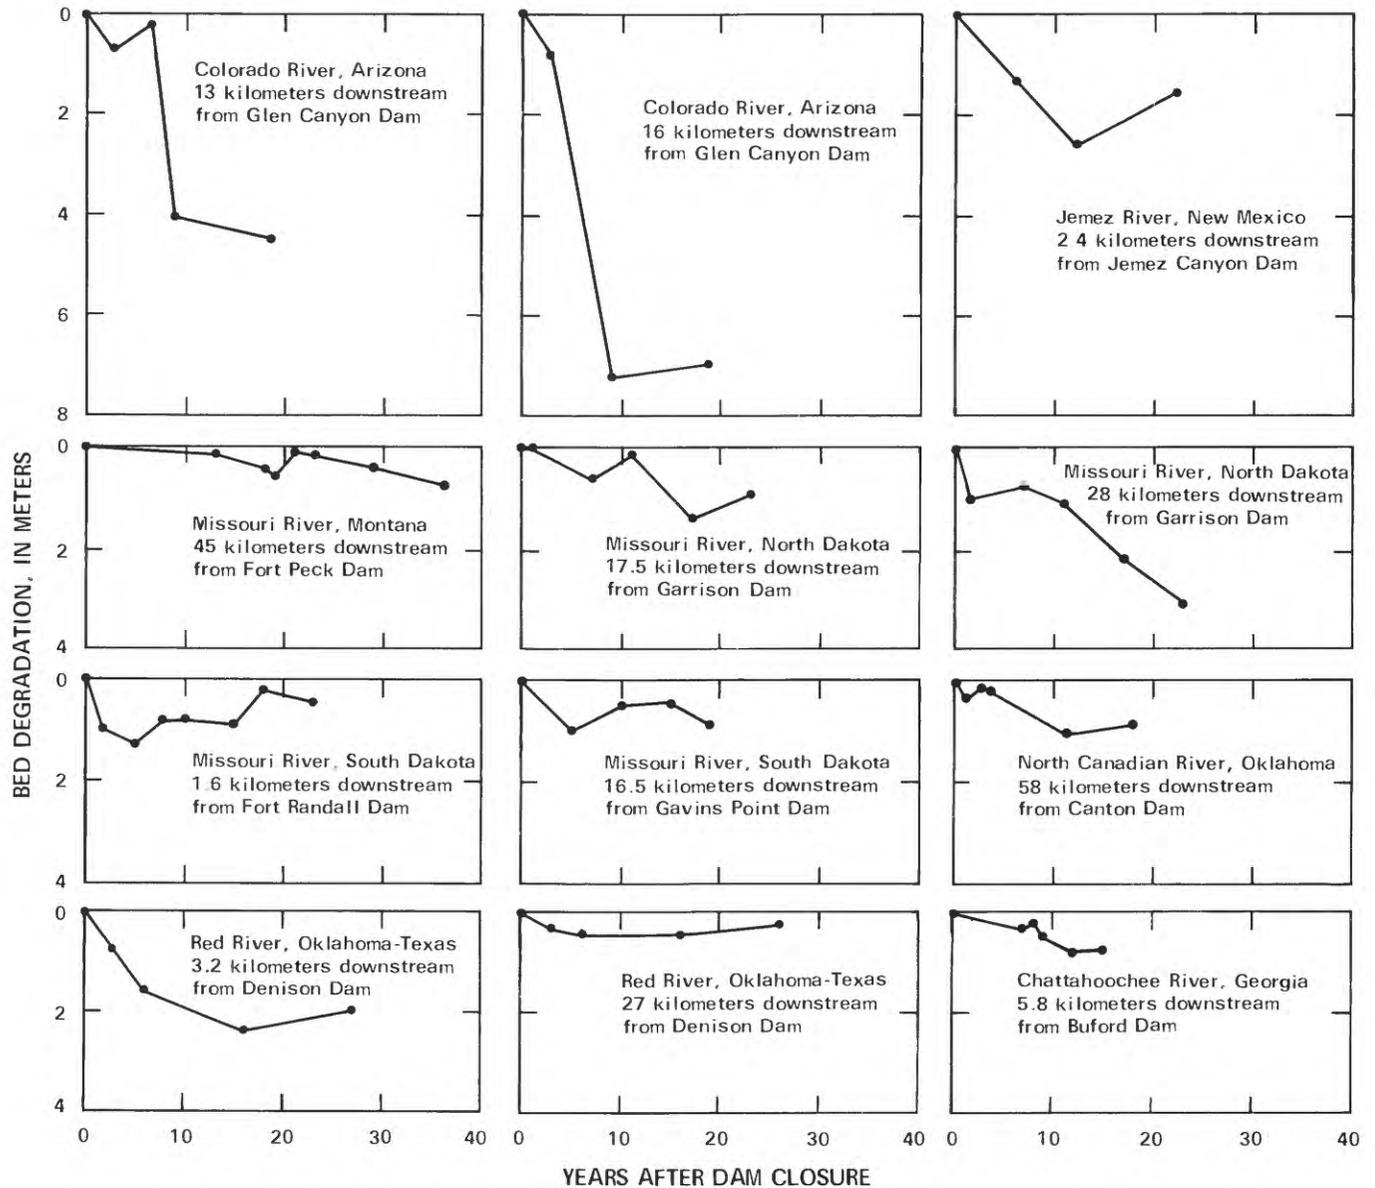
FIGURE 8.—Examples of irregular rates of bed degradation with time. Data from table 13.

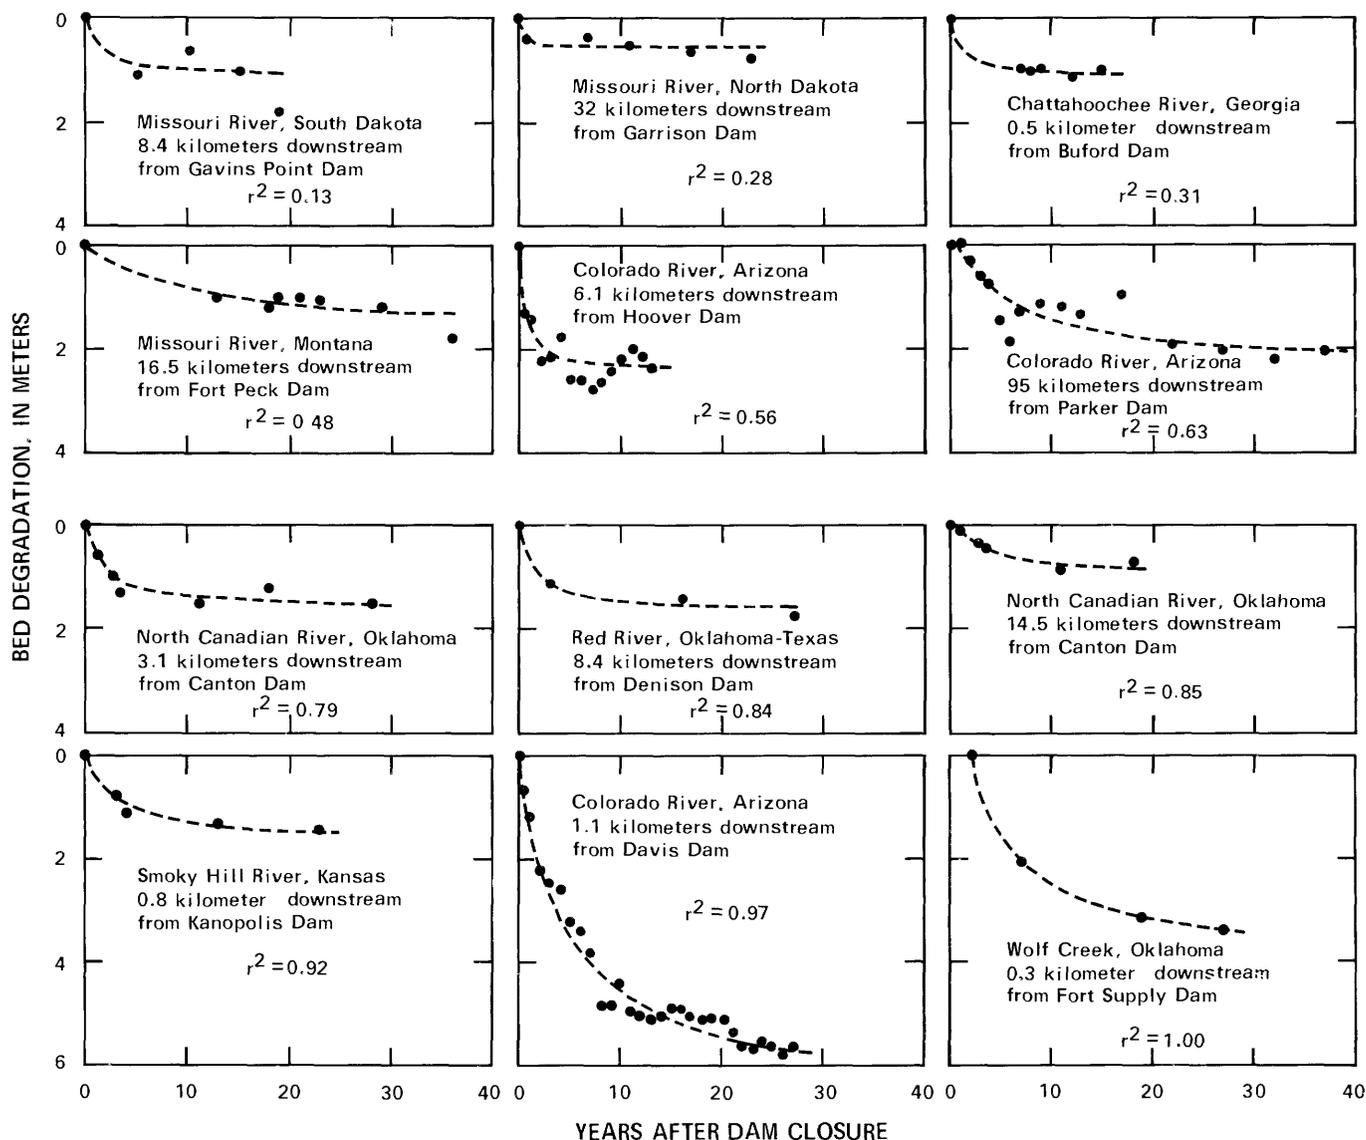
FIGURE 9.—Representative regression curves (dashed lines) of bed degradation with time at selected sites. Data from table 13.

This general curve is shown in figure 11, with the data for the 12 representative cross sections of figure 9. (Axes in fig. 11 correspond to the form of eq. 1 rather than eq. 2 for easier comparison to the plots of fig. 9.) The scatter is greatest for sites having low correlations with the model curve on the unstandardized plots (fig. 9) and improves as the fit on the unstandardized plots improves.

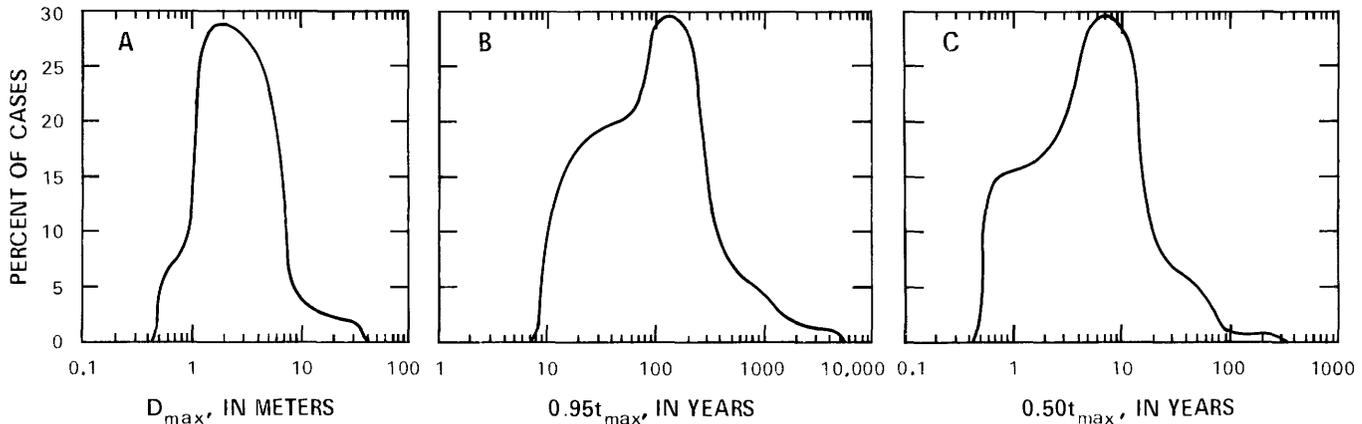
FIGURE 10.—Frequency distributions based on 111 measured cross sections on various rivers: A, maximum expected degradation depth; B, years needed to deepen to 95 percent of maximum depth; and C, years needed to deepen to 50 percent of maximum depth.

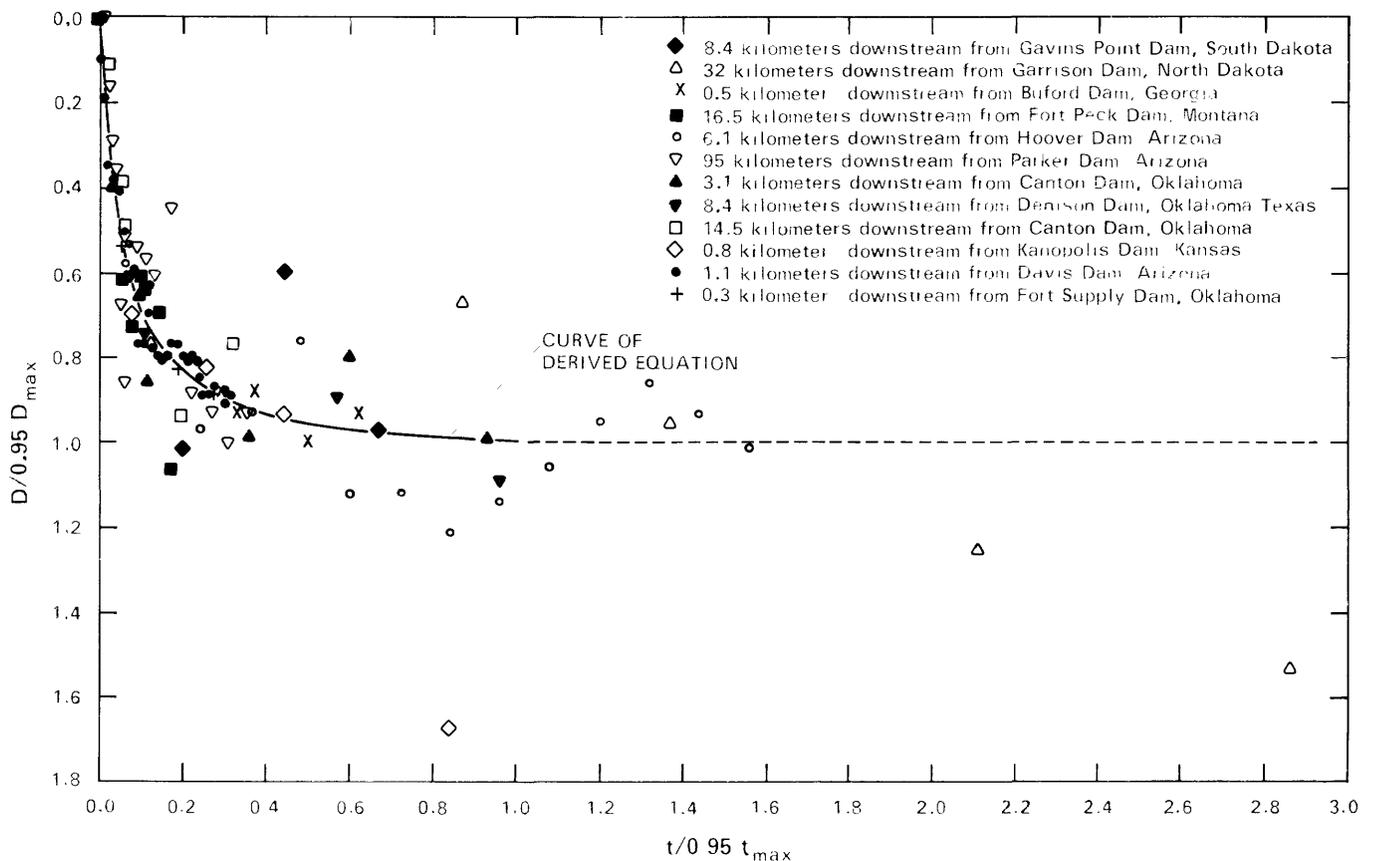
FIGURE 11.—Standardized degradation-time dimensionless plot of degradation curves in figure 9.

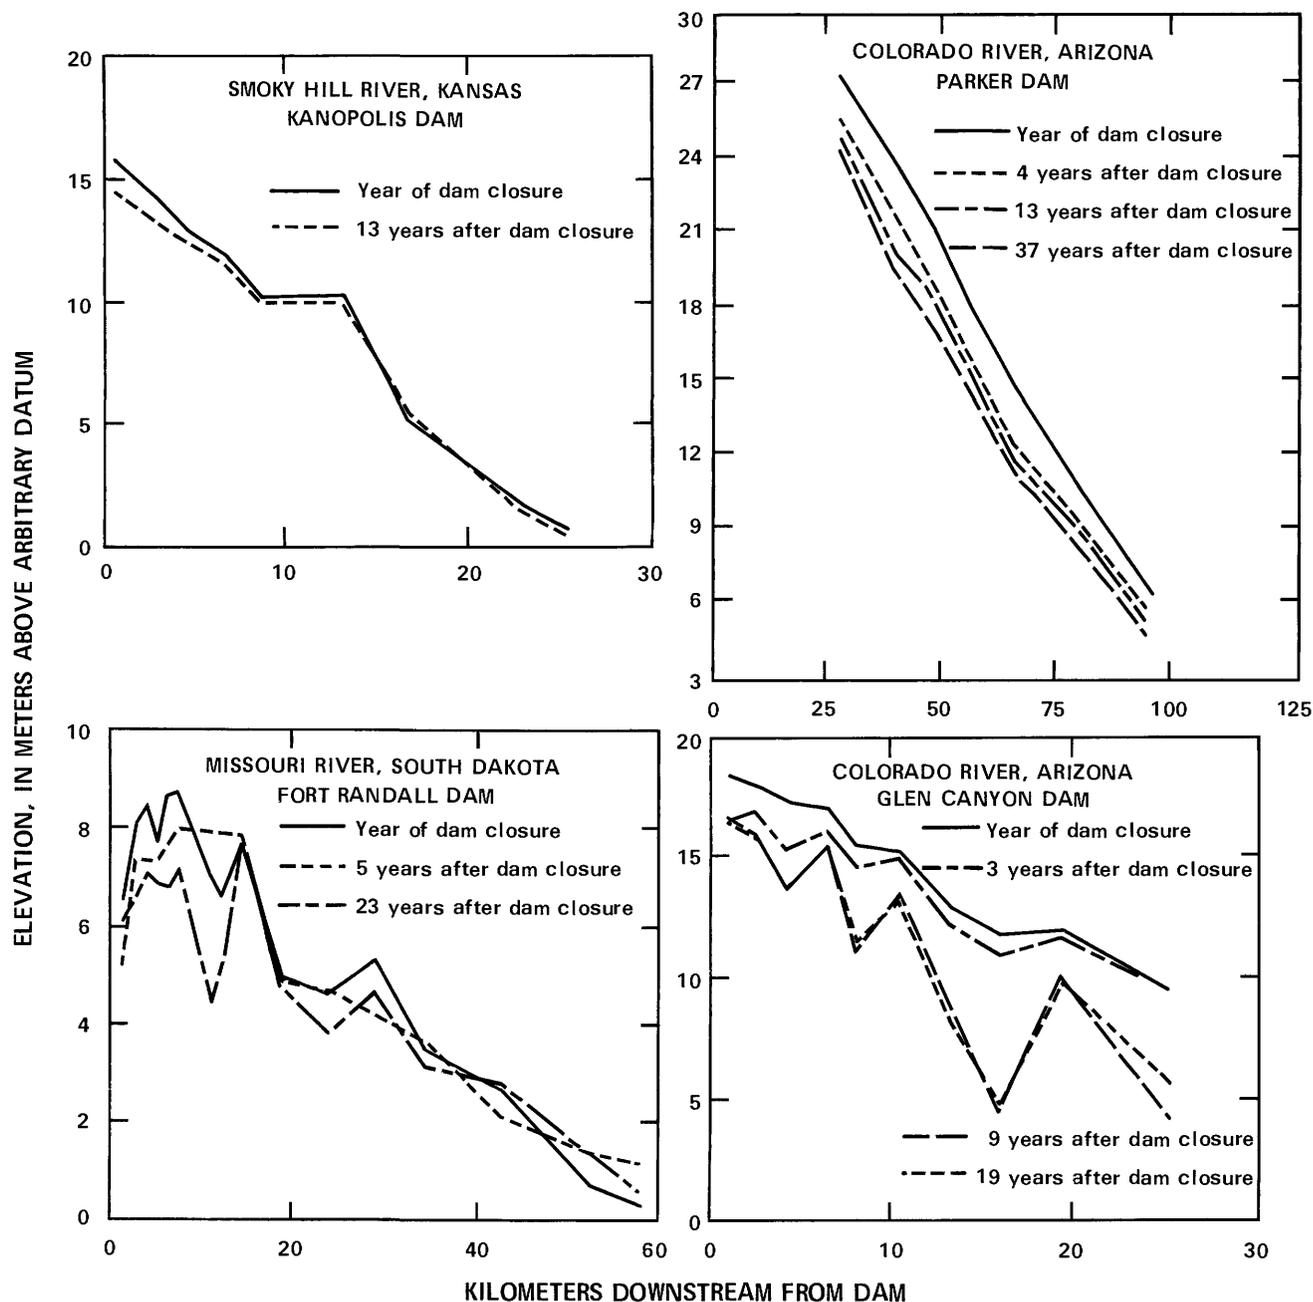
FIGURE 12.—Longitudinal-profile changes downstream from four dams.

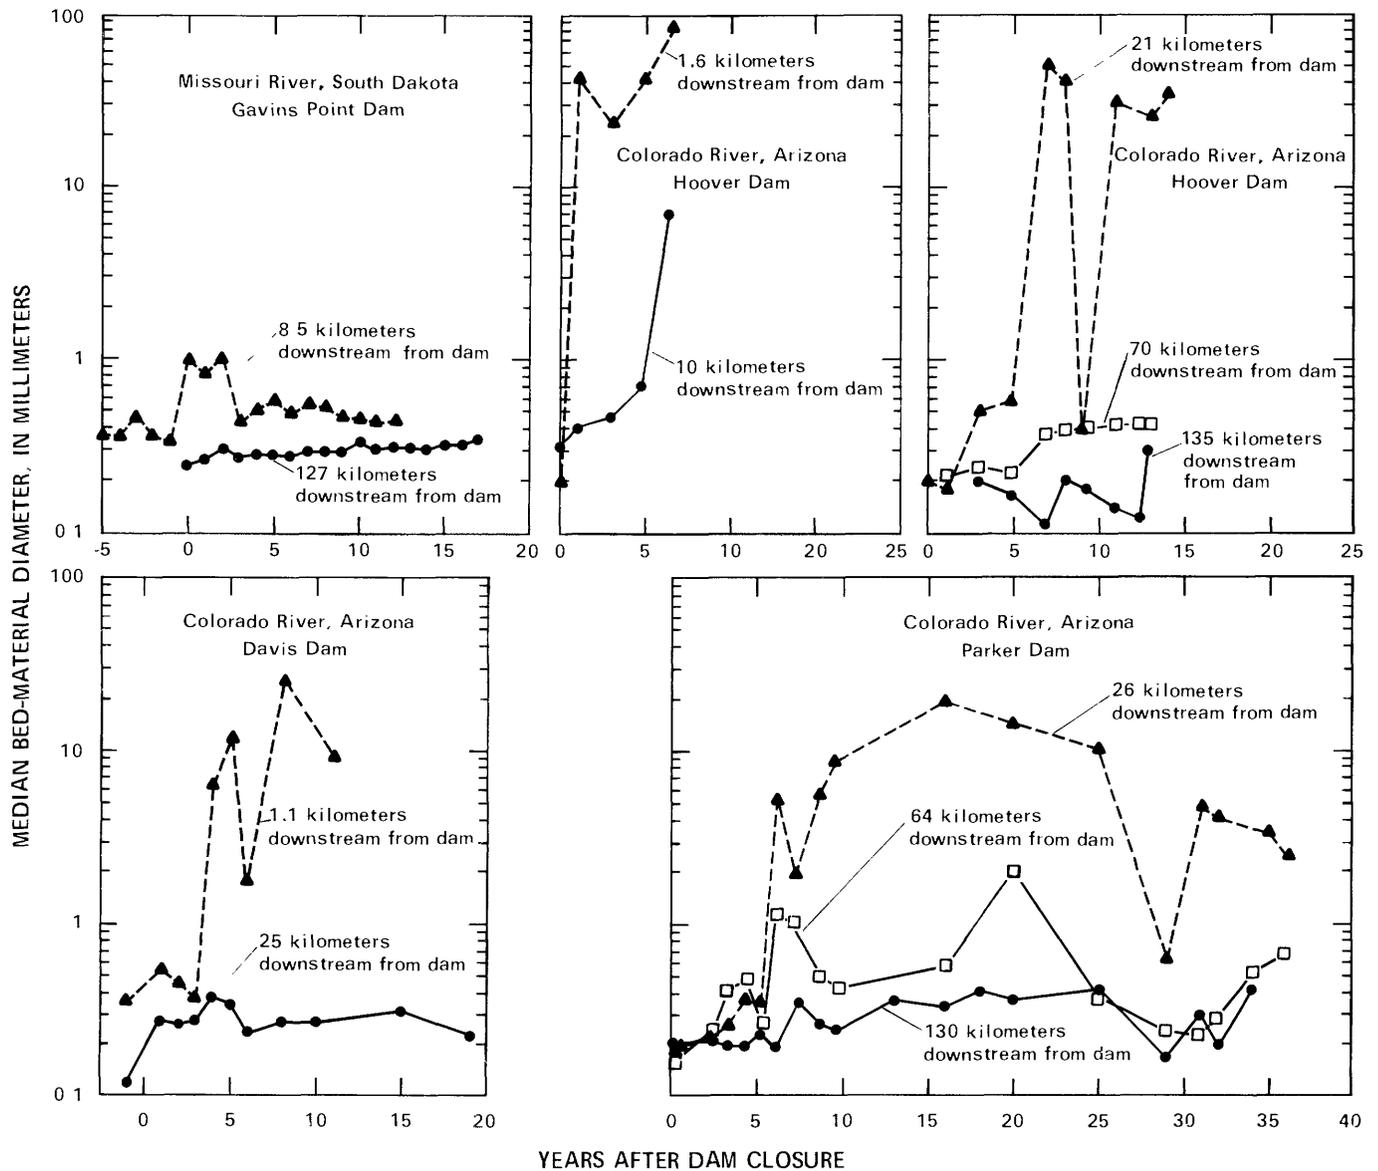
FIGURE 13.—Variation in bed-material size with time at a site, after dam closure.

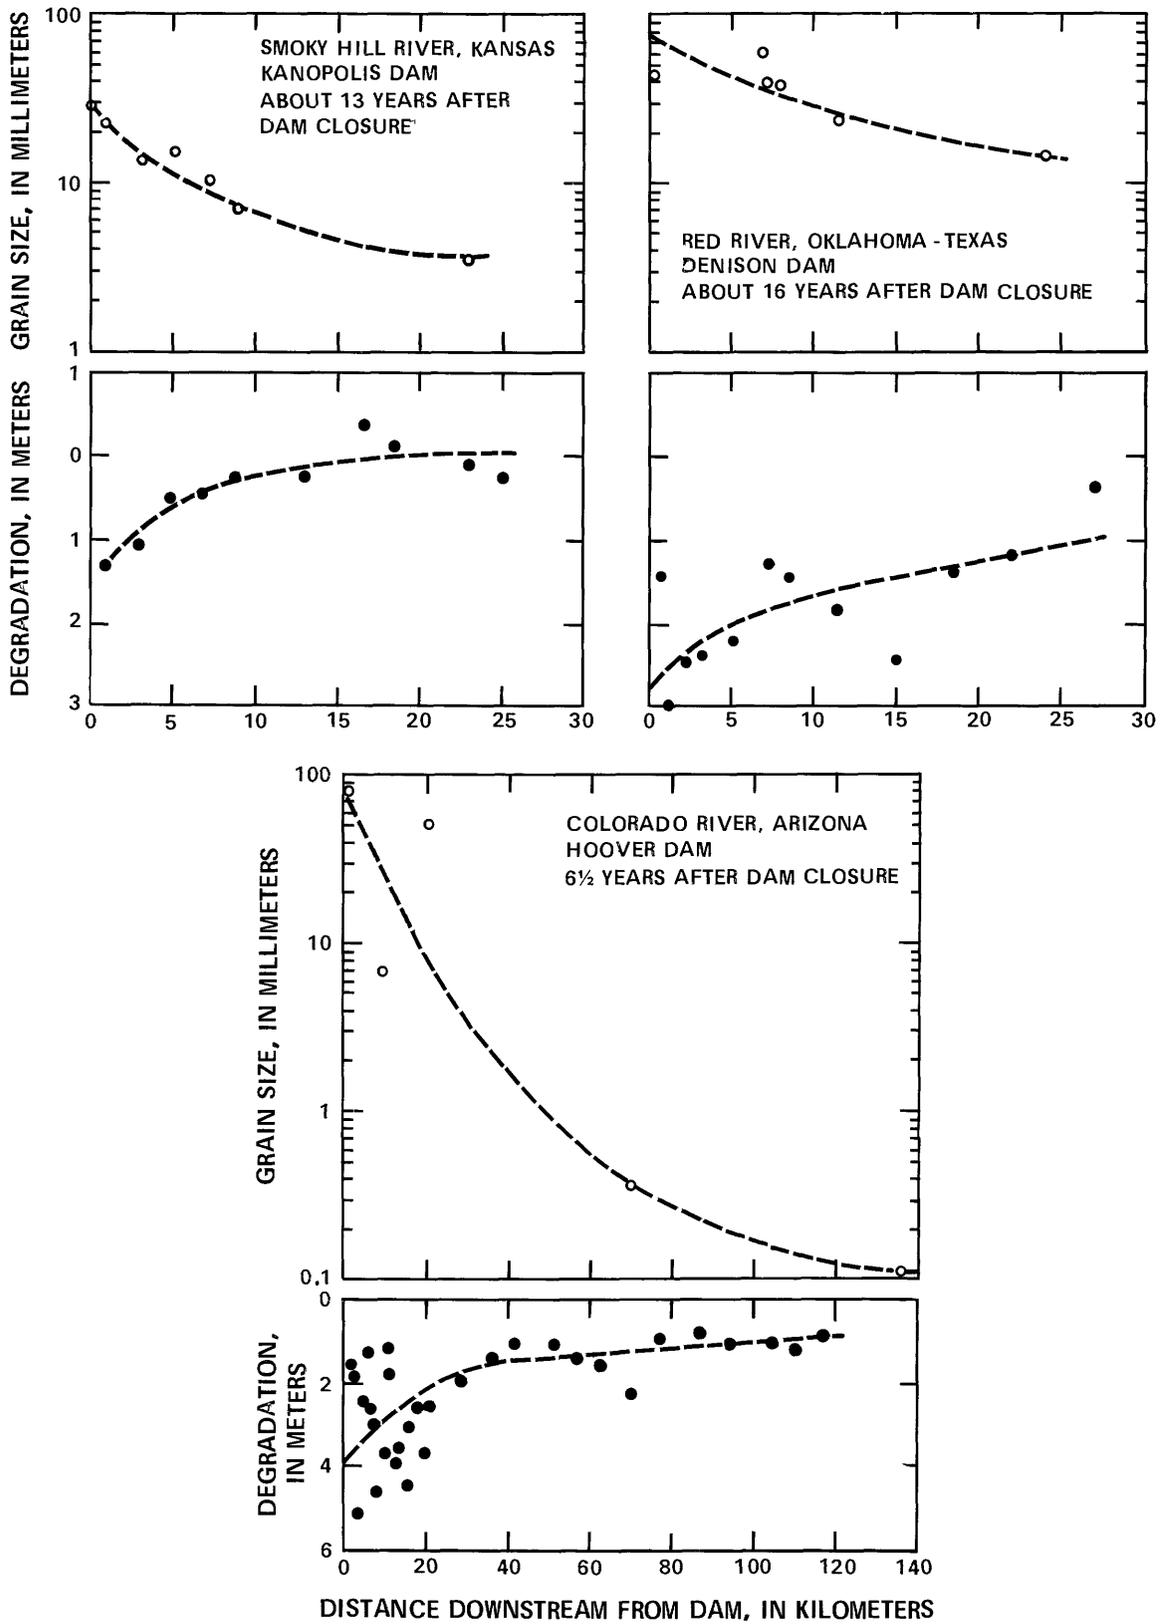
FIGURE 14.—Variation in bed-material diameter and bed degradation with distance downstream, at a given time after dam closure. Smoky Hill and Red River data are median diameter from pebble counts on gravel bars; Colorado River size data are d_{50} for entire sample of sieved bed material. Degradation data are from table 13.

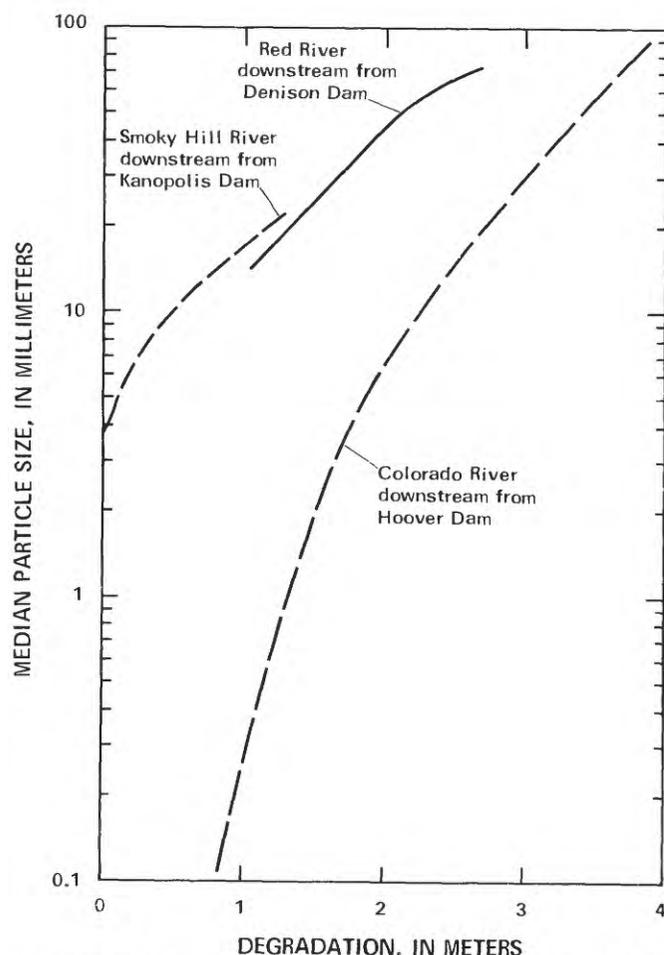
FIGURE 15.—Increase in bed-material size with bed degradation downstream from three dams (as estimated from the smoothed curves in figure 14).

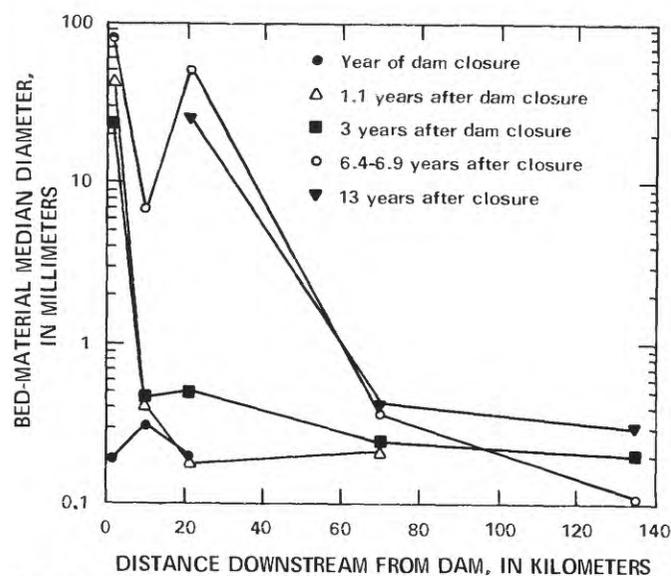
FIGURE 16.—Variation in median bed-material diameter with distance along the Colorado River downstream from Hoover Dam, at successive times after dam closure.

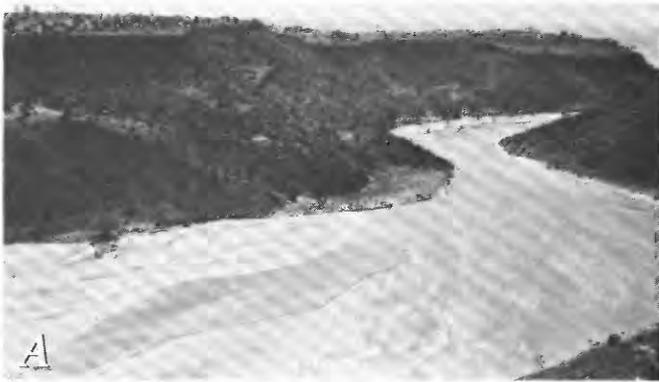
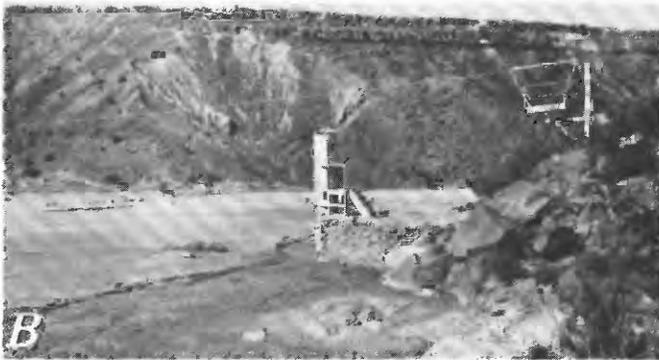
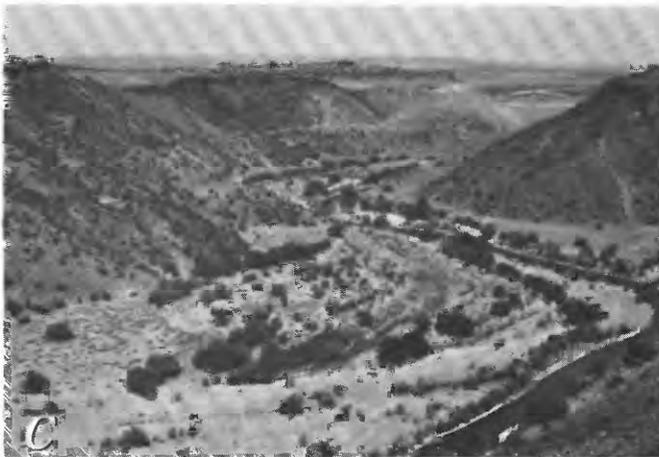
FIGURE 17.—Jemez River downstream from Jemez Dam, New Mexico, A, April 1936; B, spring 1951; C, June 1980. Dam was closed in 1953.

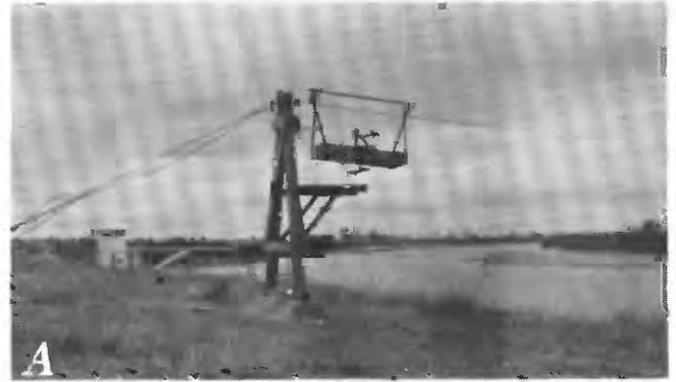
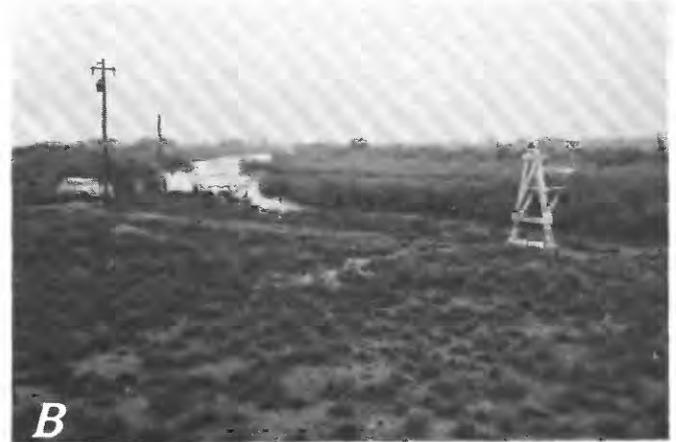
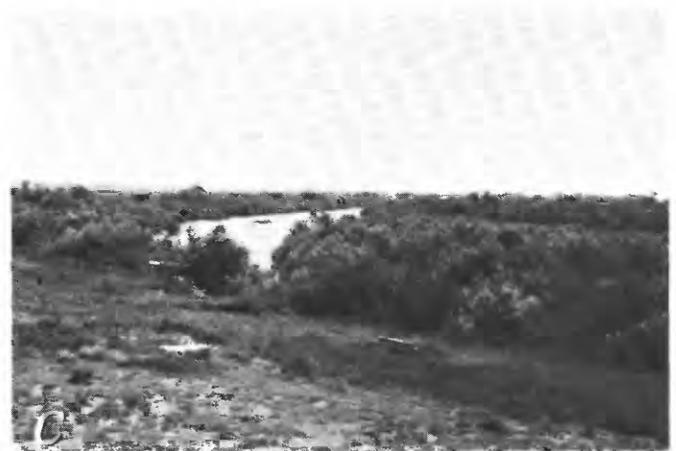
FIGURE 18.—Old streamflow-gaging site on Arkansas River 3 kilometers downstream from John Martin Dam, Colorado. A, March 1946; B, September 1959; C, July 1980. Dam was closed in 1943.

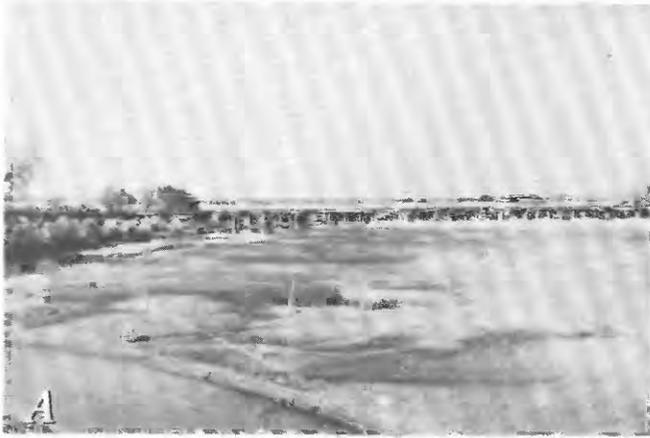
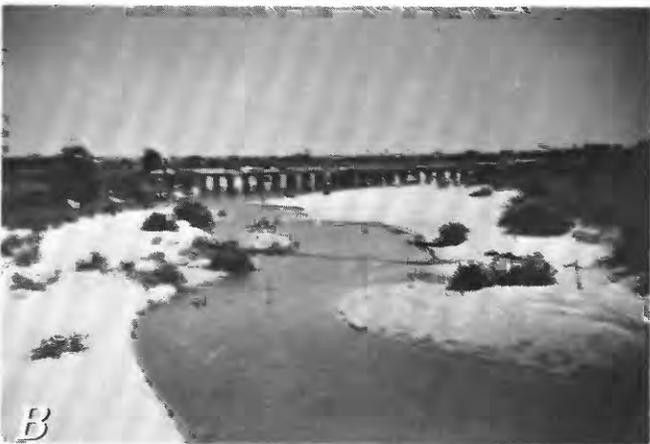
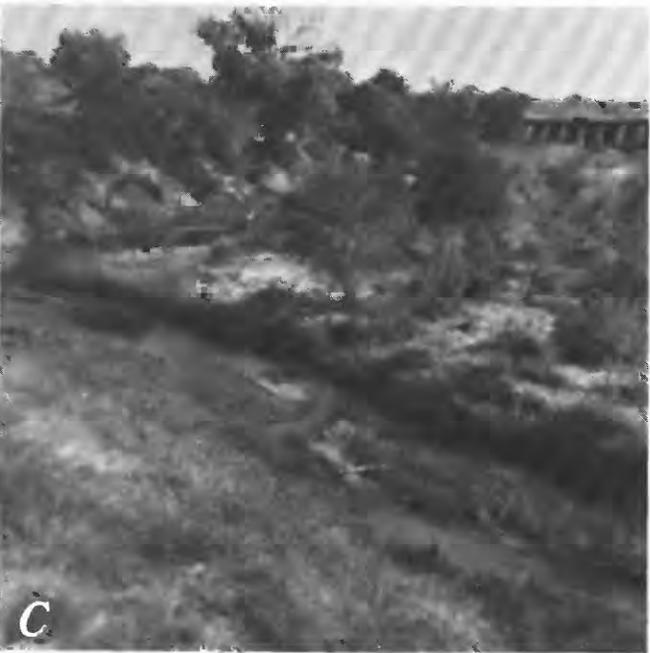
FIGURE 19.—Wolf Creek about 2.6 kilometers downstream from Fort Supply Dam, Oklahoma. *A*, April 1940; *B*, September 1958; *C*, August 1972. Dam was closed in 1942.

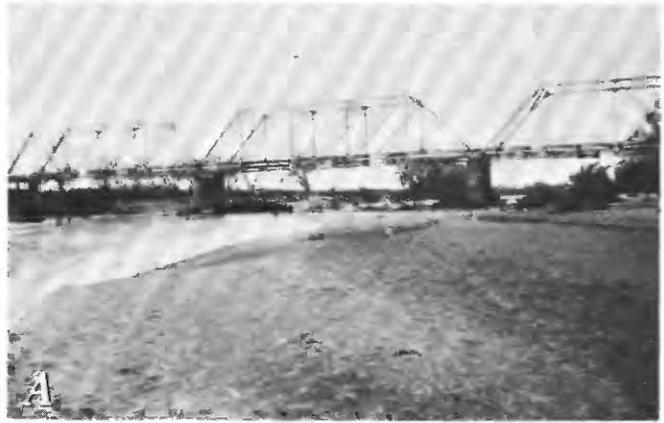
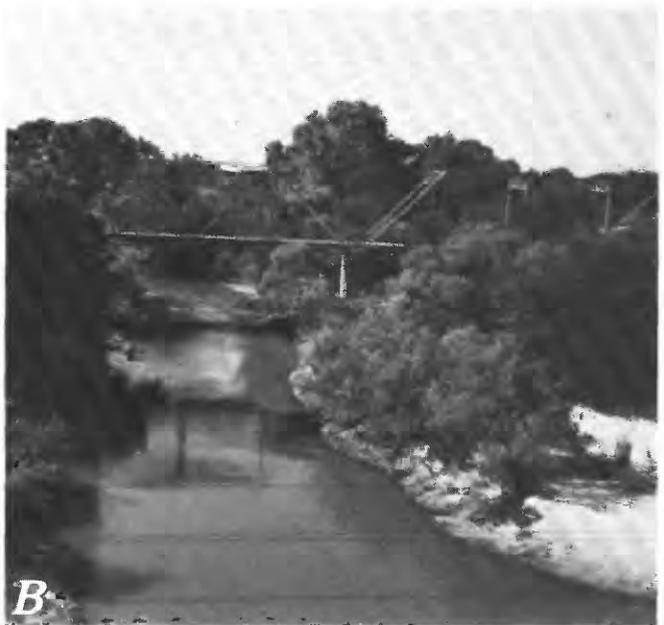
FIGURE 20.—North Canadian River about 0.8 kilometer downstream from Canton Dam, Oklahoma. *A*, about 1938; *B*, July 1980. Dam was closed in 1948. Both scenes are looking downstream at the highway bridge.

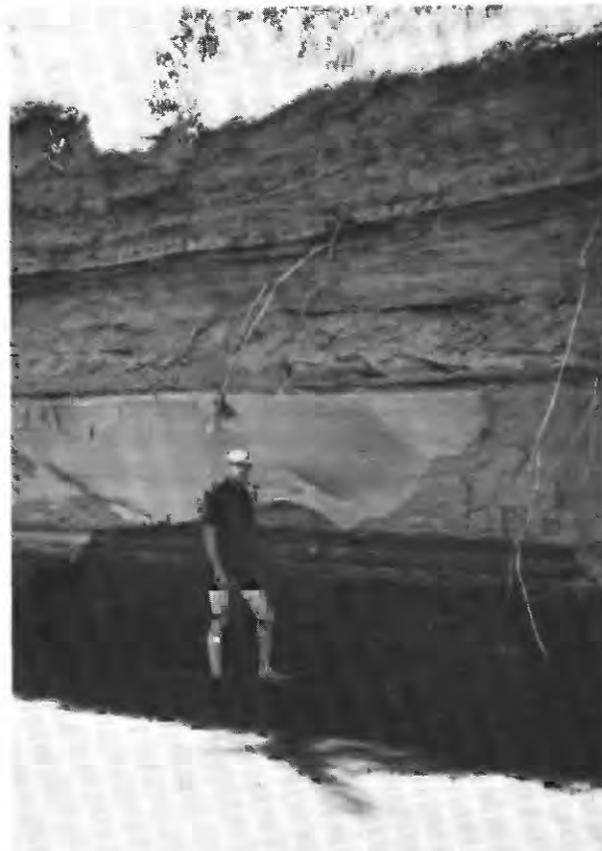
FIGURE 21.—Sandy bank of Missouri River about 10 kilometers downstream from Garrison Dam, North Dakota.

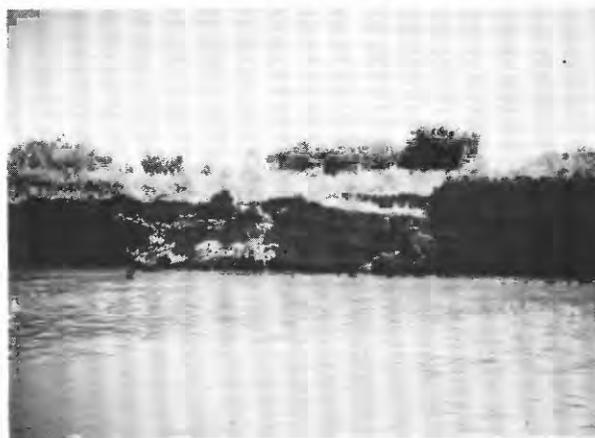
FIGURE 22.—Stratified sand and silt bank, Missouri River downstream from Garrison Dam, North Dakota.

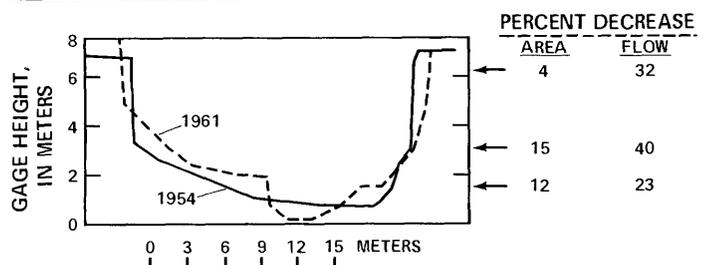
FIGURE 23.—Changes in channel cross section of Sandstone Creek, Oklahoma, at the streamflow-gaging station, 1954-61, caused by many upstream flood-detention dams (modified from Bergman and Sullivan, 1963).

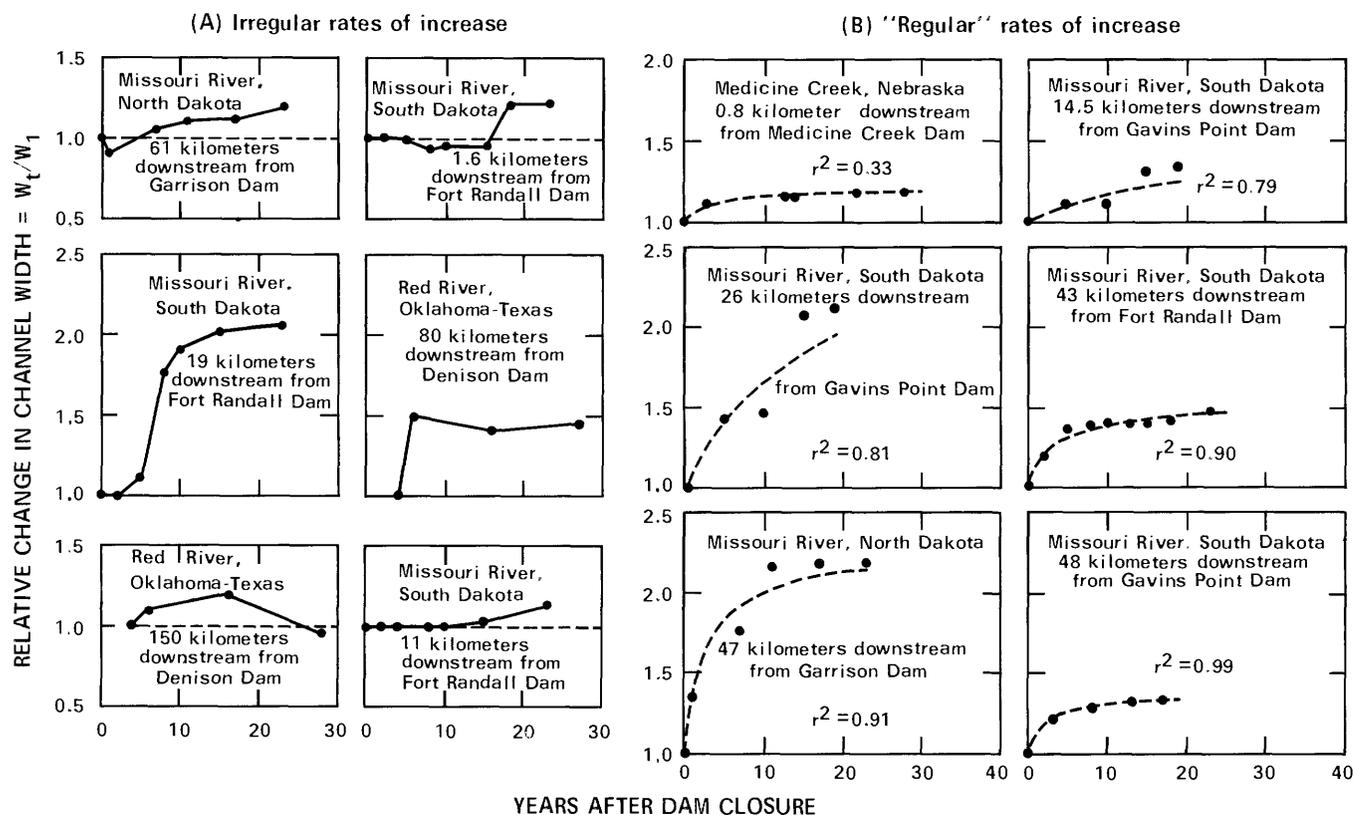
FIGURE 24.—Examples of relative increase of channel width with time: A, irregular rates; B, regular rates with fitted regression curves (dashed lines). Data from table 13.
