Downstream Effects of Dams on Alluvial Rivers

GEOLOGICAL SURVEY PROFESSIONAL PAPER 1286

By GARNETT P. WILLIAMS *and* M. GORDON WOLMAN

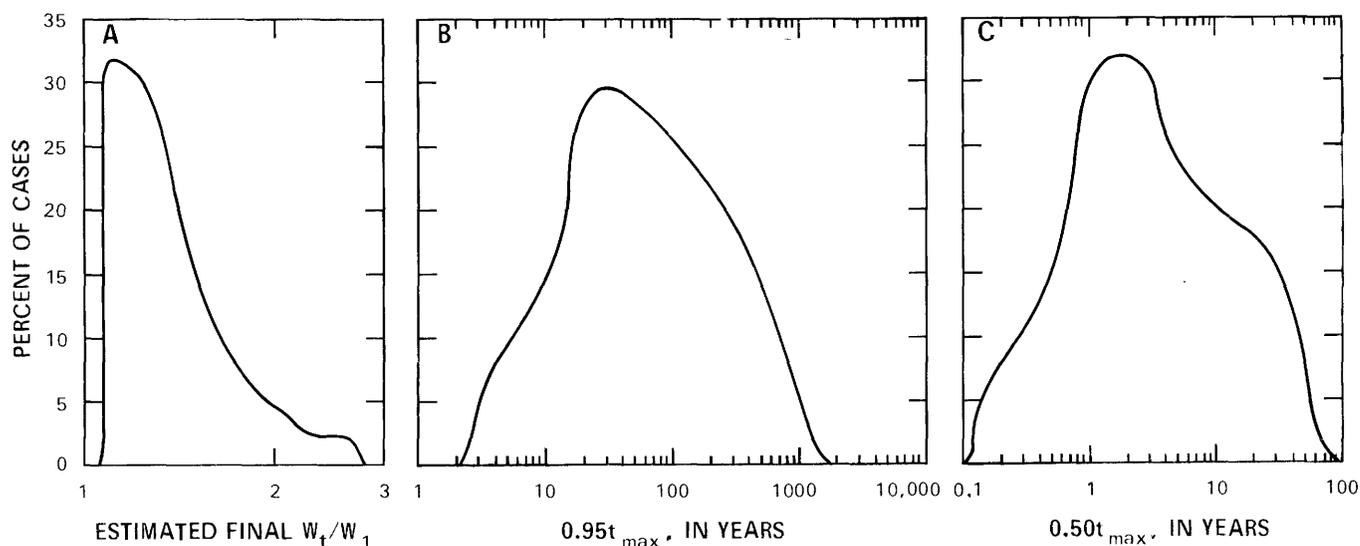
FIGURE 25.—Frequency distributions of estimated eventual increases in channel width, based on 44 measured cross sections on various rivers: A, final values of W_t/W_1 ; B, years needed to widen to 95 percent of final W_t/W_1 ; C, years needed to widen to 50 percent of final W_t/W_1 .

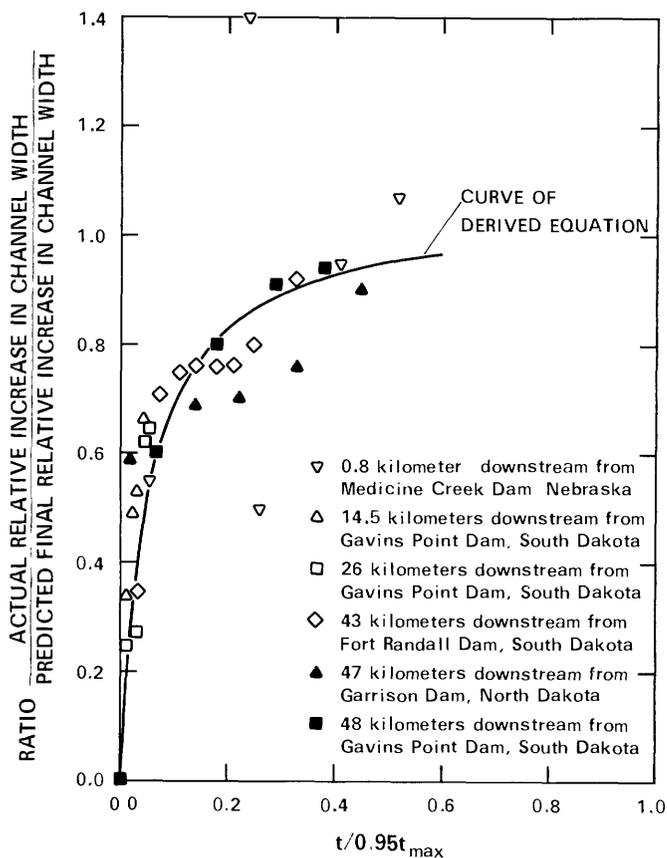
FIGURE 26.—Dimensionless plot of relative increase in channel width with time, for the 6 representative cross sections of figure 24B. Data from table 13.

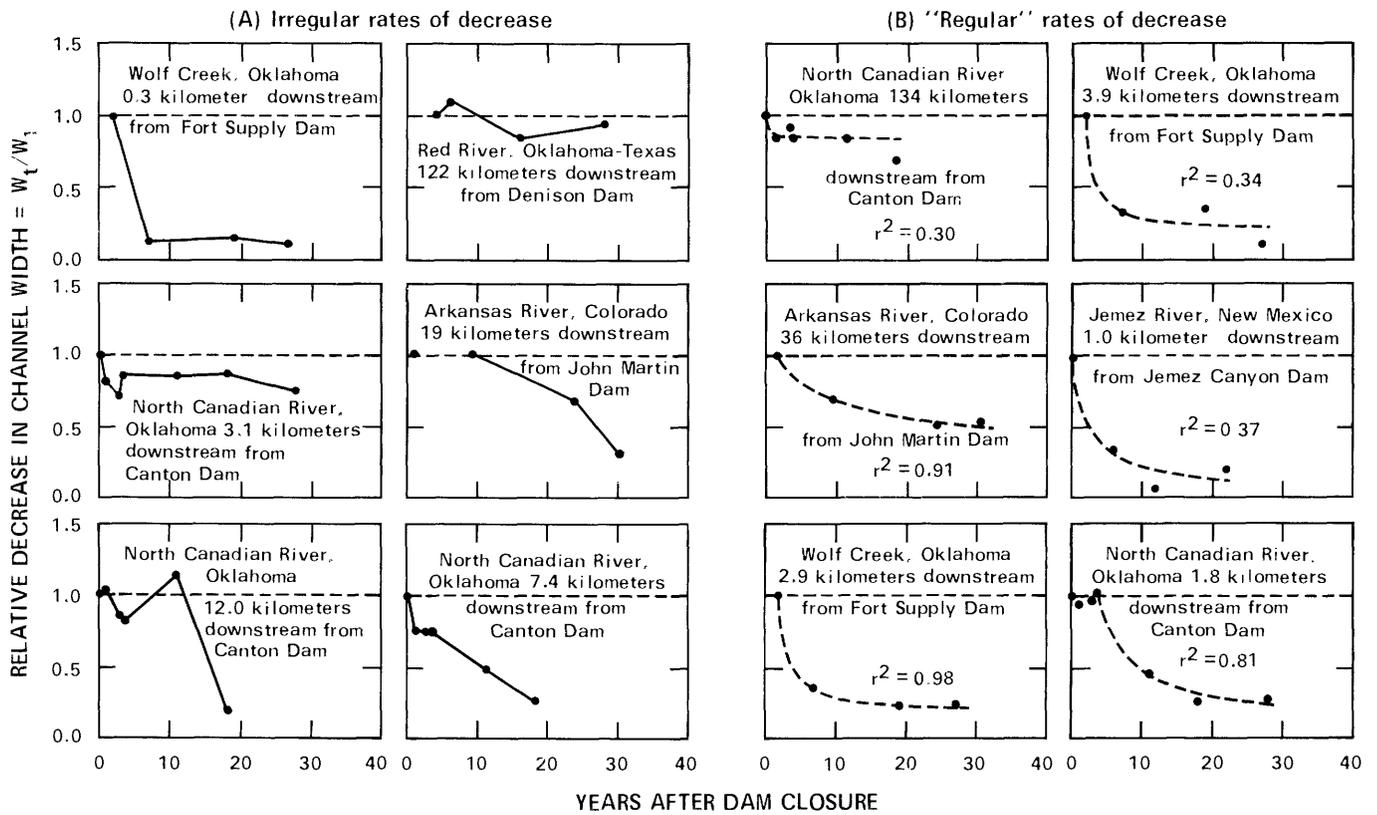
FIGURE 27.—Examples of relative decrease in channel width with time: A, irregular rates; B, regular rates with fitted regression curves (dashed lines). Data from table 13.

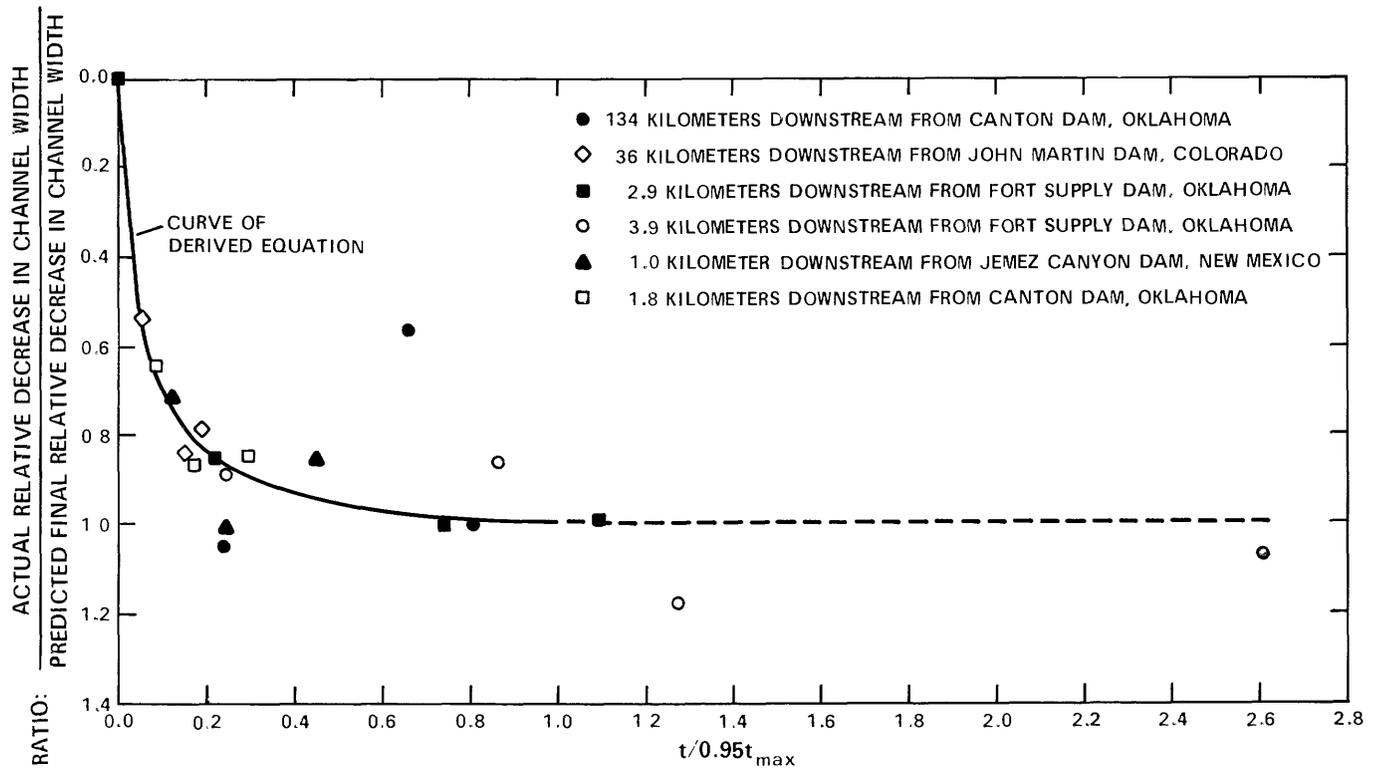
FIGURE 28.—Dimensionless plot of relative decrease in channel width with time, for the 6 cross sections of figure 27B. One point (for the section 134 kilometers downstream from Canton Dam) plots off the graph. Data from table 13.

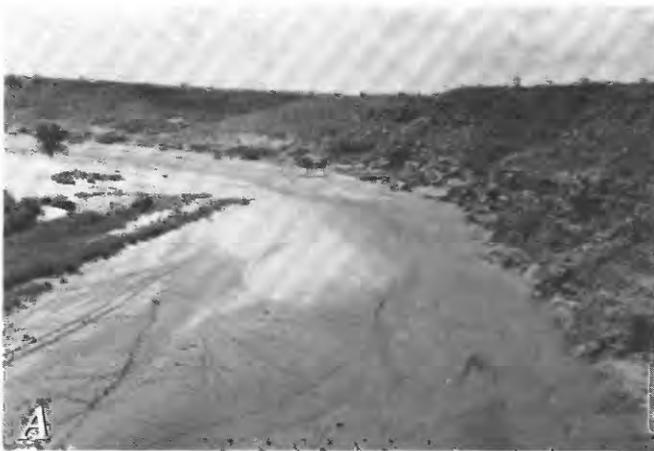
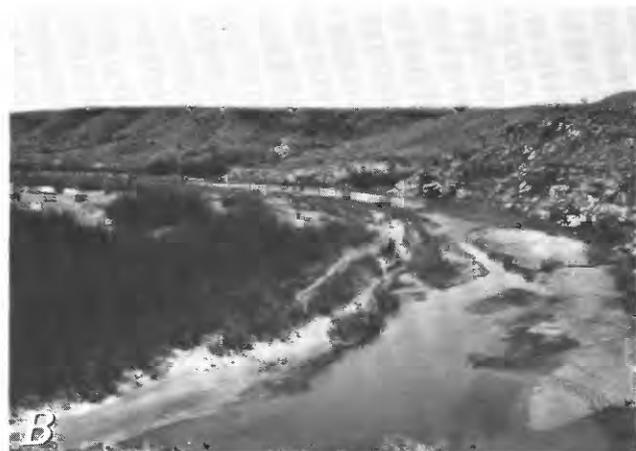
FIGURE 30.—Canadian River about 3 kilometers downstream from Ute Dam, New Mexico. A, August 1954; B, April 1980. Dam was closed in 1963.

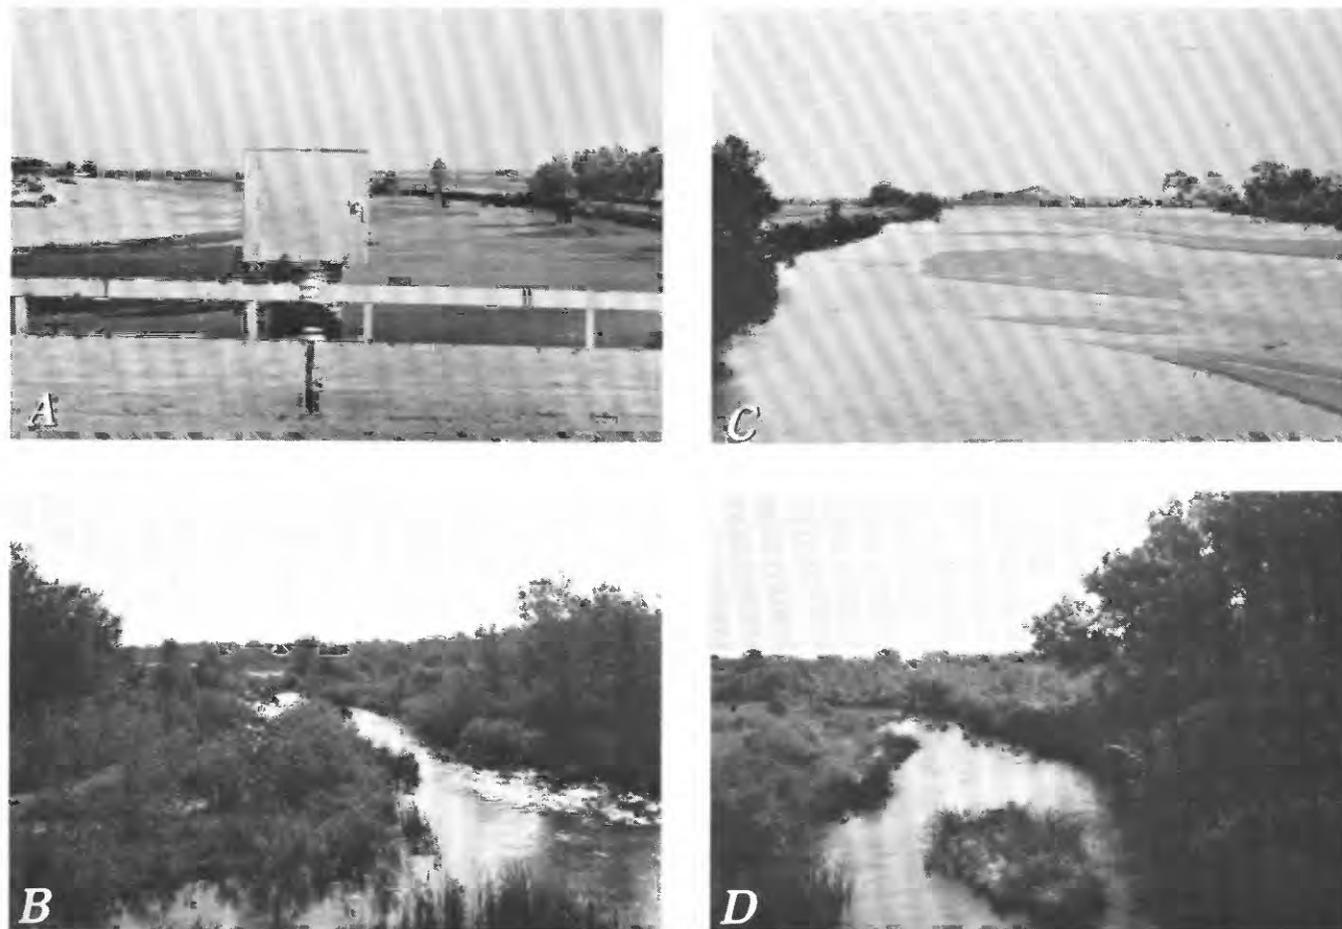
FIGURE 31.—Republican River downstream from Trenton Dam, Nebraska. Dam was closed in 1953. Looking downstream from bridge at Trenton (4 kilometers downstream from the dam), about 1949 (A) and July 1980 (B). Looking downstream from bridge at Culbertson (19 kilometers downstream from dam), July 1932 (C) and July 1980 (D).

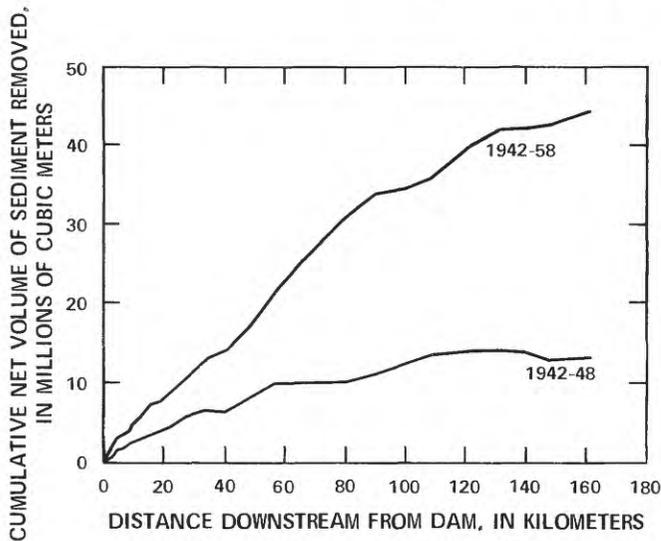
FIGURE 32.—Variation in cumulative net sediment volumes of channel erosion with distance downstream from Denison Dam on the Red River, Oklahoma-Texas.

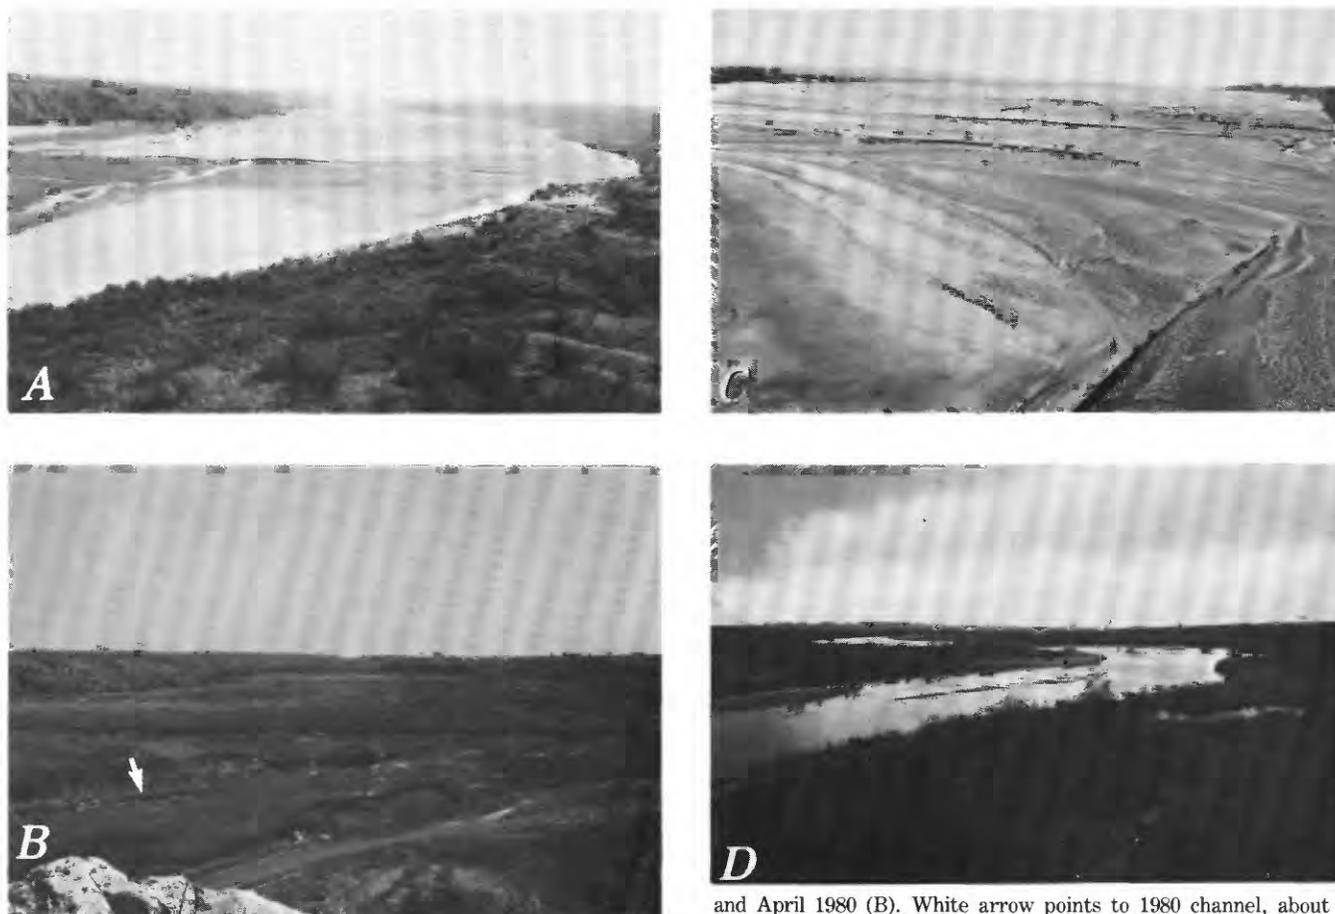
FIGURE 33.—Canadian River downstream from Sanford Dam, Texas. Dam was closed in 1964. Looking downstream from about 400 meters downstream from damsite, October 1960 (A, prior to dam)

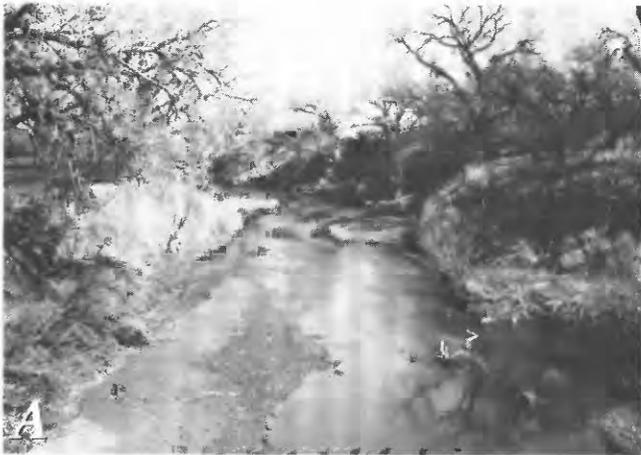
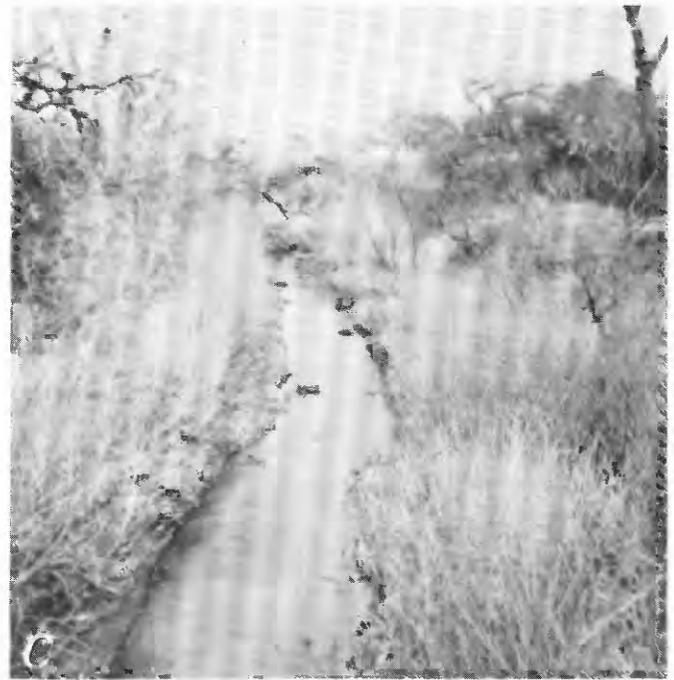
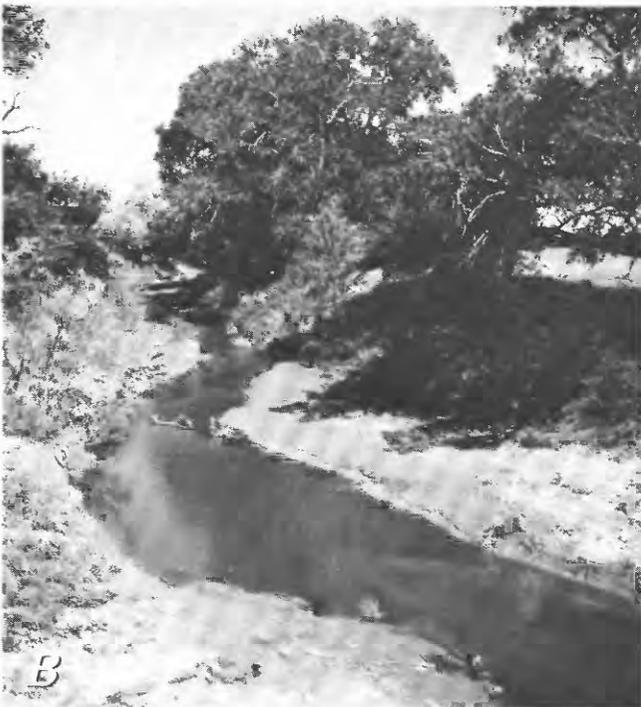
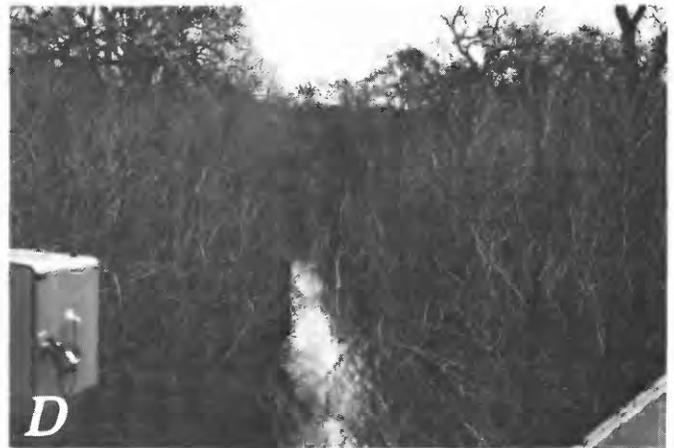
FIGURE 34.—Washita River about 1.4 kilometers downstream from Foss Dam, Oklahoma. A, February 1958; B, May 1962; C, March 1967; D, February 1970. Dam was closed in 1961.

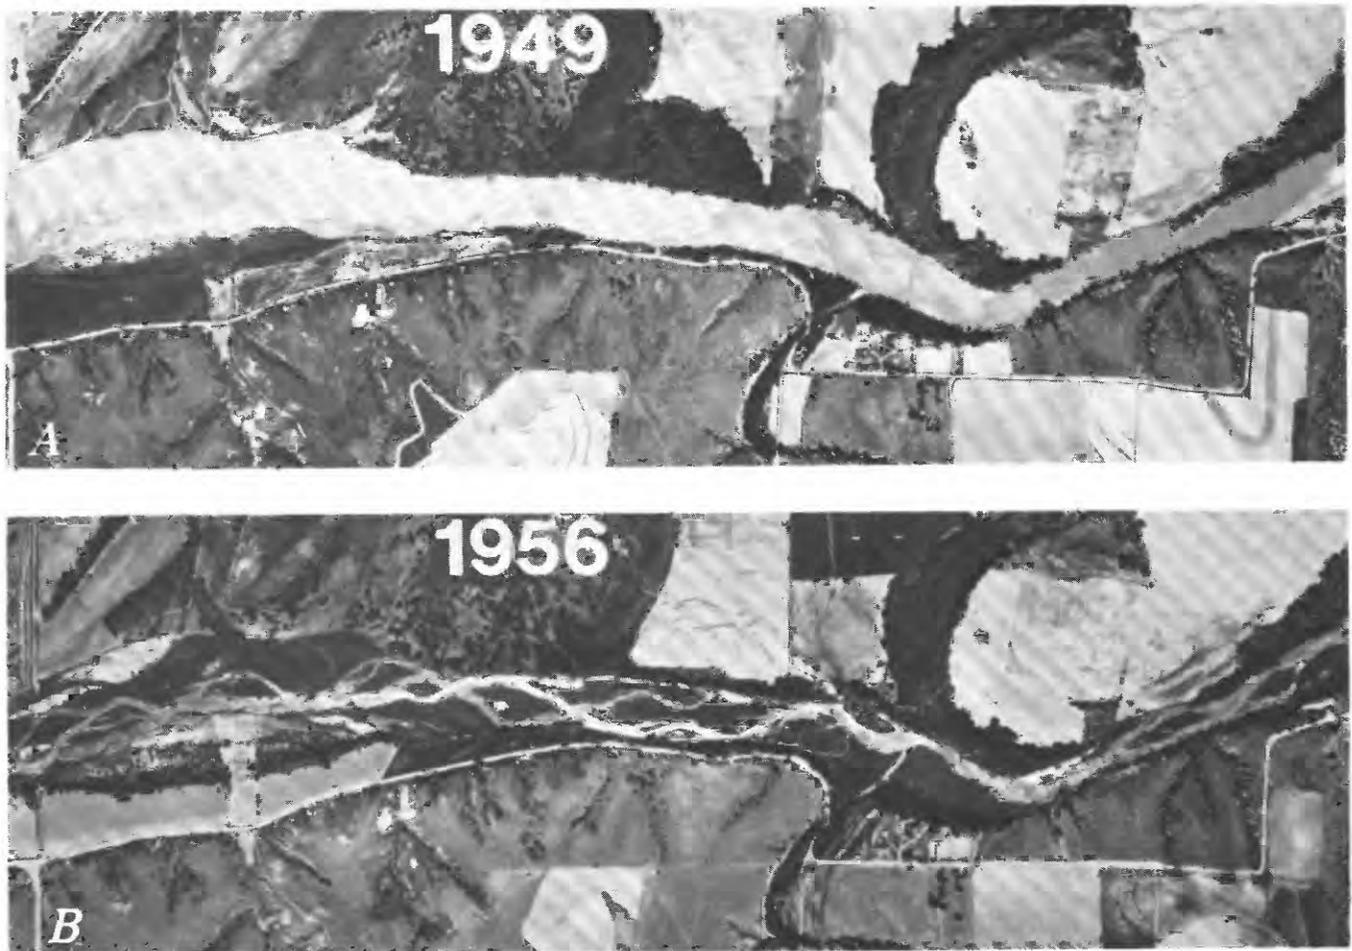
FIGURE 35.—Republican River downstream from Harlan County Dam, Nebraska, before and after dam closure. Reach shown is near Bloomington, Nebraska. Flow was 29 cubic meters per second at time of 1949 photograph and only 1.8 cubic meters per second at time of 1956 photograph, but the increase in vegetation (dark areas) and the change in channel pattern are nonetheless apparent.

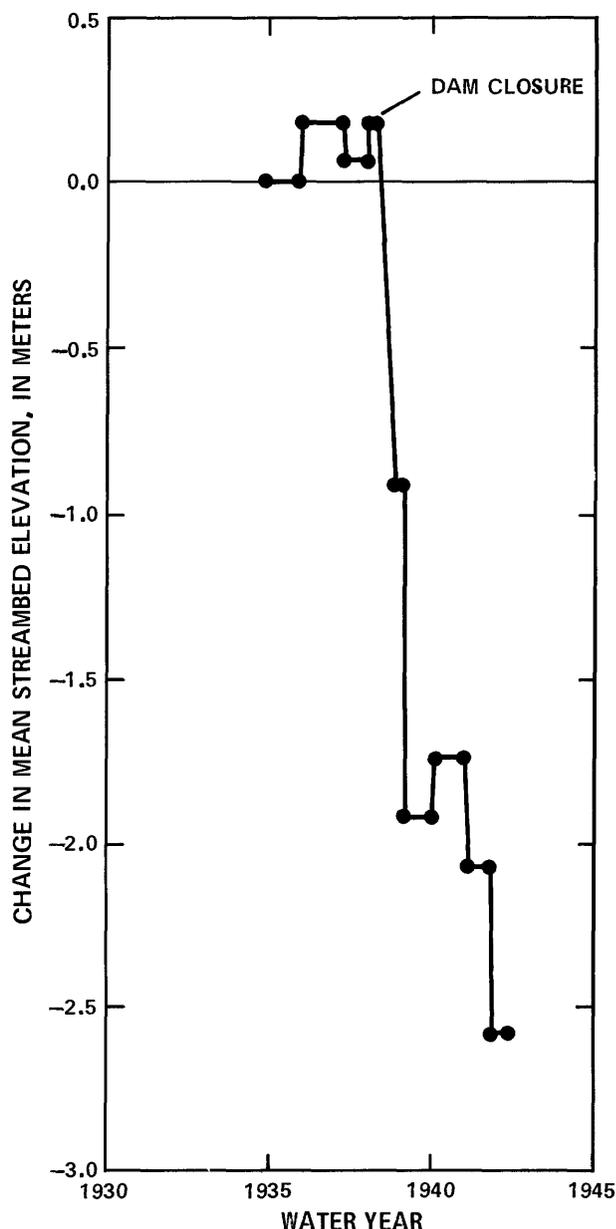
FIGURE 36.—Changes in mean streambed elevation with time at streamflow-gaging station on Colorado River 6.4 kilometers downstream from Parker Dam, Arizona. Plotted points represent elevation corresponding to a discharge of 90.6 cubic meters per second, as determined from rating tables. No upstream control station available.

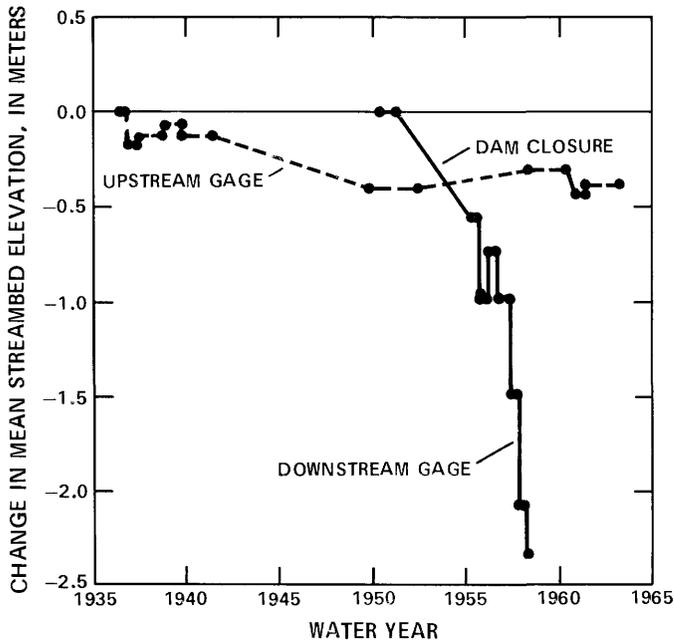
FIGURE 37.—Changes in mean streambed elevation with time at streamflow-gaging station on Jemez River 1.3 kilometers downstream from Jemez Canyon Dam, New Mexico, and at the control station near Jemez 13 kilometers upstream from dam. Plotted points represent elevation corresponding to a discharge of 0.034 cubic meter per second downstream from dam and 0.37 cubic meter per second upstream from dam, as determined from rating tables.

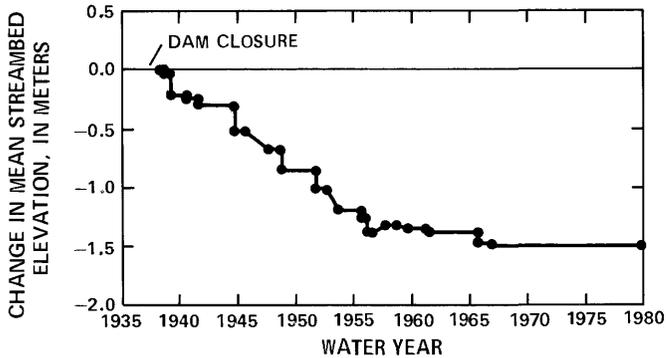
FIGURE 38.—Changes in mean streambed elevation with time at streamflow-gaging station on Missouri River 13 kilometers downstream from Fort Peck Dam, Montana. Plotted points represent elevation corresponding to a discharge of 85 cubic meters per second as determined from rating tables. No upstream control station available.

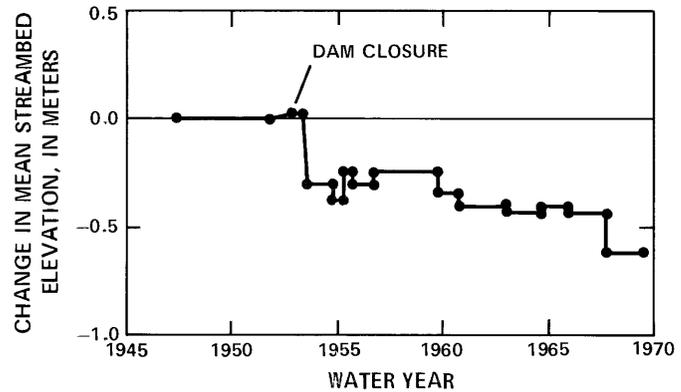
FIGURE 39.—Changes in mean streambed elevation with time at streamflow-gaging station on Missouri River 11 kilometers downstream from Fort Randall Dam, South Dakota. Plotted points represent elevation corresponding to a discharge of 464 cubic meters per second, as determined from rating tables. No upstream control station available.

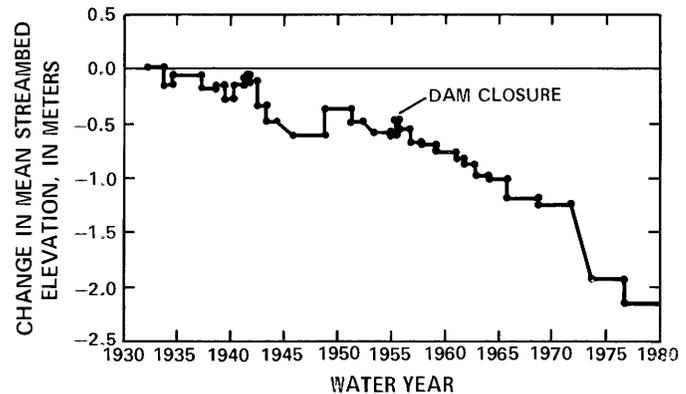
FIGURE 40.—Changes in mean streambed elevation with time at streamflow-gaging station on Missouri River 8 kilometers downstream from Gavins Point Dam, South Dakota. Plotted points represent elevation corresponding to a discharge of 312 cubic meters per second, as determined from rating tables. No upstream control station available.

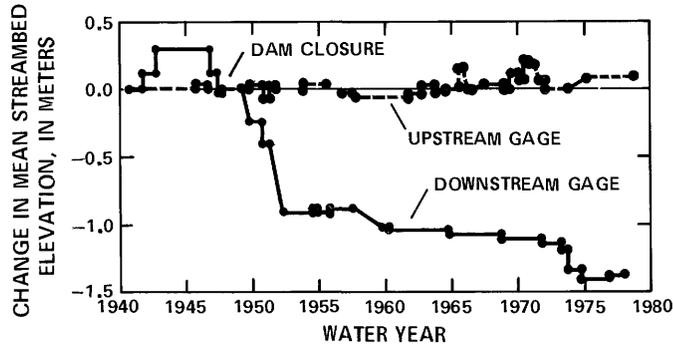
FIGURE 41.—Changes in mean streambed elevation with time at streamflow-gaging station on Smoky Hill River 1.3 kilometers downstream from Kanopolis Dam, Kansas, and at the control station at Ellsworth 48 kilometers upstream from dam. Plotted points represent elevation corresponding to a discharge of 0.51 cubic meter per second downstream from dam and 0.43 cubic meter per second upstream from dam, as determined from rating tables.

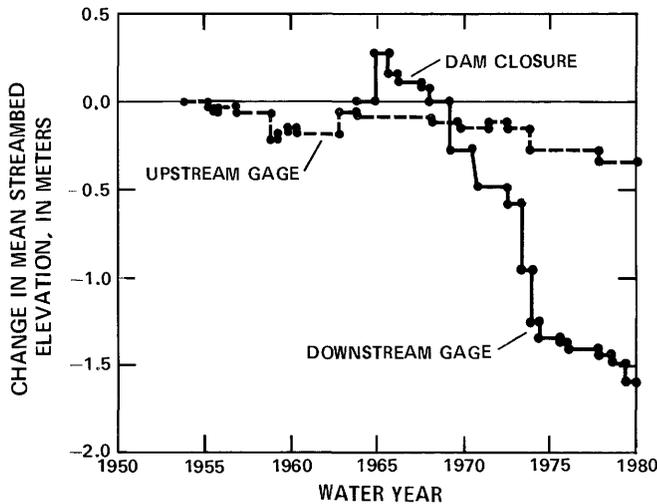
FIGURE 42.—Changes in mean streambed elevation with time at streamflow-gaging station on Republican River 2.7 kilometers downstream from Milford Dam, Kansas, and at control station at Clay Center 49 kilometers upstream from dam. Plotted points represent elevation corresponding to a discharge of 1.2 cubic meters per second downstream from dam and 3.4 cubic meters per second upstream from dam, as determined from rating tables.

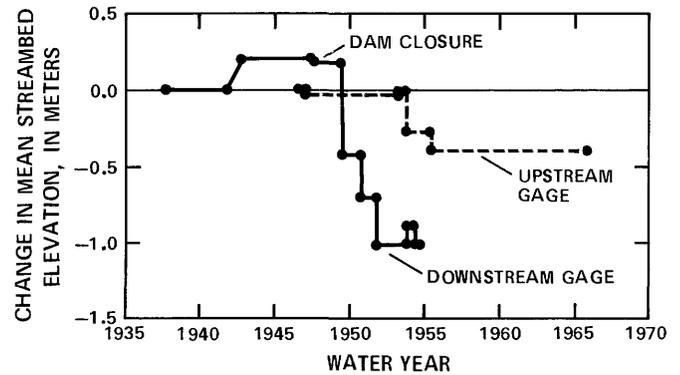
FIGURE 43.—Changes in mean streambed elevation with time at streamflow-gaging station on North Canadian River 4.8 kilometers downstream from Canton Dam, Oklahoma, and at the control station near Seiling 45 kilometers upstream from dam. Plotted points represent elevation corresponding to a discharge of 0.031 cubic meter per second downstream from dam and 0.00057 cubic meter per second upstream from dam, as determined from rating tables.

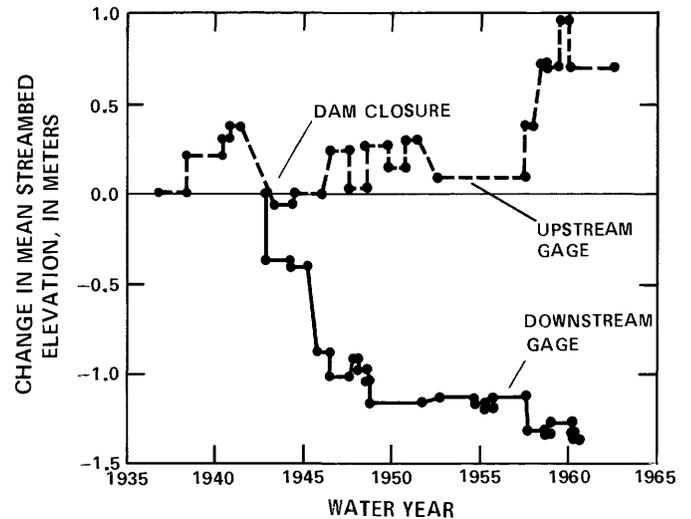
FIGURE 44.—Changes in mean streambed elevation with time at streamflow-gaging station on Red River 4.5 kilometers downstream from Denison Dam, Oklahoma, and at the control station near Gainesville, Texas, 106 kilometers upstream from dam. Plotted points represent elevation corresponding to a discharge of 3.7 cubic meters per second downstream from dam and 4.2 cubic meters per second upstream from dam, as determined from rating tables.

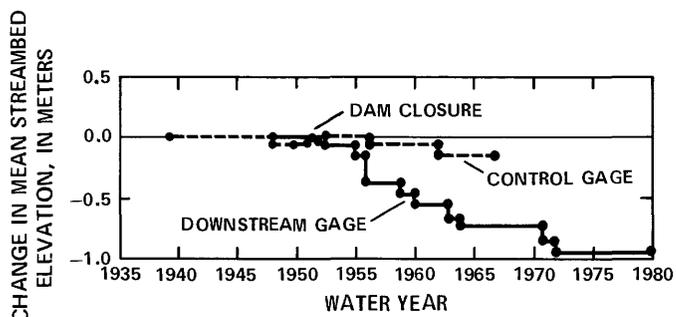
FIGURE 45.—Changes in mean streambed elevation with time at streamflow-gaging station on Neches River 0.5 kilometer downstream from Town Bluff Dam, Texas, and at the control station on Village Creek near Kountze in an adjacent drainage basin. Plotted points represent elevation corresponding to a discharge of 4.2 cubic meters per second downstream from dam and 1.5 cubic meters per second at the control station, as determined from rating tables.

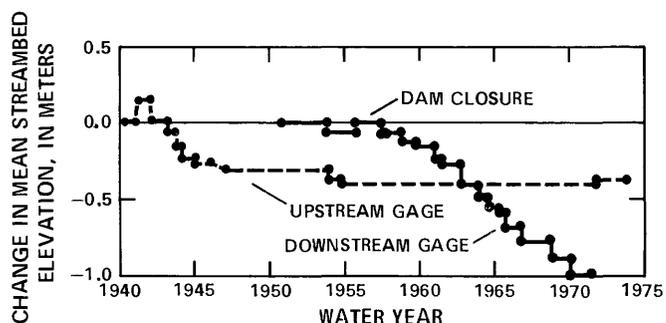
FIGURE 46.—Changes in mean streambed elevation with time at streamflow-gaging station on Chattahoochee River 4 kilometers downstream from Buford Dam, Georgia, and at the control station on the Chestatee River near Dahlonega 73 kilometers upstream from dam. Plotted points represent elevation corresponding to a discharge of 12.2 cubic meters per second downstream from dam and 3.4 cubic meters per second upstream from dam, as determined from rating tables.

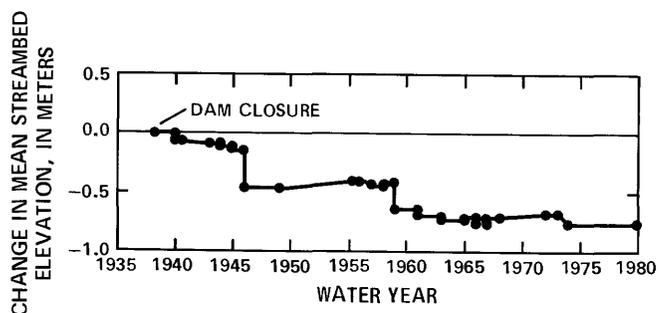
FIGURE 47.—Changes in mean streambed elevation with time at streamflow-gaging station on Rio Grande 1.3 kilometers downstream from Caballo Dam, New Mexico. Plotted points represent elevation corresponding to a discharge of 28.3 cubic meters per second, as determined from rating tables. No control station.

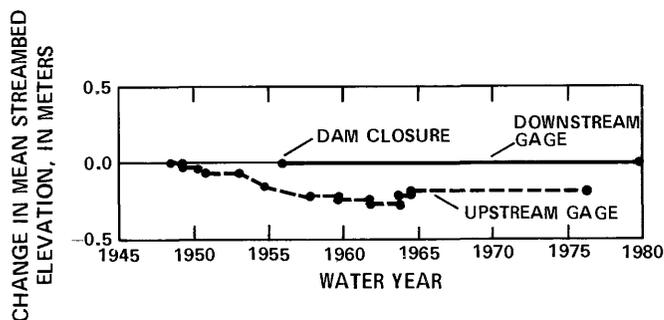
FIGURE 48.—Changes in mean streambed elevation with time at streamflow-gaging station on Marias River 3.2 kilometers downstream from Tiber Dam, Montana, and at the control station near Shelby 65 kilometers upstream from dam. Plotted points represent elevation corresponding to a discharge of 2.8 cubic meters per second downstream from dam and 4.0 cubic meters per second upstream from dam, as determined from rating tables.

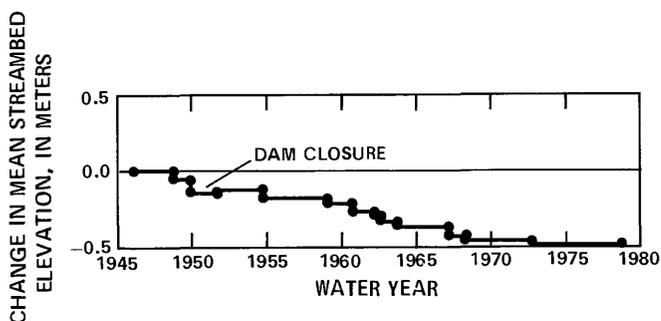
FIGURE 49.—Changes in mean streambed elevation with time at streamflow gaging station on Frenchman Creek 0.3 kilometer downstream from Enders Dam, Nebraska. Plotted points represent elevation corresponding to a discharge of 1.3 cubic meters per second, as determined from rating tables. No control station available.
