**STRATIGRAPHY OF LATE HOLOCENE CHANNEL AND FLOOD-PLAIN DEPOSITS EXPOSED IN A TRENCH EXCAVATED ACROSS THE ANIMAS RIVER VALLEY FLOOR 1.4 KILOMETERS DOWNSTREAM OF THE EUREKA TOWNSITE, SAN JUAN COUNTY, COLORADO**

By  
Kirk R. Vincent and John G. Elliott  
2007

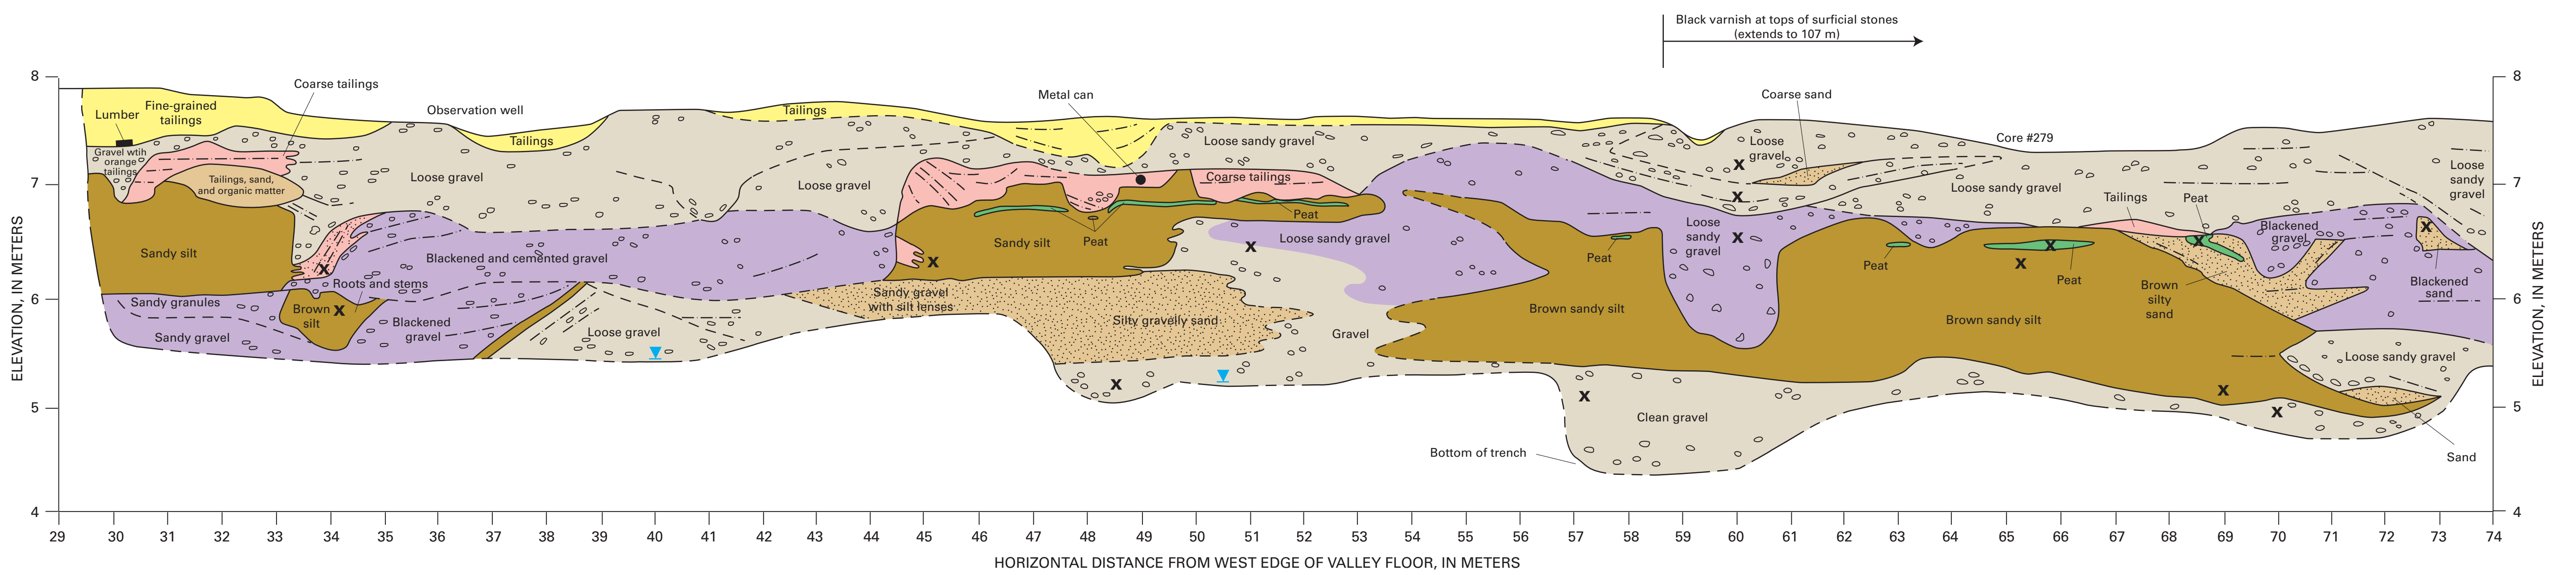
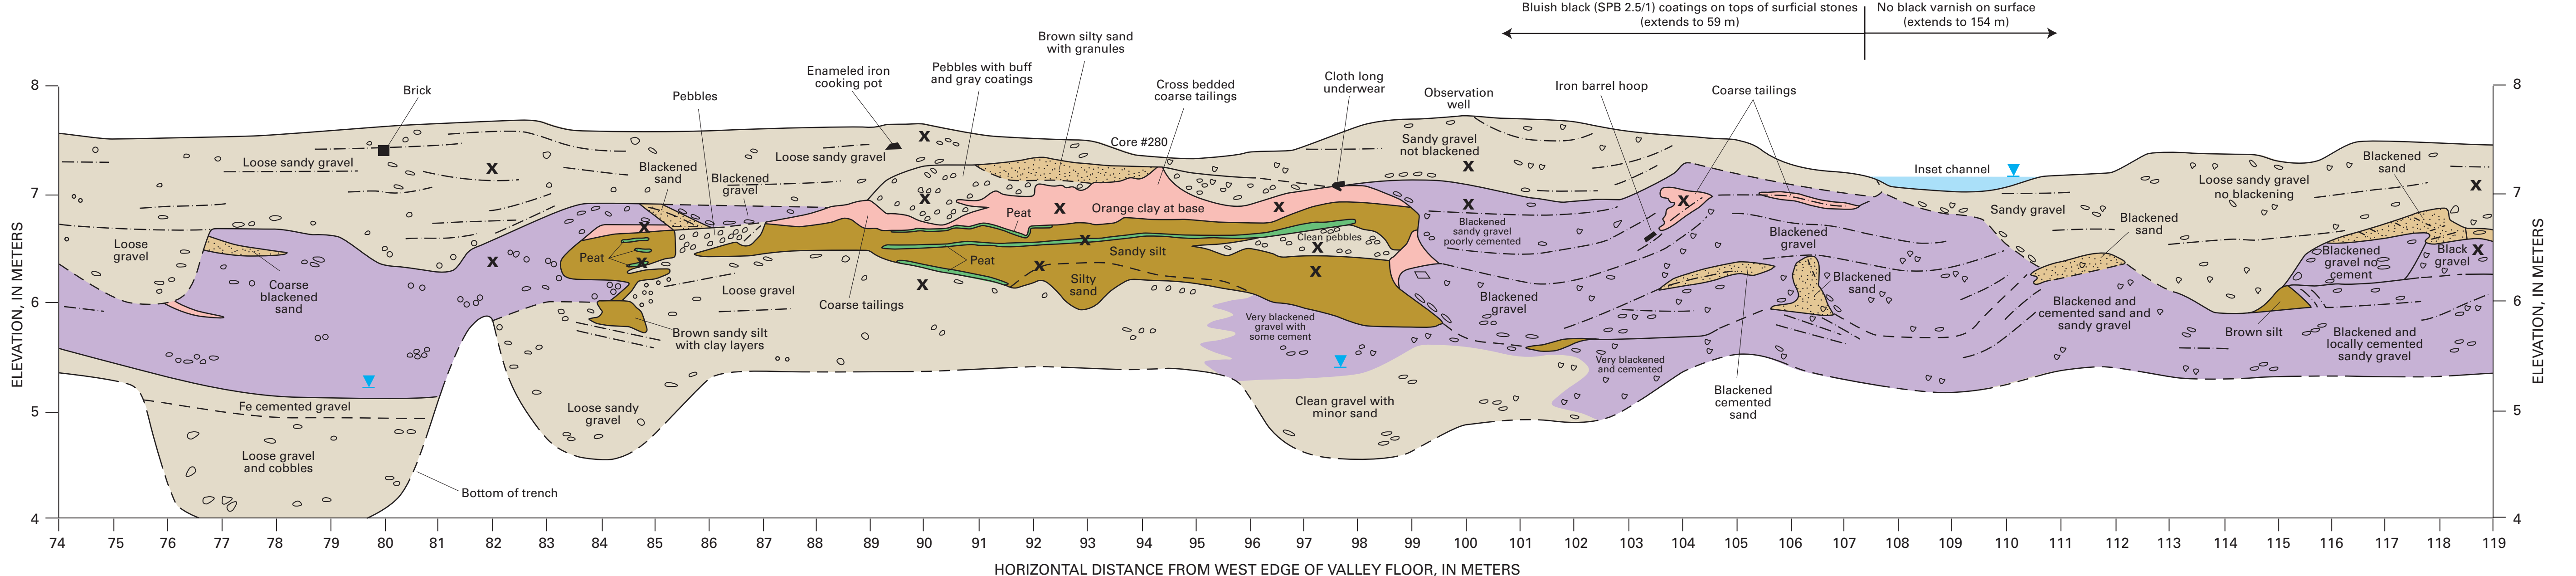
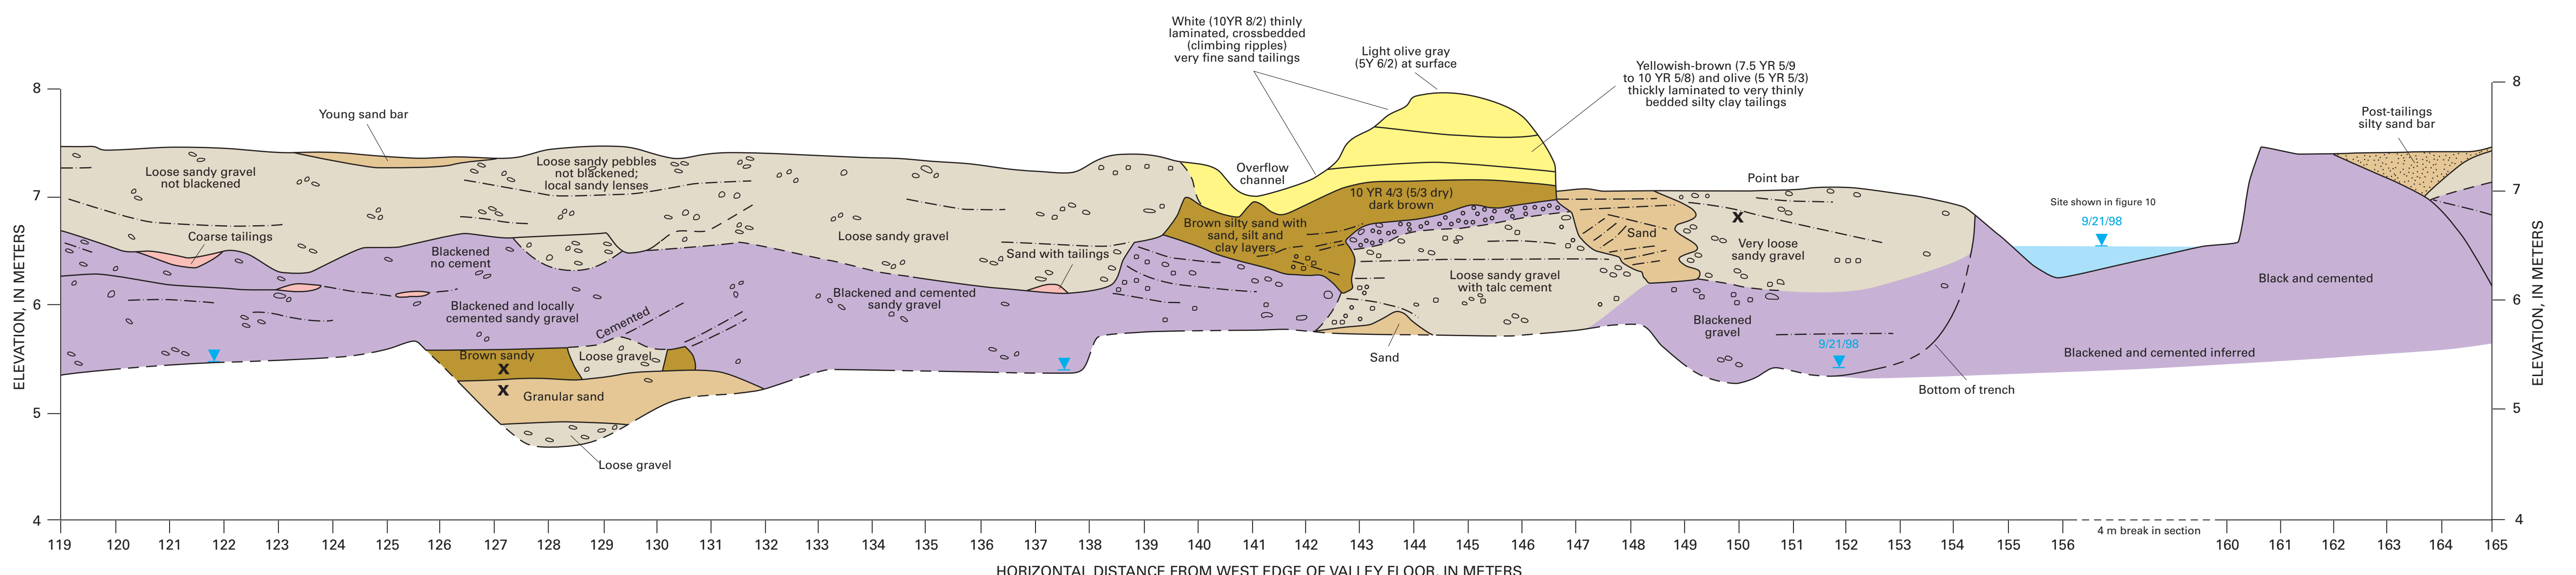
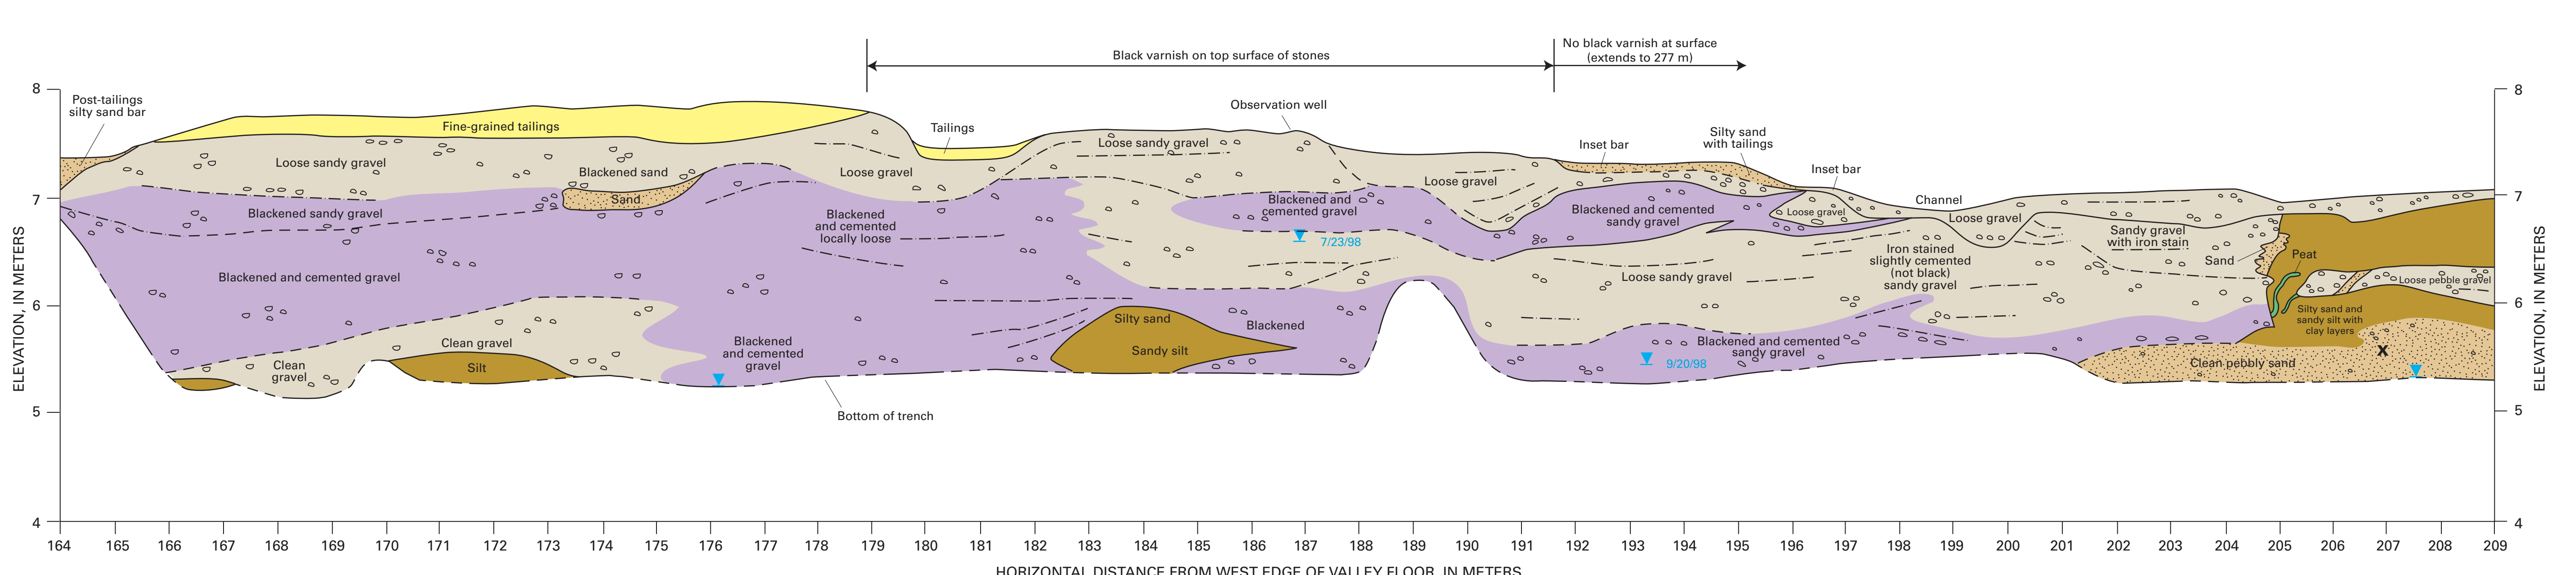
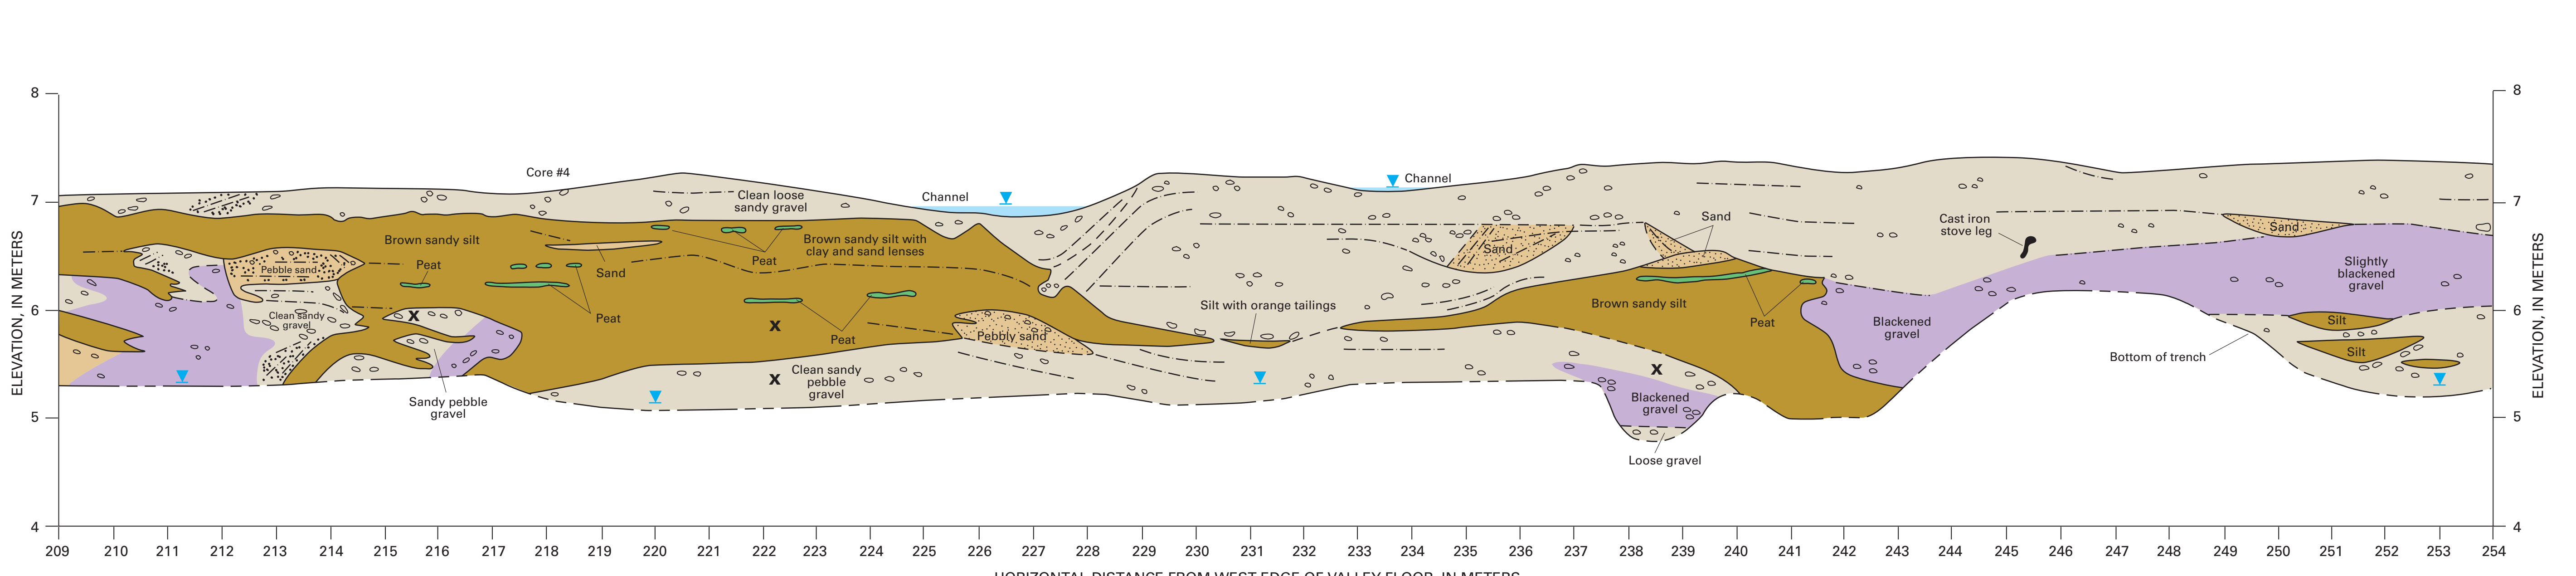
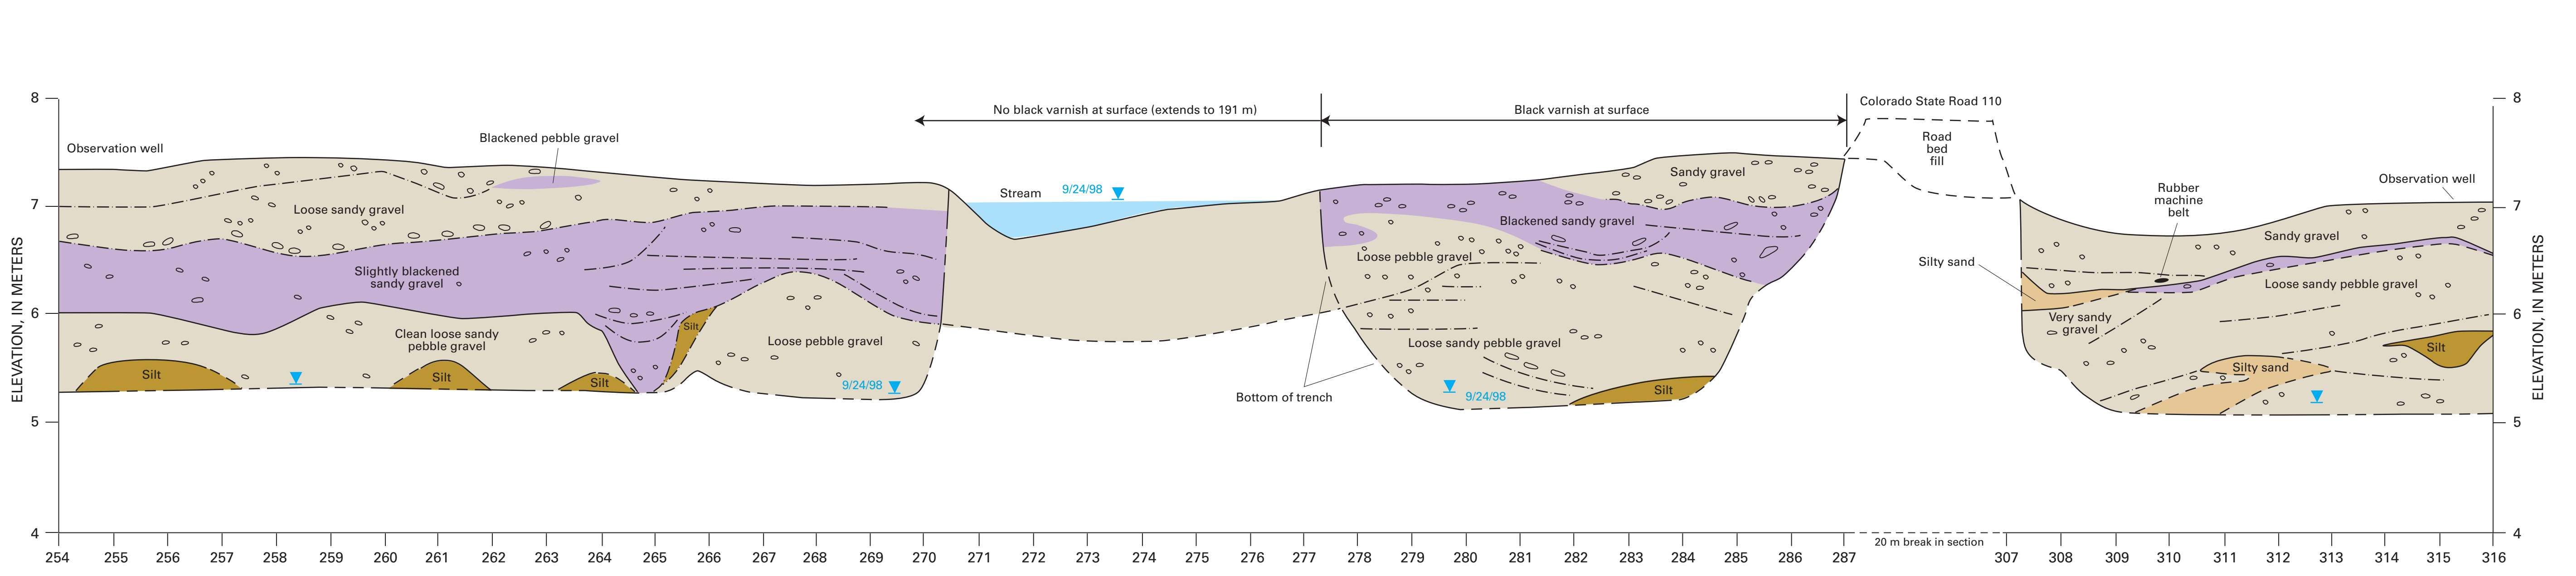
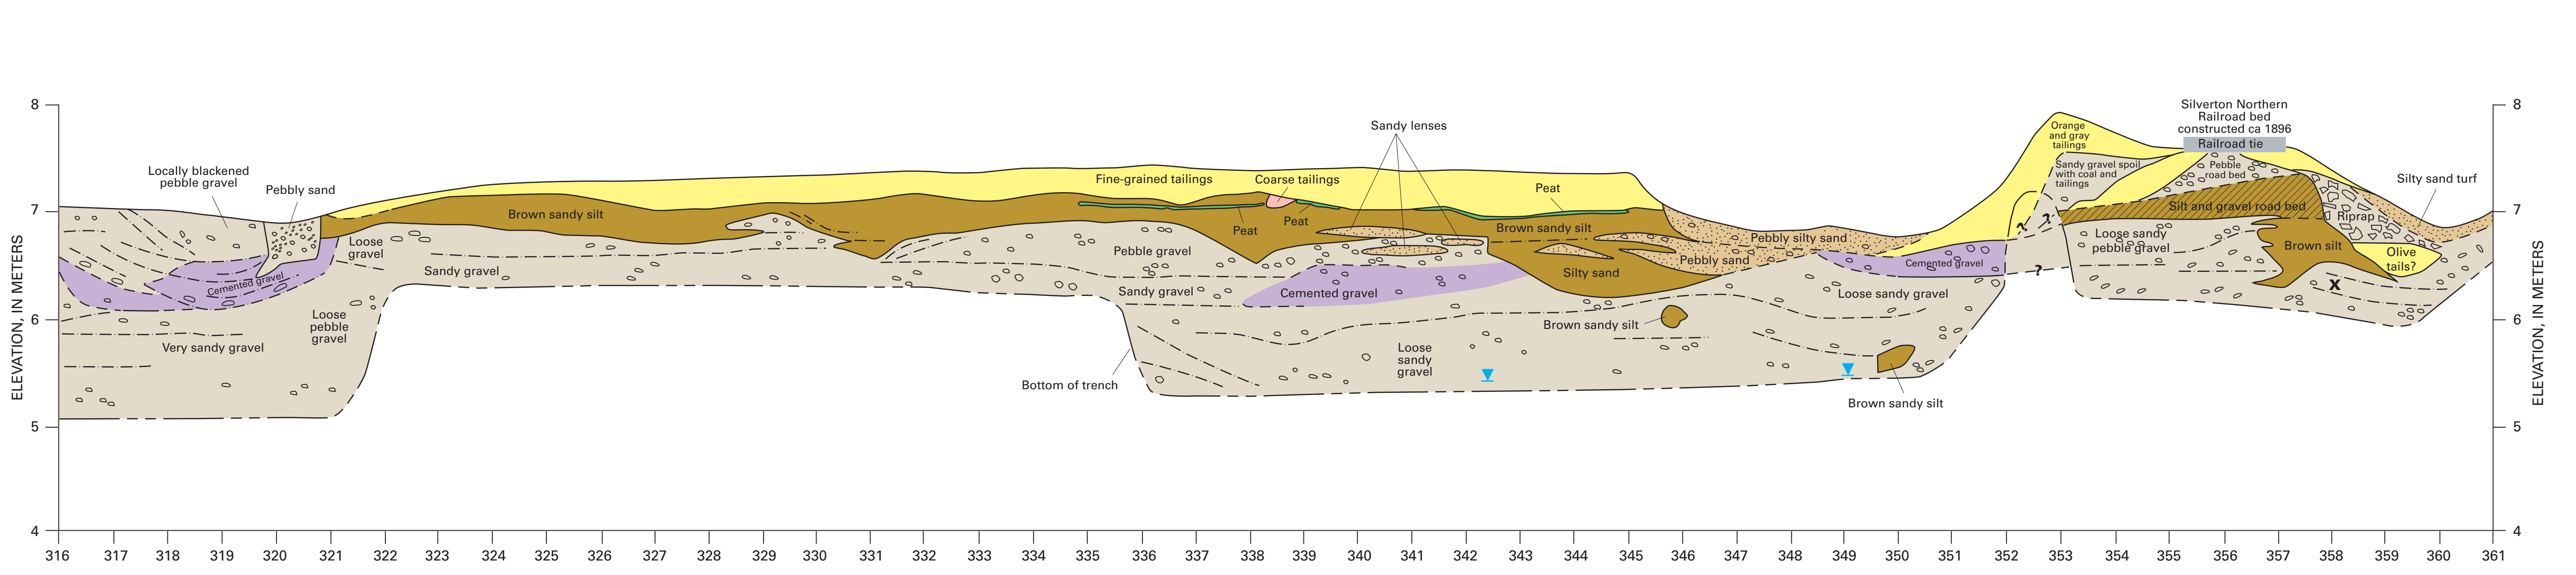
Elevation datum approximately 2,980 meters above mean sea level  
View looking upstream (north)  
Vertical exaggeration x2

1. The location of the trench is shown in figs. 1, 2, and 4 of text of Chapter E22. The sediments are shown in the photographs of figs. 10, 11, and 12.

2. The boundaries of polygons of stained or cemented gravel were not given a special line style, as not to obscure contacts between sedimentary beds or modification within beds. In many locations the boundaries of staining or cementation coincided with a stratigraphic contact or a bedding boundary. In other locations, however, the margin of staining or cementation did not coincide with a contact or bedding, and this is illustrated by the absence of a black boundary line.

3. The beds of the ground-water table, and water surface of stream, were all measured between August 11 and 20, 1998, with one exception. The ground-water table was measured in a test excavation at 167 m on July 23, 1998, and during the following 2 months the water table declined about 1 meter (see water level at 167 m). During that season an clay mat under the streambed, and thereby the ground-water raised because it was not being recharged by infiltrating stream water (see fig. 10).

4. Organic material was sampled for radiocarbon dating, and the results are shown in table 7 and figure 13. The fine fraction of siltstone was sampled for geochemical analysis. The geochemical results are shown in table 8 and figure 14, and the data are included in the database of data and others (this volume, Chapter E2).
