13-2 FHA

USGS QUAD MAP MOUNT CHITTENDEN (1991)

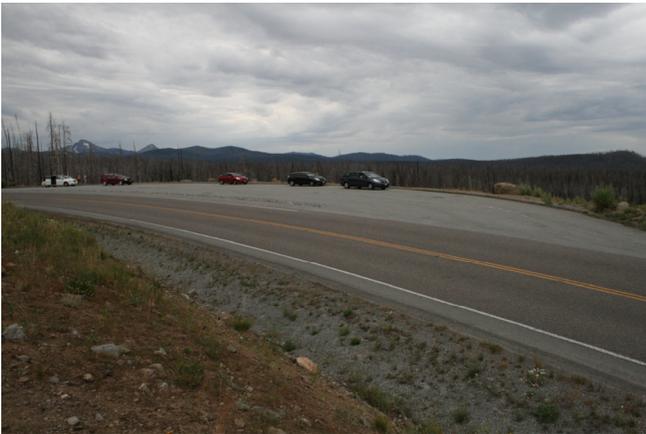
In 2008 the bench mark was searched for and not found, presumed destroyed. The FHWA description places the bench mark at the location of large, new pullout. Trees referenced in FHWA description are not found and were likely removed. The bench mark was probably destroyed by road work.

Looking southeast at large pullout and probable location of 13-2 (likely destroyed).
