## 13-3 FHA

**STAMPING** 13-3 1986  
**USGS QUAD MAP** SYLVAN LAKE (1991)  
**NGS PID** PY0896

### **DATE OF DESCRIPTION** 2008

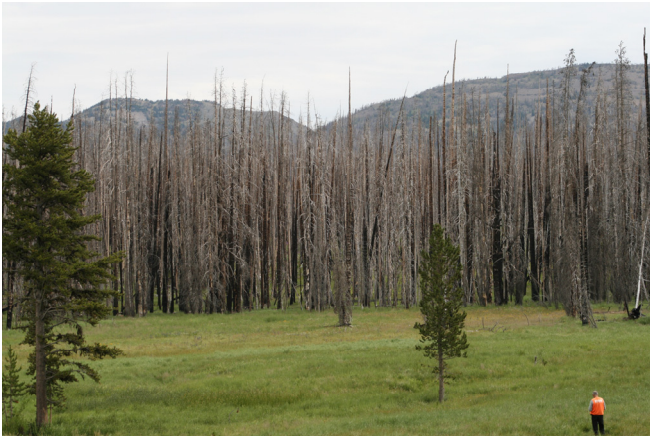
Photograph of the two trees referenced in the FHA description and approximate location of mark (orange vest).

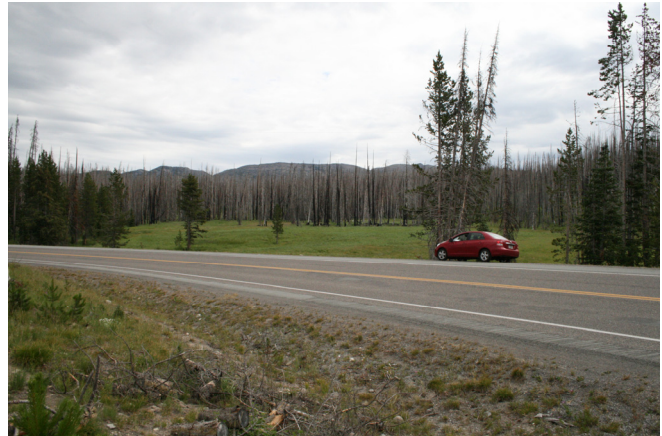
Looking northeast at meadow and probable location of bench mark. Trees referenced in the FHA description are in the left-middle ground.
