**LOCATION MAP OF GROUND FAILURES IN THE
NORTH COAST COUNTIES REGION**

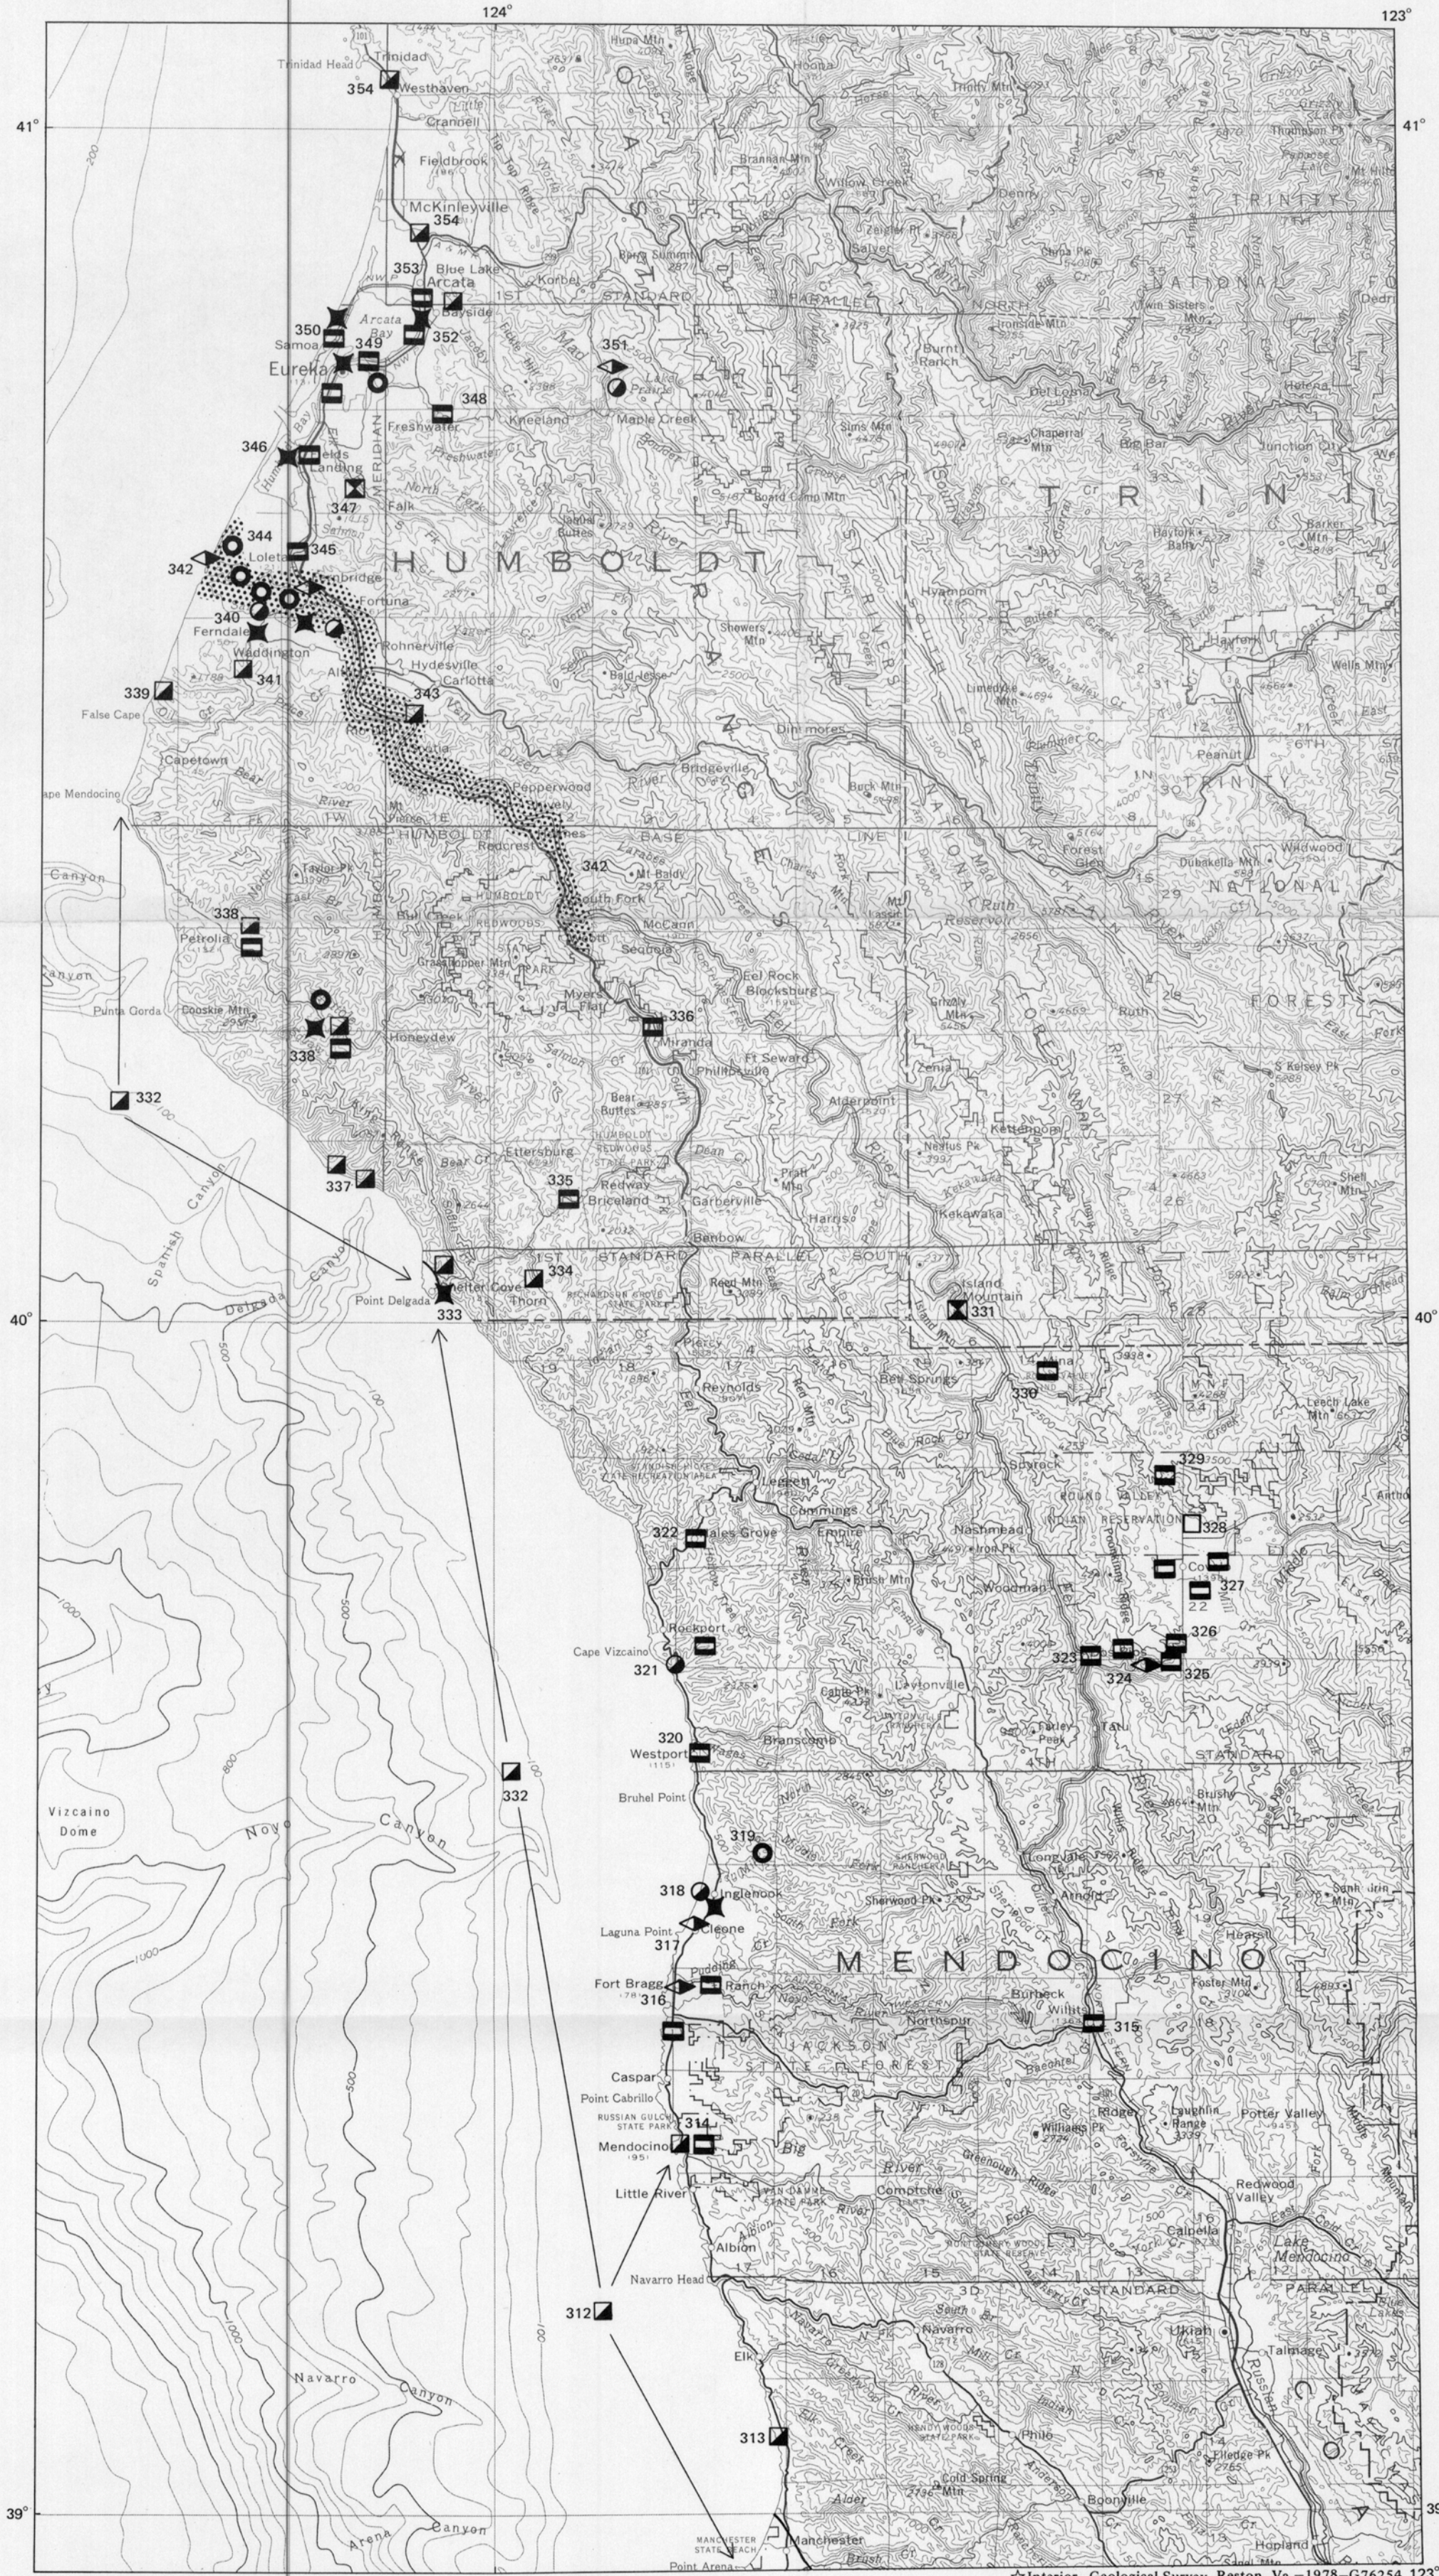
- EXPLANATION**
- Failure type is indicated by the following symbols. Quotations describing these ground failures are found in table 9
- ▣ Hillside landslides including rotational slumps, block glides, debris avalanches, and rockfalls

- Streambank landslides including rotational slumps and soil falls
 - ◄ Lateral spread
 - ⊠ Ground settlement
 - ▣ Ground cracks not clearly associated with landslides, lateral spreads, settlement, or primary fault movements

- ⋯ River stretches with extensively fissured flood plains; pattern indicates stretches of river affected and not width of disturbed zone
 - Sand boils

- Absence of ground failure noted
 - ⊠ Miscellaneous effects
 - ◄ □ ► Arrows showing extent of area affected. Symbol shows failure type
- 312 Location number assigned to each reported ground failure site. Corresponding number found in table 9

- Approximate trace of fracture on San Andreas fault, April 18, 1906
