# ASSESSING EARTHQUAKE HAZARDS AND REDUCING RISK IN THE PACIFIC NORTHWEST

**U.S. GEOLOGICAL SURVEY PROFESSIONAL PAPER 1560**

*An investigation of the earthquake potential in the  
Pacific Northwest and examination of the measures  
necessary to reduce seismic hazards*

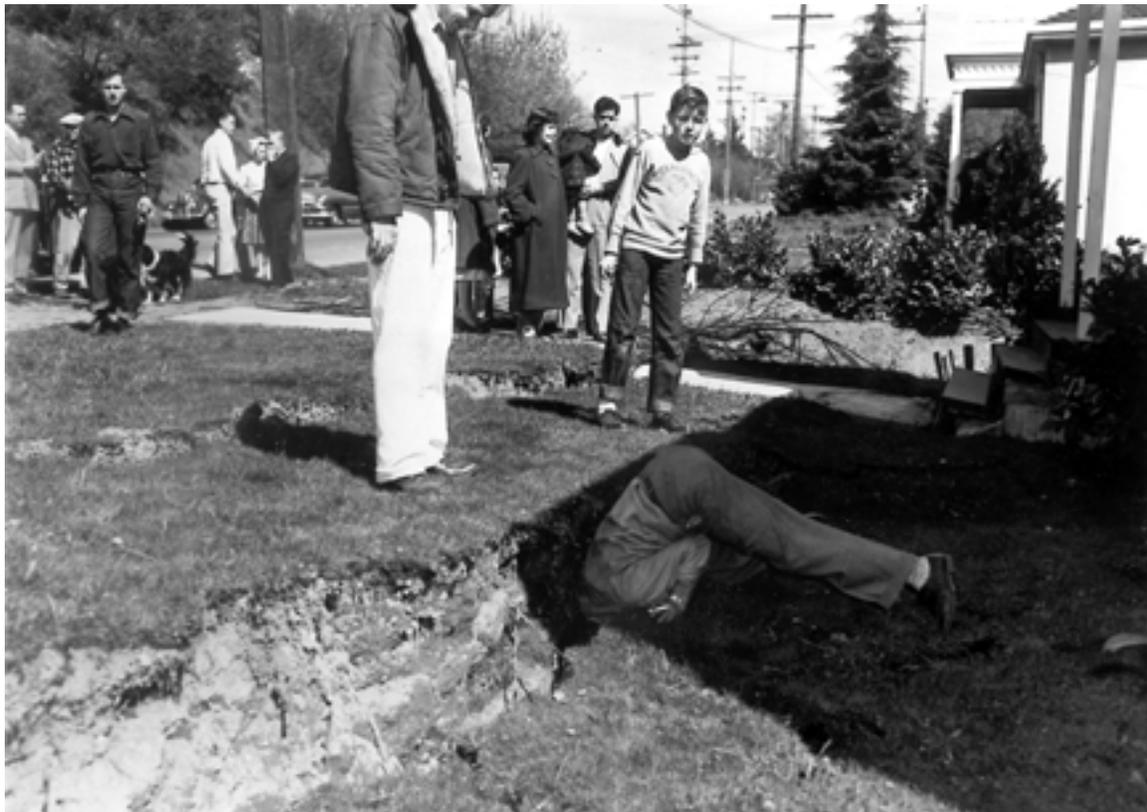
**Figure 190.** Slumping and settlement in West Seattle (pl. 4, loc. 10) induced by the April 13, 1949, earthquake. The slumping exposed artificial fill (lower left) that underlies the site. Photograph from the Seattle Post-Intelligencer Collection, courtesy of the Museum of History and Industry, Seattle, Wash.

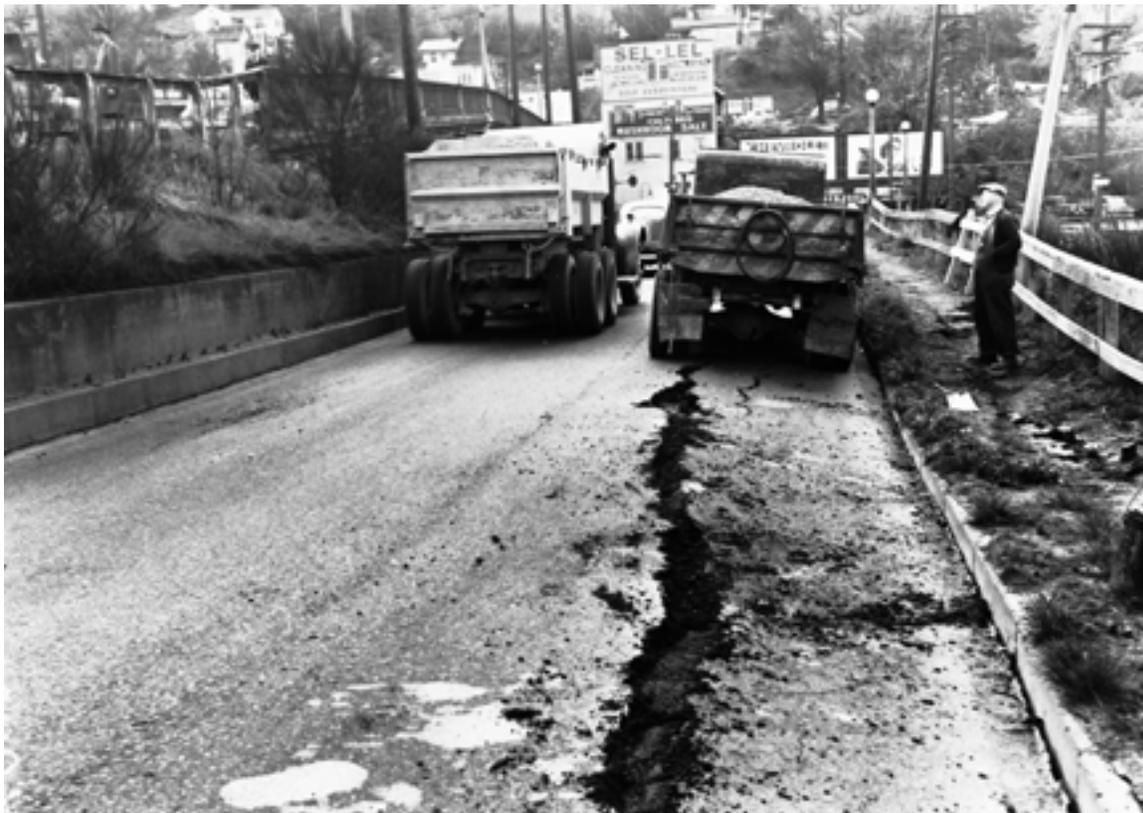
**Figure 193.** Ground failure along Spokane Street approach to West Seattle (pl. 4, loc. 16) triggered by the April 13, 1949, earthquake. Pavement cracks and slight slump are in a road embankment composed of artificial fill. Note arcuate scarp and tilted light pole at right. Photograph from the Seattle-Post Intelligencer Collection, courtesy of the Museum of History and Industry, Seattle, Wash.

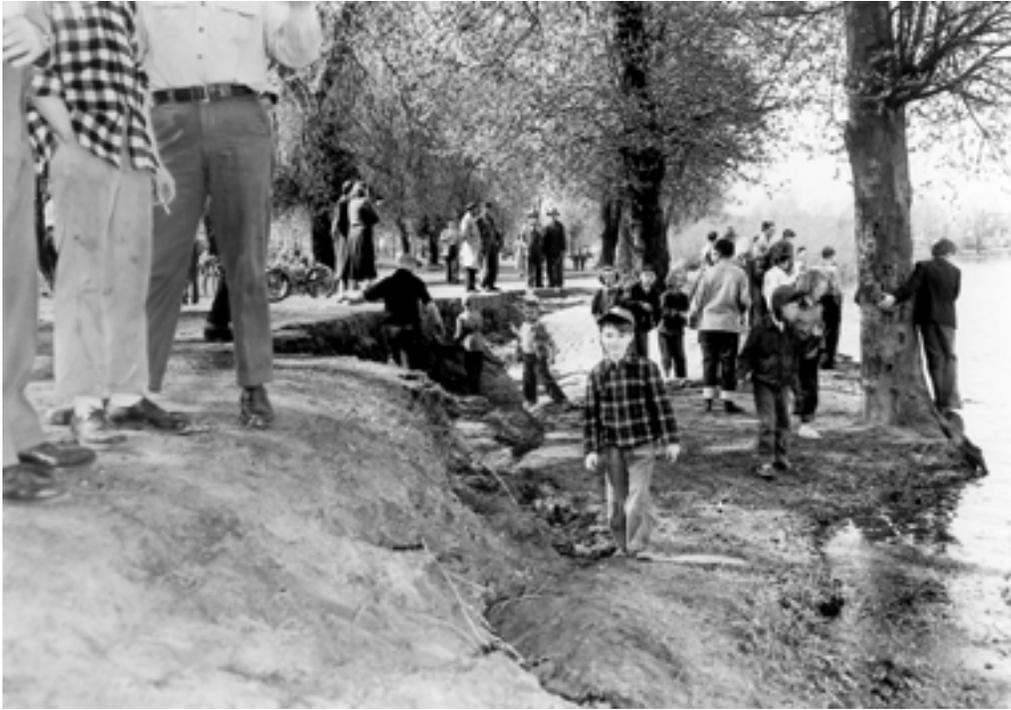
**Figure 194.** Slump along the shore of Green Lake, north of downtown Seattle. This 1949 earthquake-induced ground failure occurred near the south end of the lake (pl. 4, loc. 33) in an area that subsequently experienced ground failure during the April 29, 1965, earthquake. Photograph from the Seattle Post-Intelligencer Collection, courtesy of the Museum of History and Industry, Seattle, Wash.

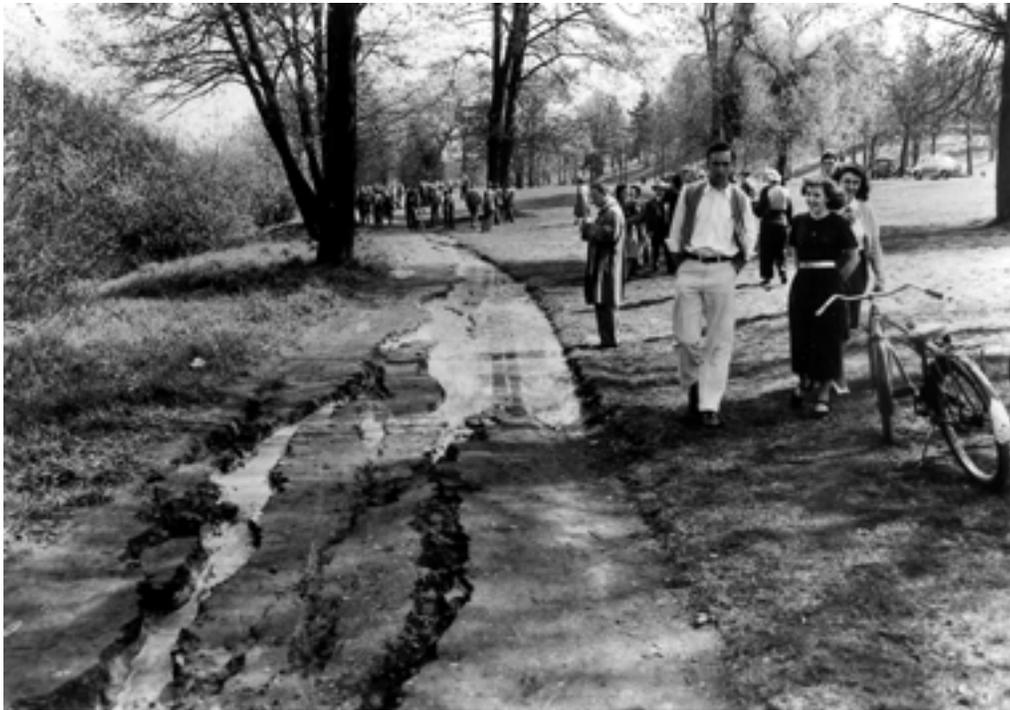
**Figure 195.** Ground cracks on the southeast side of Green Lake in north Seattle (pl. 4, loc. 33). The cracks opened during or shortly after the April 13, 1949, earthquake and probably resulted from subsidence and lateral movement of ground downslope toward the lake (out of sight to the left of view). Photograph from the Seattle Post-Intelligencer Collection, courtesy of the Museum of History and Industry, Seattle, Wash.

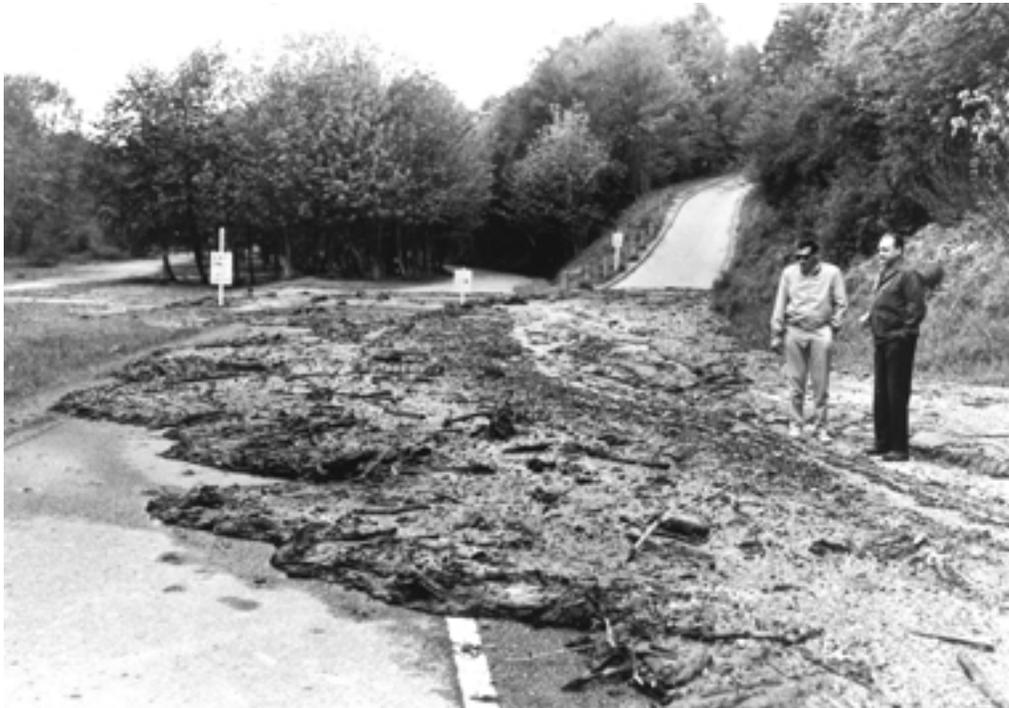
**Figure 196.** Mudflow covering Carkeek Park Road in northwest Seattle (pl. 4, loc. 36). This mudflow developed as material from an earth slide triggered by the April 29, 1965, earthquake mixed with water and flowed down a Piper Creek tributary ravine. Photograph used by permission of the *Seattle Times* Co.

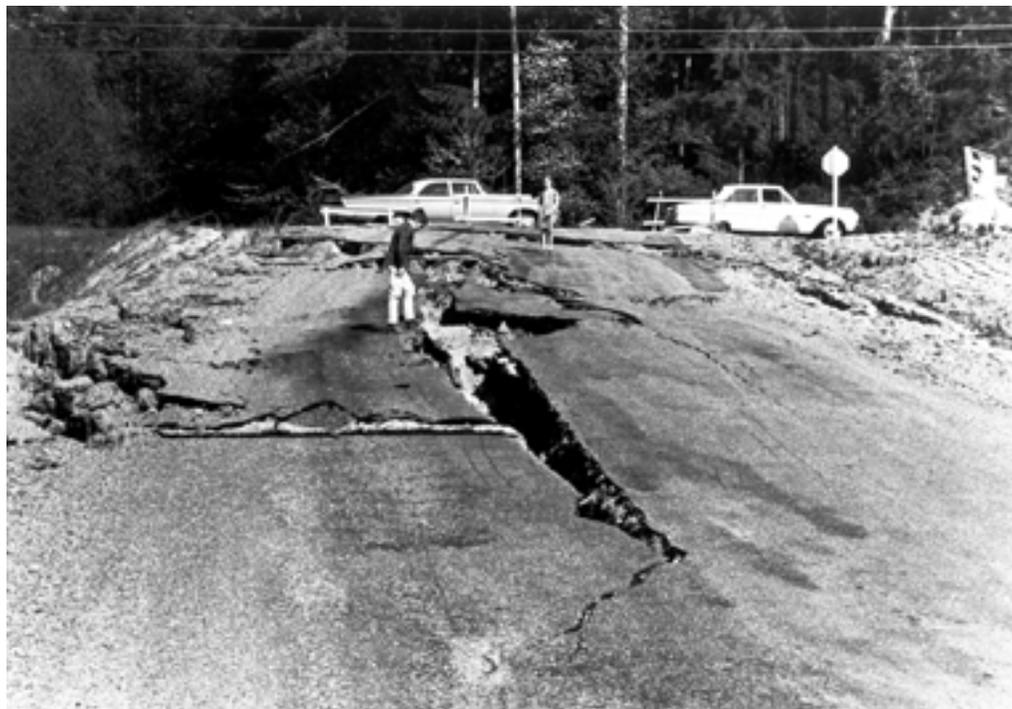
**Figure 198.** Damage to Country Club Road, southwest of Port Orchard, Wash. (pl. 4, loc. 2), due to slumping induced by the April 29, 1965, earthquake. This slump occurred in granular fill underlain by glacial deposits of the Vashon Drift. Photograph used by permission of the Bremerton Sun.

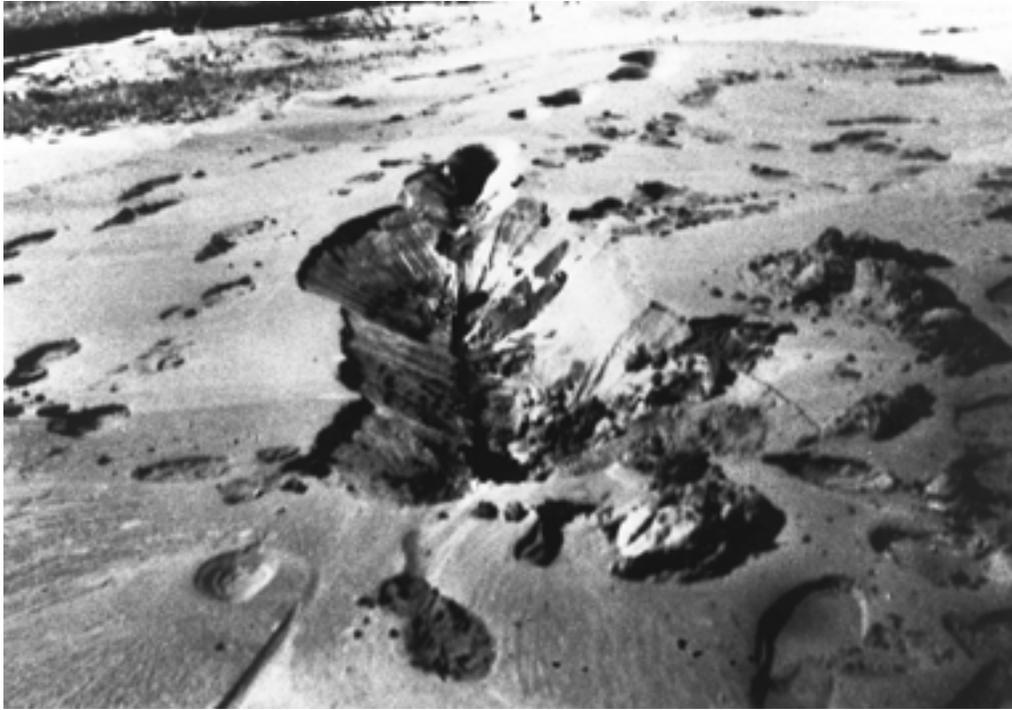
**Figure 199.** Sand boil in Puyallup, Wash. (pl. 5, loc. 68), produced by the April 13, 1949, earthquake. The earthquake generated many sand boils in northwest Puyallup. Some, such as this one, deposited considerable volumes of sediment on the surface; others were associated with damage to homes in the area. The sand boil vent (collapsed area in the center) is 2–3 m long. Photograph by Richard Six, Puyallup, Wash.

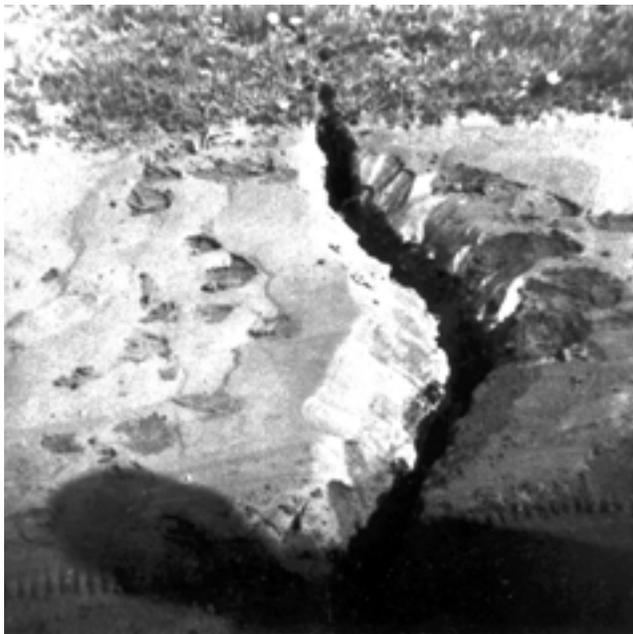
**Figure 200.** Ground crack and ejected sediment (sand boil) produced by the April 13, 1949, earthquake. This ground failure in northwest Puyallup, Wash. (pl. 5, loc. 68), may indicate incipient lateral spreading due to liquefaction of sediments. Shadow of individual (lower left) shows scale. Photograph by Richard Six, Puyallup, Wash.

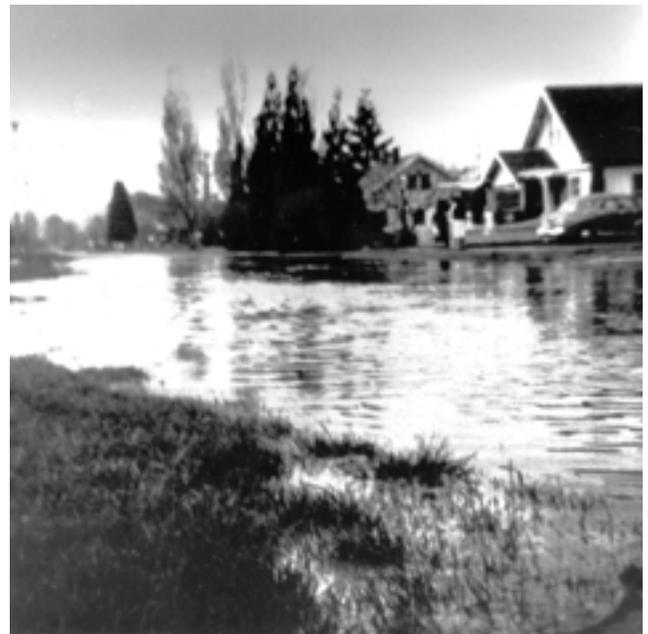
**Figure 201.** Flooding in northwest Puyallup, Wash. (pl. 5, loc. 68), at the time of the April 13, 1949, earthquake. According to local residents, the flooding could not be attributed to broken water mains and may have resulted from the ejection of ground water from the many sand boils that occurred in the area. Photograph by Richard Six, Puyallup, Wash.

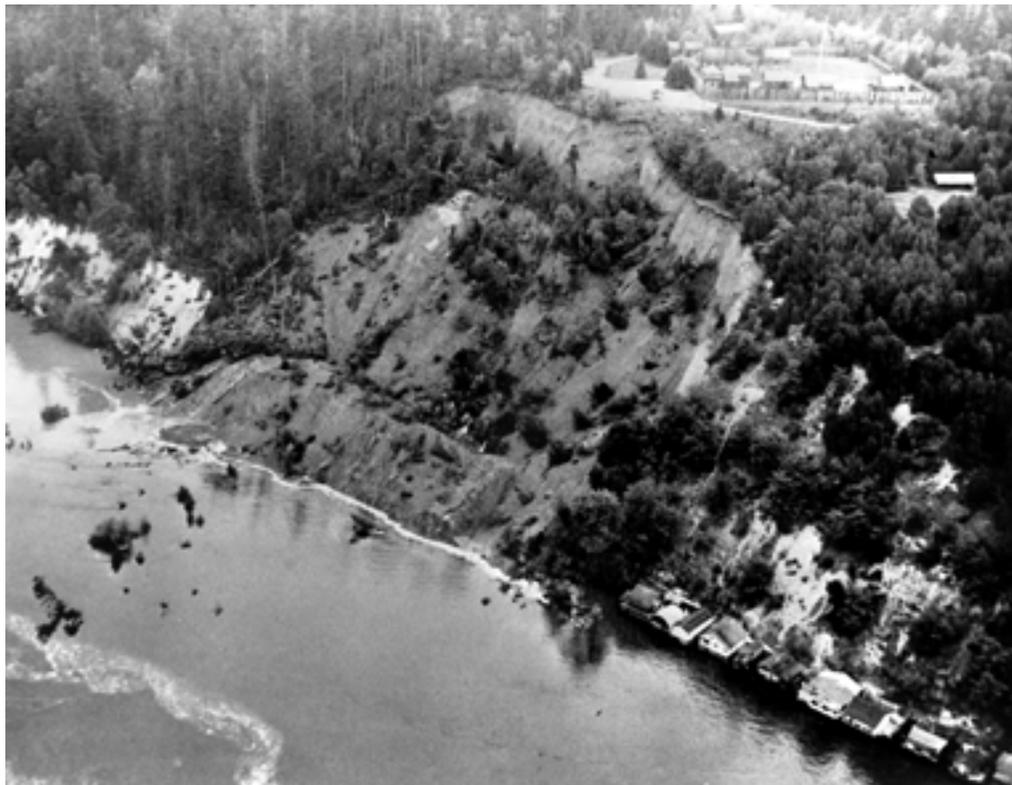
**Figure 203.** Tacoma, Wash., landslide, April 16, 1949 (pl. 5, loc. 81). This landslide was probably initiated by the 1949 earthquake that occurred 3 days previously. The large mass narrowly missed homes to the south on Salmon Beach as it plunged into the waters of the Tacoma Narrows. The resulting 2.5 m tidal wave damaged small boats and nearby dock facilities. Photograph used by permission of the Associated Press.

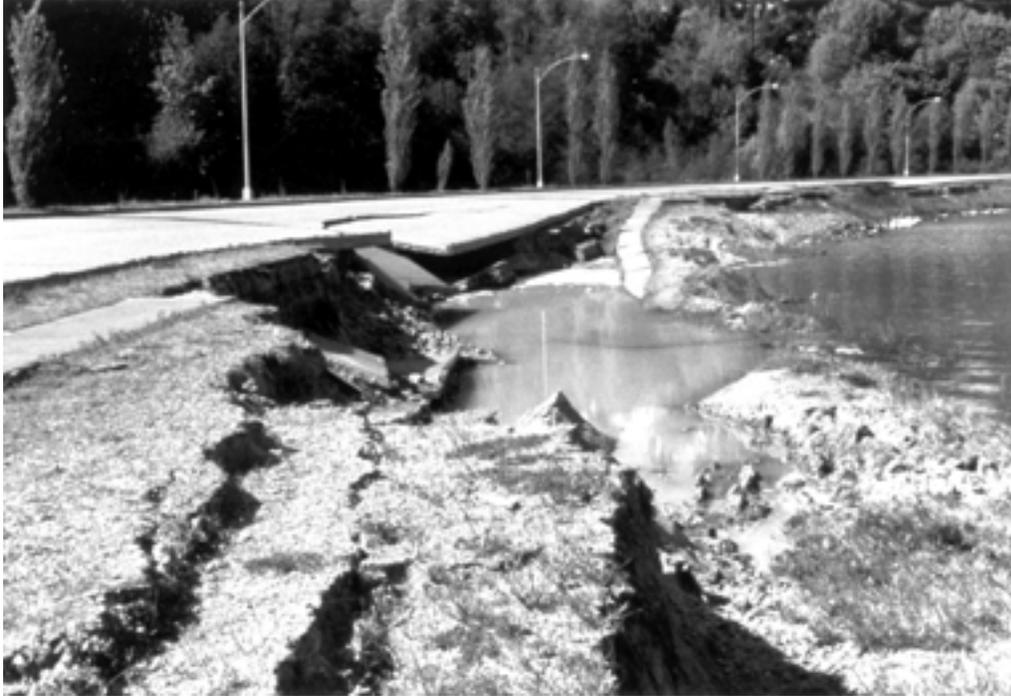
**Figure 204.** Damage to Deschutes Parkway, Olympia, Wash., resulting from a 1965 earthquake-induced ground failure (pl. 5, loc. 48). The parkway was constructed on granular fill placed on tidal flat muds that are now within the limits of Capitol Lake; failure was probably due to liquefaction. Photograph by Gerald W. Thorsen, Division of Geology and Earth Resources, Washington Department of Natural Resources, Olympia, Wash.

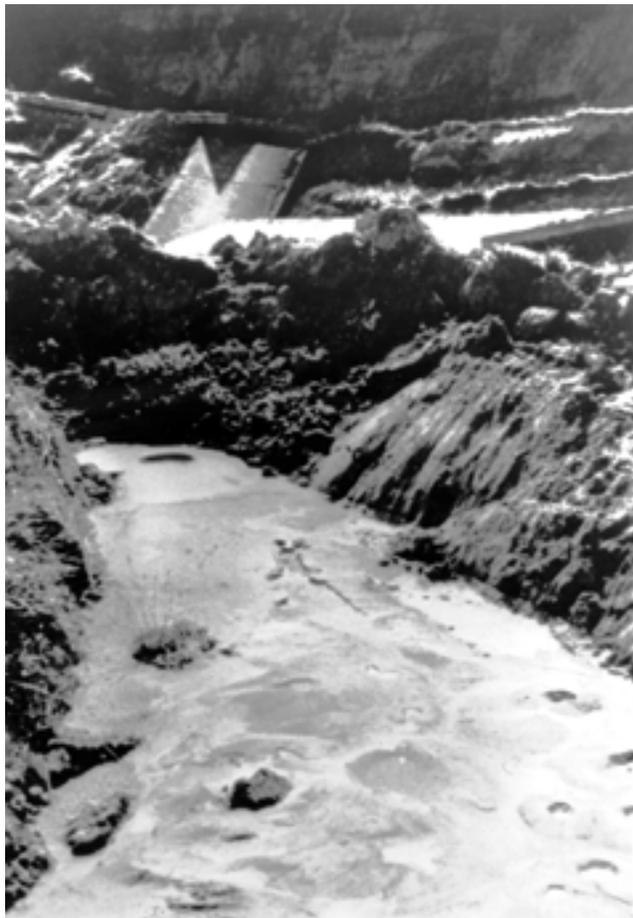
**Figure 205.** Sand boils near Capitol Lake in Olympia, Wash., related to the earthquake of April 29, 1965 (pl. 5, loc. 48). The sand boils are evidence of soil liquefaction at this ground failure location. Sidewalk slab in background shows scale. Photograph by Gerald W. Thorsen, Division of Geology and Earth Resources, Washington Department of Natural Resources, Olympia, Wash.

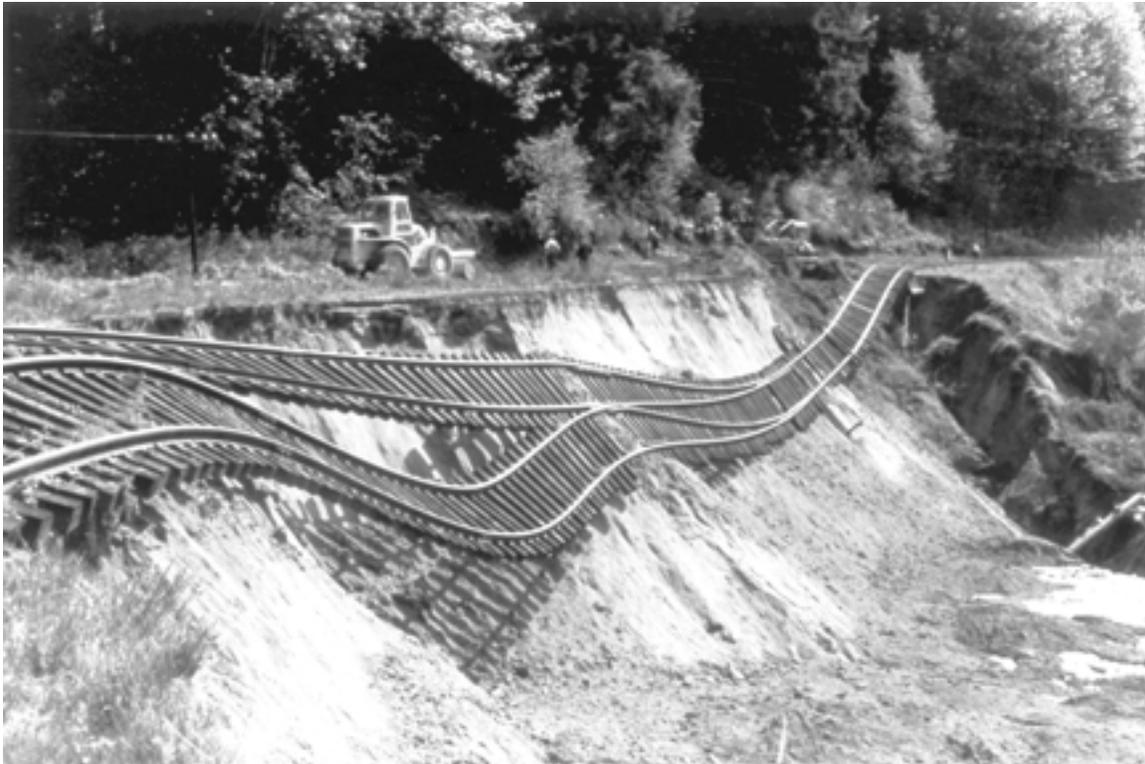
**Figure 206.** Damage to Union Pacific Railroad tracks near Tumwater, Wash. (pl. 5, loc. 45), due to a 1965 earthquake-induced slope failure in artificial fill. Photograph by Gerald W. Thorsen, Division of Geology and Earth Resources, Washington Department of Natural Resources, Olympia, Wash.

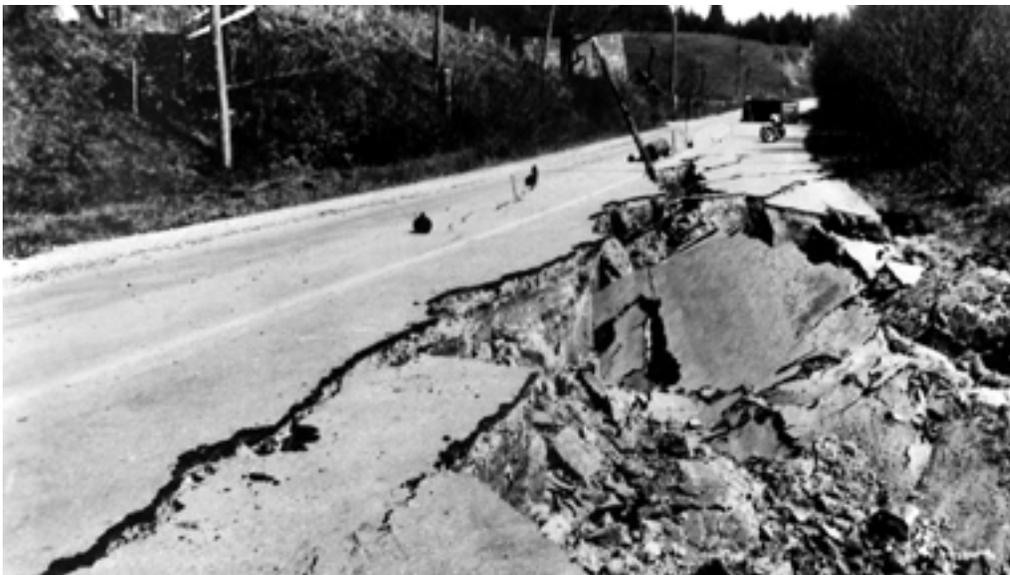
**Figure 207.** Damage to Black Lake Road south of Olympia, Wash. (pl. 5, loc. 44), caused by failure of a steep lake bank during the earthquake of April 13, 1949. Photograph used by permission of Jack Goldsby, Tumwater, Wash.

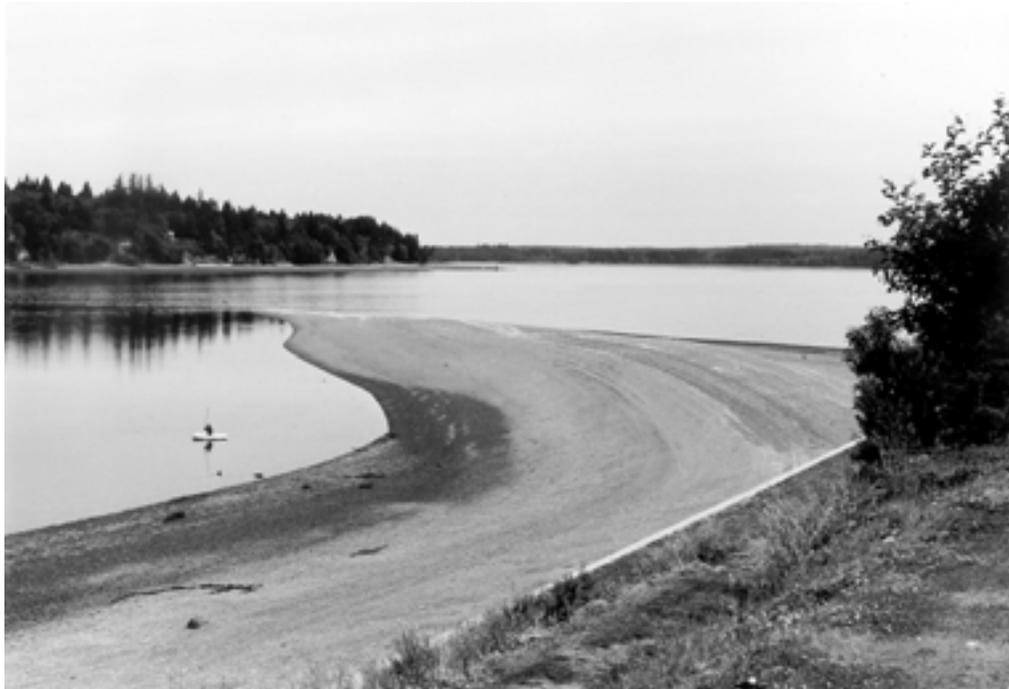
**Figure 208.** View of Cooper's Point, located 11 km north of Olympia, Wash. (pl. 5, loc. 51). About 45 m of the end of the sand spit failed and disappeared into Puget Sound during the April 13, 1949, earthquake. Photograph was taken in 1988.

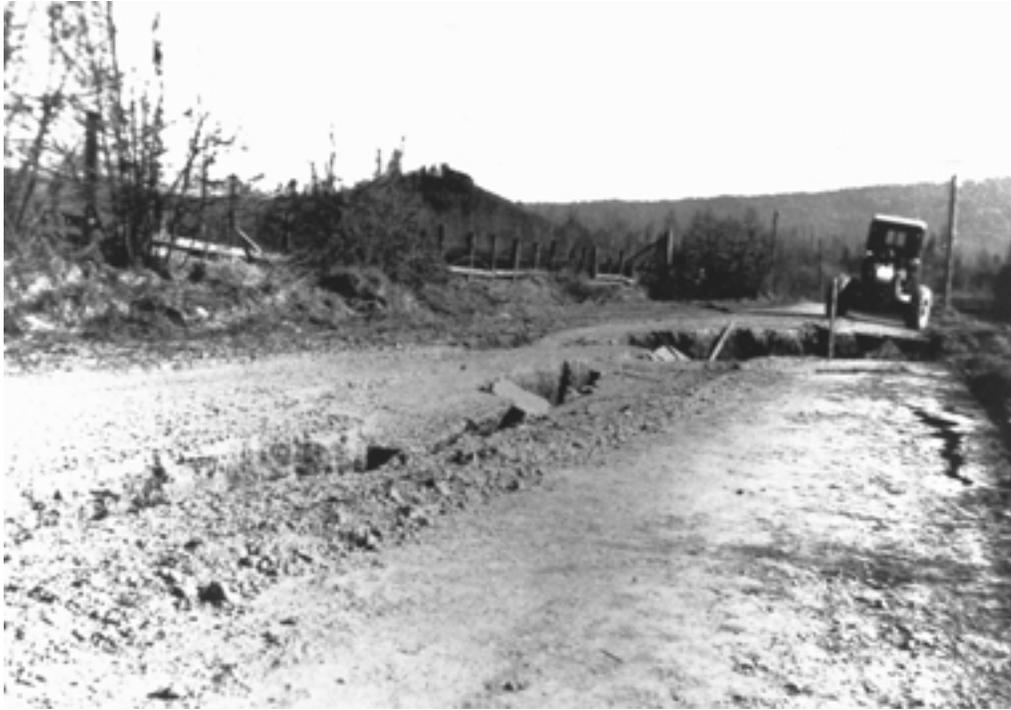
**Figure 209.** Slump in a 1- to 1.2-m-high road embankment in the Cowlitz River Valley, about 1.6 km southwest of Randle, Wash. (pl. 6, loc. 118). This April 13, 1949, earthquake-induced ground failure occurred in artificial fill underlain by loose liquefiable sand. The earthquake also produced sand boils in an adjacent field. Photograph by Alice Peters, Randle, Wash.

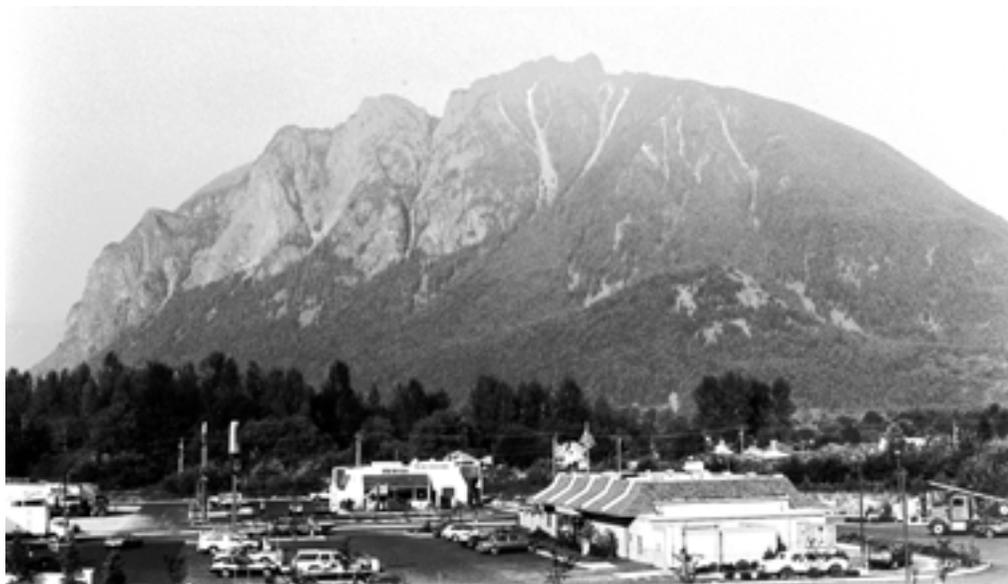
**Figure 210.** Mount Si near North Bend, Wash. (pl. 6, loc. 130). “Rockslides” on Mount Si were reported for the Puget Sound area earthquakes of April 29, 1945, April 13, 1949, and April 29, 1965. Photograph was taken in 1988.

Mount Si (fig. 210; pl. 6, loc. 130) was the site of earthquake-triggered rock slides in 1945, 1949, and 1965. On April 29, 1945, an earthquake with a felt magnitude of 5.9 (Noson and others, 1988) triggered landsliding on Mount Si that was described by Bodle and Murphy (1947), as follows: “At the Mount Si Ranger Station, near North Bend, the earth buckled and heaved and tons of rock and earth cascaded down the 4,000 ft [1,220 m] cliffs of Mount Si.” In 1949, a

large dust cloud caused by a rock slide was observed rising from the west side of the mountain at about the 600 m level and, in 1965, a slide on the southwest slope of Mount Si was described as “extensive.” The 1945, 1949, and 1965 ground failures demonstrate the high susceptibility of steep rock slopes on Mount Si to earthquake-induced rock falls, rock slides, and rock avalanches. Metavolcanic rocks (metamorphosed basic lavas), some of which are foliated, form the bedrock surface over much of the western part of Mount Si (Kremer, 1959). The rocks on the western part of the mountain dip very steeply to the west, and much of the rock is fractured. Fractures and bedding planes with unfavorable orientations commonly contribute to the instability of rock slopes. As stated by Piteau and Peckover (1978), “The stability of rock slopes depends largely on the presence and nature of defective planes or discontinuities within the rock mass.”

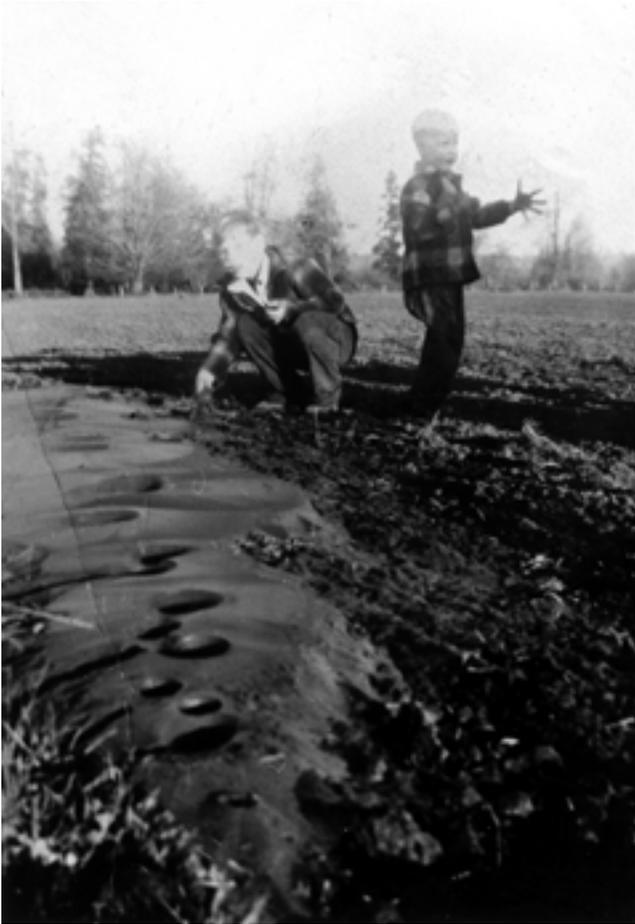
**Figure 211.** Alignment of sand boils in a field 1.6 km southwest of Centralia, Wash. (pl. 7, loc. 146), is related to linear ground crack from which the water and sand were emitted during a 1949 liquefaction incident. Photograph by Ted Dorn, Centralia, Wash.

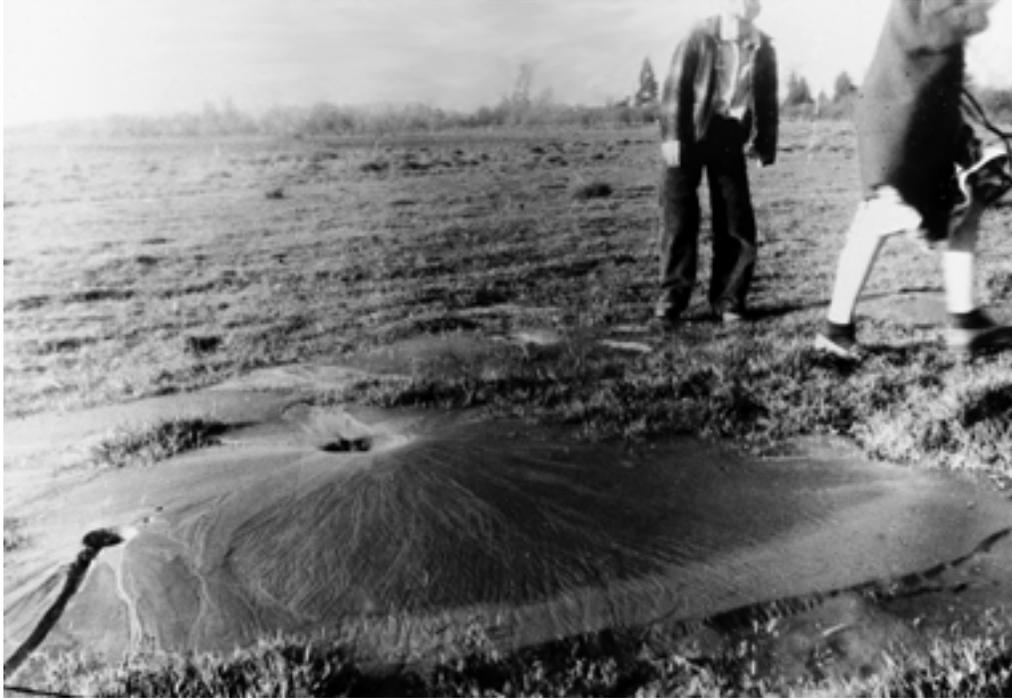
**Figure 212.** Sand boils on the floodplain of the Chehalis River, about 1.6 km southwest of Centralia, Wash. (pl. 7, loc 146). Water and sand spouted from several ground cracks at this location at the time of the April 13, 1949, earthquake. Photograph by Ted Dorn, Centralia, Wash.

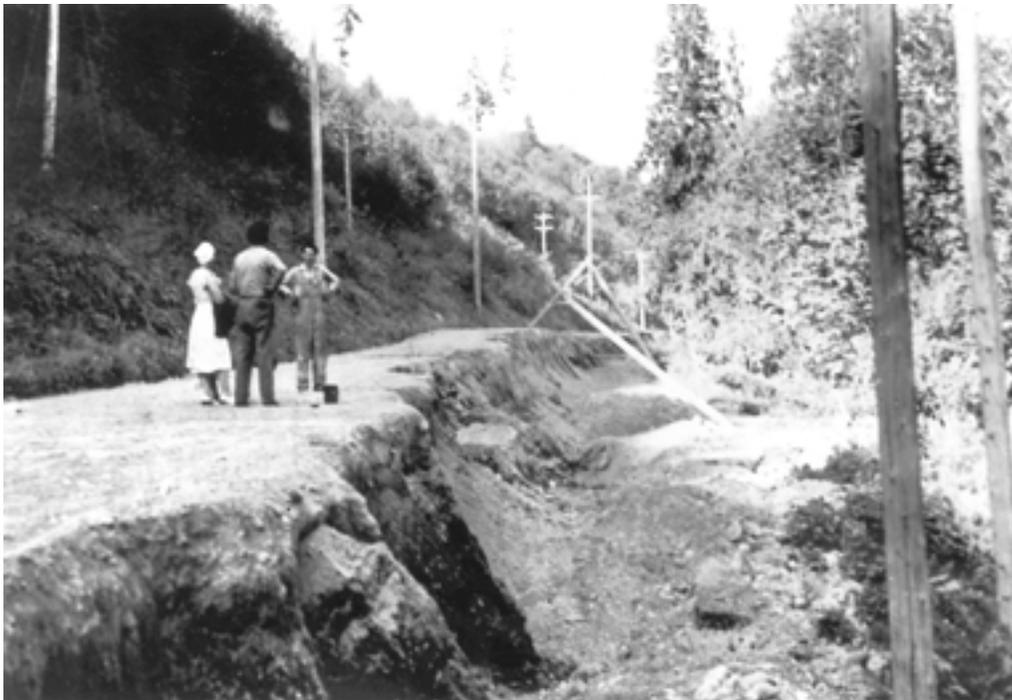
**Figure 213.** Scarp created by a landslide on the west side of Ohop Lake, Pierce County, Wash. (pl. 7, loc. 138). Incipient failure induced by the April 13, 1949, earthquake resulted in the development of a large ground crack. On May 13, complete failure occurred as the unstable mass suddenly slumped into the lake, damaging the roadway, utility lines, and cottages near the shore. Photograph used by permission of the Tacoma News Tribune.

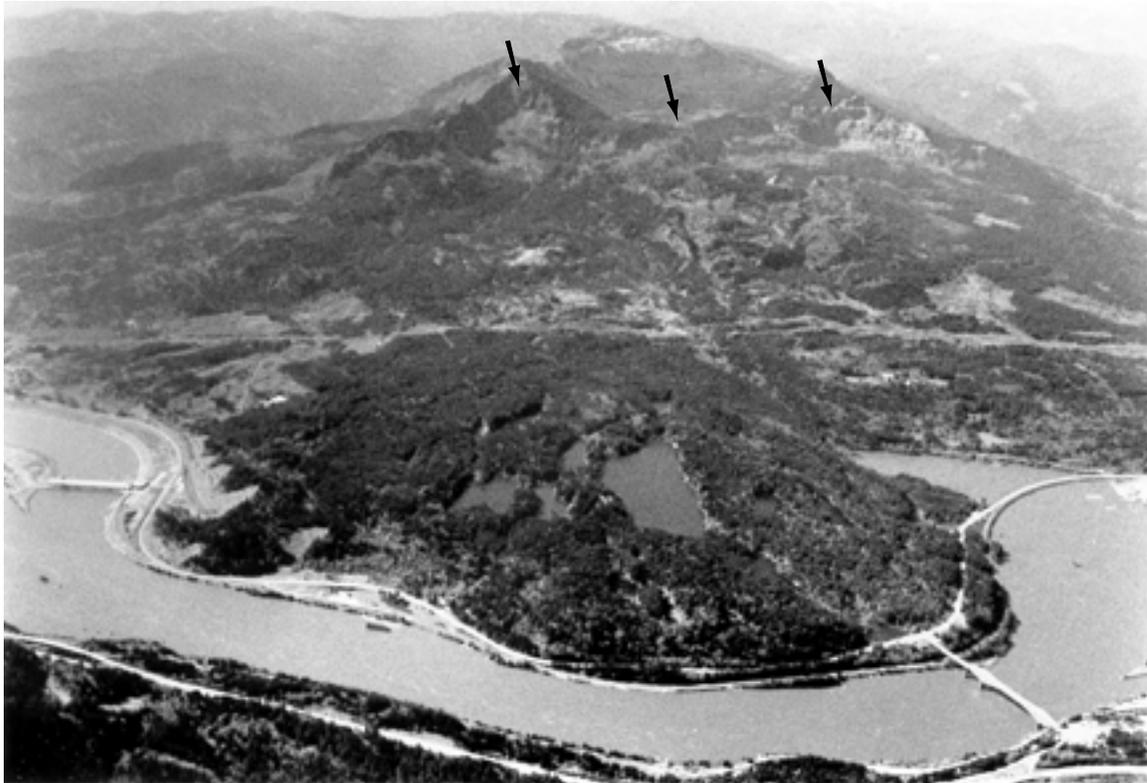
**Figure 214.** Bonneville landslide area along the Columbia River west of Stevenson, Wash. (pl. 8, loc. 160). Rock fall/rock avalanche activity triggered by the April 13, 1949, earthquake occurred along the steep head scarp (arrows), creating a dust cloud visible for many kilometers along the Columbia River Gorge. Photograph by Derek Cornforth, Landslide Technology, Portland, Oreg.

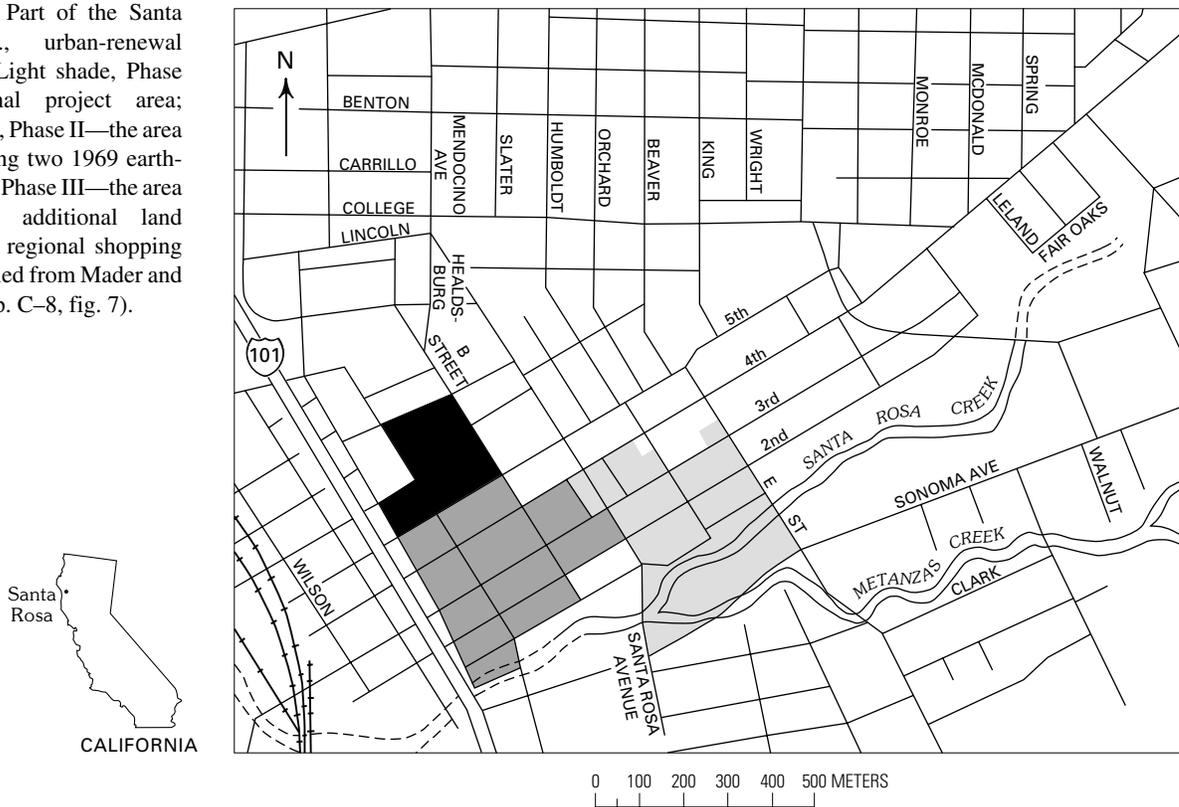
**Figure 226.** Part of the Santa Rosa, Calif., urban-renewal project area. Light shade, Phase I—the original project area; medium shade, Phase II—the area added following two 1969 earthquakes; black, Phase III—the area surveyed for additional land required for a regional shopping center. Modified from Mader and others (1980, p. C-8, fig. 7).

The time and effort required to get the revised redevelopment project funded and underway after the earthquakes was significantly shortened because of the existence of an up-to-date plan (fig. 226) adopted prior to the earthquakes.

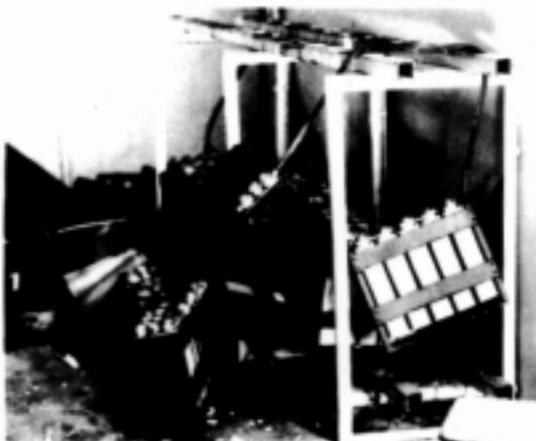
EMERGENCY POWER GENERATORS										
DAMAGE EXAMPLE					PROTECTIVE COUNTERMEASURE

earthquake: 1971 San Fernando credit: John F. Meehan					\$10 per rack for strapping APPROXIMATE COST: \$50 for bolting					
EXISTING VULNERABILITY					UPGRADED VULNERABILITY					
SHAKING INTENSITY	EFFECTS	+	\$	⏏	SHAKING INTENSITY	EFFECTS	+	\$	⏏	
LIGHT	slight chance of piping connection break	low	0-5%	mod	LIGHT	no damage	low	0%	low	
MODERATE	slight shifting of equipment; batteries slide	low	5-20%	high	MODERATE	no damage	low	0%	low	
SEVERE	lurching of generator off supports; batteries fall	mod	20-50%	high	SEVERE	damage to rest of electrical system more likely than generator damage	low	0-5%	low	
		+	\$				⏏			
		LIFE SAFETY HAZARD			% OF REPLACEMENT VALUE DAMAGED			POST-EARTHQUAKE OUTAGE

**Figure 230.** An example of how to reduce the risk of earthquake damage to one type of nonstructural building component. From Reitherman (1983, p. 39).

An excellent guidebook on reducing the risk of non-structural earthquake damage was prepared by Reitherman (1983). He described typical conditions found in office, retail, and government buildings. Measures are suggested for restraining more than 20 nonstructural building components such as office machines, electrical equipment, file cabinets, partitions, suspended ceilings, exterior ornamentation, elevators, piping, stairways, and parapets. Each component is rated for existing and upgraded vulnerability to life-safety hazards, percent of replacement-value damaged, and postearthquake outages for three levels of shaking intensity (fig. 230).

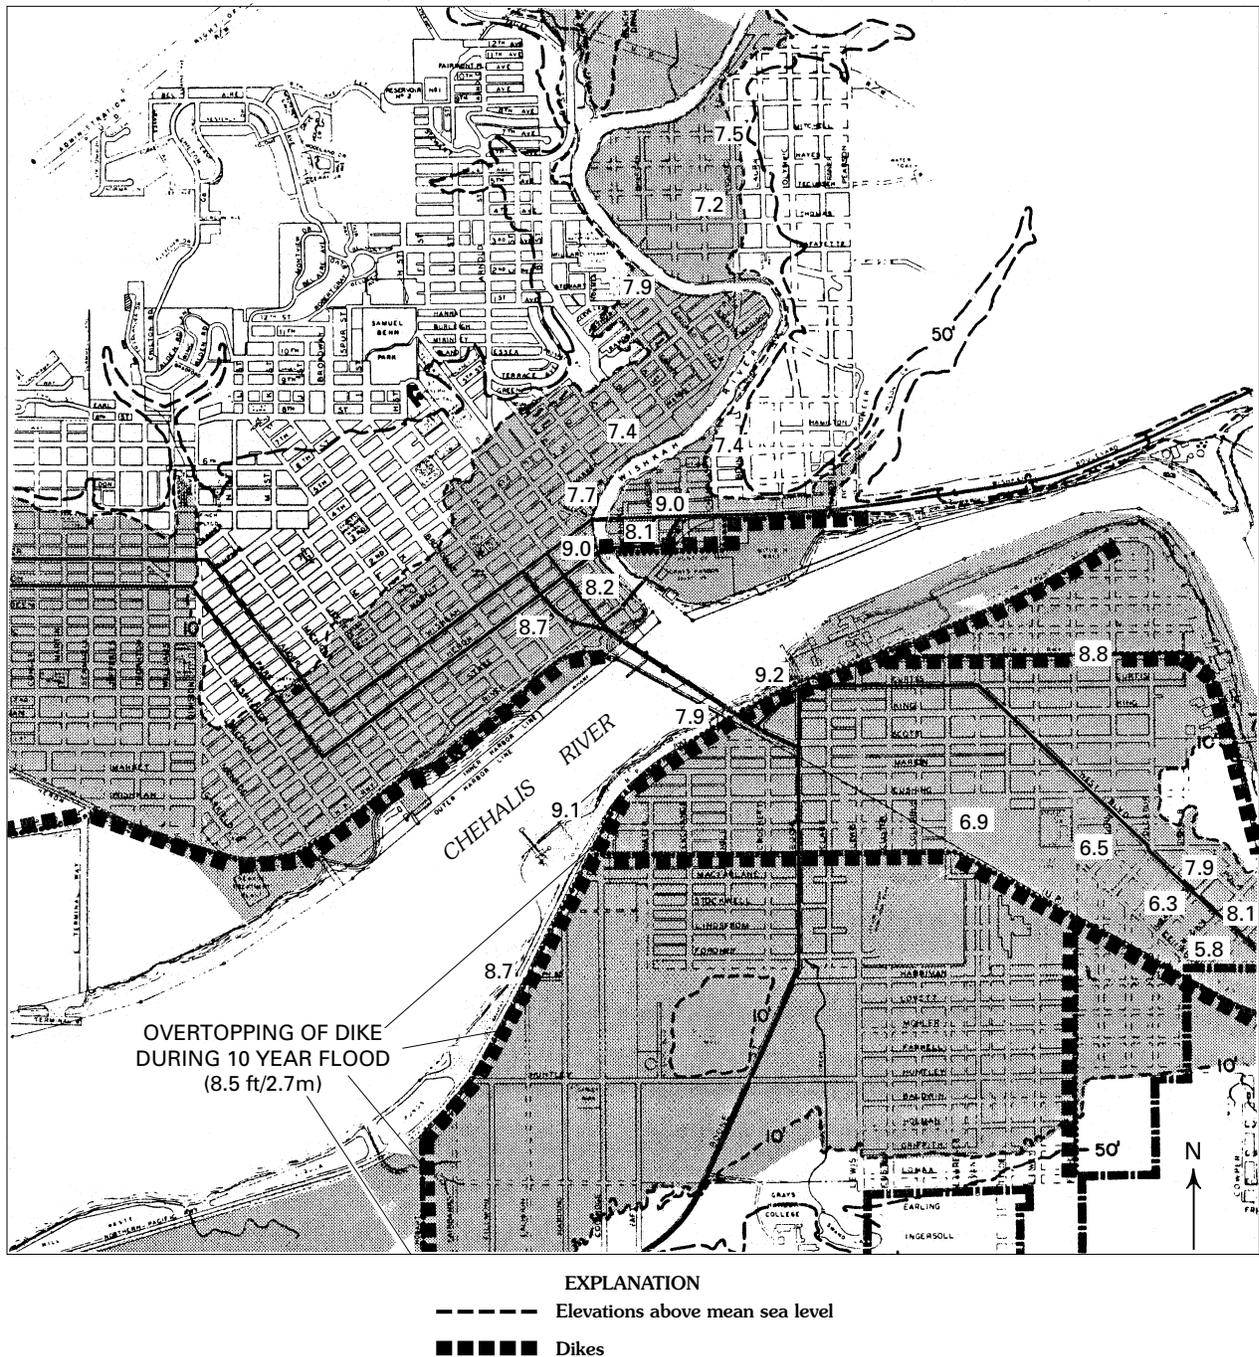
**Figure 243.** Critical flood levels for Aberdeen (north side of Chehalis River) and South Aberdeen (south side of river). Low-lying areas will be subject to flooding during low tide; during high tide, the entire urbanized area will be subject to extensive flooding that, because of deeper water level, could have relatively high velocity. One hundred year flood boundary defined by FEMA in conjunction with NFIP (National Flood Insurance Program) is the 10-foot contour. From Urban Regional Research (1986).

Projections of land-use disruption must rely on an estimate of potential flood areas, which to a large extent is a function of ground elevation. This analysis, therefore, encompasses all the area below 6.1 m elevation (above mean sea level), the slope of which is 0–2 percent. A three-dimensional terrain model was used as the basis for the land-use analysis (fig. 244). Correlation of topography with land use permits rapid assessment of geographically based vulnerability to flooding. The urbanized area of Ocean Shores, a community of predominantly second homes, is entirely below 3 m elevation. Land-use patterns indicate that the urban and industrial areas in the central business districts of Hoquiam and Aberdeen are on coastal lowlands, virtually all of which are unconsolidated fills. Grays Harbor has several industrial complexes located along the shore. About 25 percent of the work force in Grays Harbor County is employed in manufacturing activities. ITT-Rayonier and Grays Harbor Paper have a combined pulp and fine-paper production facility on the waterfront in Hoquiam. A large Weyerhaeuser wood-pulp facility is in South Aberdeen. The harbor has several port
