Concentration of 1,4-Dioxane in Wells Sampled During 2002–2009 in the Vicinity of the Tucson International Airport Area Superfund Site, Arizona

By
Fred D Tillman
2010

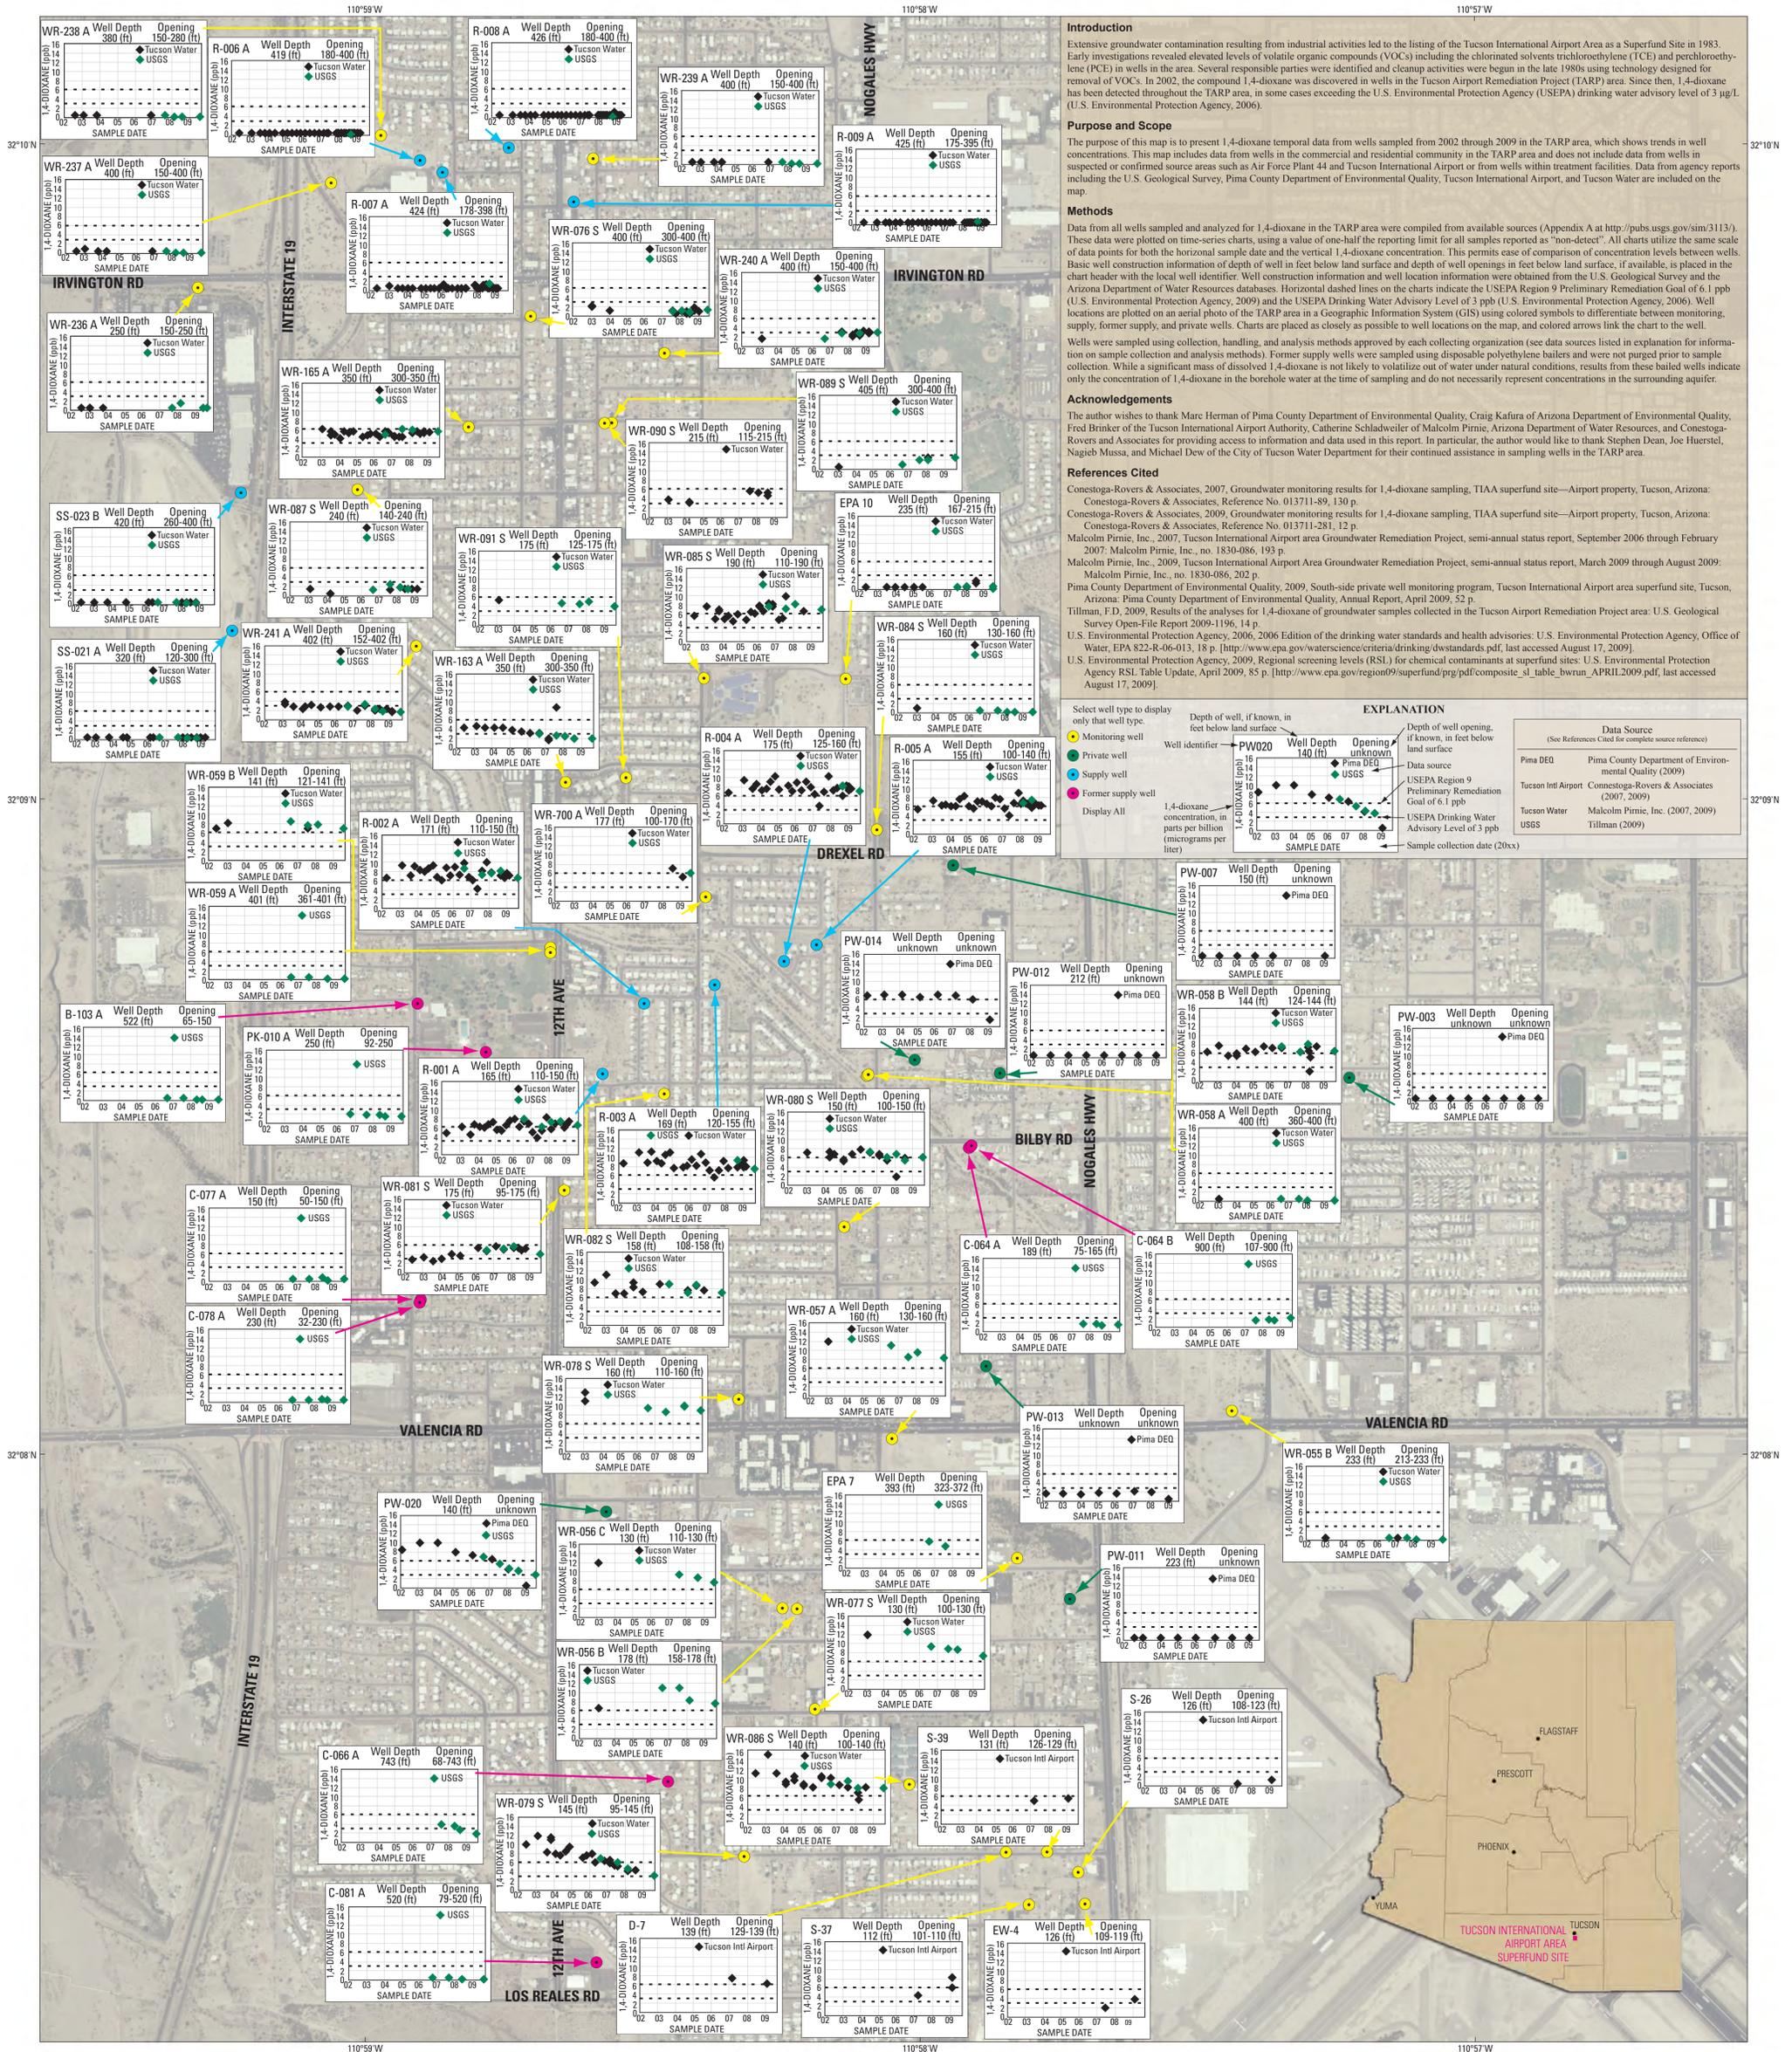
The purpose of this map is to present 1,4-dioxane temporal data from wells sampled from 2002 through 2009 in the TARP area, which shows trends in well concentrations. This map includes data from wells in the commercial and residential community in the TARP area and does not include data from wells in suspected or confirmed source areas such as Air Force Plant 44 and Tucson International Airport or from wells within treatment facilities. Data from agency reports including the U.S. Geological Survey, Pima County Department of Environmental Quality, Tucson International Airport, and Tucson Water are included on the map.

Data from all wells sampled and analyzed for 1,4-dioxane in the TARP area were compiled from available sources (Appendix A at <http://pubs.usgs.gov/sim/3113/>). These data were plotted on time-series charts, using a value of one-half the reporting limit for all samples reported as "non-detected". All charts utilize the same scale of data points for both the horizontal sample date and the vertical 1,4-dioxane concentration. This permits ease of comparison of concentration levels between wells. Basic well construction information of depth of well in feet below land surface and depth of well openings in feet below land surface, if available, is placed in the chart header with the well identifier. Well construction information and well location information were obtained from the U.S. Geological Survey and the Arizona Department of Water Resources databases. Horizontal dashed lines on the charts indicate the USEPA Region 9 Preliminary Remediation Goal of 6.1 ppb (U.S. Environmental Protection Agency, 2009) and the USEPA Drinking Water Advisory Level of 3 ppb (U.S. Environmental Protection Agency, 2006). Well locations are plotted on an aerial photo of the TARP area in a Geographic Information System (GIS) using colored symbols to differentiate between monitoring, supply, former supply, and private wells. Charts are placed as closely as possible to well locations on the map, and colored arrows link the chart to the well.

Wells were sampled using collection, handling, and analysis methods approved by each collecting organization (see data sources listed in explanation for information on sample collection and analysis methods). Former supply wells were sampled using disposable polyethylene bailers and were not purged prior to sample collection. While a significant mass of dissolved 1,4-dioxane is not likely to volatilize out of water under natural conditions, results from these bailed wells indicate only the concentration of 1,4-dioxane in the borehole water at the time of sampling and do not necessarily represent concentrations in the surrounding aquifer.
