## Bathymetric Contour Map, and Surface Area and Capacity Table for Mozingo Lake near Maryville, Missouri, 2020

By  
Richard J. Huizinga, Lindi D. Oyler, and Benjamin C. Rivers  
2022

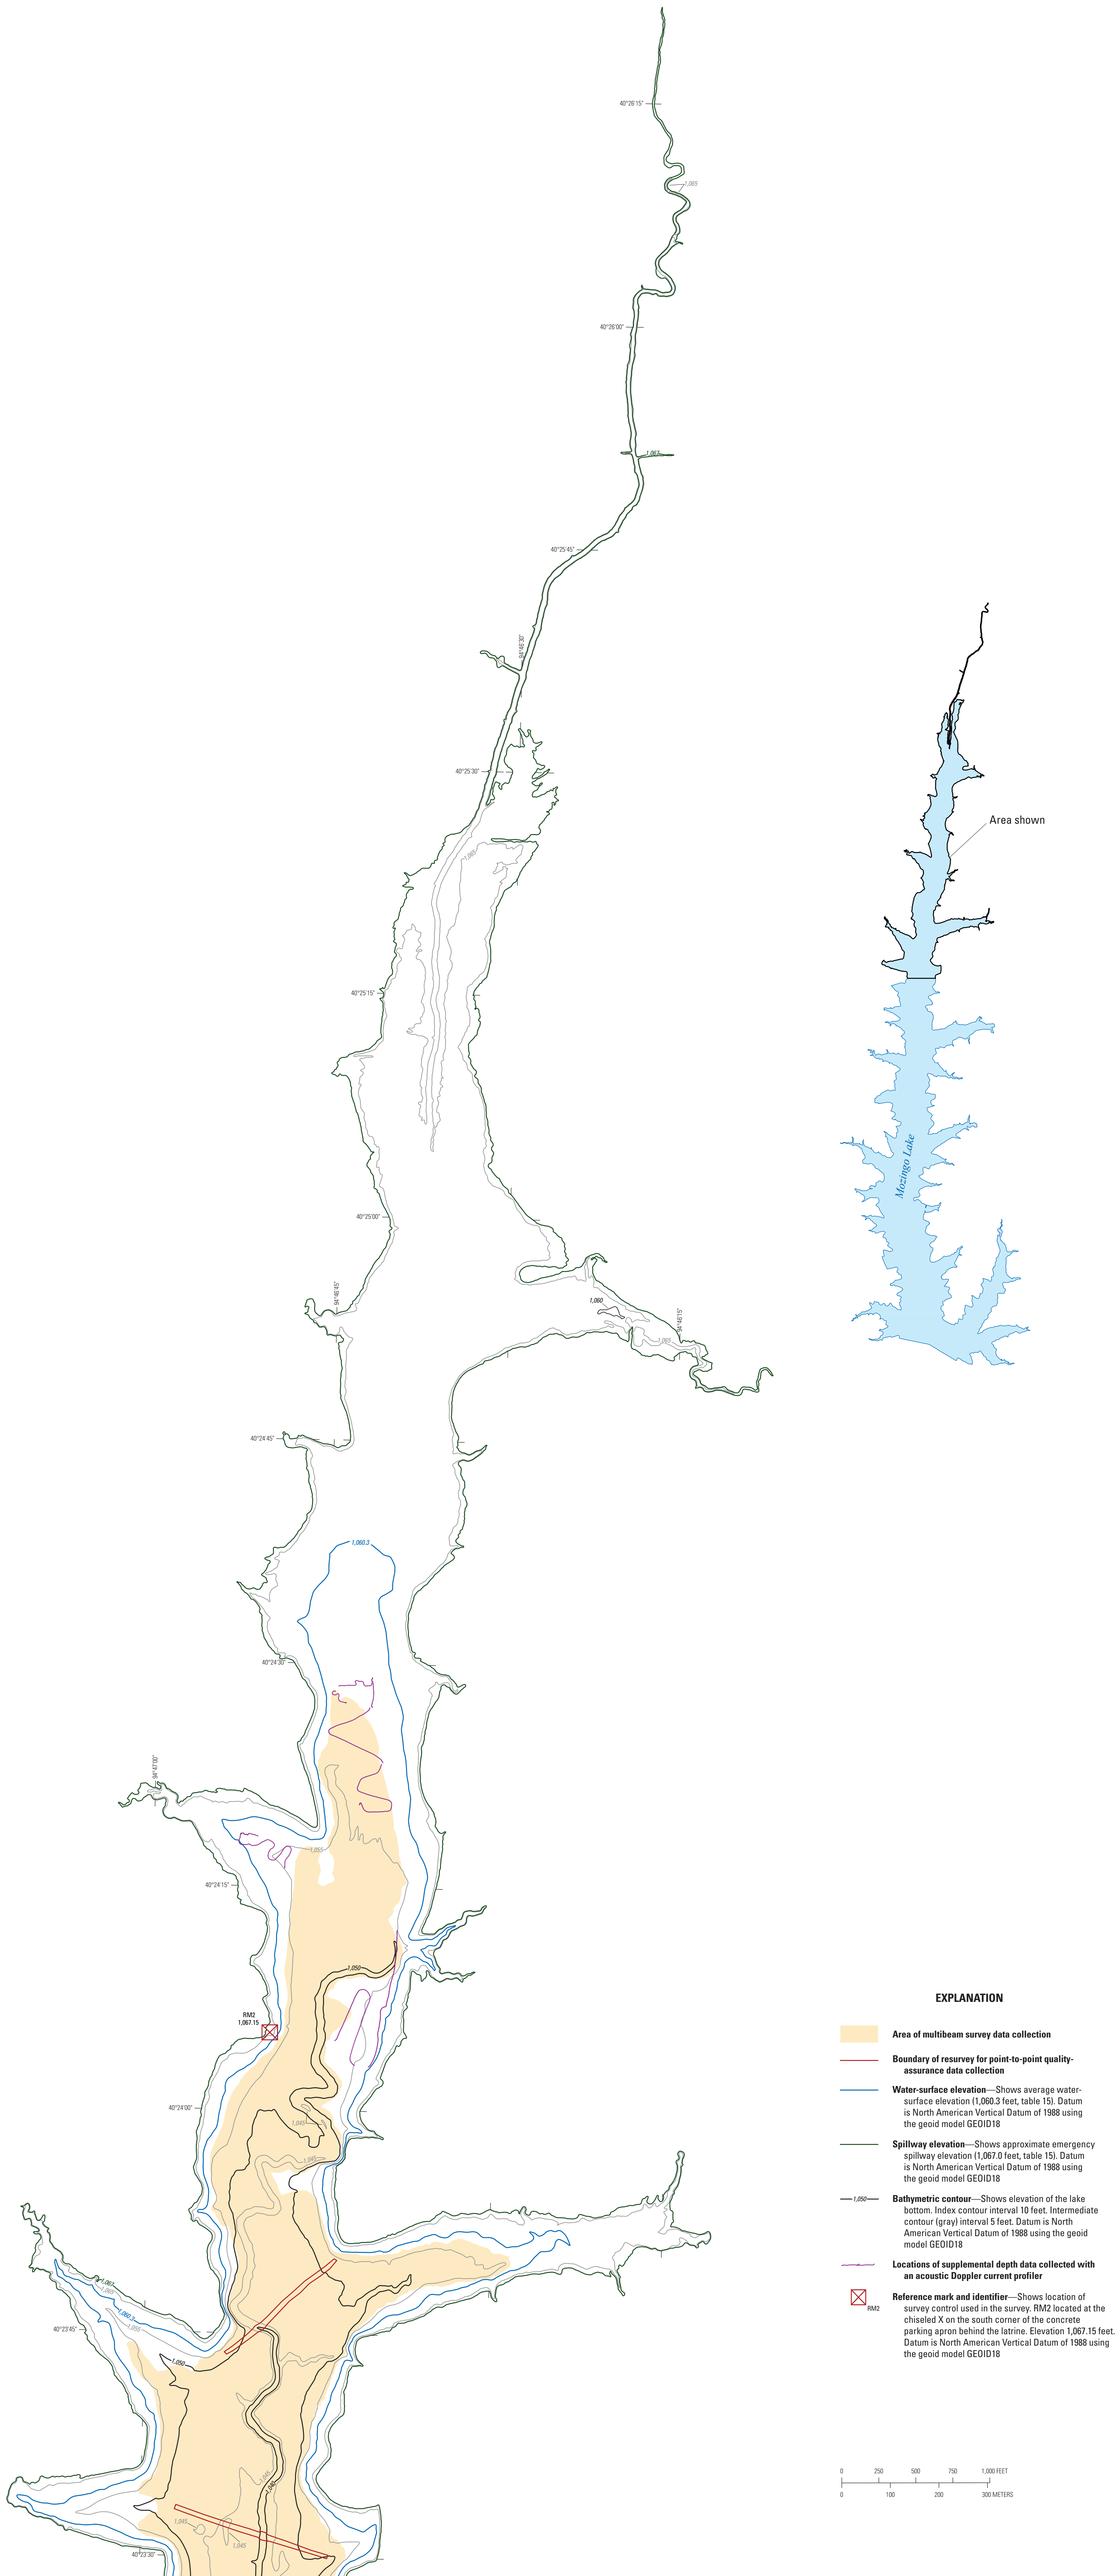
Figure 50. Bathymetric contours for Mozingo Lake (lake 11; fig. 1; table 1) near Maryville, Missouri, resulting from a survey on June 23–26, 2020.

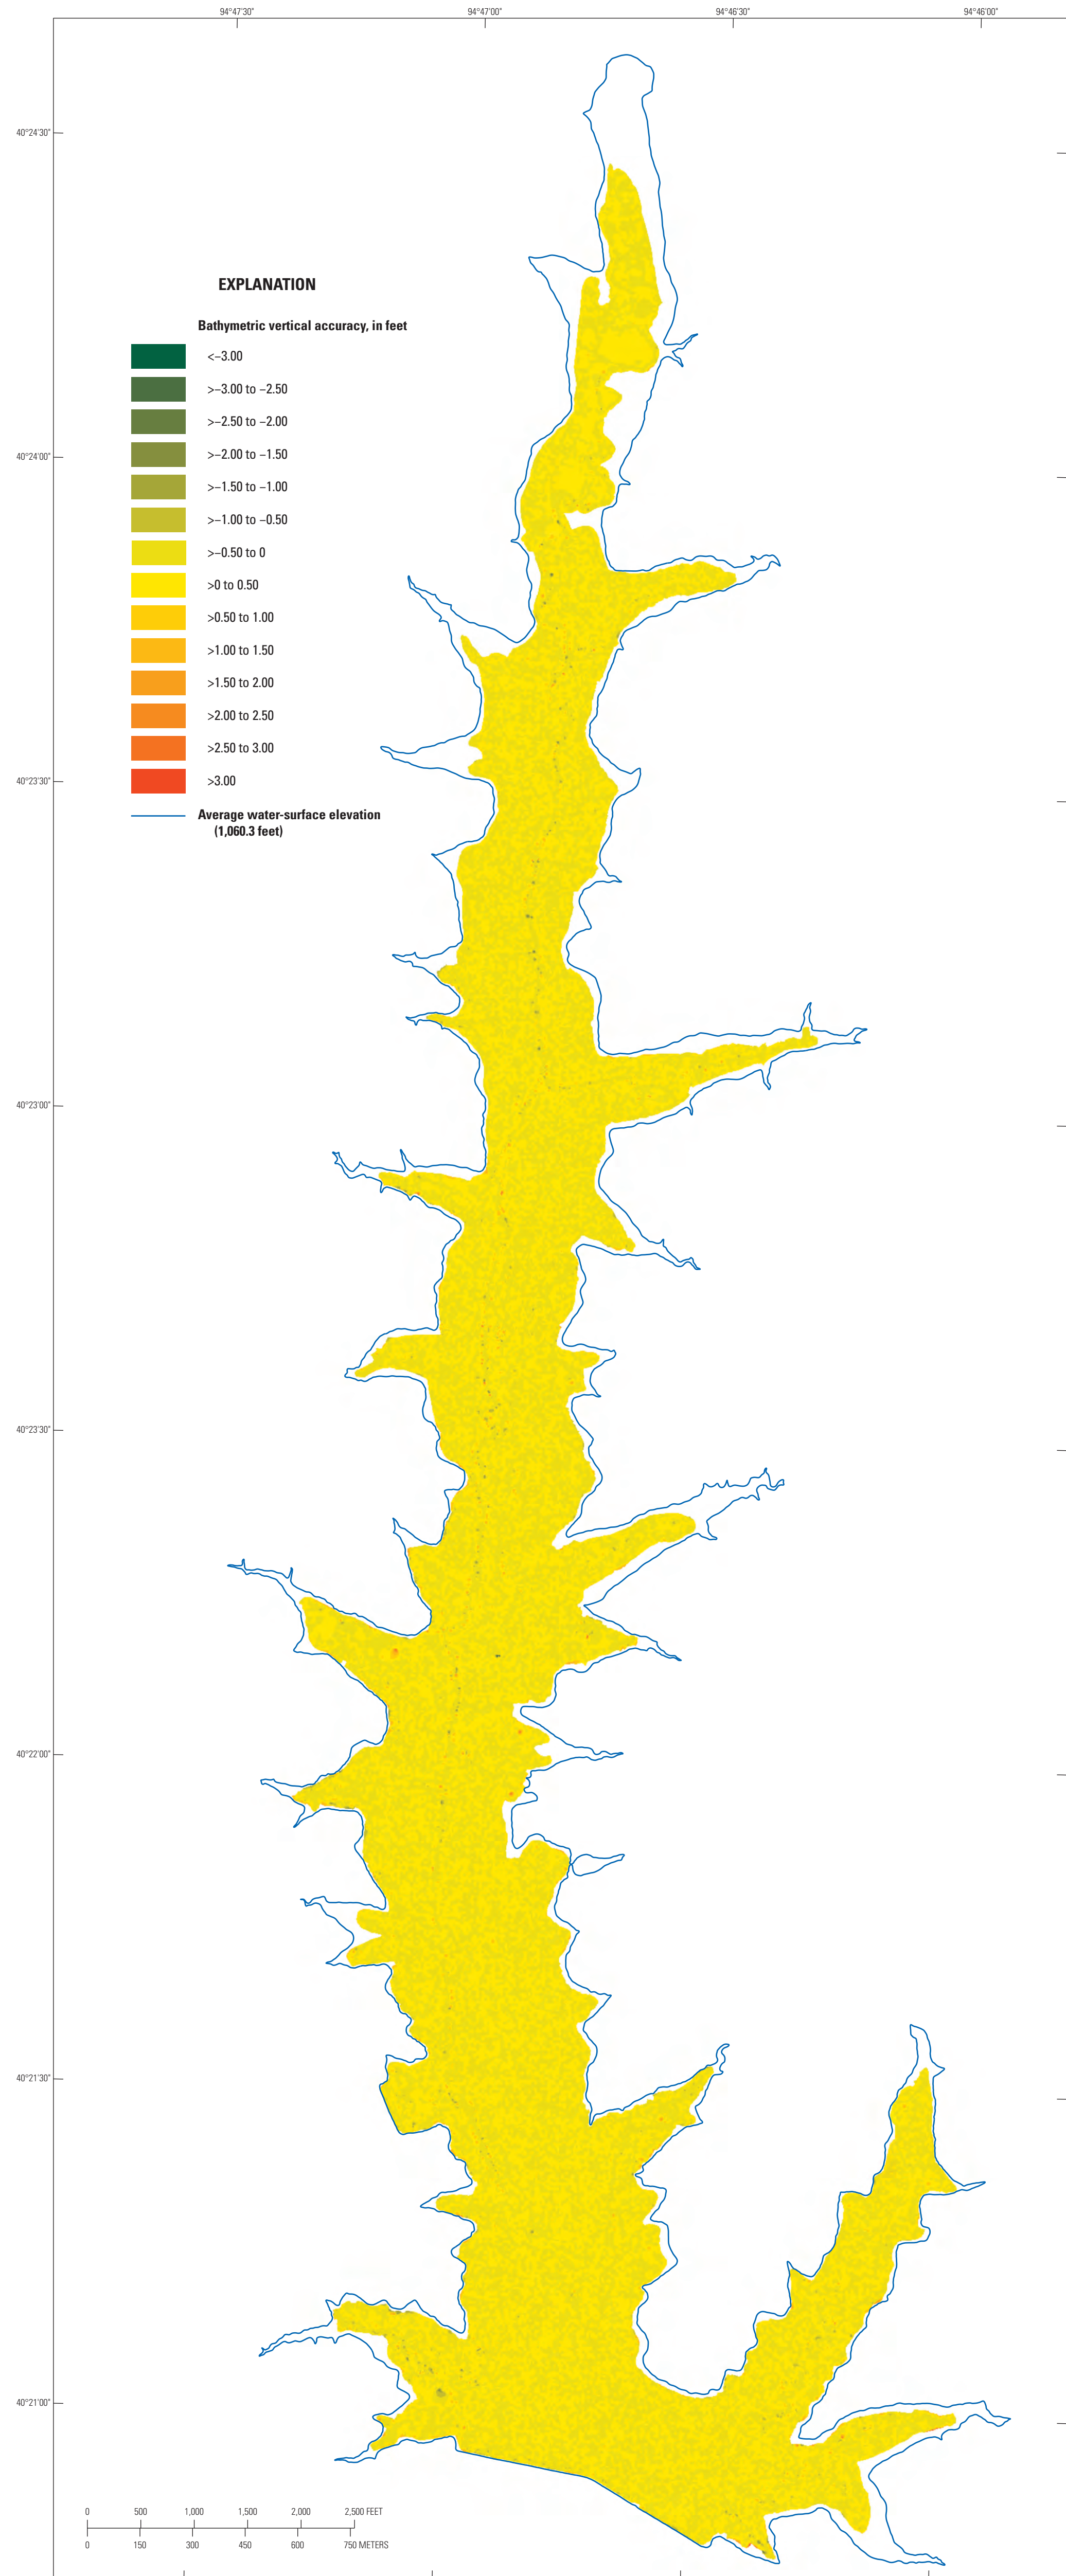
Figure 51. Vertical accuracy of the bathymetric surface of Mozingo Lake near Maryville, Missouri, 2020.
