# Potentiometric Surface of Winter 2020 Groundwater Conditions and Groundwater-level Change Between Winter 2015 and Winter 2020 in the Cannon Air Force Base Area, Curry County, New Mexico

By  
**Blake A. Goodwin and Meghan T. Bell**  
2023

Suggested citation: Goodwin, B.A., and Bell, M.T., 2023, Potentiometric Surface Map of the Southern High Plains Aquifer in the Cannon Air Force Base Area, Curry County, New Mexico, 2020: U.S. Geological Survey Scientific Investigations Map 3504, 1 sheet, 18-p. pamphlet, <https://doi.org/10.3133/sim3504>

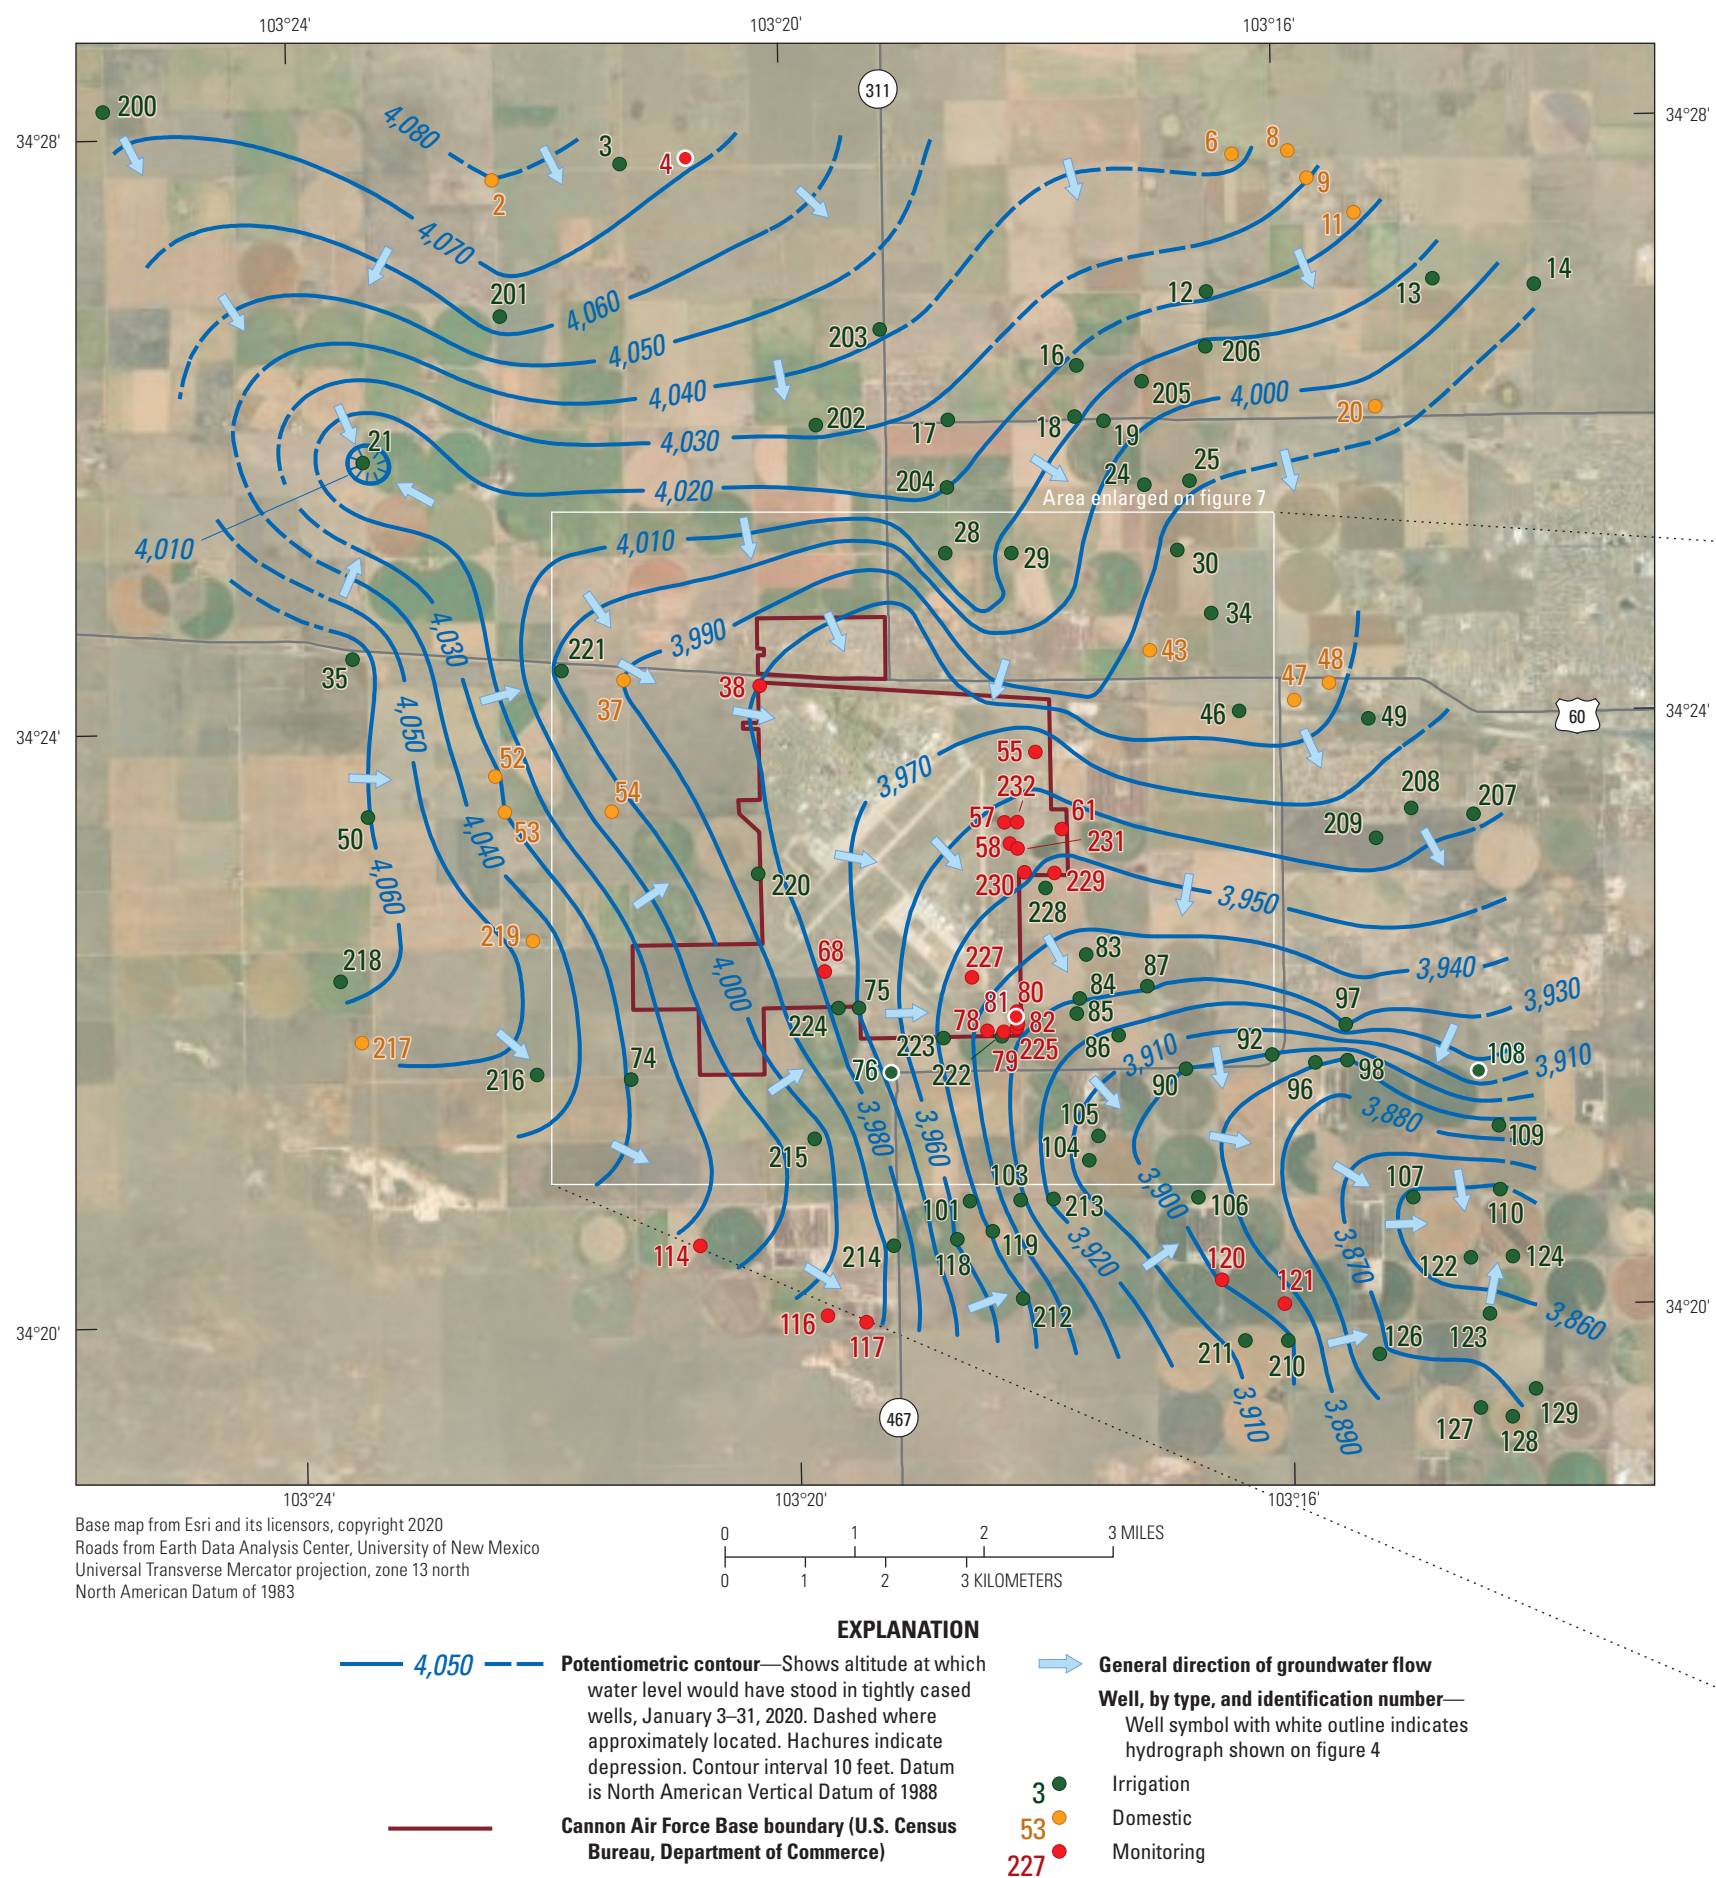
**Figure 6.** Potentiometric surface of winter groundwater conditions in the Cannon Air Force Base area, January 13-31, 2020, Curry County, New Mexico. Data shown in table 1.
