Losses and Gains for Eight Unlined Canals Along the Purgatoire River near Trinidad, Colorado, 2000–2004

Scientific Investigations Report 2006–5164

By Lisa D. Miller

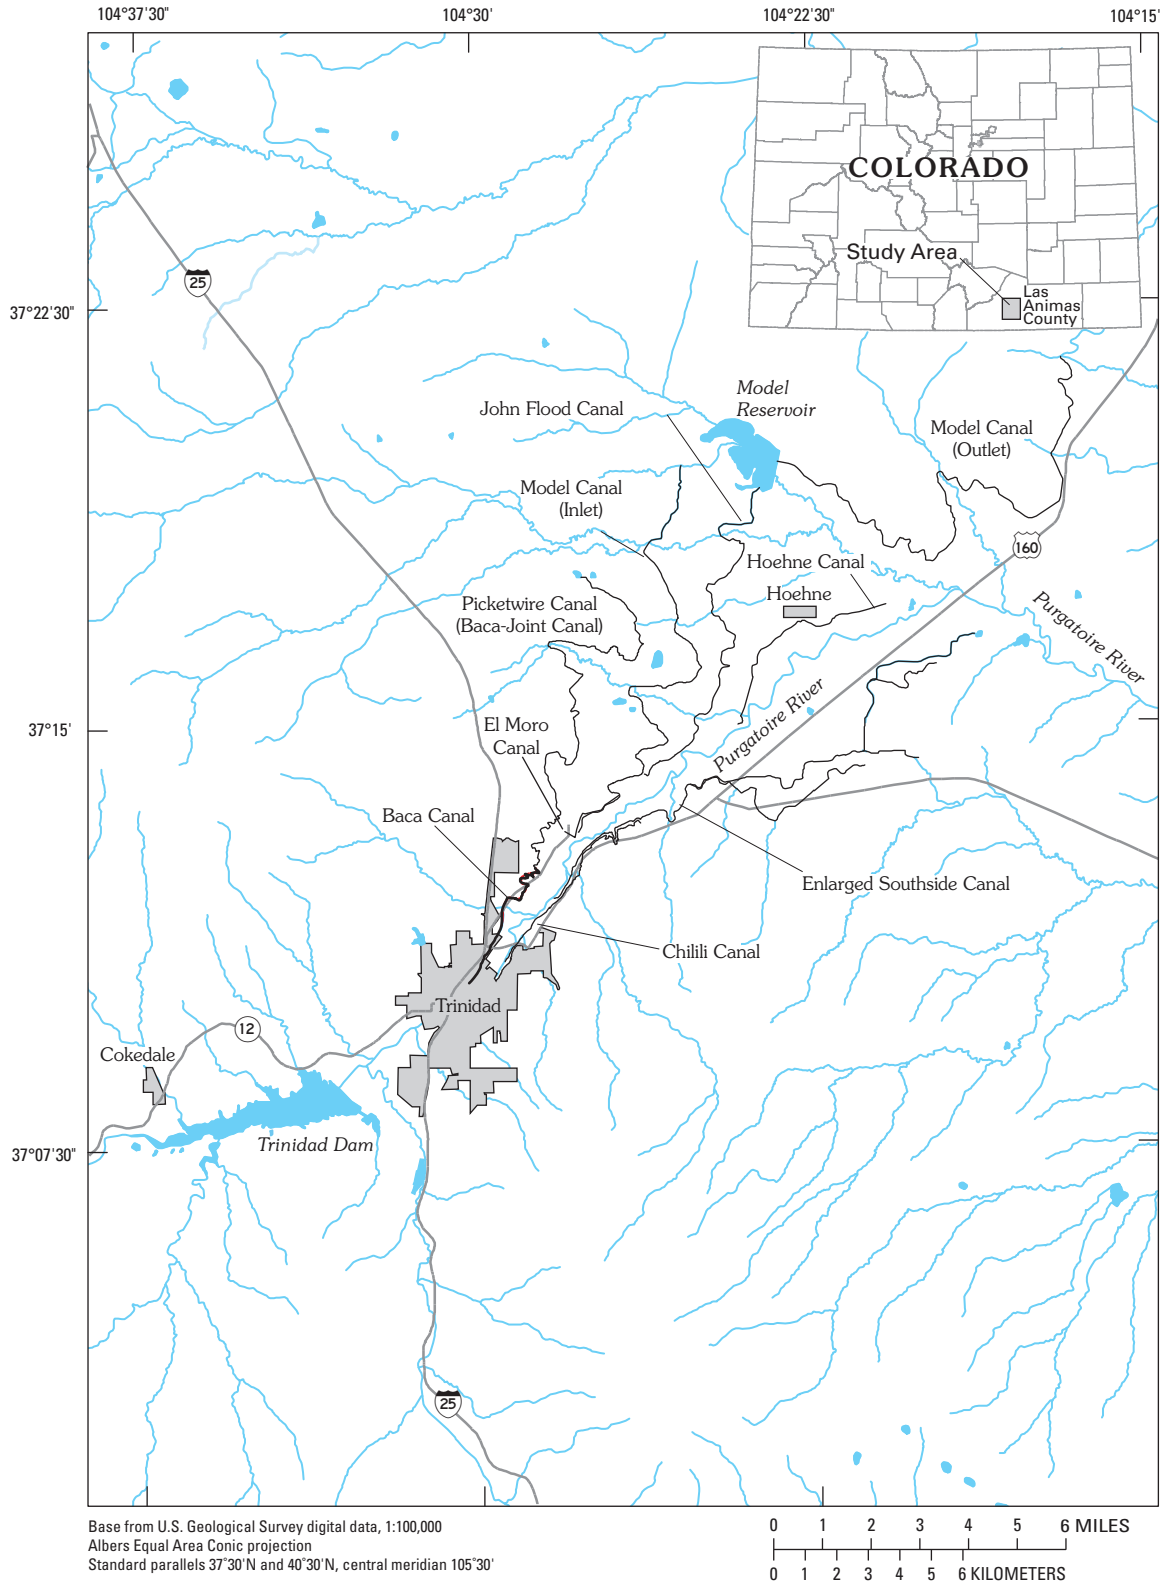
Figure 1. Location of study area and selected Purgatoire River Water Conservancy District Canals near Trinidad, Colorado.

Principal areas of irrigation in the upper Purgatoire River Basin include areas in the vicinity of Trinidad, Colorado (fig. 1). Irrigated lands near Trinidad extend down the valley for about 35 miles along gently sloping plateaus. Eleven canal systems downstream from Trinidad Dam are part of the Purgatoire River Water Conservancy District (PRWCD). These canals receive water from the U. S. Army Corps of Engineer's (Corps) Trinidad Dam and Reservoir Project to irrigate about 20,000 acres of cropland. Irrigation is conducted in accordance with Operating Principles and Operating Criteria established under the repayment contract for the irrigation portion of the Project. The Bureau of Reclamation (BOR) is responsible for administration of the repayment contract (U.S. Army Corps of Engineers, 1978).

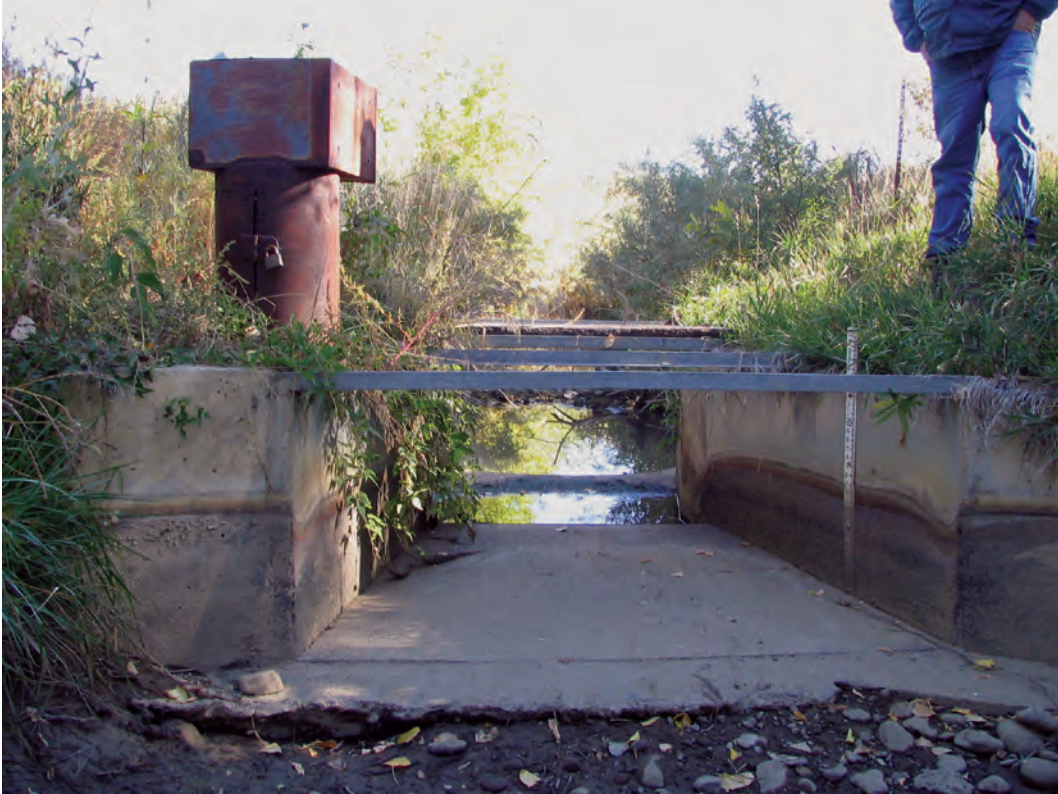
Figure 2. Water-stage recorder and Parshall flume at measurement site HOHG (Hoehne Canal headgate).

Differences between the precalibrated Parshall flume ratings and measured discharges appear to occur at the PRWCD headgates. These differences probably occur due to changes over time in the flume or in the canal channel immediately upstream or downstream from the flume. To accurately measure flow with a flume using precalibrated discharge ratings, the flume must be level, free of debris, and have good approach (that is, entering flow should be well distributed across the width and parallel to the flume centerline) and exit conditions. Shifts (difference between precalibrated discharge ratings and measured discharge) in the stage-discharge relation of a critical-flow flume are most commonly caused by changes in the approach section—either in the channel immediately upstream from the flume or in the converging section upstream from the flume throat (Kilpatrick and Schneider, 1983). Deposition of rocks and debris upstream from the flume may divert most of the flow to the gage-side of the flume, resulting in a higher stage reading for a given discharge. Conversely, if most of the water is diverted to the side opposite of the gage, the observed stage would be lower for the measured discharge.

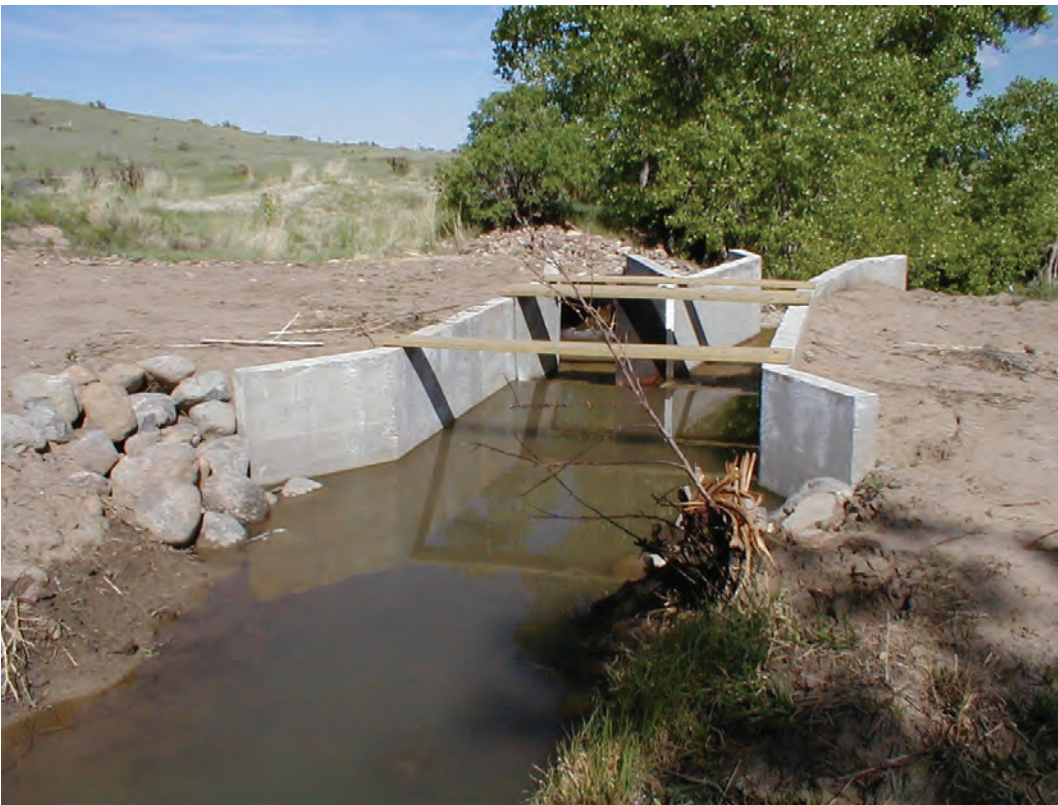
Figure 3. Splitter box located at measurement site SS07 on the Enlarged Southside Canal.

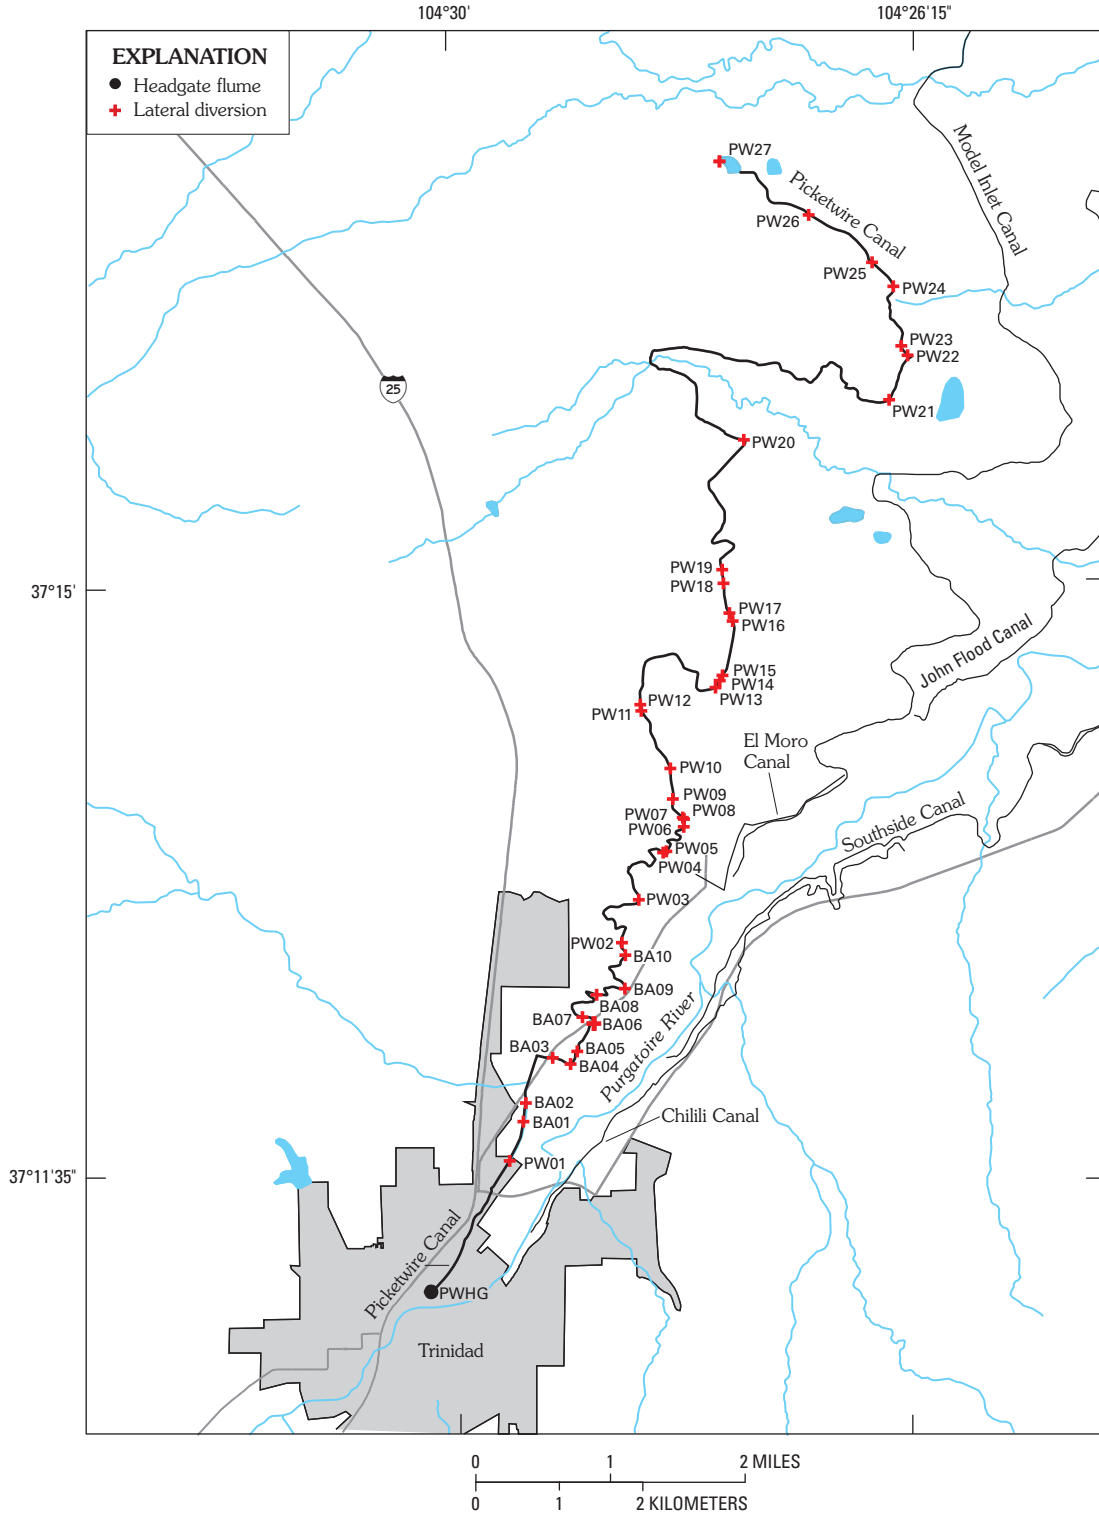
Figure 4. Location of measurement sites along Picketwire Canal (Baca Joint Canal).

Discharge measurements were made at main canal and diversion locations from PWHG to PW02 on June 18, 2003 (fig. 4). No leakage was observed at the diversion gates

On June 10, 2004, discharge measurements were made at main canal and diversion locations from PWHG to PW26 (fig. 4). Minor leakage of less than 0.02 ft³/s was estimated at three closed diversion gates (table A1). No leakage was observed at the remaining diversion gates. A loss of about 1.7 ft³/s (4 percent of the subreach inflow) was measured along the Baca subreach from BA02 to BA10 (table 4), a 1.9-mile reach. The loss from PWHG to PW26 was computed to be 4.8 ft³/s, or 12 percent of the headgate inflow (fig. 5 and table 3).

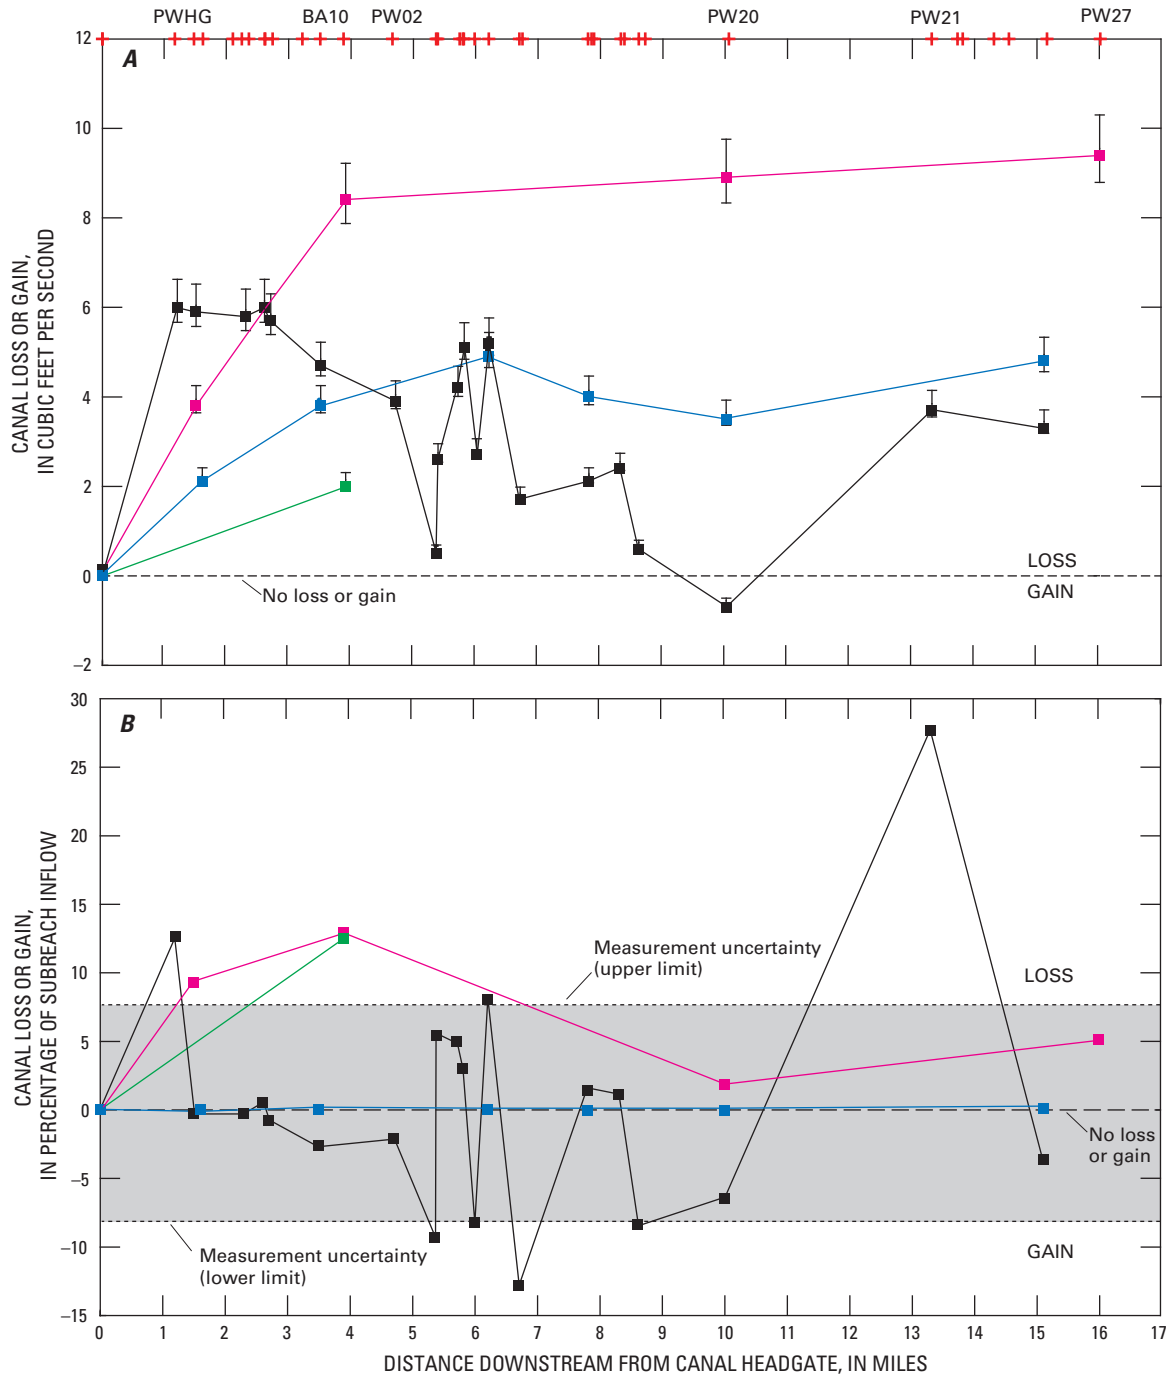
- Measurement uncertainty
- Error bars—Plus or minus 8 percent
- + Site locations
- August 2, 2000—Canal flowing continuously 107 days
- May 16, 2001—Canal flowing continuously 10 days
- June 18, 2003—Canal flowing continuously 44 days
- June 10, 2004—Canal flowing continuously 32 days

On August 2, 2000, discharge measurements were made at main canal and diversion locations from the headgate (PWHG) to PW26, a distance of about 15.1 miles. Leakage was observed at three closed diversion gates (table A1). The total leakage from the three gates was estimated to be about 0.9 ft³/s. A gain of about 1.2 ft³/s (3 percent of the subreach inflow) was measured along the Baca subreach from BA01 to BA10 (table 4). The loss for the entire Picketwire Canal from PWHG to PW26 was computed to be 3.3 ft³/s, or 7 percent of the headgate inflow (table 3 and fig. 5).

Discharge measurements were made at main canal and diversion locations from PWHG to PW27, a distance of about 16.0 miles, on May 16, 2001. No leakage was observed at the diversion gates (table A1). A loss of about 4.6 ft³/s (13 percent of the subreach inflow) was measured from BA01 to PW02 (tables 3 and 4), a 2.4-mile reach. The loss from PWHG to PW27 (table 3) was computed to be 9.4 ft³/s, or 23 percent of the headgate inflow (fig. 5).

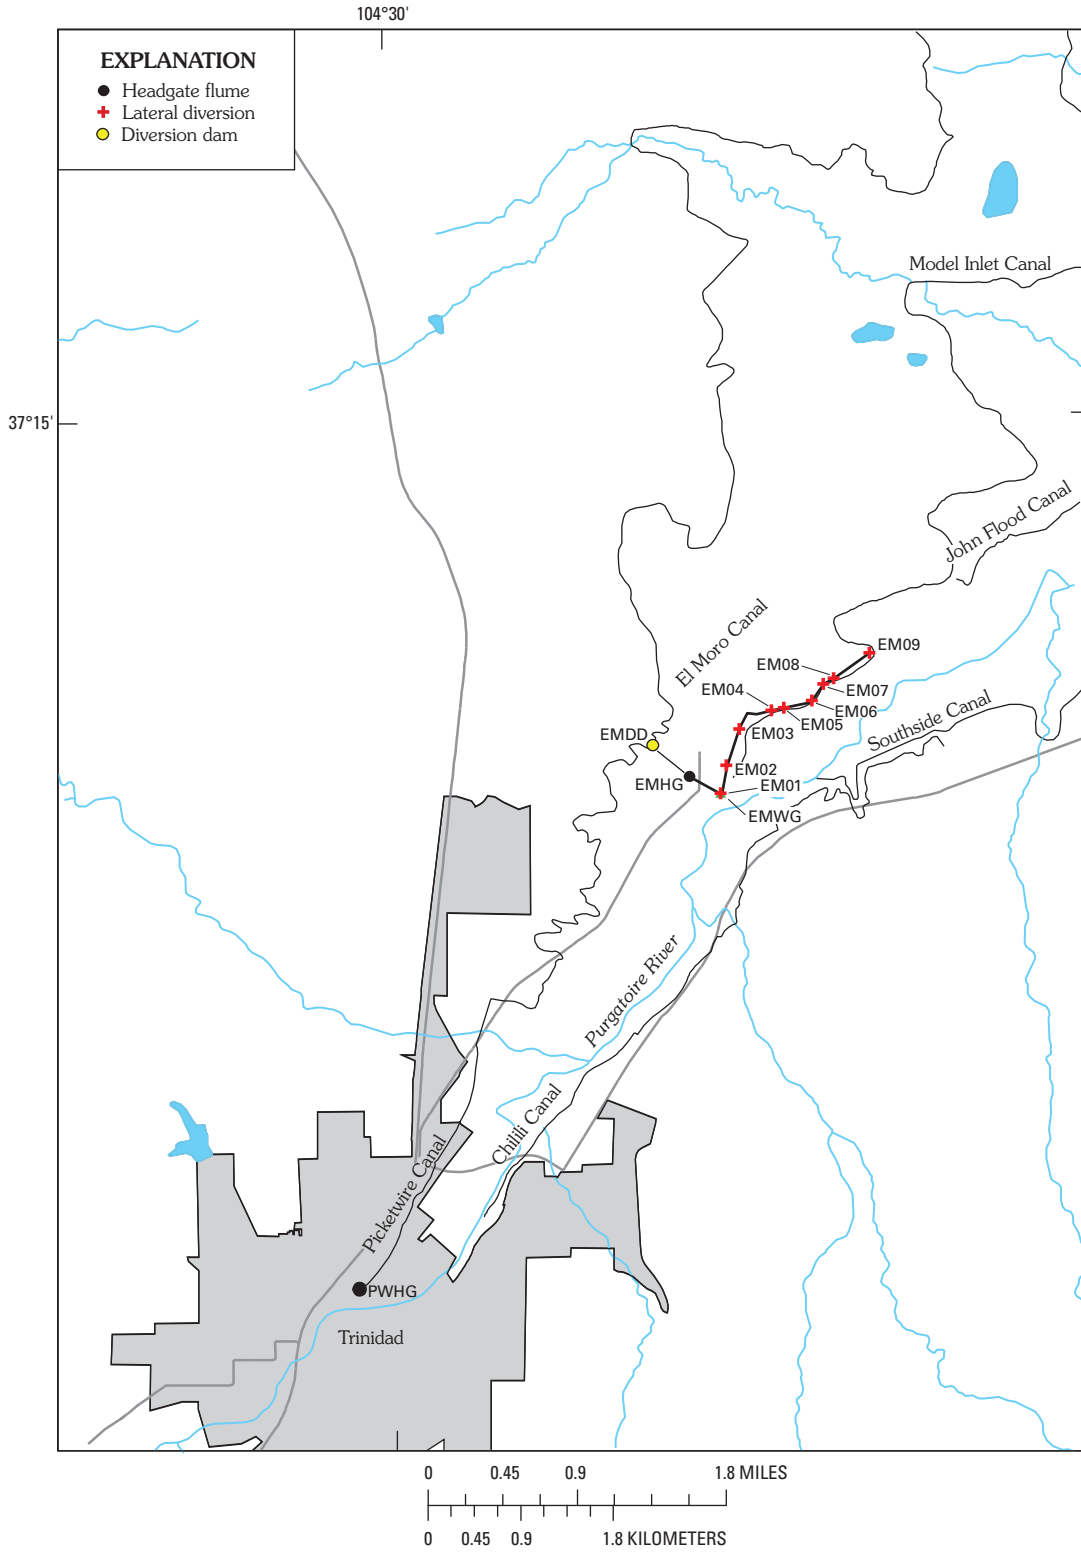
Figure 6. Location of measurement sites along El Moro Canal.

On August 1, 2000, discharge measurements were made at main channel and diversion locations from the headgate (EMHG) to EM09, which is upstream from the final two diversions on El Moro Canal (fig. 6). Five diversion gates were closed on August 1, 2000 (table A2). Leakage of about 0.1 ft³/s was estimated at one of the gates. No leakage was observed at the remaining gates. A gain of 0.4 ft³/s, or 10 percent of the headgate inflow, was determined for El Moro Canal between EMHG and EM04, a distance of about 0.9 mile. This is compared to a loss of 1.1 ft³/s (28 percent of the headgate inflow) computed between EMHG and EM09, a distance of about 1.6 miles (table 5 and fig. 7).

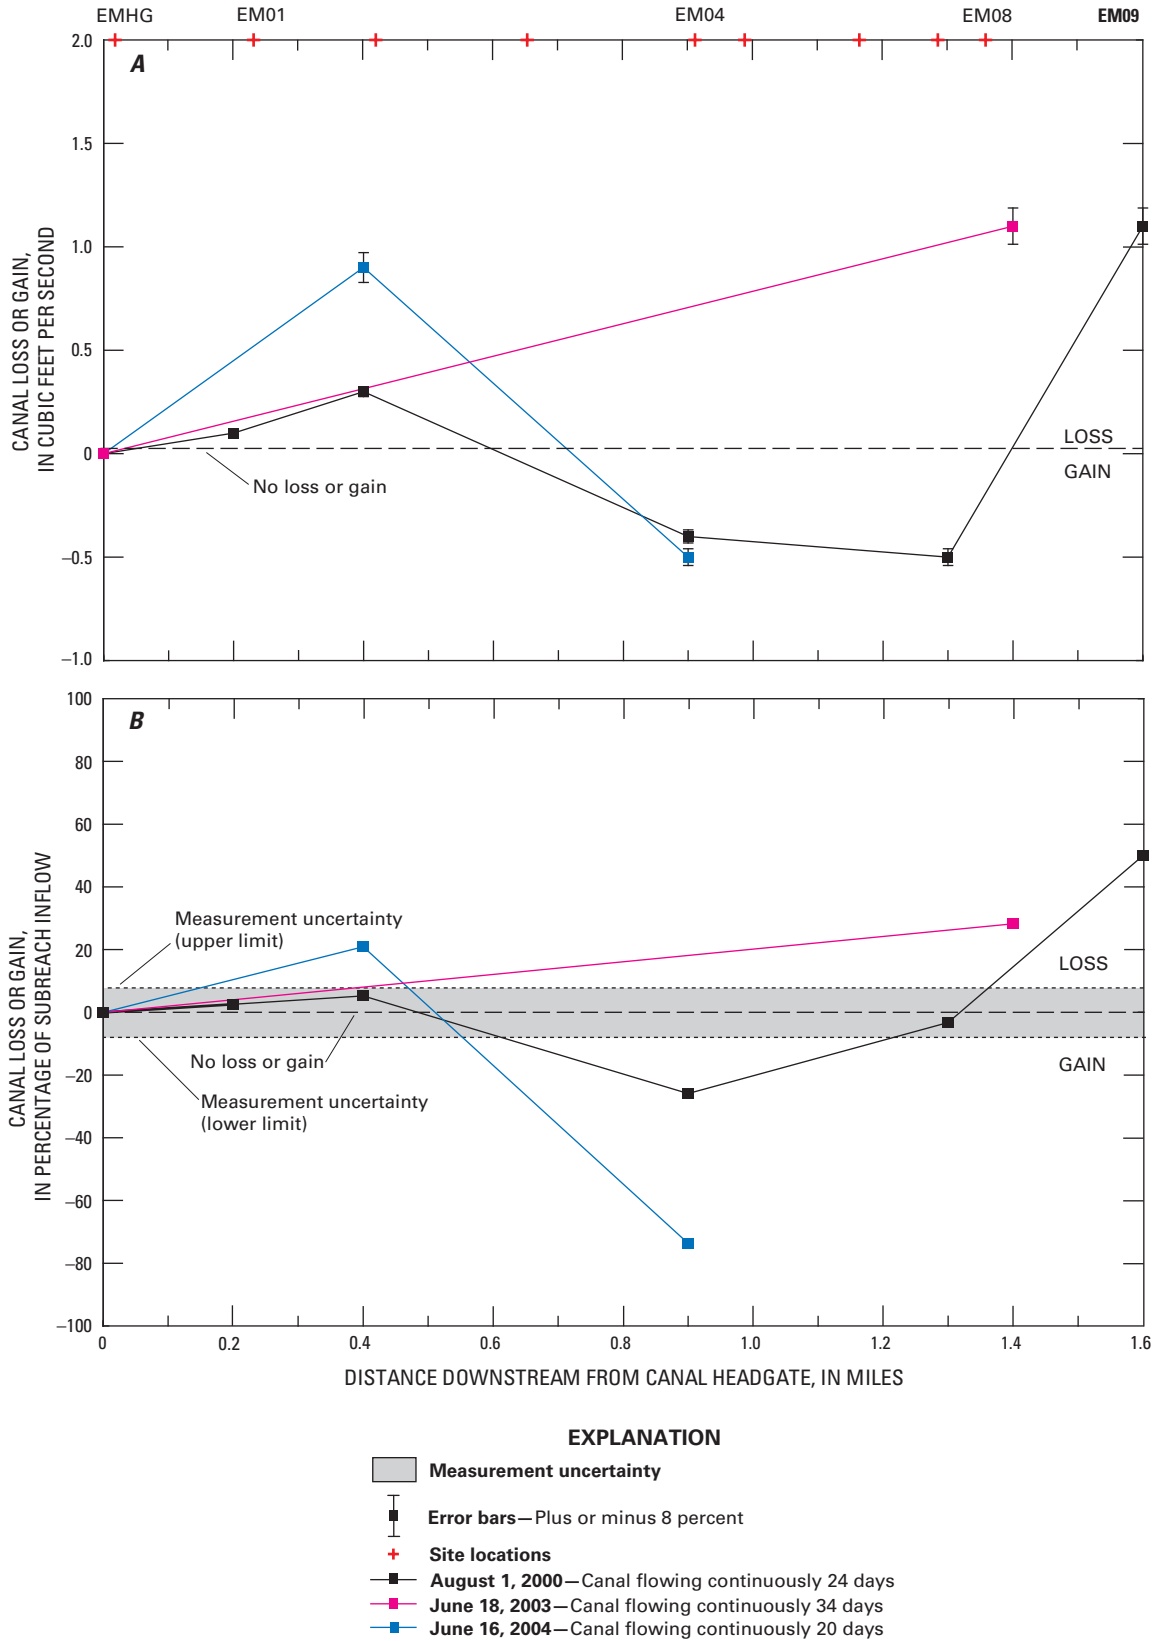
Figure 7. Losses and gains in (A) cubic feet per second and (B) percentage of subreach inflow in selected subreaches of the El Moro Canal.

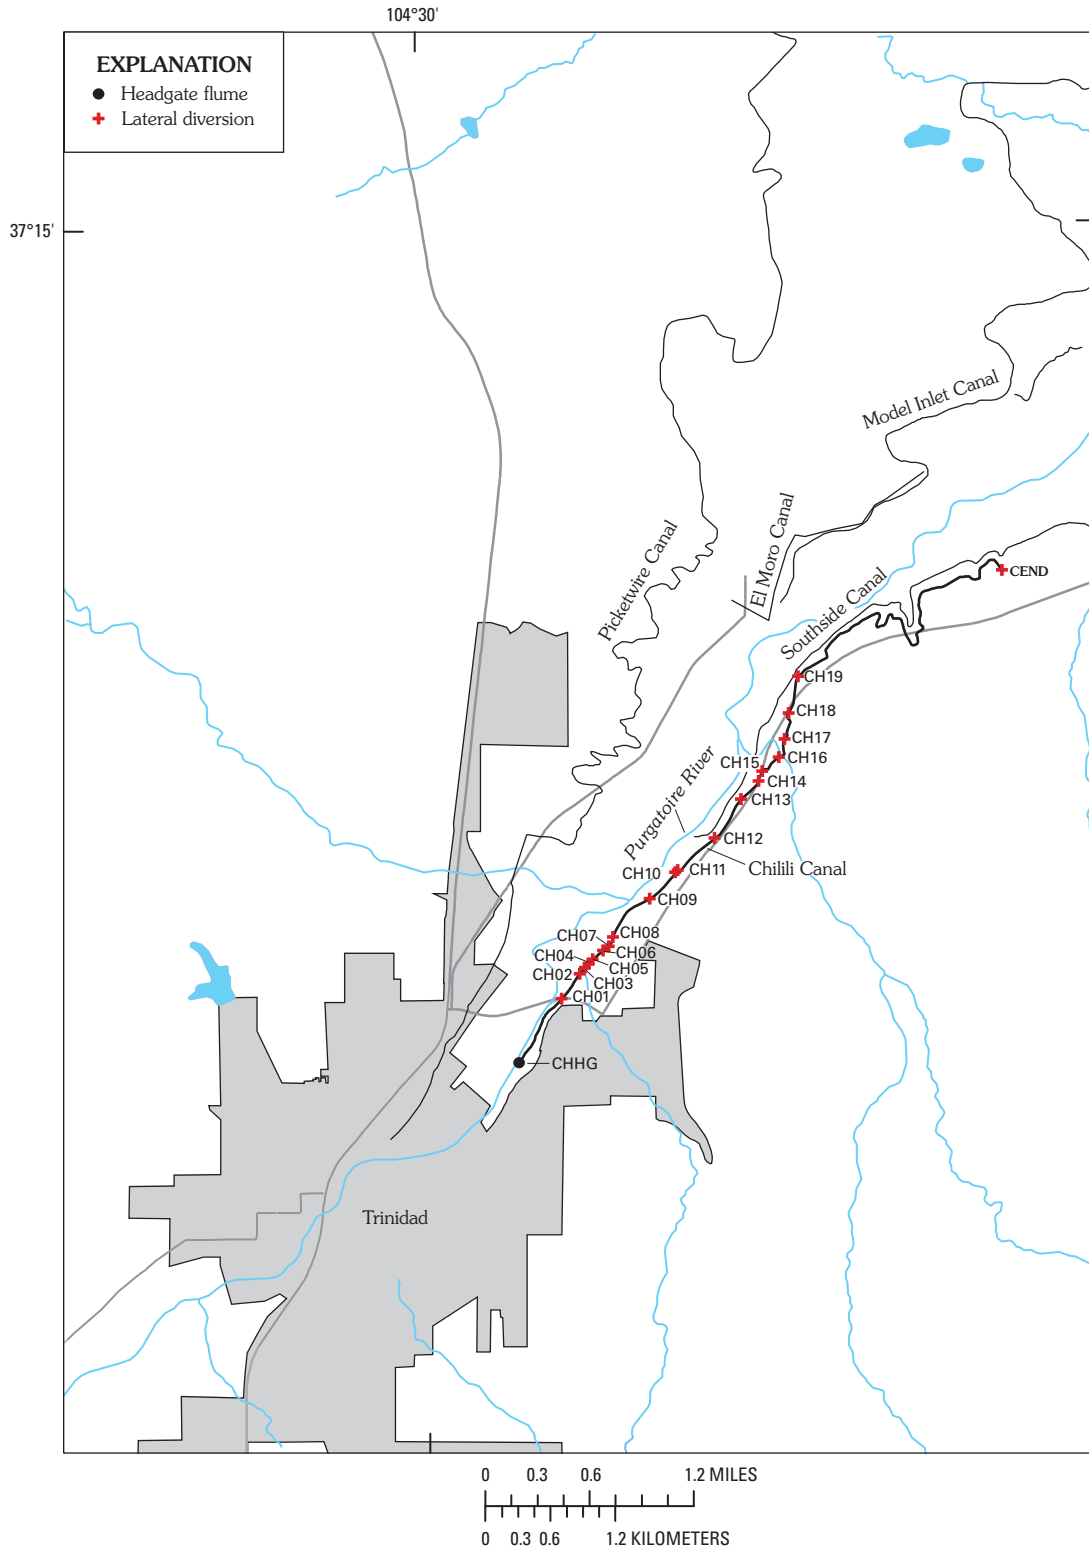
Figure 8. Location of measurement sites along Chilili Canal.

On August 1, 2000, discharge measurements were made at main channel and diversion locations from the headgate (CHHG) to CEND, a distance of about 4.9 miles (fig. 8, and table A3). No leakage was observed at the diversion gates. The loss from CHHG to CEND was computed to be 0.2 ft³/s, or 2 percent of the headgate inflow, which is within the uncertainty of the measurement (fig. 9 and table 6).

Discharge measurements were made at main channel and diversion locations from CHHG to CH10, a distance of about 1.4 miles, on May 17, 2001 (fig. 8 and table A3). Leakage of about 0.002 ft³/s was estimated at one of the diversion gates. No leakage was observed at the other gates. Main canal loss and gain measurements were ended at CH10 due to a thunderstorm. The loss from CHHG to CH10 was computed to be 2.3 ft³/s, or 25 percent of the headgate inflow (fig. 9 and table 6).

On June 19, 2003, discharge measurements were made at main canal and diversion locations from CHHG to CEND, a distance of about 4.9 miles (fig. 8 and table A3). Minor leakage of about 0.002 ft³/s was estimated at each of two diversion gates (table A3). The loss from CHHG to CEND was computed to be 2.8 ft³/s, or 34 percent of the headgate inflow (fig. 9 and table 6).

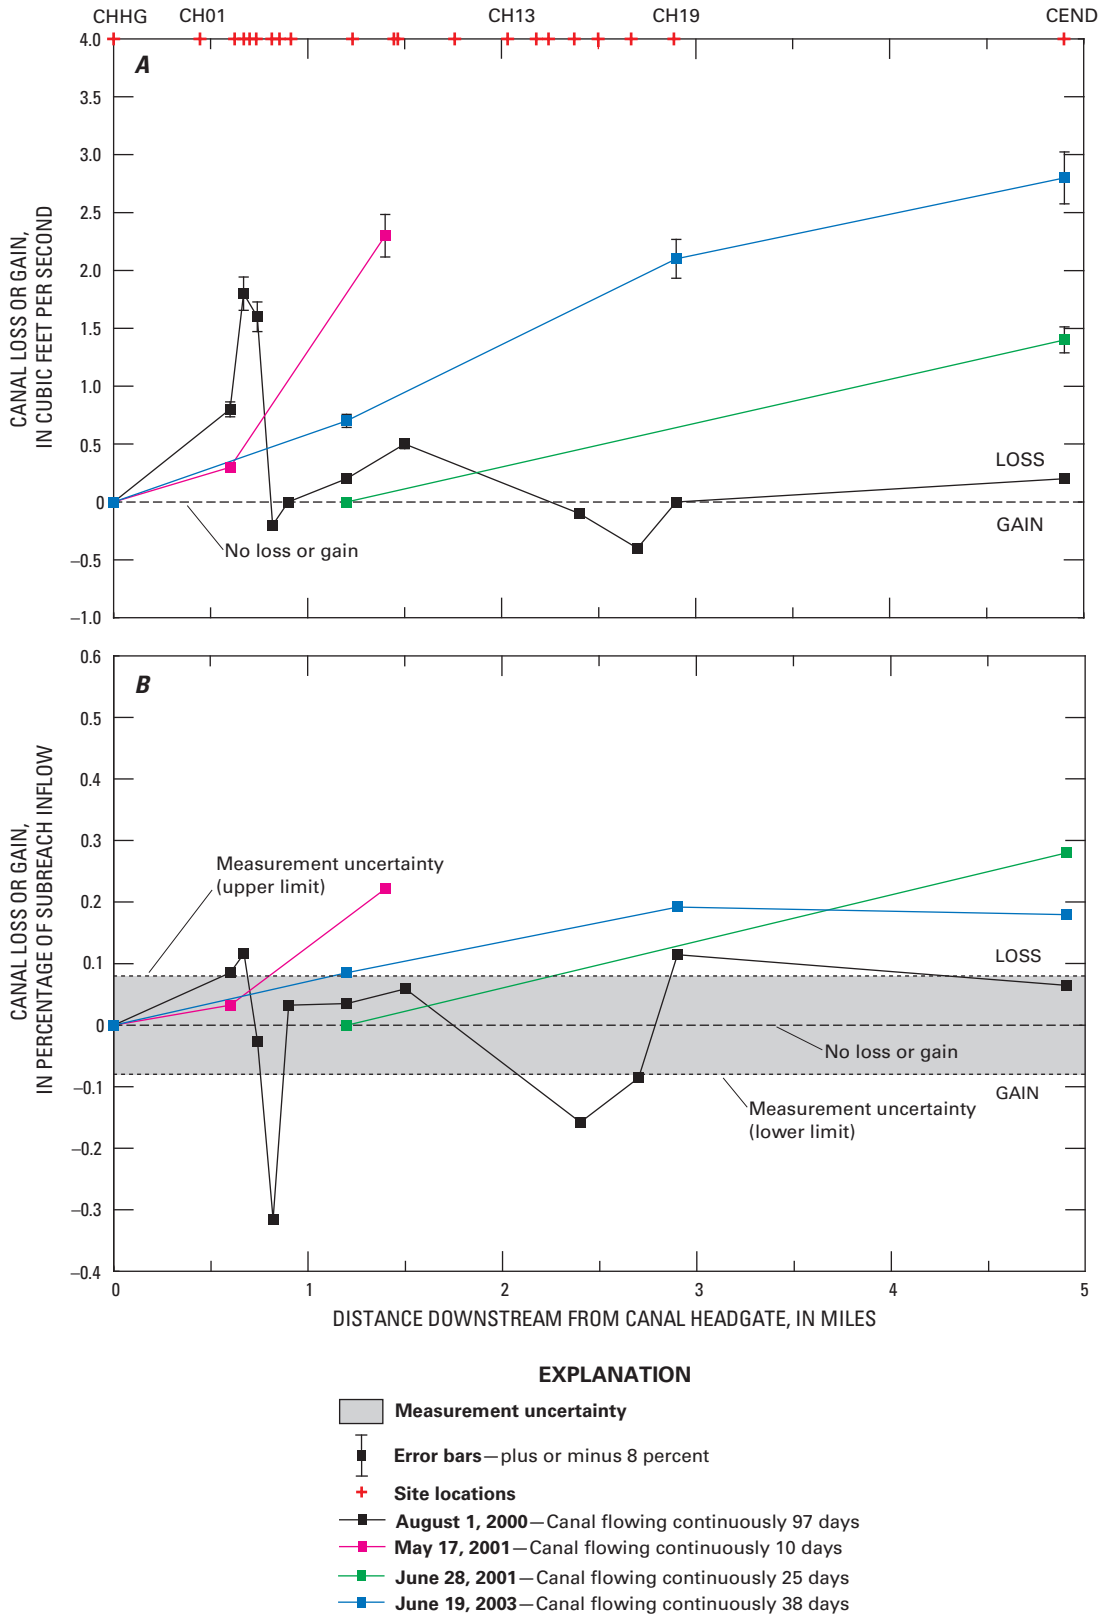
Figure 9. Losses and gains in (A) cubic feet per second and (B) percentage of subreach inflow in selected subreaches of the Chilili Canal.

On June 28, 2001, discharge measurements were made at main canal and diversion locations from CH09 to CEND, a 3.7-mile subreach of Chilili Canal beginning about 1.2 miles downstream from the headgate (fig. 8 and table A3). No leakage was observed at the diversion gates. The loss from CH09 to CEND was computed to be 1.4 ft³/s, or 28 percent of the subreach inflow (fig. 9 and table 6).

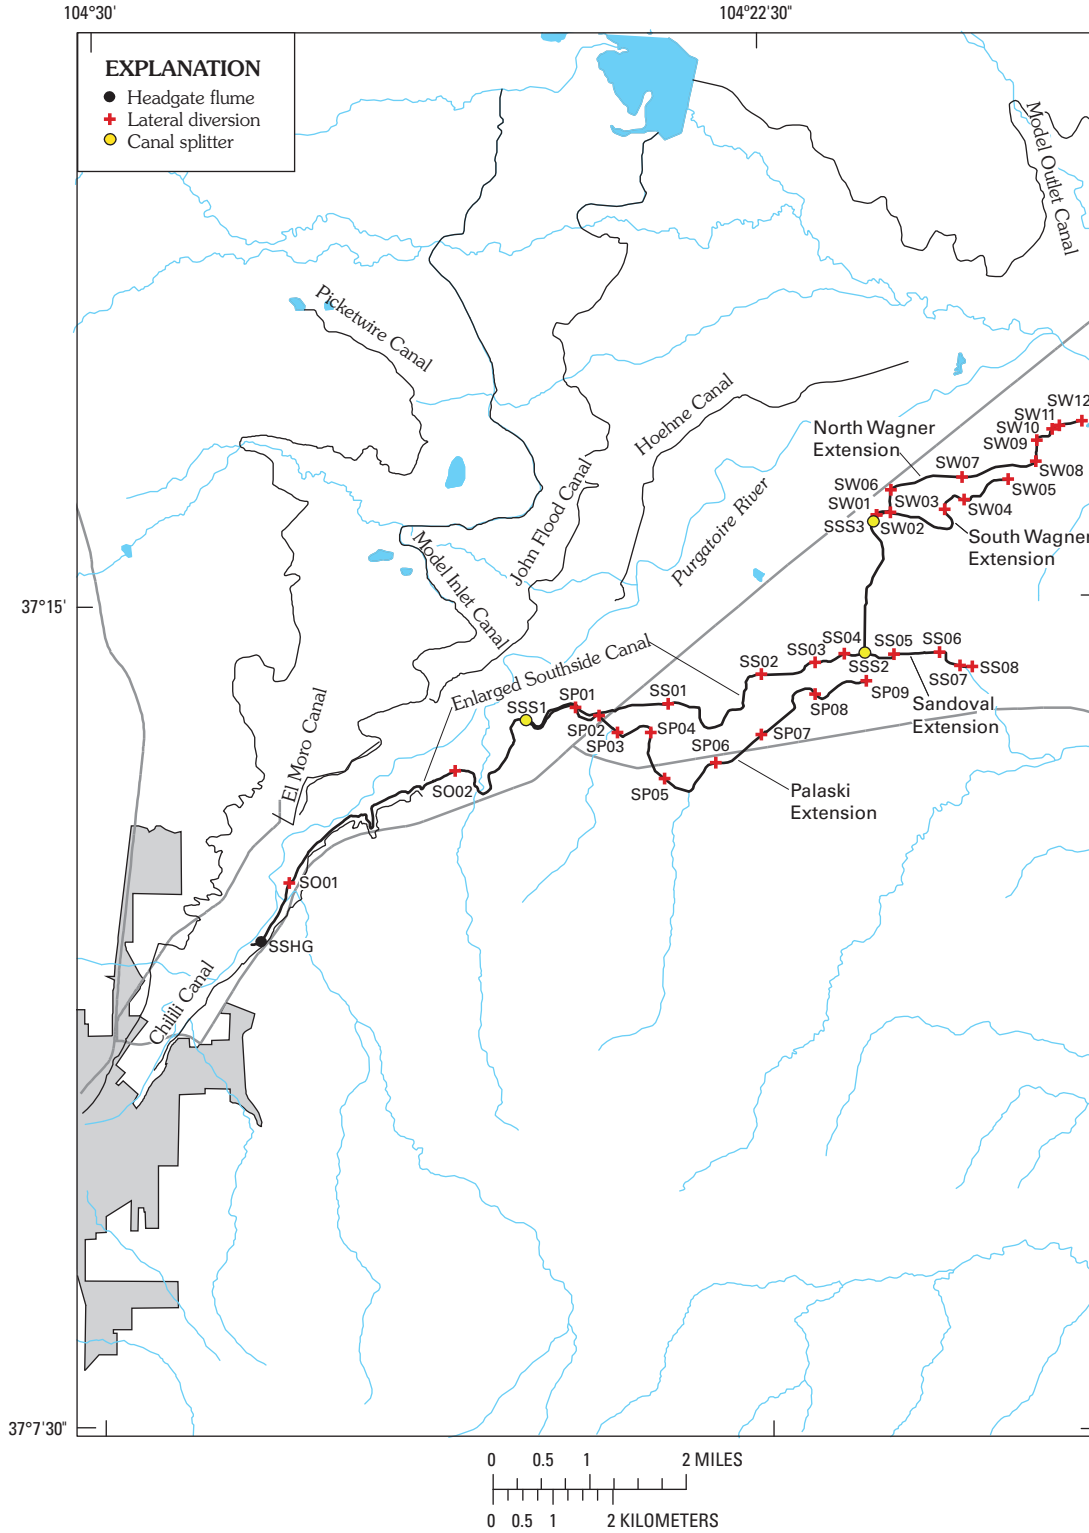
Figure 10. Location of measurement sites along Enlarged Southside Canal.

On August 9–11, 2000, discharge measurements were made at main channel and diversion locations along Enlarged Southside Canal (fig. 10). Leakage was reported at one closed diversion gate. The leakage was determined to be about

Discharge measurements were made from SSHG to SSS1, SSS1 to SP10, SSS1 to SSS2, SSS2 to SS08, and SSS2 to SSS3 on May 22–23, 2001 (fig. 10). One diversion gate (SP05) was closed with some leakage reported; however, no estimate of leakage was made. Before the measurements, the canal had been continuously flowing for only about 10 days. Computed losses and gains in the subreaches were all within the measurement error of 8 percent except along the Sandoval Extension between sites SSS2 to SS08. This subreach had a computed loss of 2.9 ft³/s, or about 11 percent of the subreach inflow (fig. 11 and table 7).

Discharge measurements were made from SSS1 to SSS2, SSS2 to SSS3, SSS3 to SW05, and SSS3 to SW12 on June 27, 2001 (fig. 10). One diversion gate was closed with no leakage observed (table A4). Before the measurements were made, the canal had been continuously flowing for about 45 days. Computed losses and gains in the subreaches were all within the measurement error of 8 percent except along the main Enlarged Southside Canal between sites SSS2 and SSS3. This subreach had a computed loss of 5.0 ft³/s, or about 14 percent of the subreach inflow (fig. 11 and table 7).

On June 8–9, 2004, discharge measurements were made at main channel and diversion locations along Enlarged Southside Canal (fig. 10). Two diversion gates were closed. Some leakage was reported at one of the closed gates (SP05); however, no estimate of leakage was made (table A4). Before the measurements were made, the canal had been continuously flowing for about 32 days. Computed losses and gains in the subreaches were all within the measurement error of 8 percent except along the North Wagner Extension between sites SSS3 and SW12. This subreach had a computed loss of 1.5 ft³/s, or about 9 percent of the subreach inflow (table 7 and fig. 11).
