Losses and Gains for Eight Unlined Canals Along the Purgatoire River near Trinidad, Colorado, 2000–2004

Scientific Investigations Report 2006–5164

By Lisa D. Miller

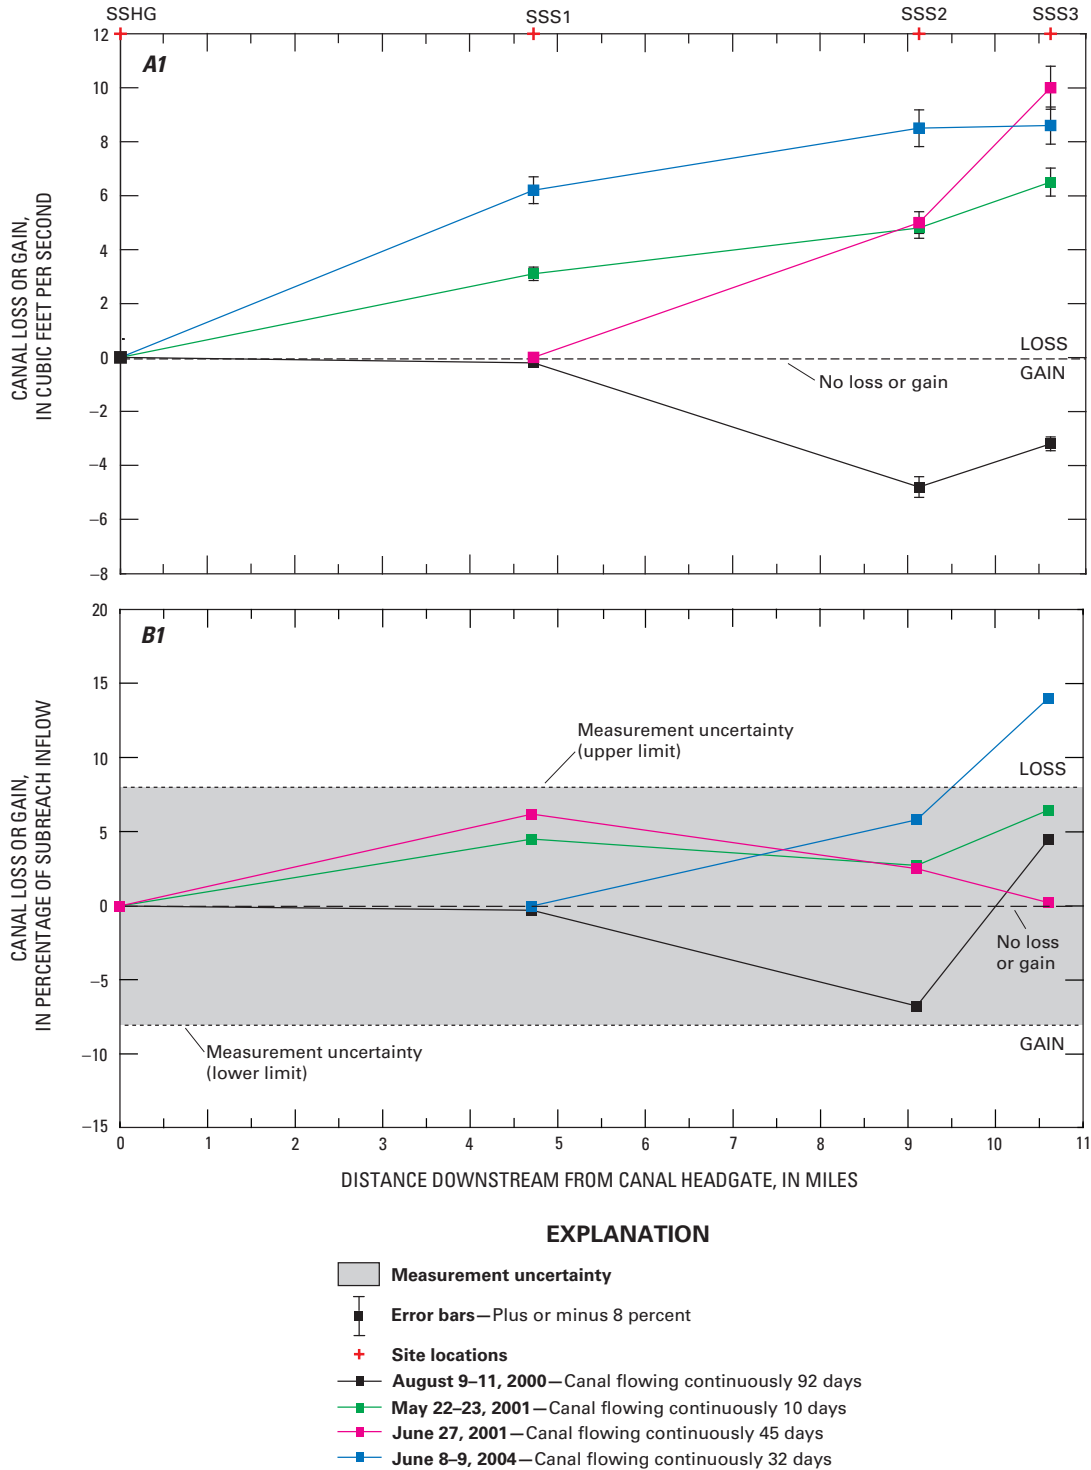
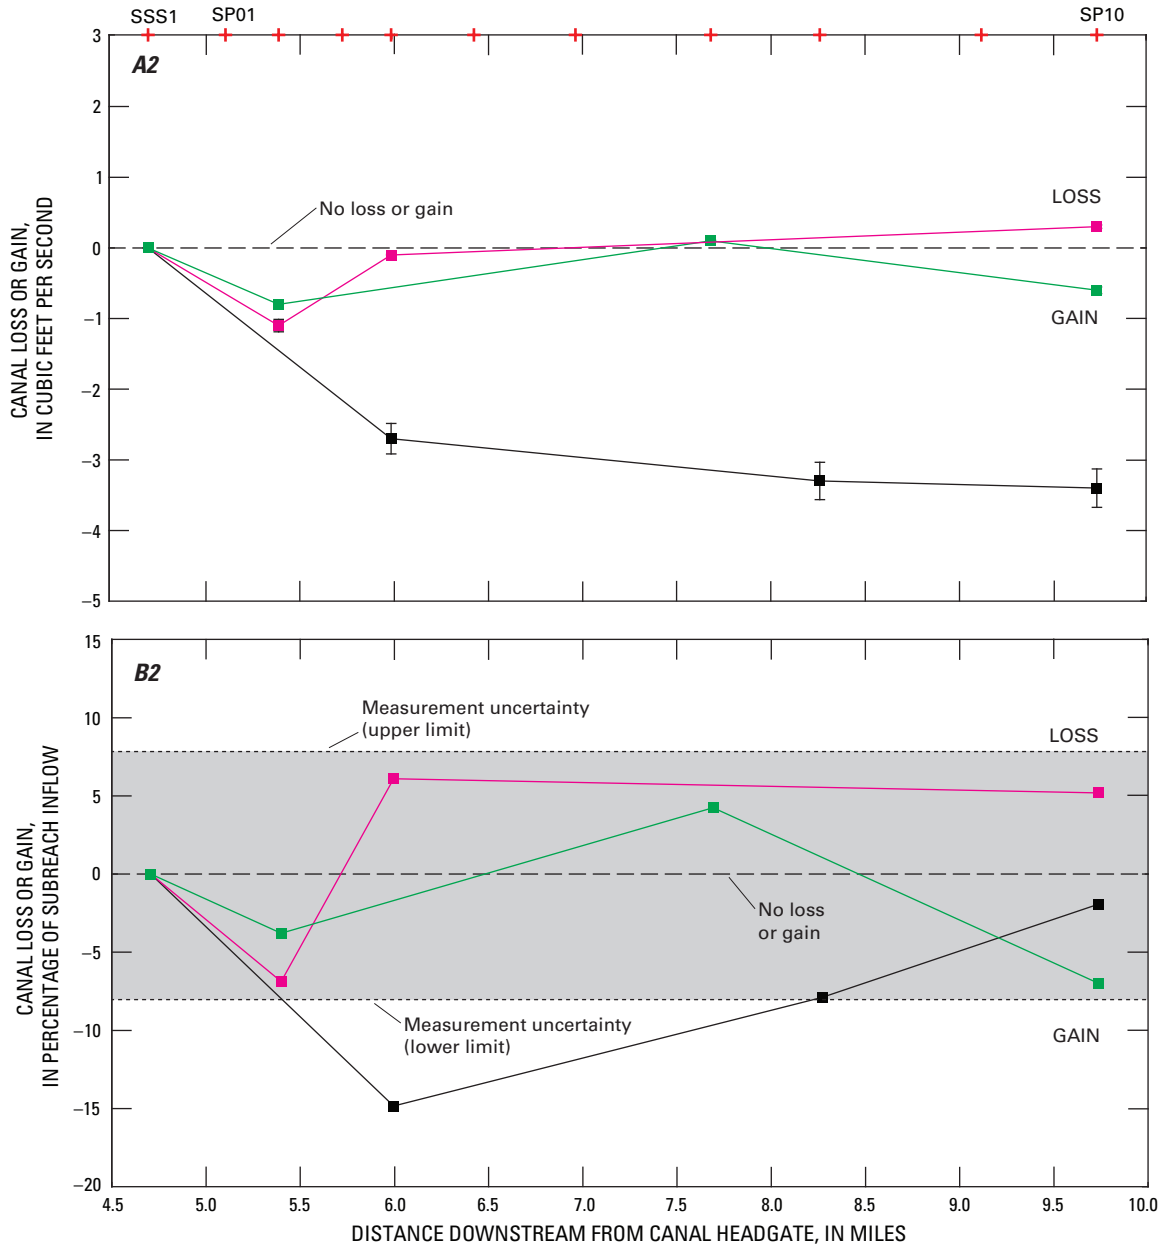
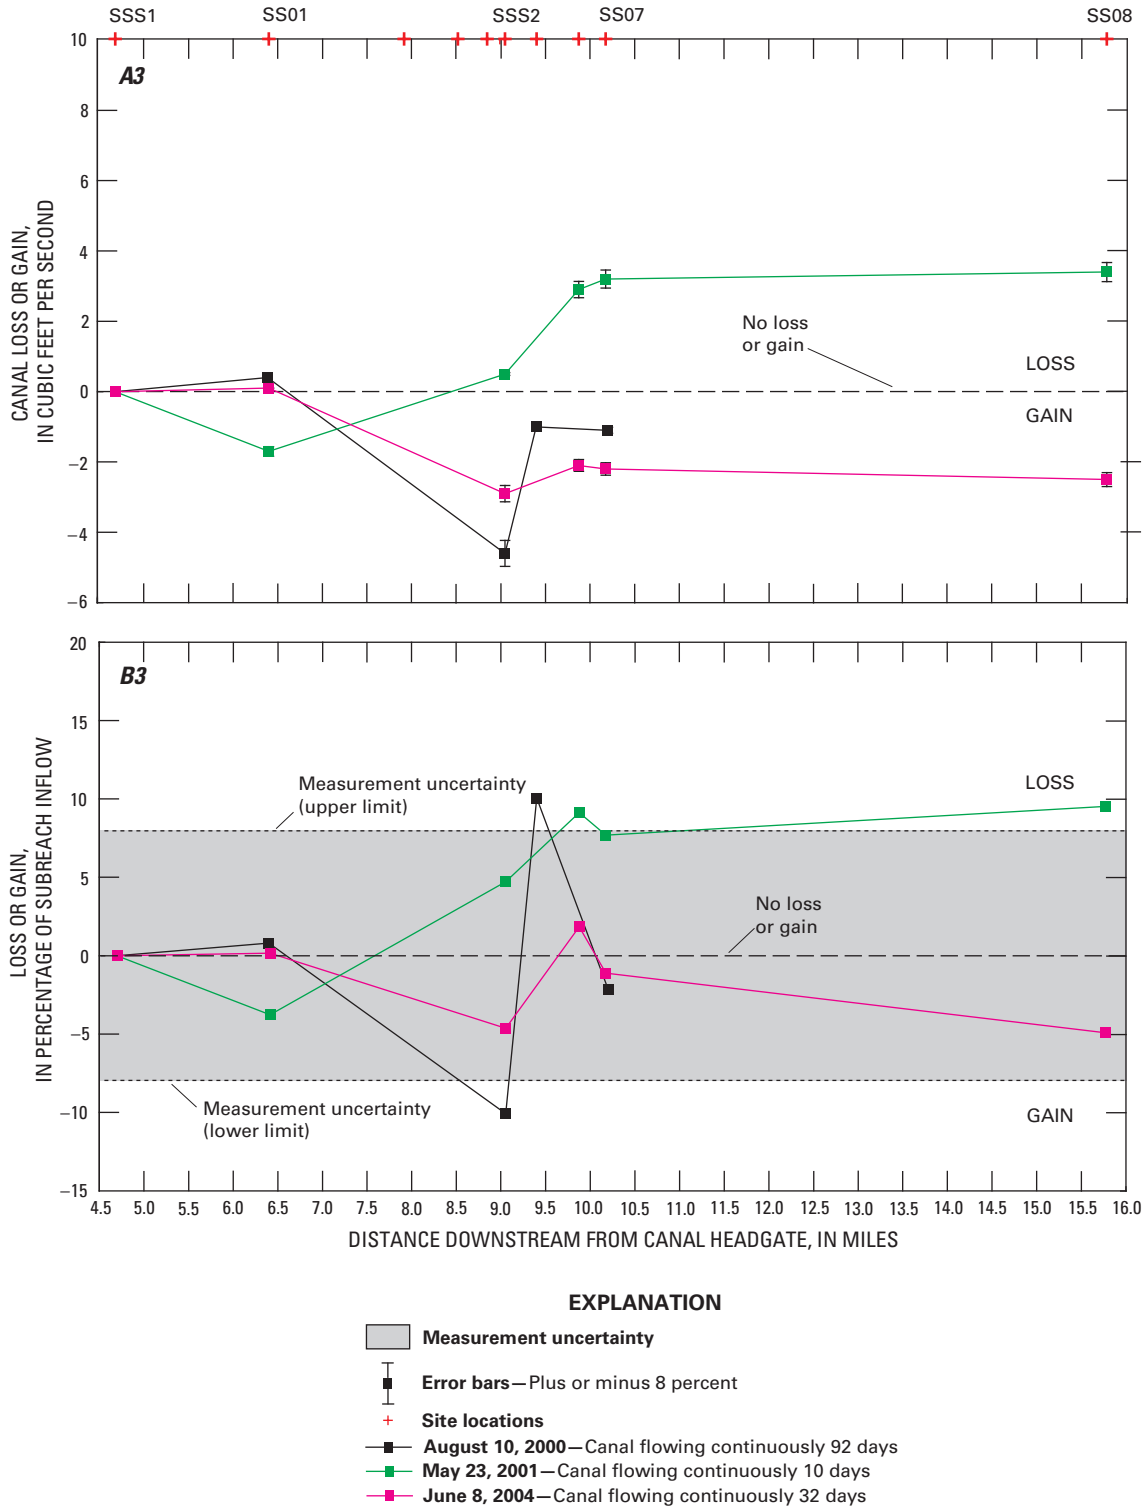
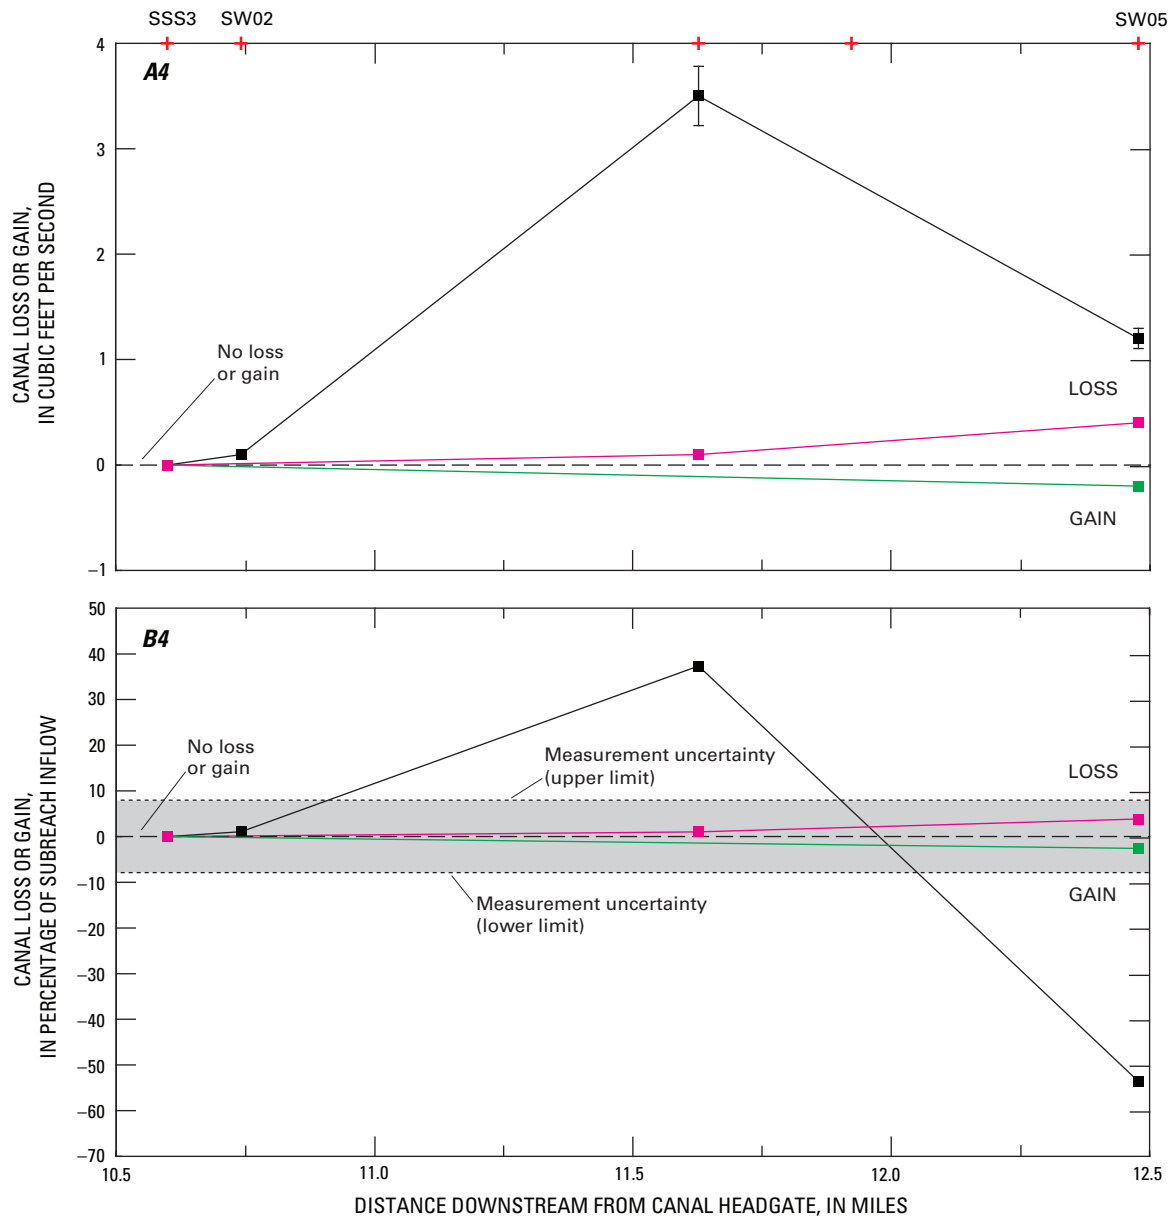
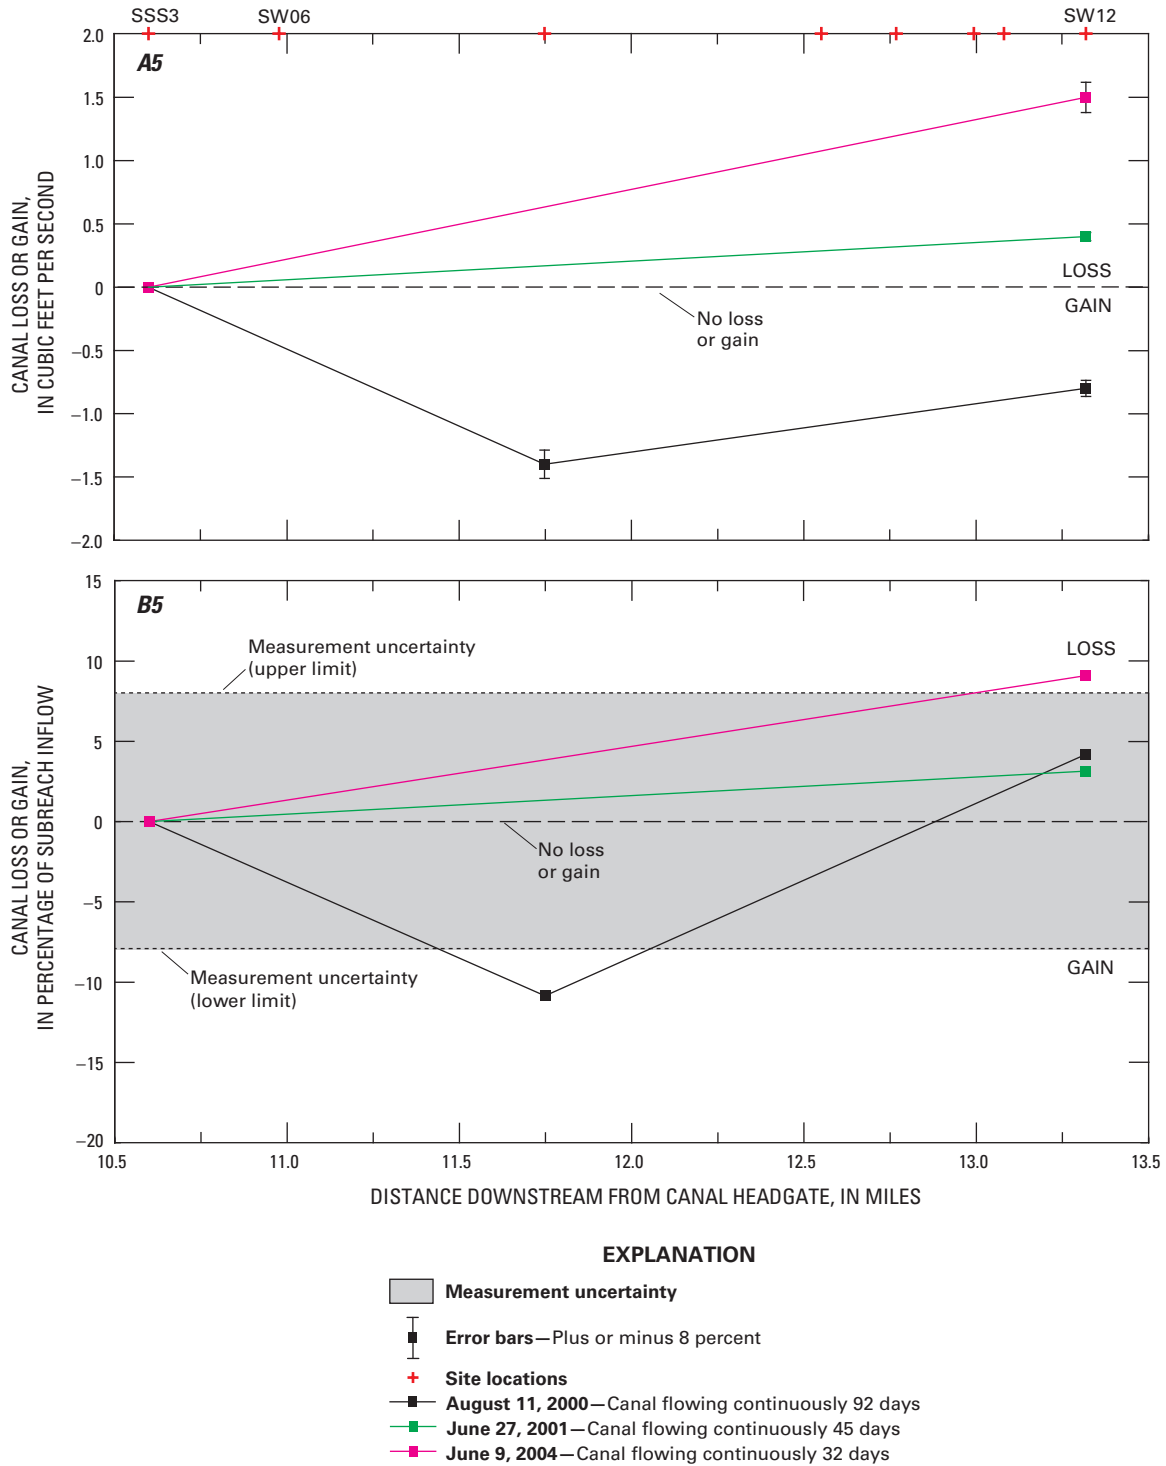
Figure 11. Losses and gains in (A1) cubic feet per second and (B1) percentage of subreach inflow in selected subreaches of the main Enlarged Southside Canal, losses and gains in (A2) cubic feet per second and (B2) percentage of subreach inflow in selected subreaches of the Palaski Extension of the Enlarged Southside Canal, losses and gains in (A3) cubic feet per second and (B3) percentage of subreach inflow in selected subreaches of the Sandoval Extension of the Enlarged Southside Canal, losses and gains in (A4) cubic feet per second and (B4) percentage of subreach inflow in selected subreaches of the South Wagner Extension of the Enlarged Southside Canal, and losses and gains in (A5) cubic feet per second and (B5) percentage of subreach inflow in selected subreaches of the North Wagner Extension of the Enlarged Southside Canal.

- Measurement uncertainty
- Error bars—Plus or minus 8 percent
- + Site locations
- August 9, 2000—Canal flowing continuously 92 days
- May 22, 2001—Canal flowing continuously 10 days
- June 8, 2004—Canal flowing continuously 32 days

- EXPLANATION**
- Measurement uncertainty
 - Error bars—Plus or minus 8 percent
 - + Site locations
 - August 11, 2000—Canal flowing continuously 92 days
 - June 27, 2001—Canal flowing continuously 45 days
 - June 9, 2004—Canal flowing continuously 32 days

Discharge measurements were made from SSHG to SSS1, SSS1 to SP10, SSS1 to SSS2, SSS2 to SS08, and SSS2 to SSS3 on May 22–23, 2001 (fig. 10). One diversion gate (SP05) was closed with some leakage reported; however, no estimate of leakage was made. Before the measurements, the canal had been continuously flowing for only about 10 days. Computed losses and gains in the subreaches were all within the measurement error of 8 percent except along the Sandoval Extension between sites SSS2 to SS08. This subreach had a computed loss of 2.9 ft³/s, or about 11 percent of the subreach inflow (fig. 11 and table 7).

Discharge measurements were made from SSS1 to SSS2, SSS2 to SSS3, SSS3 to SW05, and SSS3 to SW12 on June 27, 2001 (fig. 10). One diversion gate was closed with no leakage observed (table A4). Before the measurements were made, the canal had been continuously flowing for about 45 days. Computed losses and gains in the subreaches were all within the measurement error of 8 percent except along the main Enlarged Southside Canal between sites SSS2 and SSS3. This subreach had a computed loss of 5.0 ft³/s, or about 14 percent of the subreach inflow (fig. 11 and table 7).

On June 8–9, 2004, discharge measurements were made at main channel and diversion locations along Enlarged Southside Canal (fig. 10). Two diversion gates were closed. Some leakage was reported at one of the closed gates (SP05); however, no estimate of leakage was made (table A4). Before the measurements were made, the canal had been continuously flowing for about 32 days. Computed losses and gains in the subreaches were all within the measurement error of 8 percent except along the North Wagner Extension between sites SSS3 and SW12. This subreach had a computed loss of 1.5 ft³/s, or about 9 percent of the subreach inflow (table 7 and fig. 11).

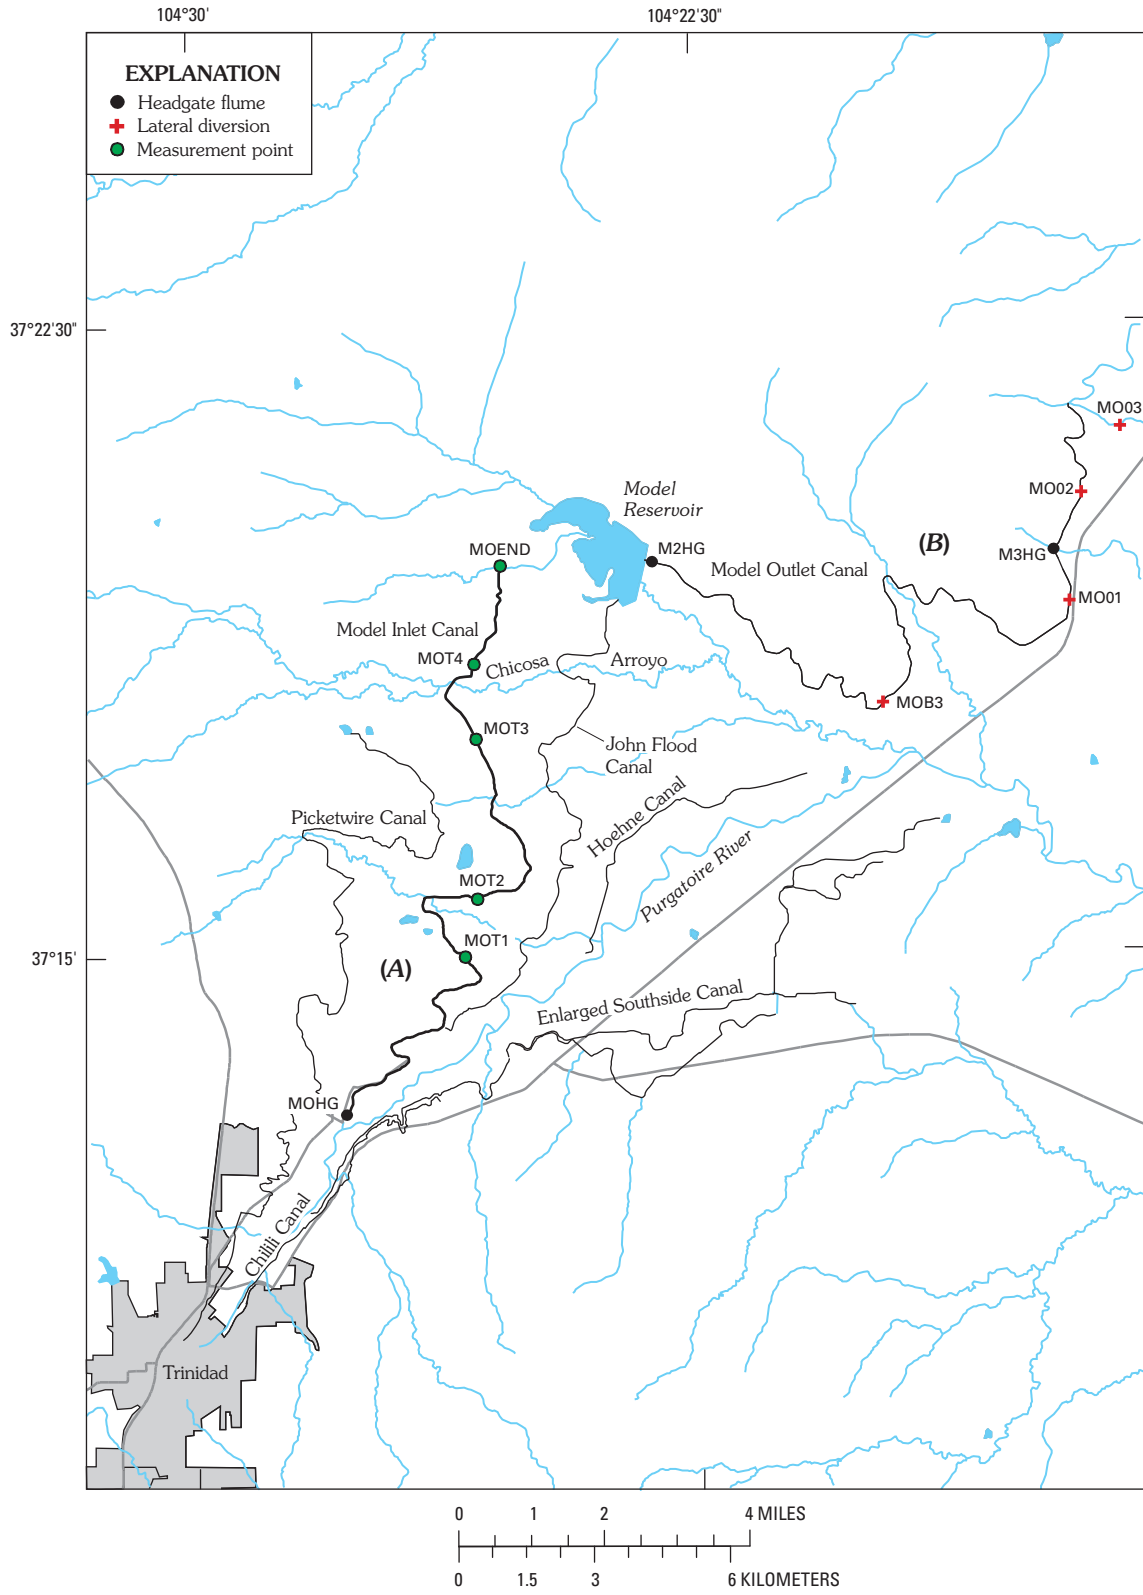
Figure 12. Location of measurement sites along Model Inlet and Outlet Canals.

Discharge measurements were made at main channel and diversion locations from M2HG to MO03 along Model Outlet Canal on June 26, 2001 (fig. 12). Two diversion gates were closed. Leakage of about 0.4 ft³/s was measured at one of the gates, and no leakage was observed at the other gate. A loss of 11.5 ft³/s, or 30 percent of the headgate inflow, was determined between M2HG and M3HG, and a gain of 0.4 ft³/s (2 percent of the subreach inflow) was determined between M3HG and MO03 (table 8 and fig. 13).

On June 11, 2004, discharge measurements were made at main channel and diversion locations along Model Inlet and Outlet canals from MOHG to MO03 (fig. 12). Minor leakage was reported at three diversion gates (table A5). No estimate of leakage was made. Loss from MOHG to MOEND (upstream from Model Reservoir) was computed to be 2.3 ft³/s, or 4 percent of the headgate inflow; whereas, a loss of 11.6 ft³/s, or 39 percent of the subreach inflow, was measured from M2HG to MO03 (table 8).

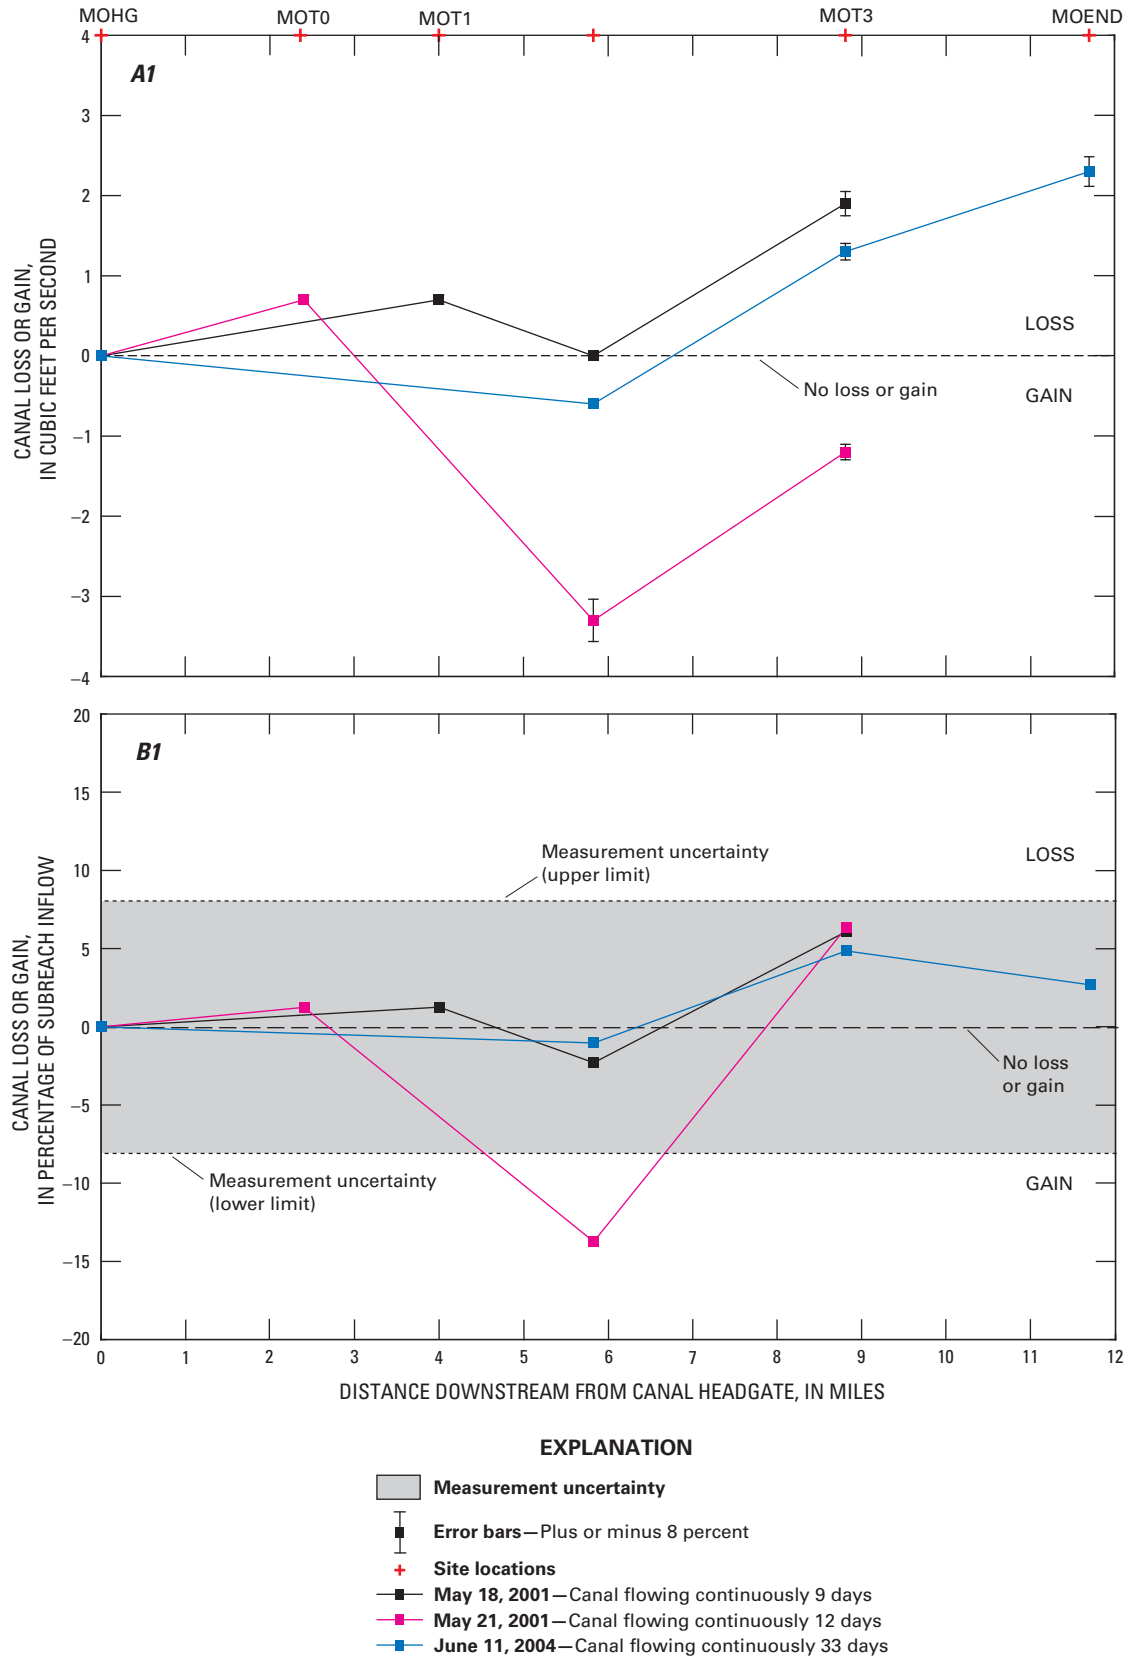
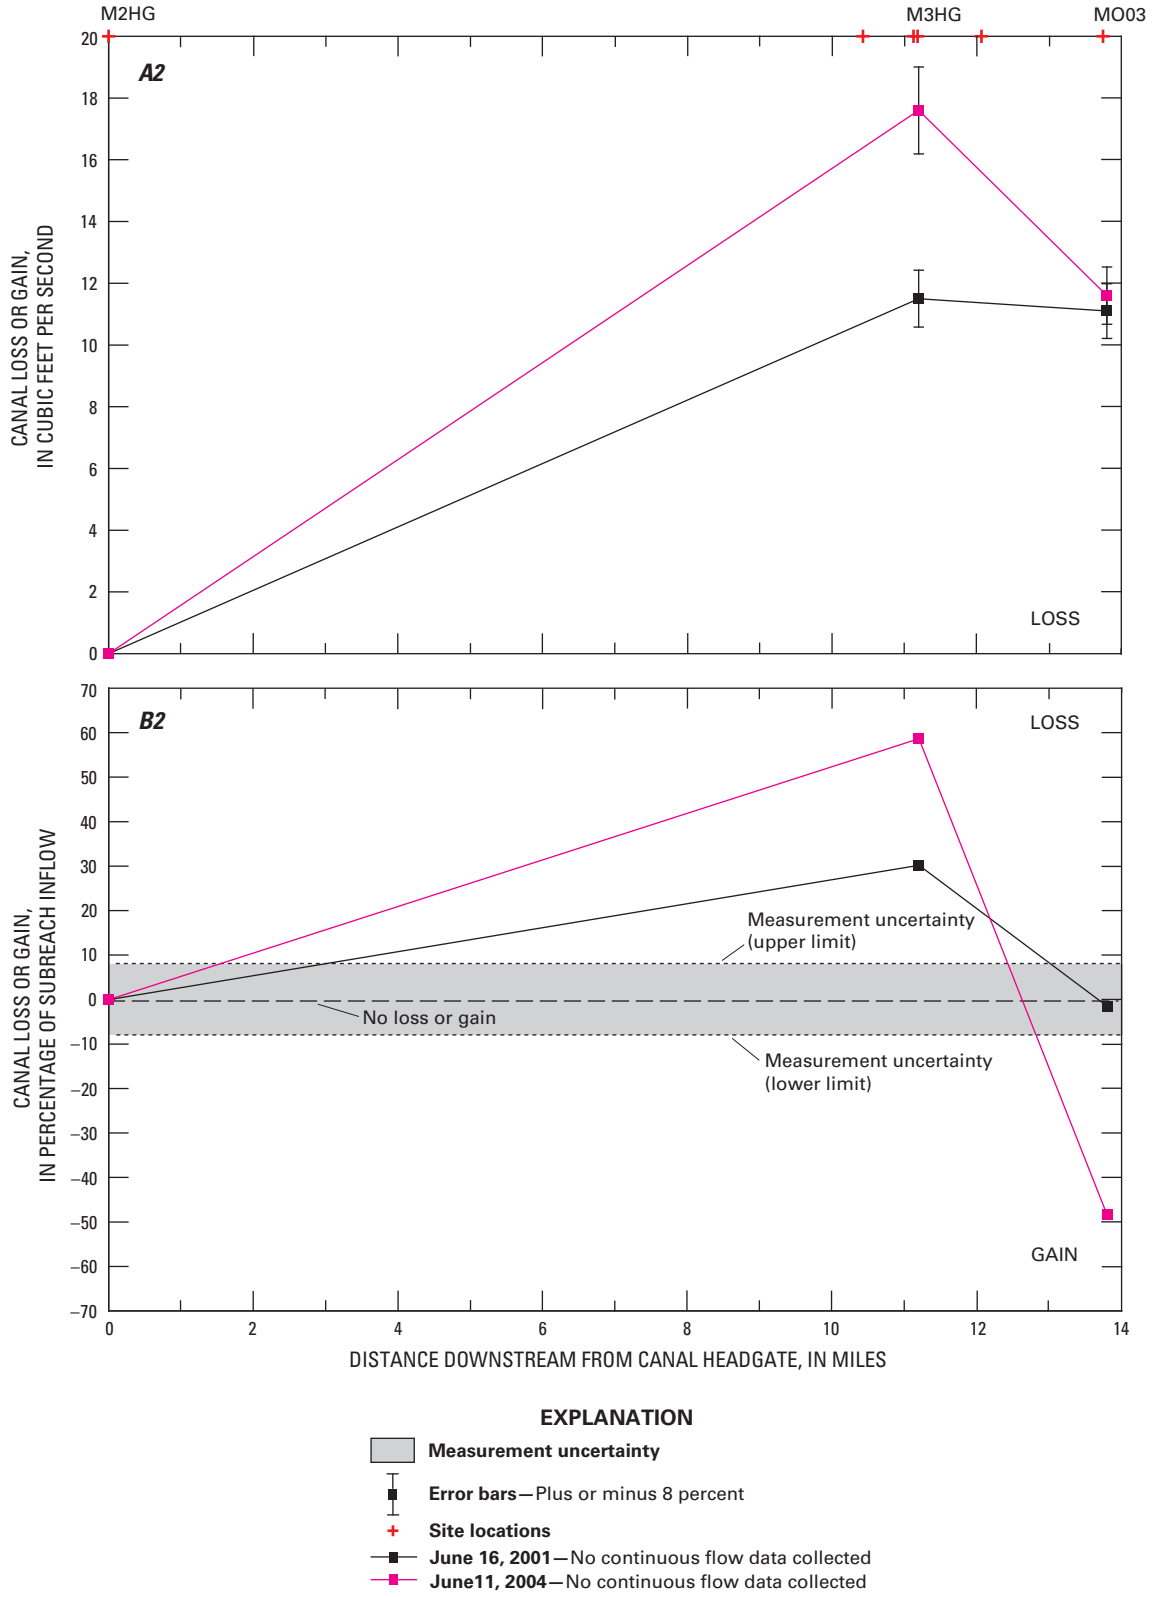
Figure 13. Losses and gains in (A1) cubic feet per second and (B1) percentage of subreach inflow in selected subreaches of the Model Inlet Canal and losses and gains in (A2) cubic feet per second and (B2) percentage of subreach inflow in selected subreaches of the Model Outlet Canal.

Loss and gain measurements made by CDWR in Model Inlet Canal (table 8) showed small losses ranging from 1 to 5 percent of the headgate inflow (losses within the uncertainty of the measurements). The USGS also found losses and gains in Model Inlet Canal to be within the uncertainty of the measurements, with the exception of one reach (MOT0 to MOT2) (fig. 13–A2 and table 8).

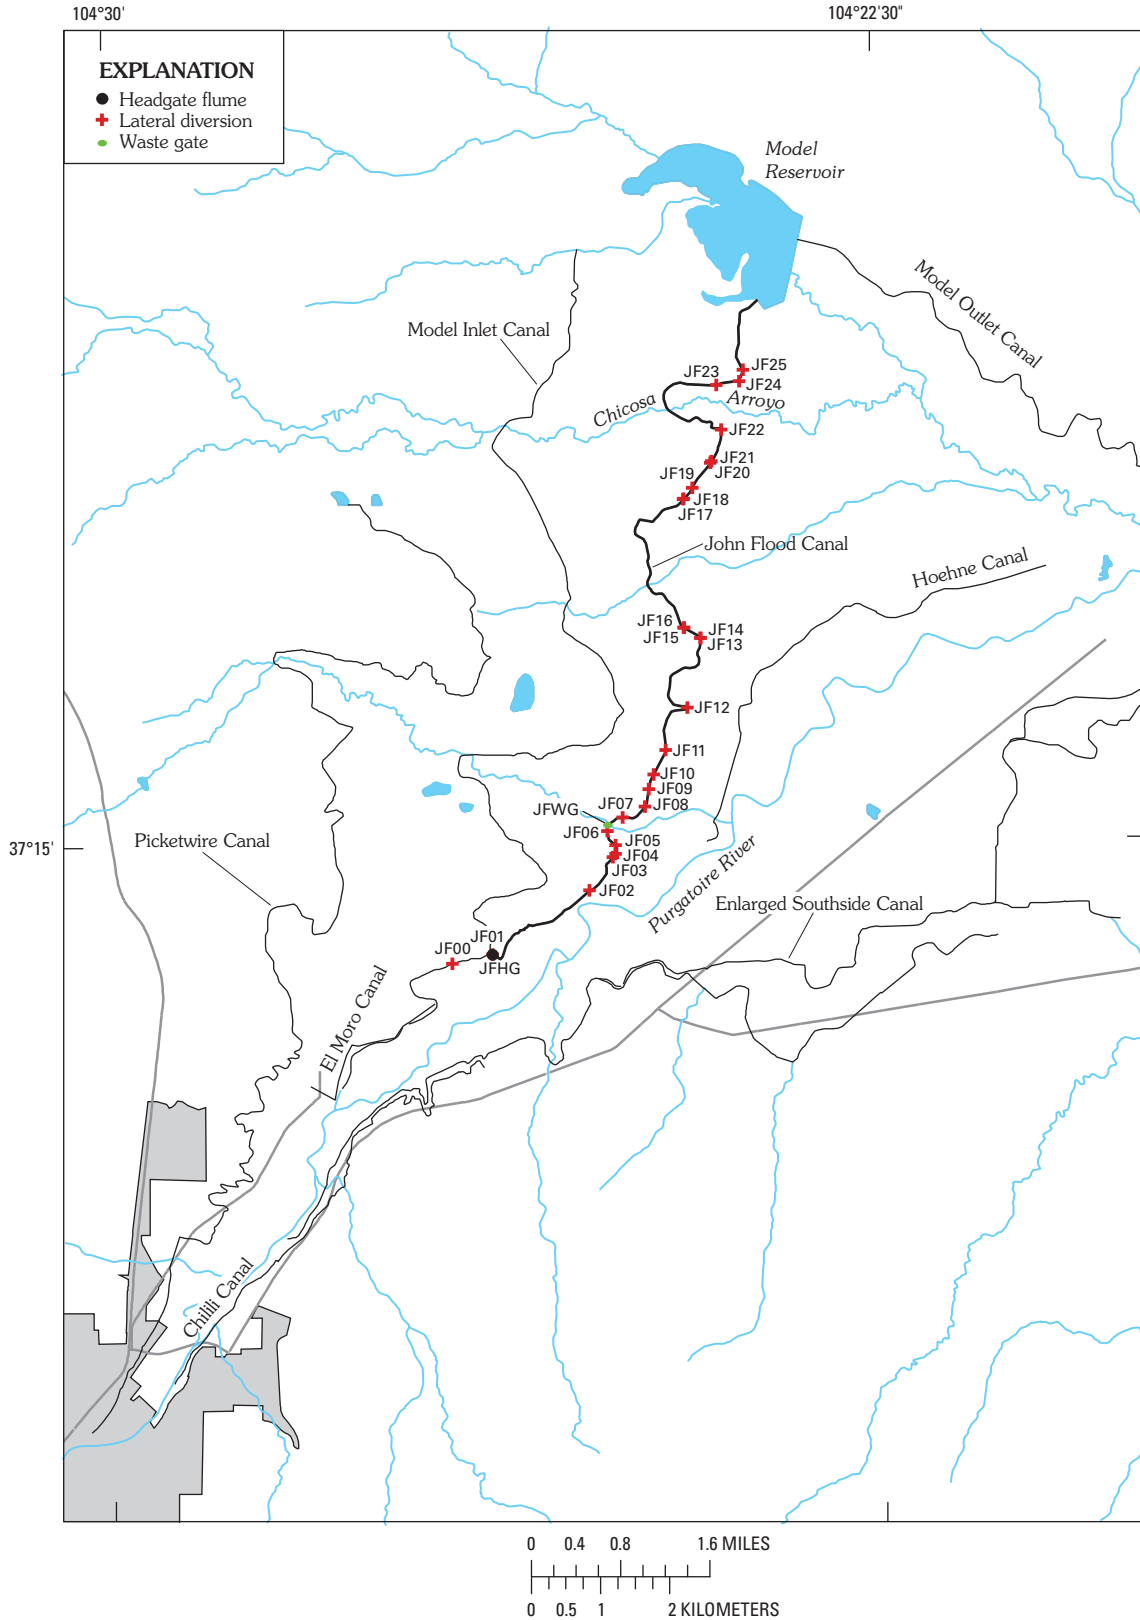
Figure 14. Location of measurement sites along John Flood Canal.

On August 8, 2000, discharge measurements were made at main channel and diversion locations from JFHG to JF25 (fig. 14). Three closed diversion gates were noted as having leakage. The total leakage was estimated to be about 0.12 ft³/s (table A6). Flow at the Parshall flume diversion at JF12 was not measured but was determined using standard Parshall flume tables. A gain of 2.6 ft³/s, or about 11 percent of the headgate inflow, was determined for John Flood Canal from JFHG to JF25 on August 8, 2000 (table 9 and fig. 15).

On June 17, 2003, discharge measurements were made at main channel and diversion locations from JFHG to JF25 (fig. 14). Leakage was noted at four closed diversion gates. The total leakage was estimated to be about 0.3 ft³/s. A loss of 2.6 ft³/s, or about 9 percent of the headgate inflow, was determined for John Flood Canal from JFHG to JF25 on June 17, 2003 (table 9 and fig. 15).

On June 15, 2004, discharge measurements were made at main channel and diversion locations from JFHG to JF25 (fig. 14). Leakage was reported at six closed diversion gates (five gates reported as having only minor leakage), but leakage was measured at only one gate. A loss of 0.2 ft³/s, or about 1 percent of the headgate inflow, was determined for John Flood Canal from JFHG to JF25 on June 15, 2004 (table 9 and fig. 15).

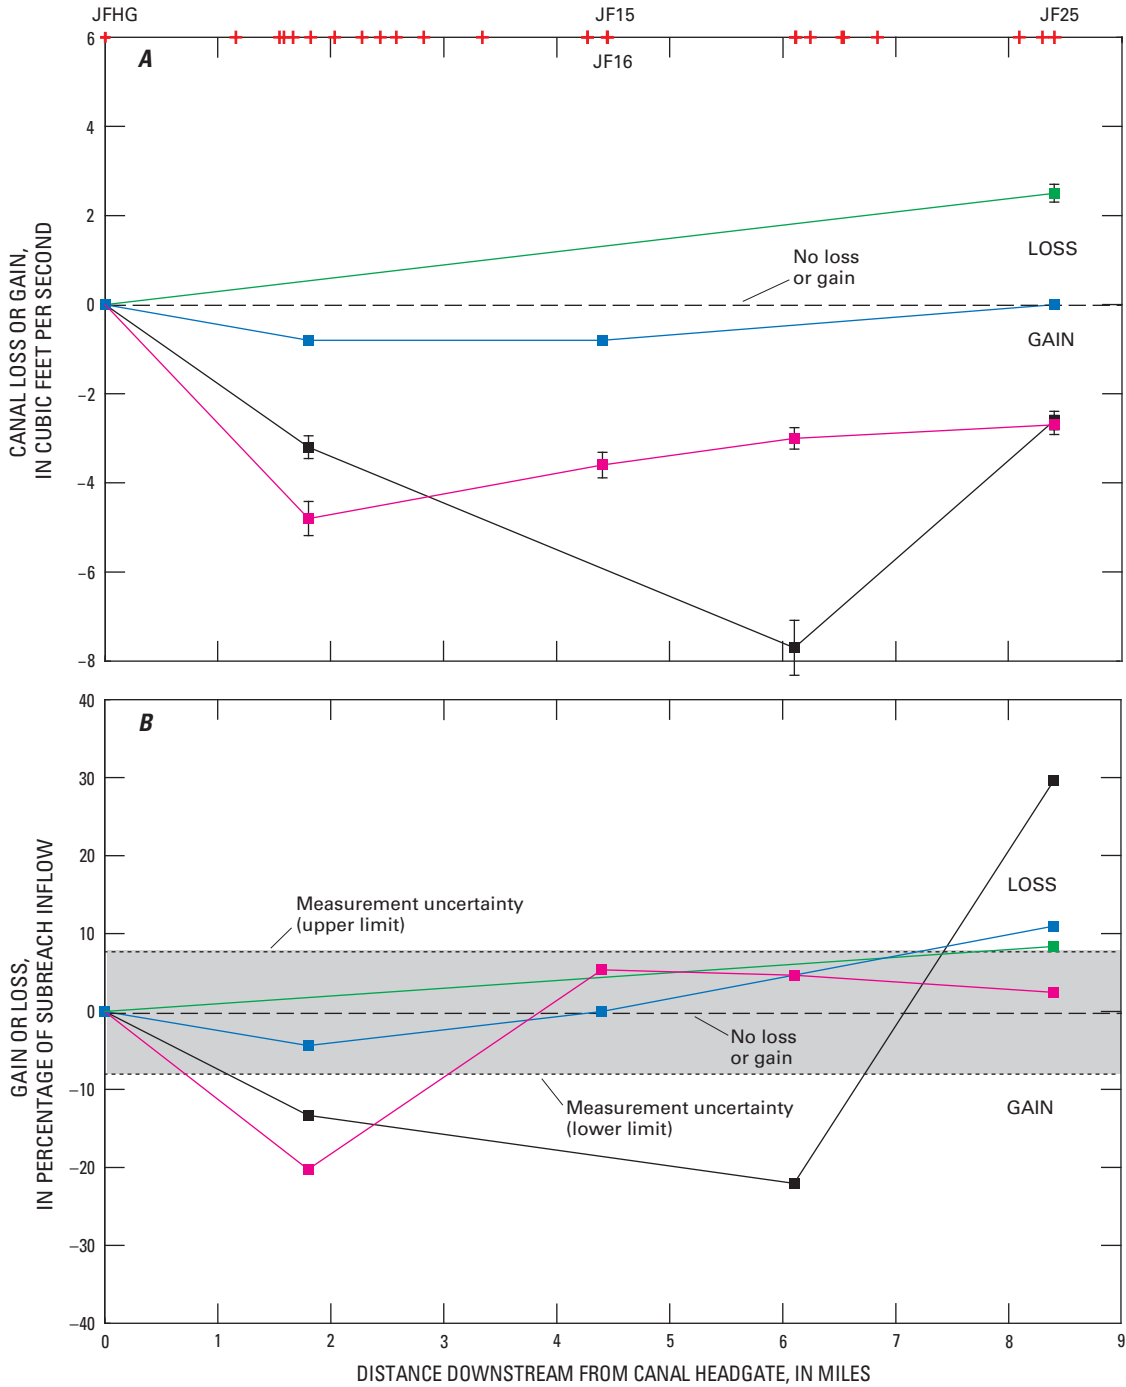
- EXPLANATION**
- Measurement uncertainty
 - Error bars—Plus or minus 8 percent
 - Site locations
 - August 8, 2000—Canal flowing continuously 98 days
 - May 24, 2001—Canal flowing continuously 15 days
 - June 17, 2003—Canal flowing continuously 42 days
 - June 15, 2004—Canal flowing continuously 37 days

Figure 15. Losses and gains in (A) cubic feet per second and (B) percentage of subreach inflow in selected subreaches the John Flood Canal.

On May 24, 2001, discharge measurements were made at main channel and diversion locations from JFHG to JF25 (table A6). Leakage was reported at four closed diversion gates (two gates reported as having minor leakage). A gain of 2.7 ft³/s, or about 11 percent of the headgate inflow, was determined for John Flood Canal from JFHG to JF25 on May 24, 2001 (table 9 and fig. 15).

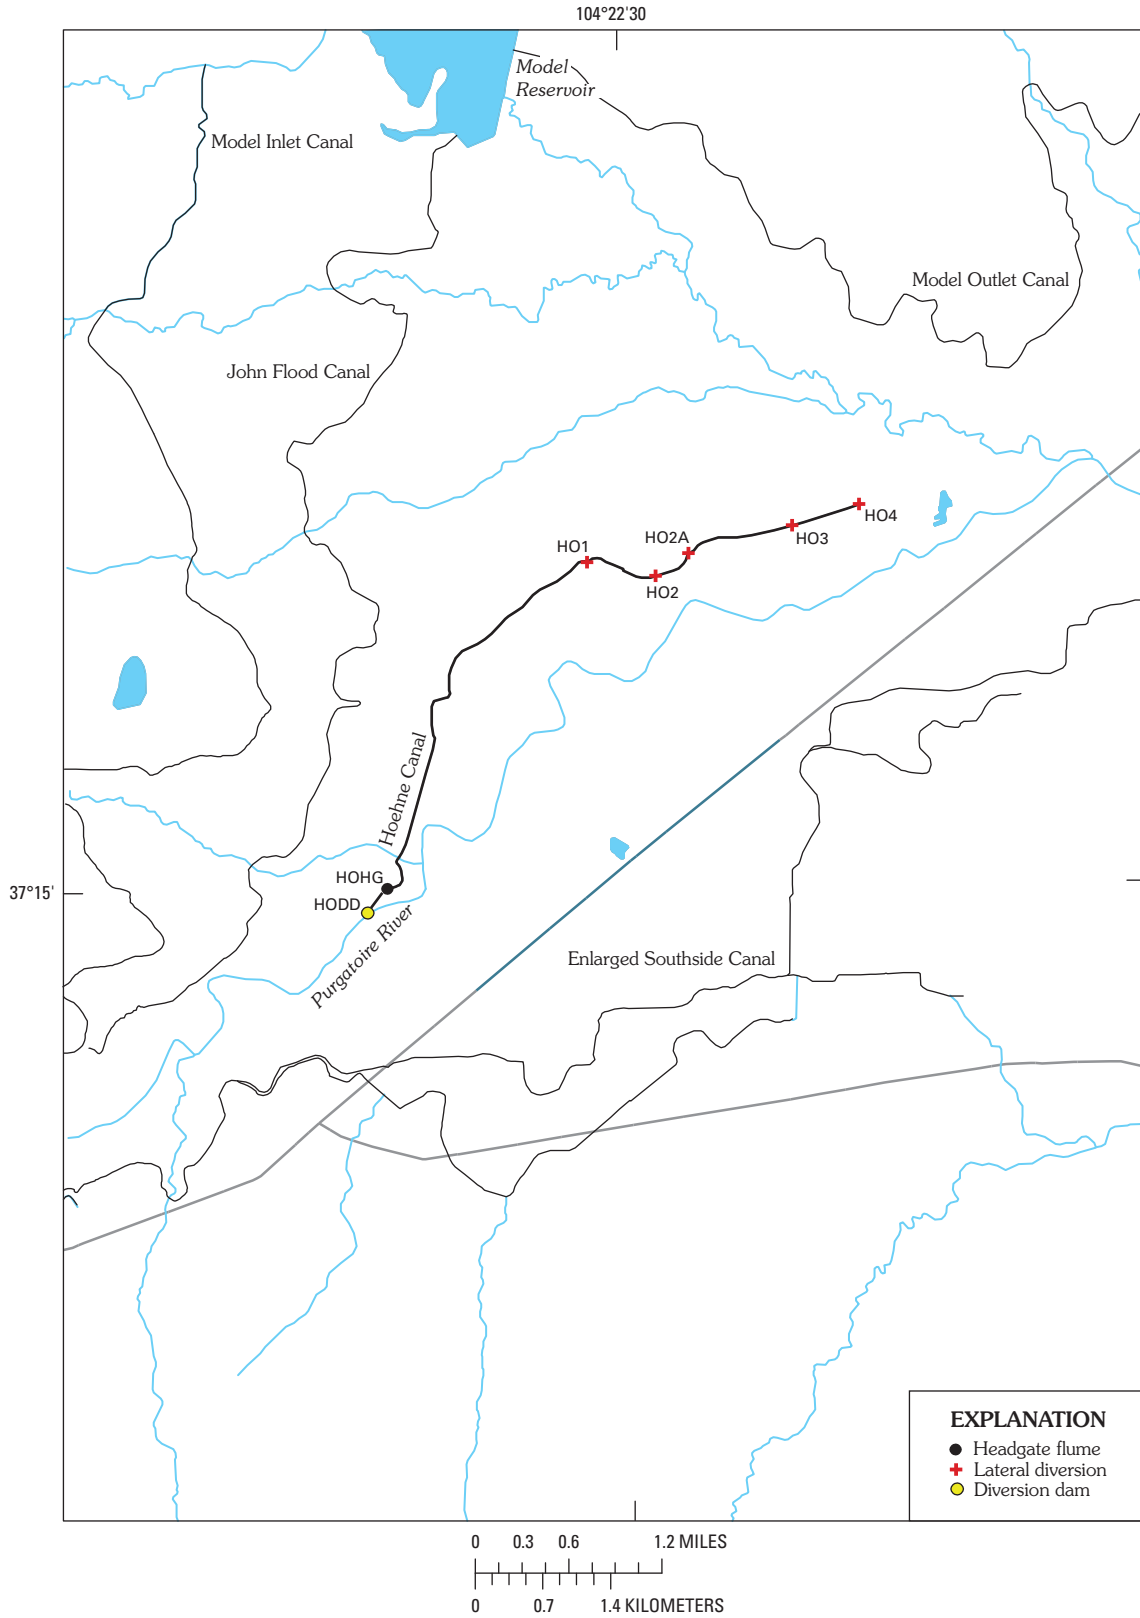
Figure 16. Location of measurement sites along Hoehne Canal.

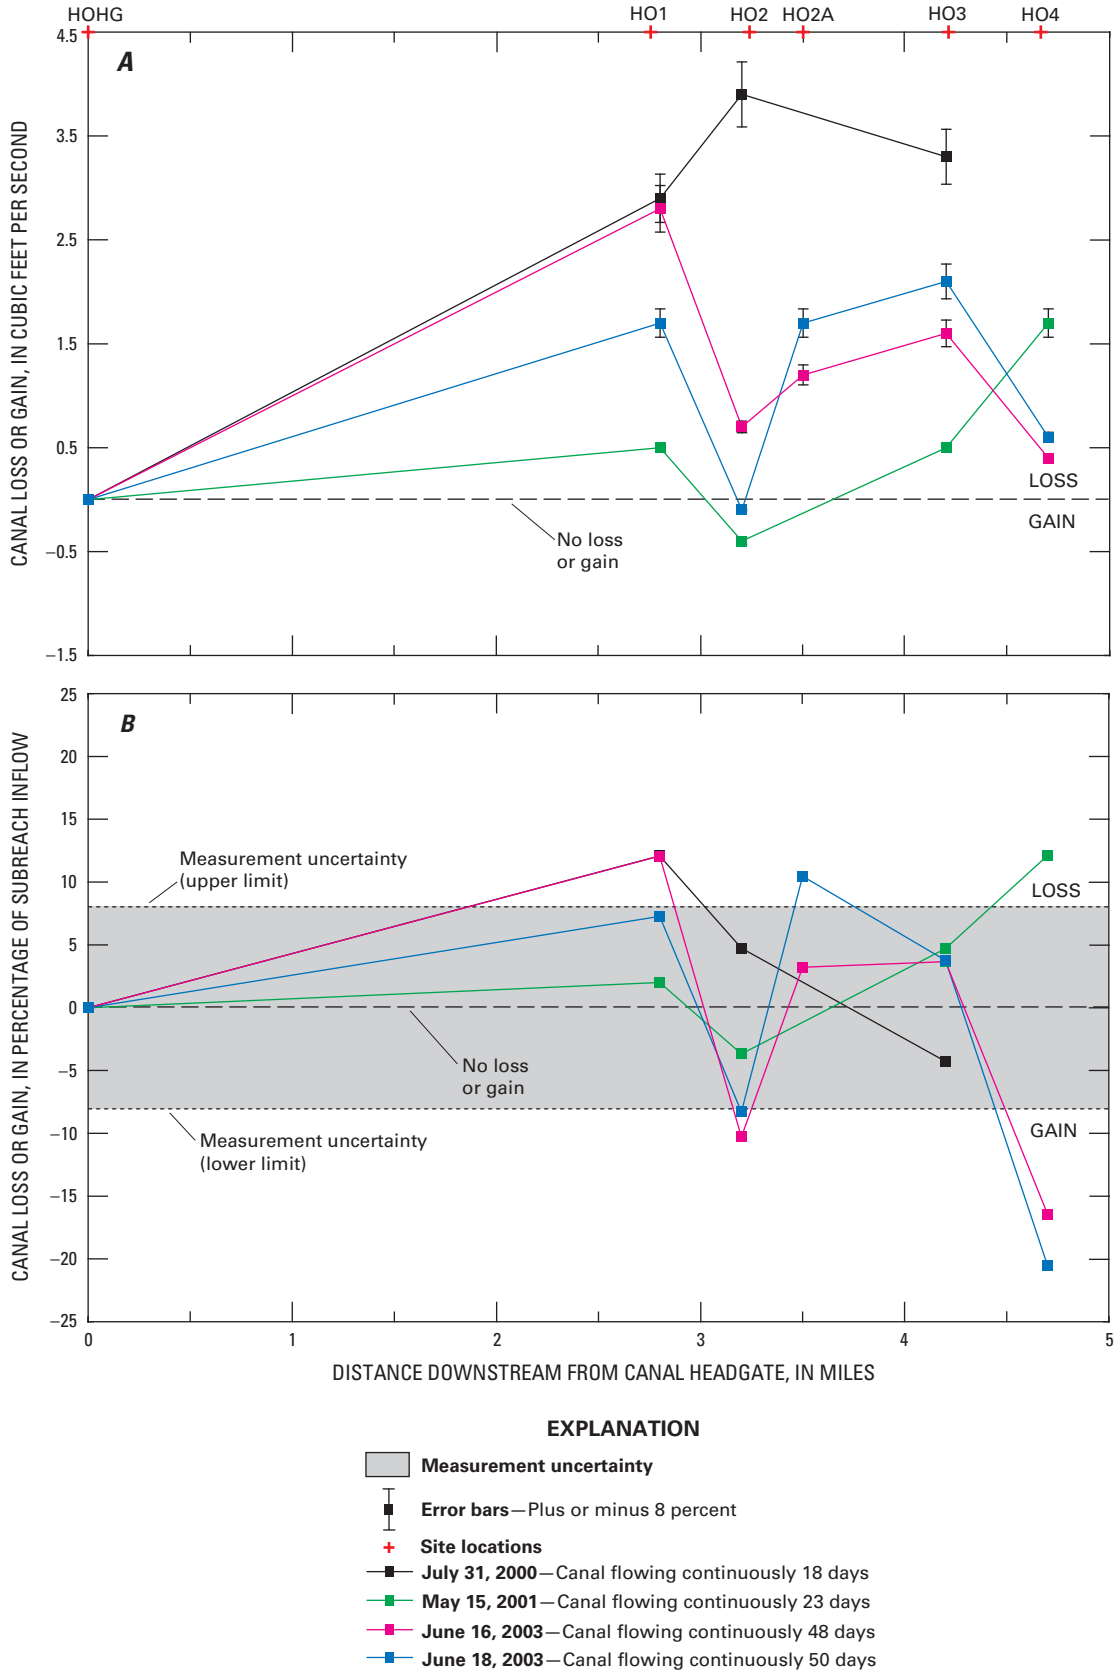
Figure 17. Losses and gains in (A) cubic feet per second and (B) percentage of subreach inflow in selected subreaches of the Hoehne Canal.
