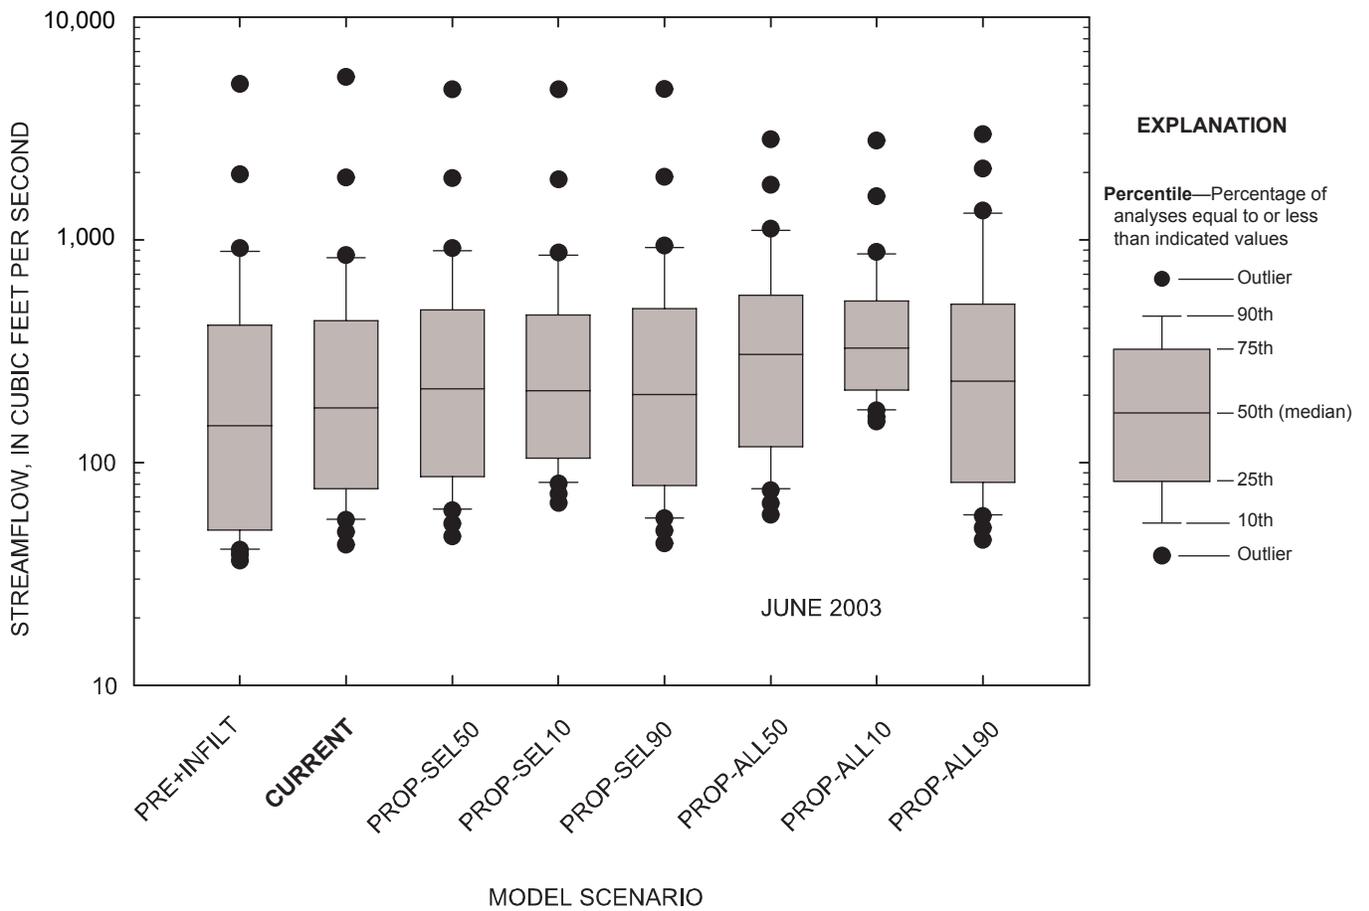
Figure 5-105. Comparison of daily streamflow for observed and simulated conditions at the Marmaton River near the Missouri-Kansas state line, Missouri, June 2003.
