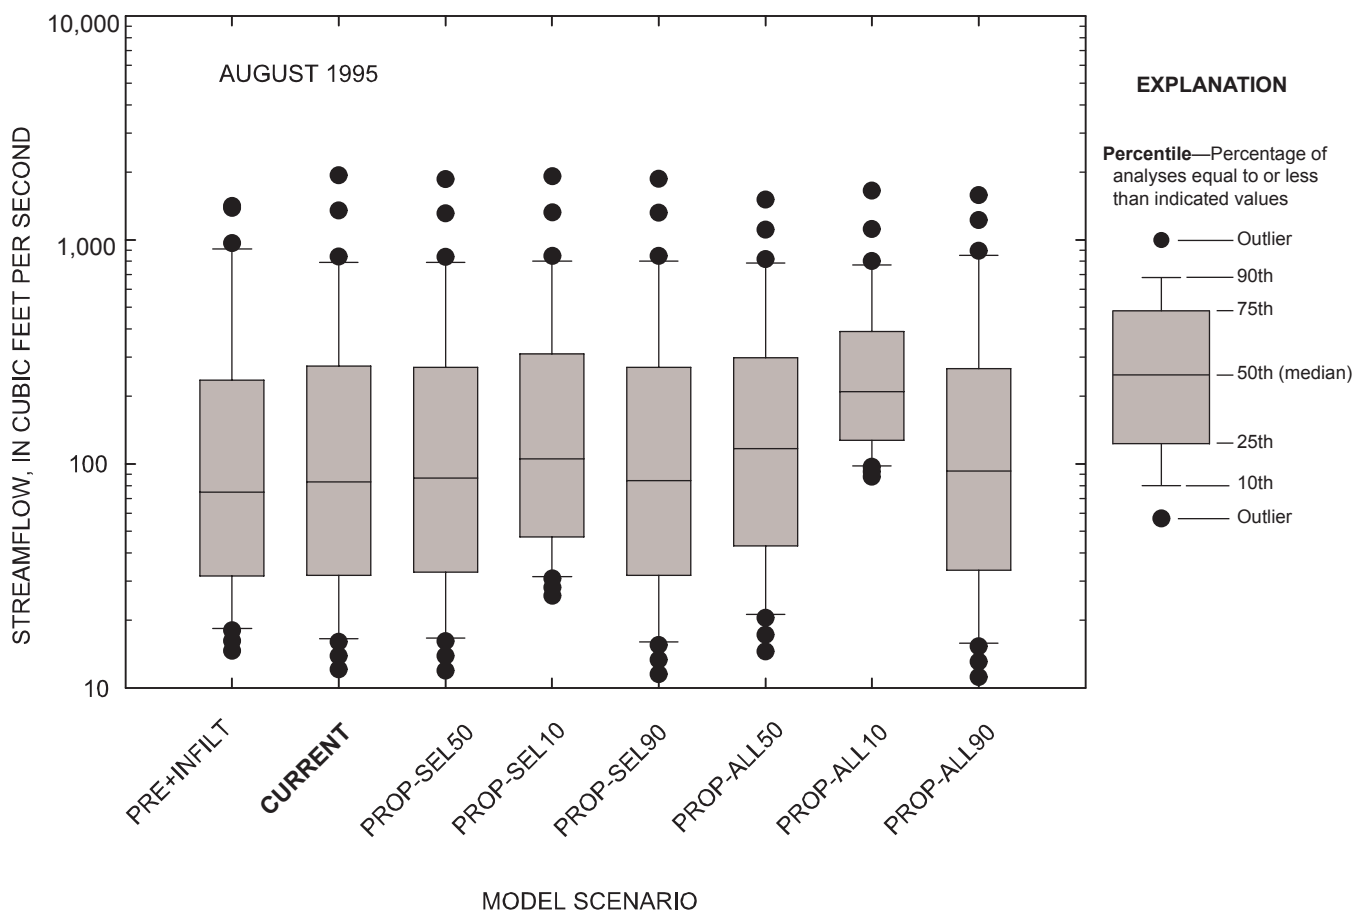
Figure 5-11. Comparison of daily streamflow for observed and simulated conditions at the Marmaton River near the Missouri-Kansas state line, Missouri, August 1995.
