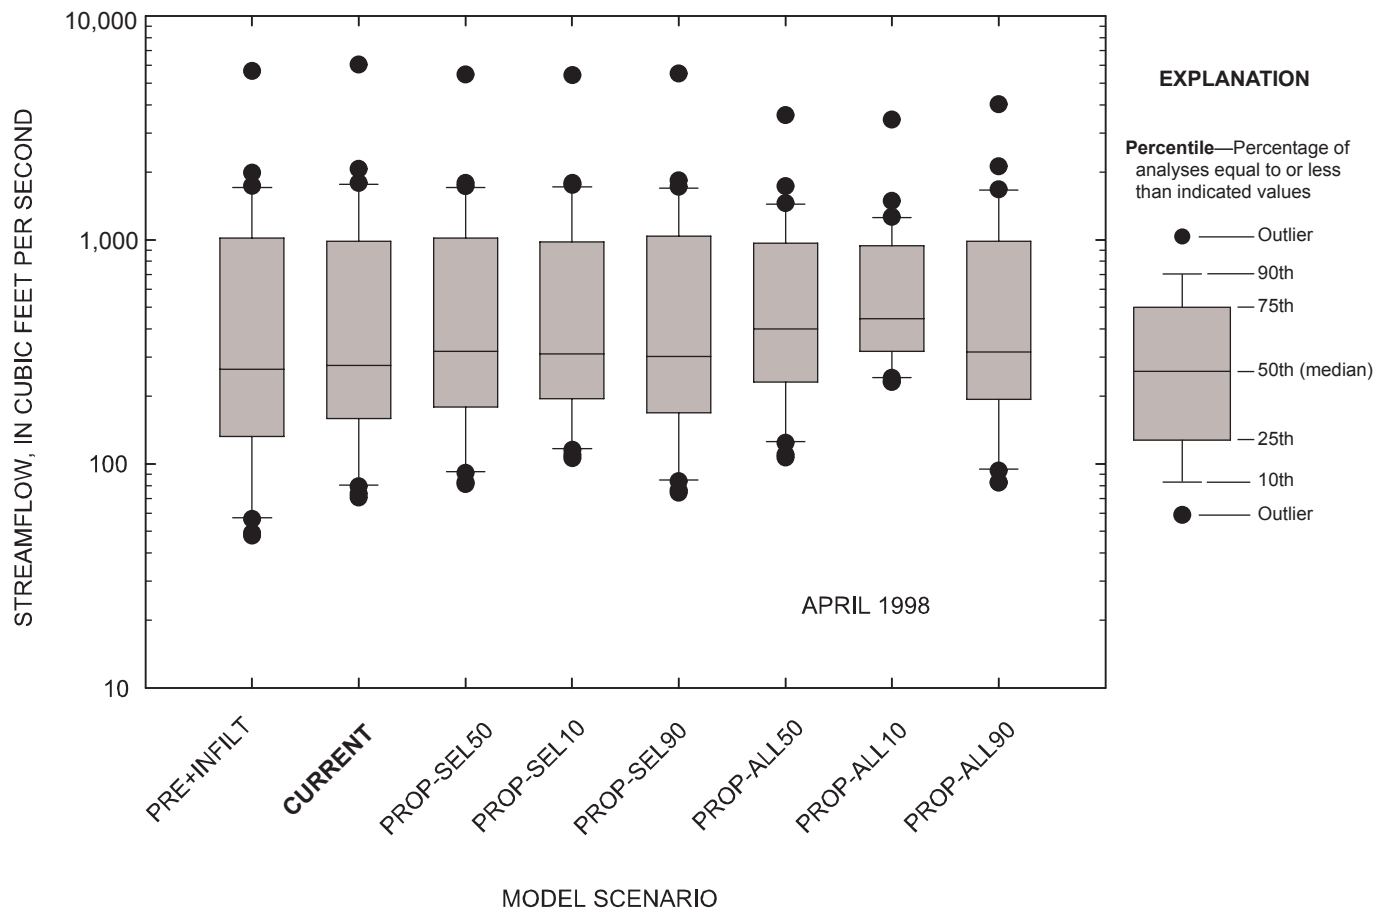
Figure 5-43. Comparison of daily streamflow for observed and simulated conditions at the Marmaton River near the Missouri-Kansas state line, Missouri, April 1998.
