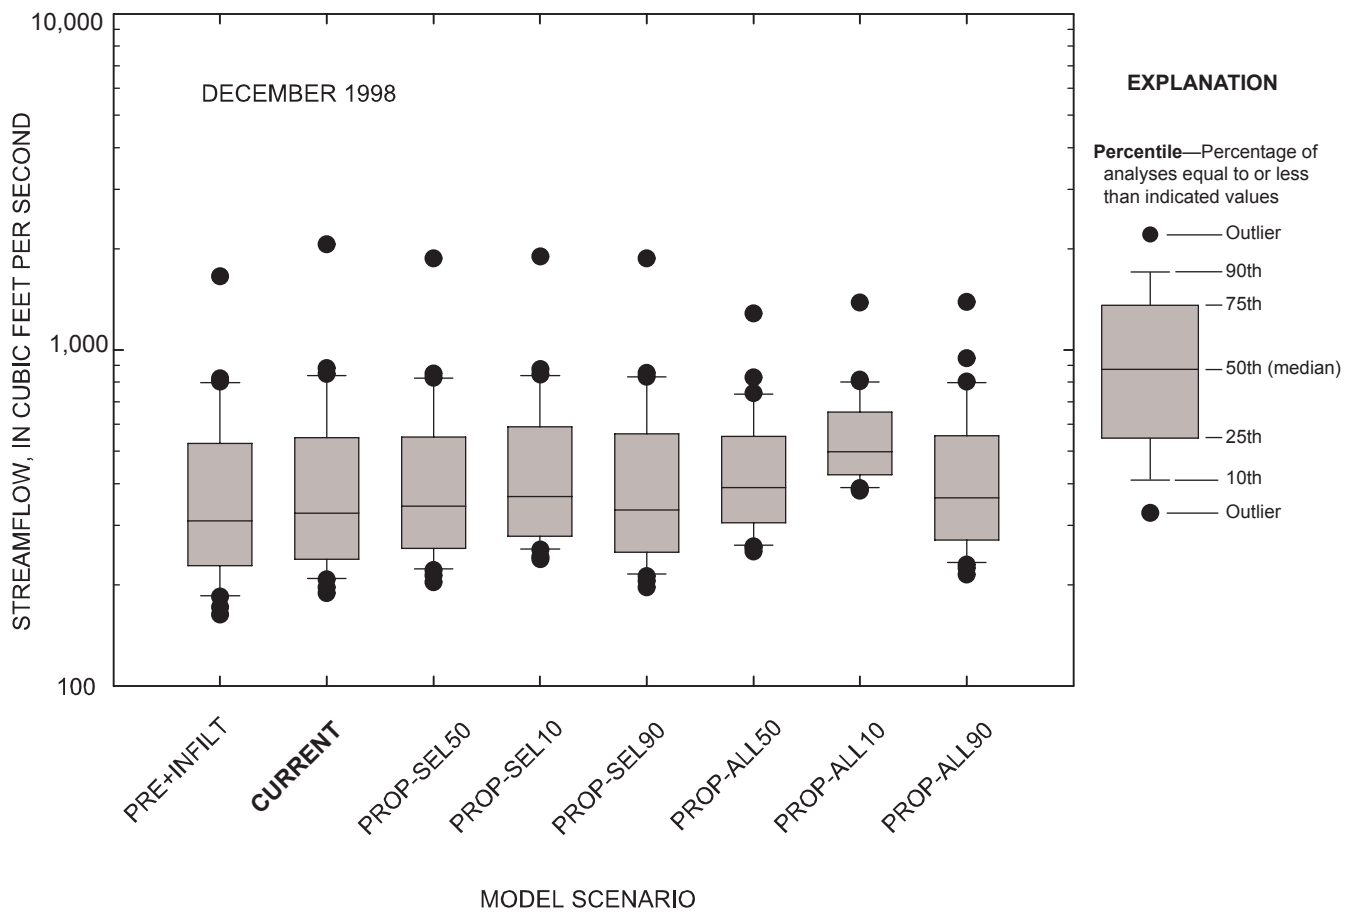
Figure 5-51. Comparison of daily streamflow for observed and simulated conditions at the Marmaton River near the Missouri-Kansas state line, Missouri, December 1998.
