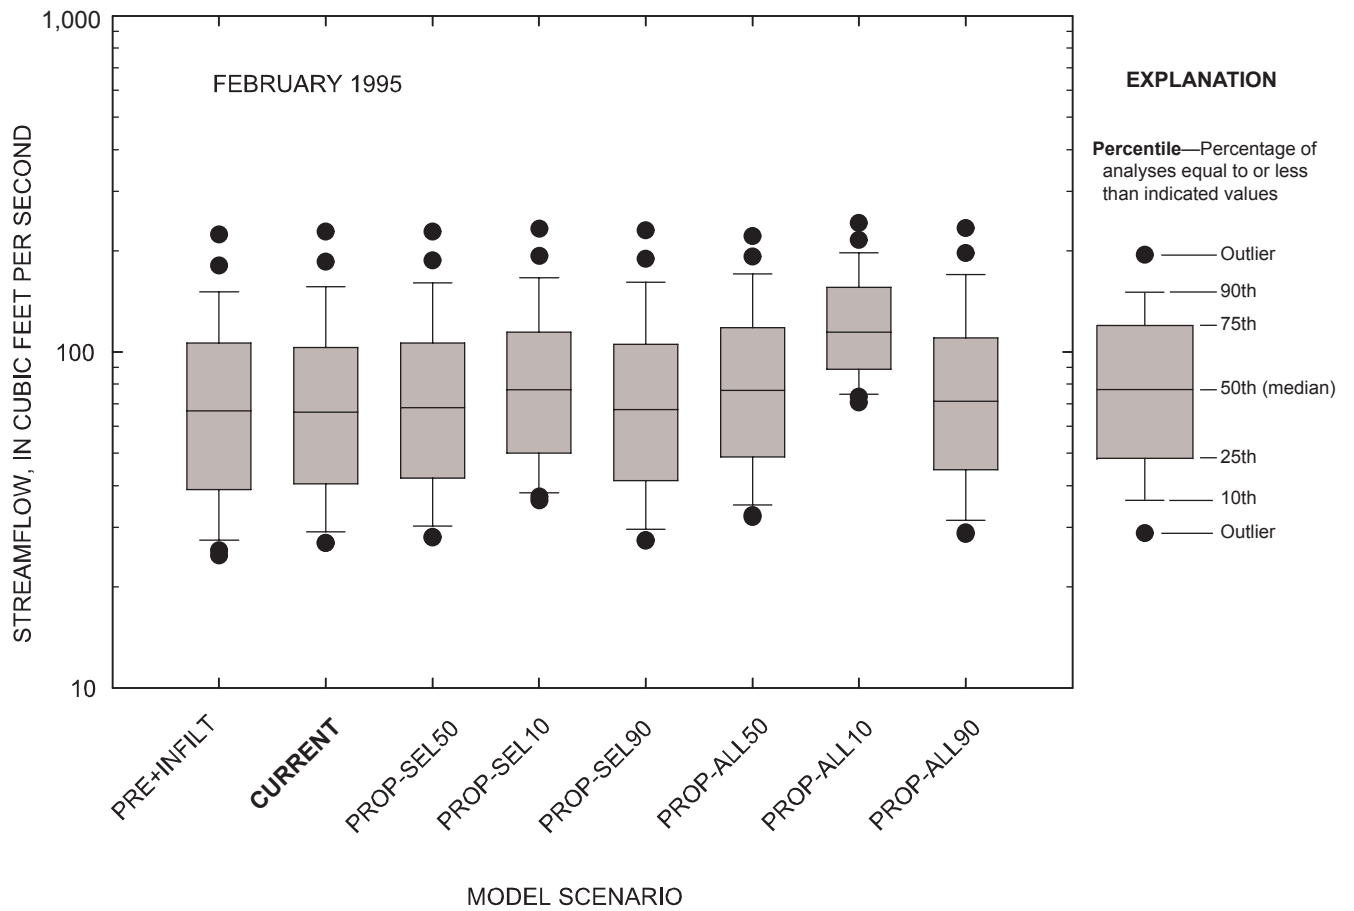
Figure 5-5. Comparison of daily streamflow for observed and simulated conditions at the Marmaton River near the Missouri-Kansas state line, Missouri, February 1995.
