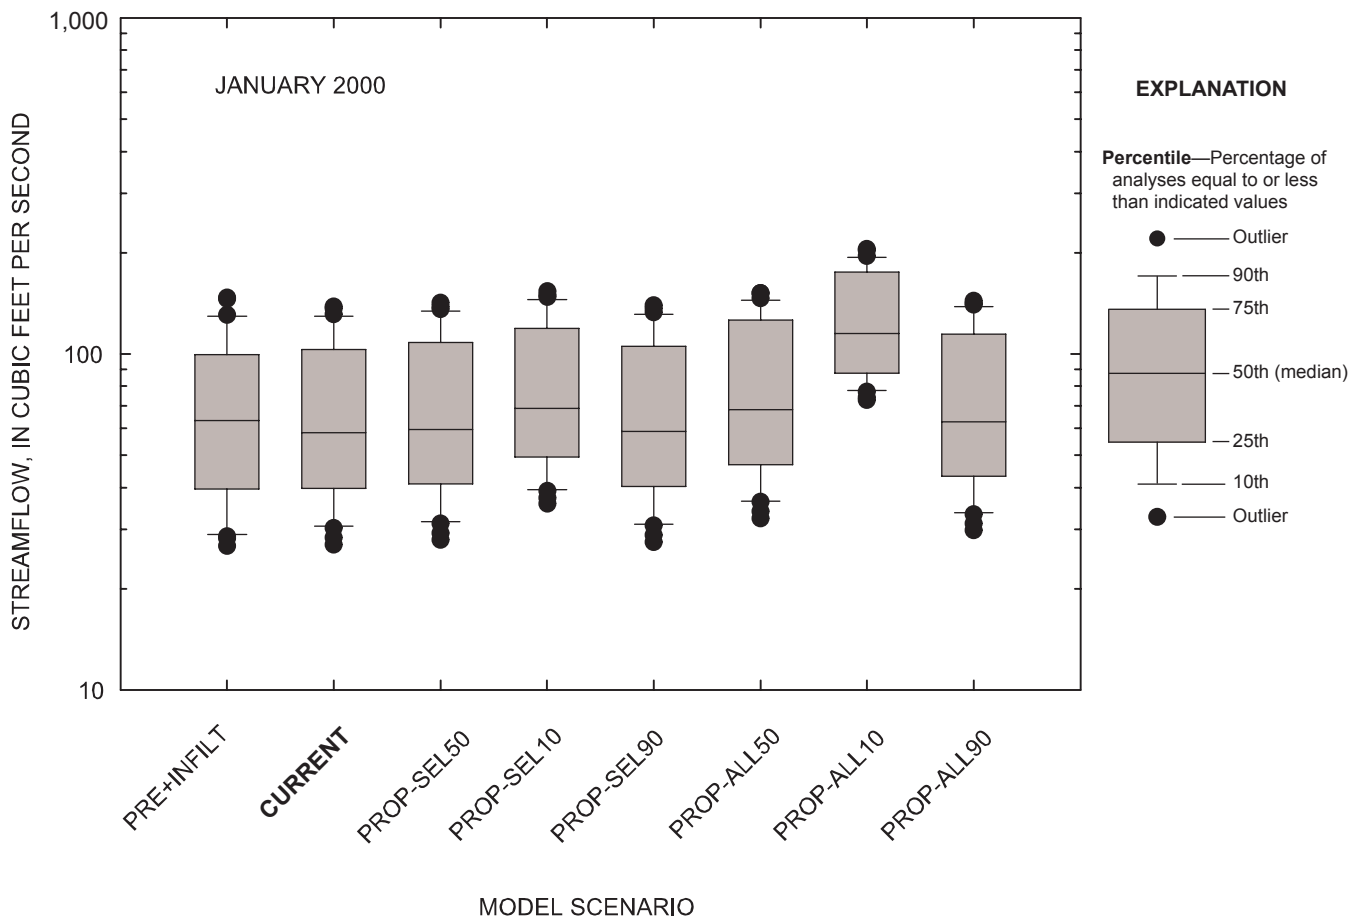
**Figure 5-64.** Comparison of daily streamflow for observed and simulated conditions at the Marmaton River near the Missouri-Kansas state line, Missouri, January 2000.
