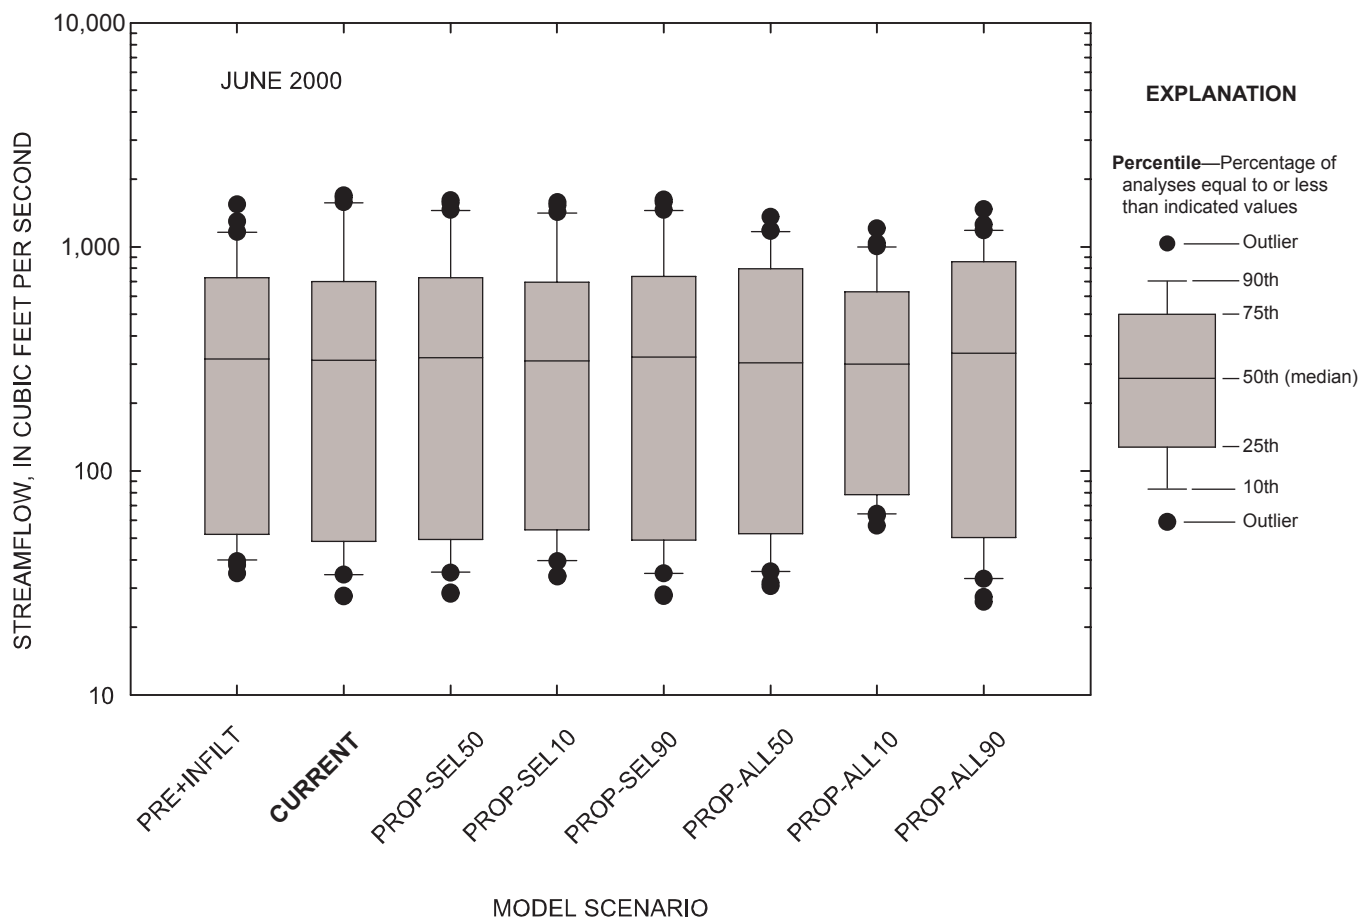
**Figure 5-69.** Comparison of daily streamflow for observed and simulated conditions at the Marmaton River near the Missouri-Kansas state line, Missouri, June 2000.
