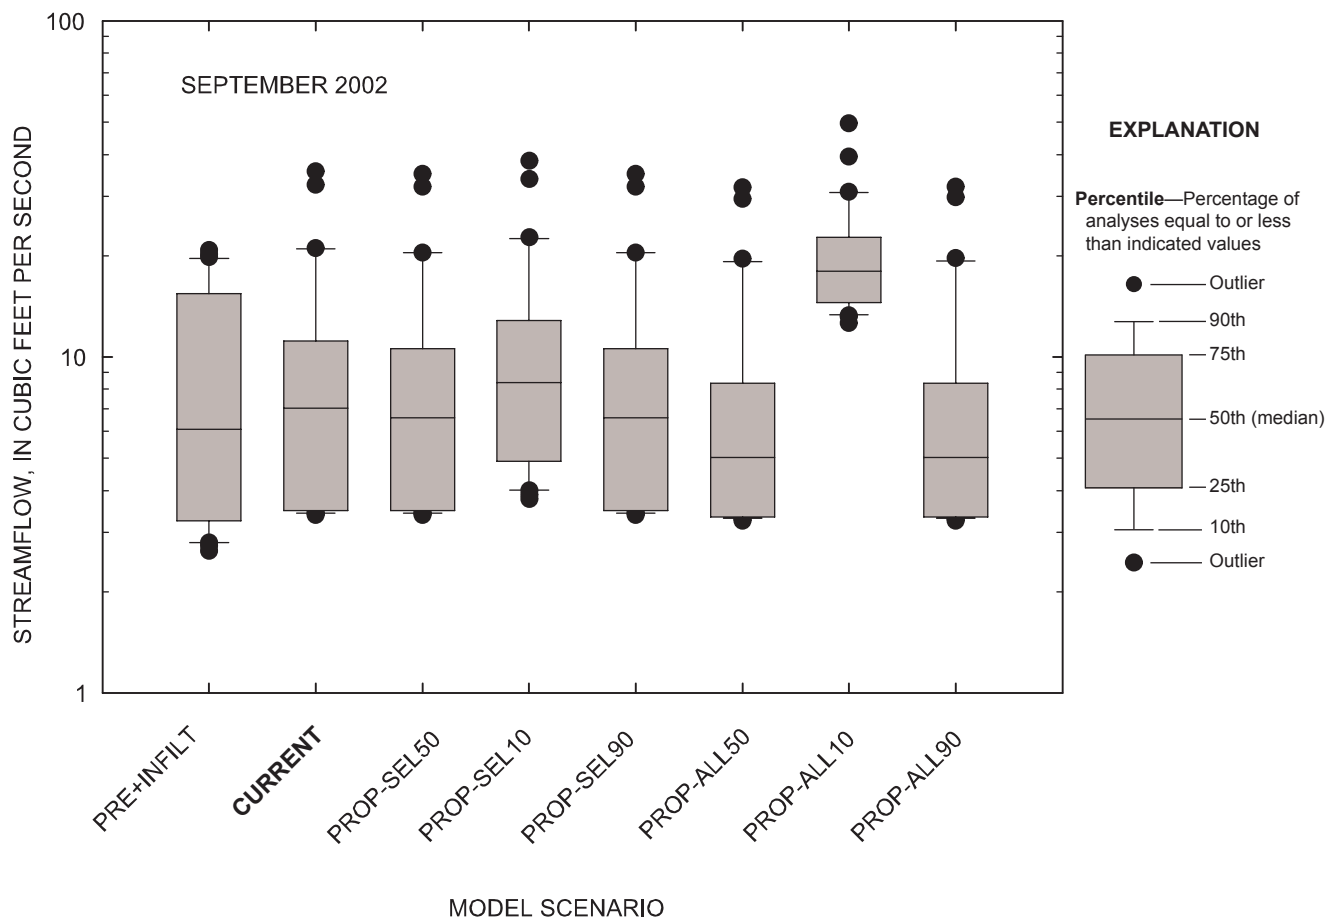
Figure 5-96. Comparison of daily streamflow for observed and simulated conditions at the Marmaton River near the Missouri-Kansas state line, Missouri, September 2002.
