01578310 Susquehanna River at Conowingo, Maryland

(Gaging station in Susquehanna River basin, USGS Maryland Water Science Center)

Review of peak discharge for the flood of June 24, 1972

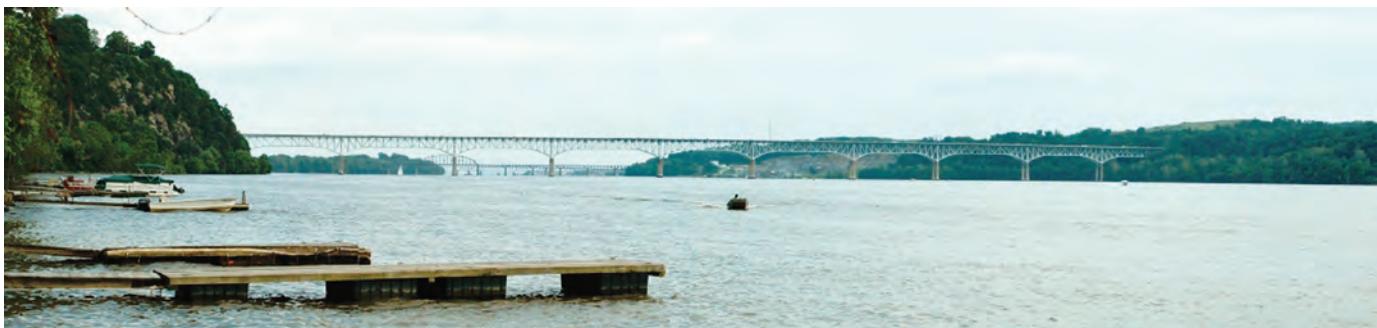
Figure A246. View upstream of Interstate Highway I-95 bridge across Susquehanna River where current-meter measurement was made of June 24, 1972 flood, Susquehanna River at Conowingo, Maryland.

Photograph of bridge where measurement was made is shown in figure A246.

Method of peak discharge determination: The peak discharge is based on a current-meter measurement made at a stage of 36.76 ft, which is 0.06 ft less than the peak stage of 36.83 ft. The measurement was made at Interstate Highway 95, about 6.5 mi downstream of the gaging station. The gaging station is located at Conowingo Dam.
