100-Year, 24-Hour Precipitation Event

By
Heriberto Torres-Sierra and Julieta Gómez-Fragoso
2015

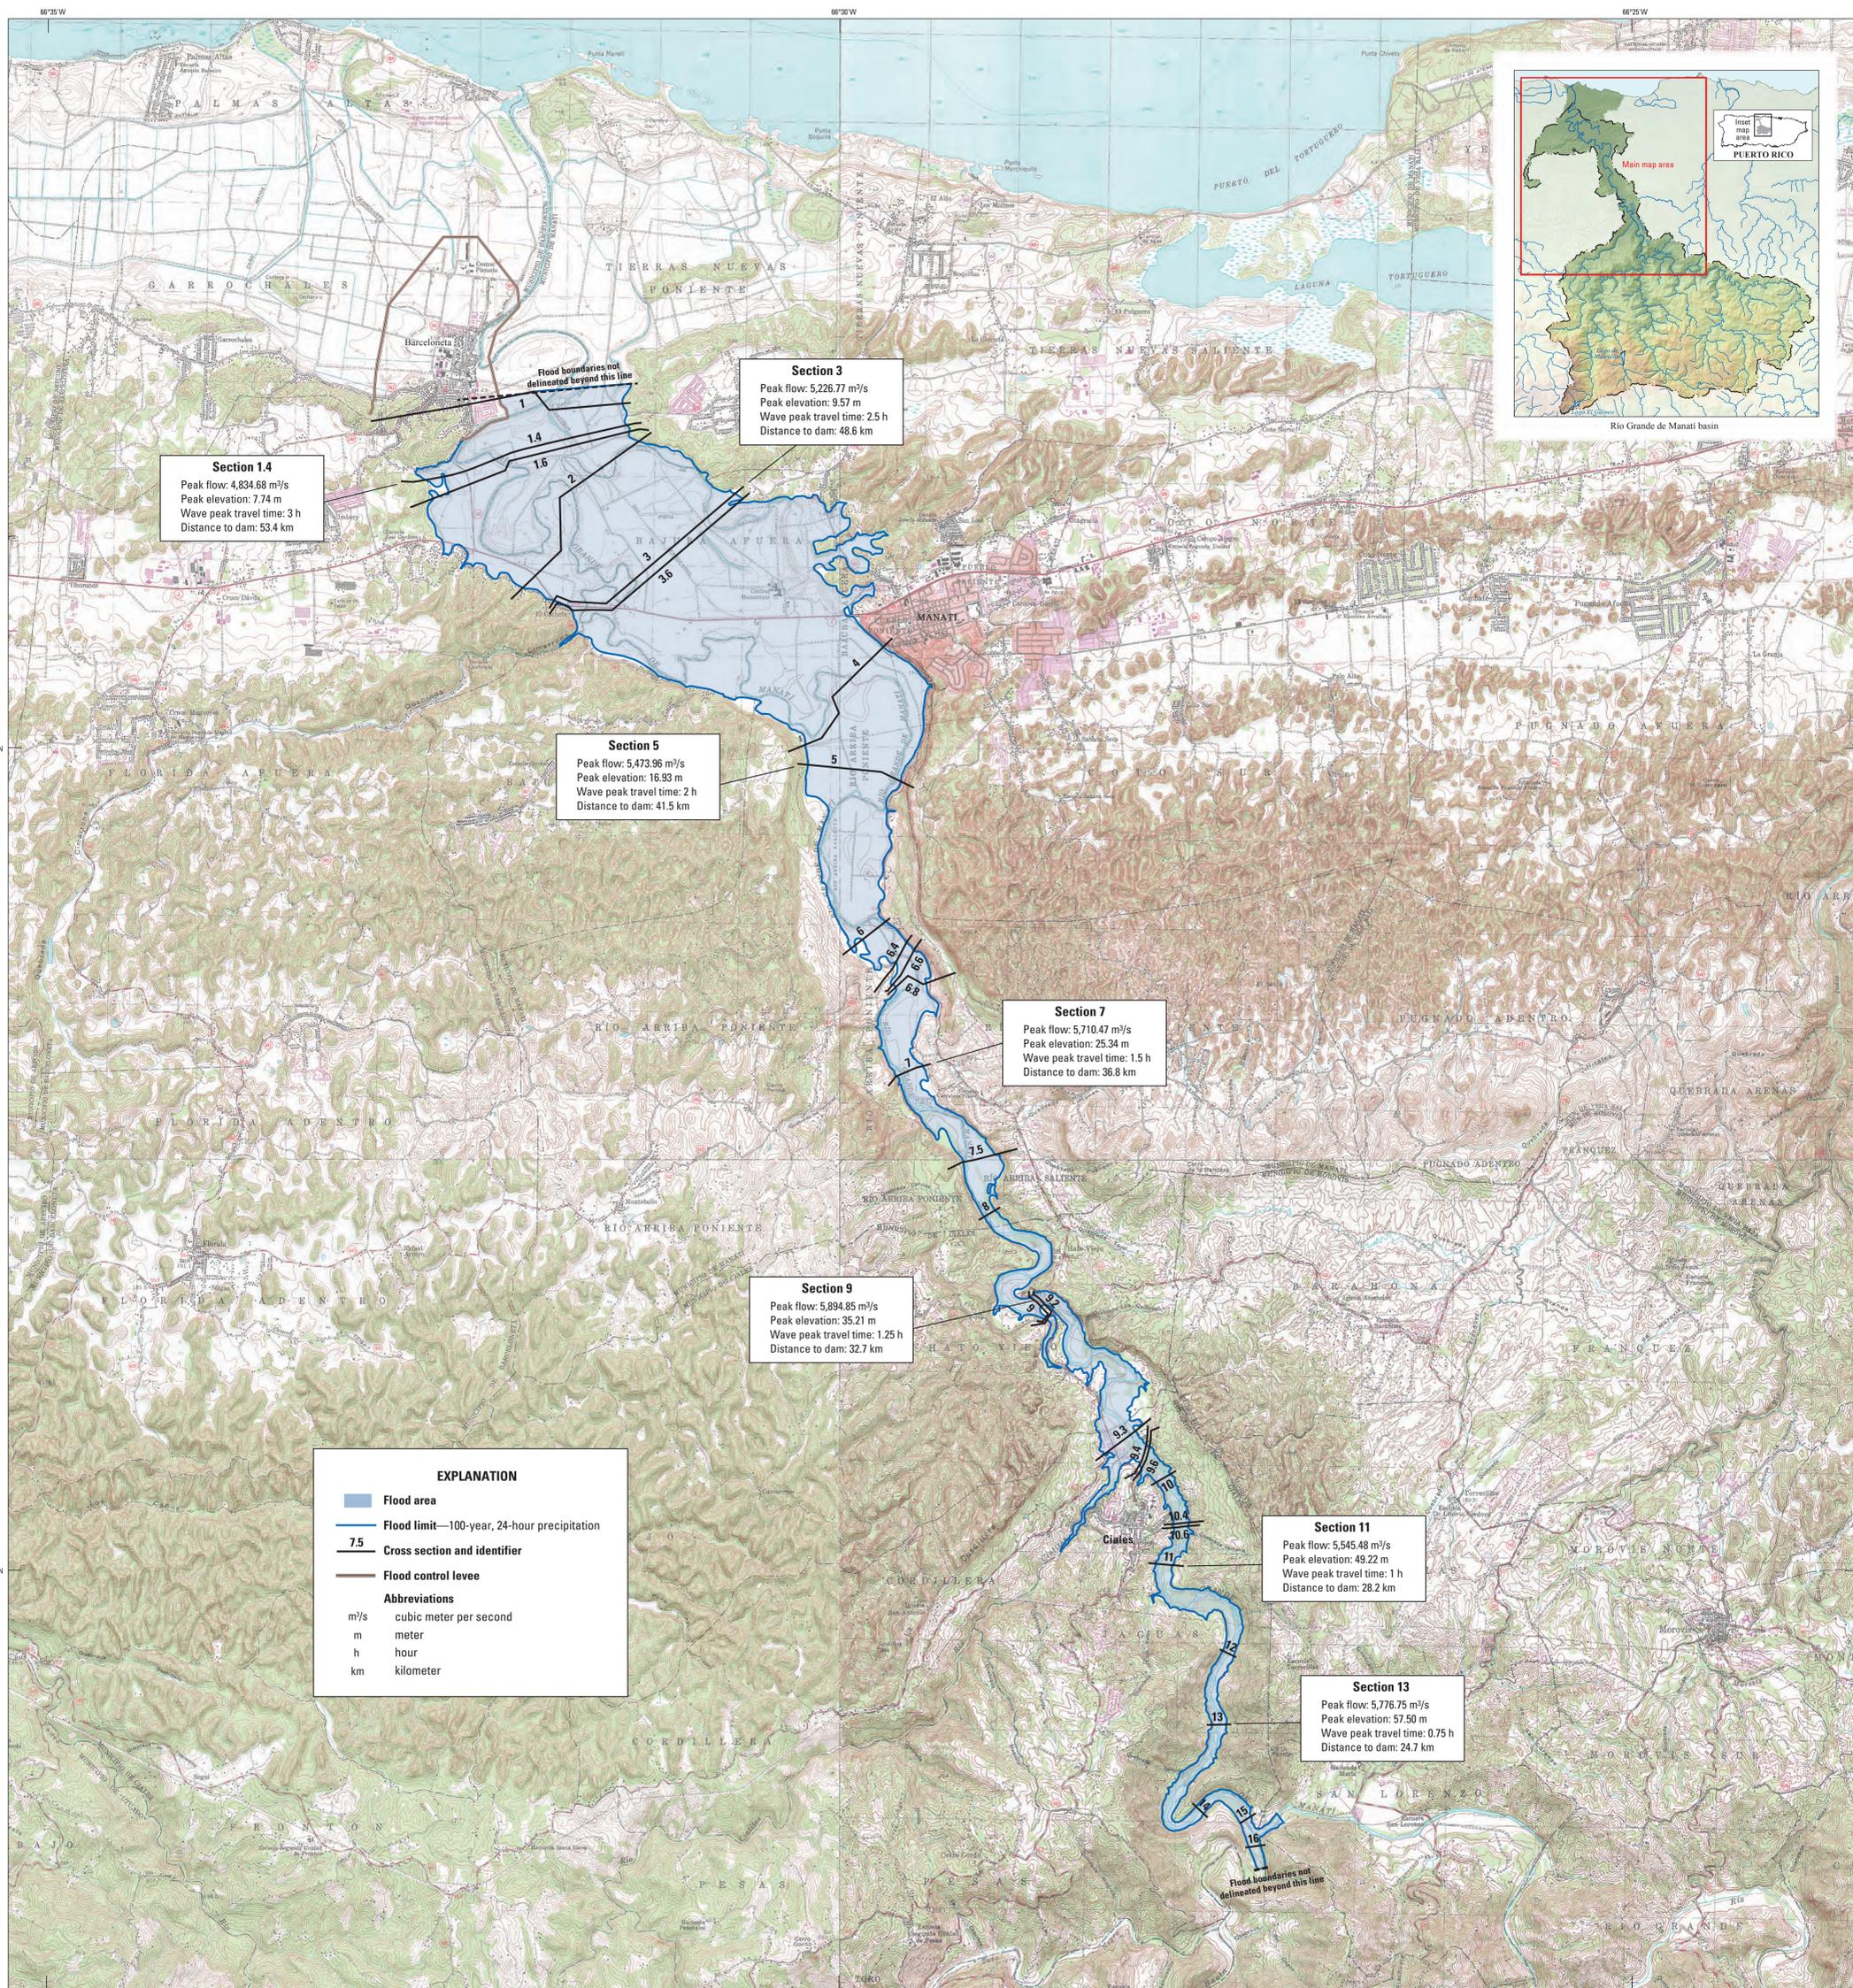
Base modified from U.S. Geological Survey Digital Raster Graphics for Barceloneta, Manatí, Florida, and Ciales, 1:25,000. Elevation from U.S. Geological Survey, National Elevation Dataset (NED). Lambert conformal conic projection, Puerto Rico Datum, 1940 Adjustment. Flood area delineated from hydraulic model results using the U.S. Army Corps of Engineers, Hydrologic Engineer Center's River Analysis System (HEC-RAS).
